Ohio FACE Investigation 990H063 -- A Window Washer Died as the Result of a 40-foot Fall from the Roof of a Three-story Building.

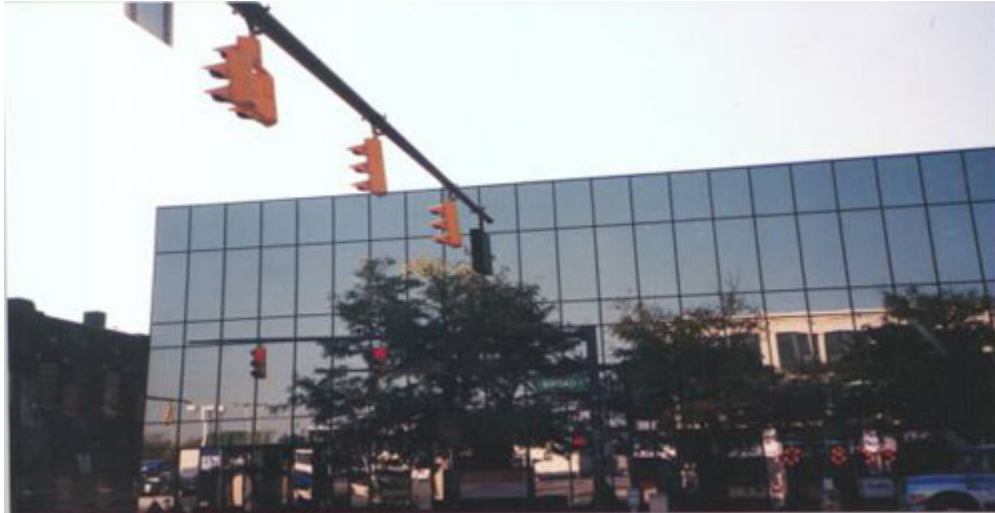
Front View of Building Accident Occurred

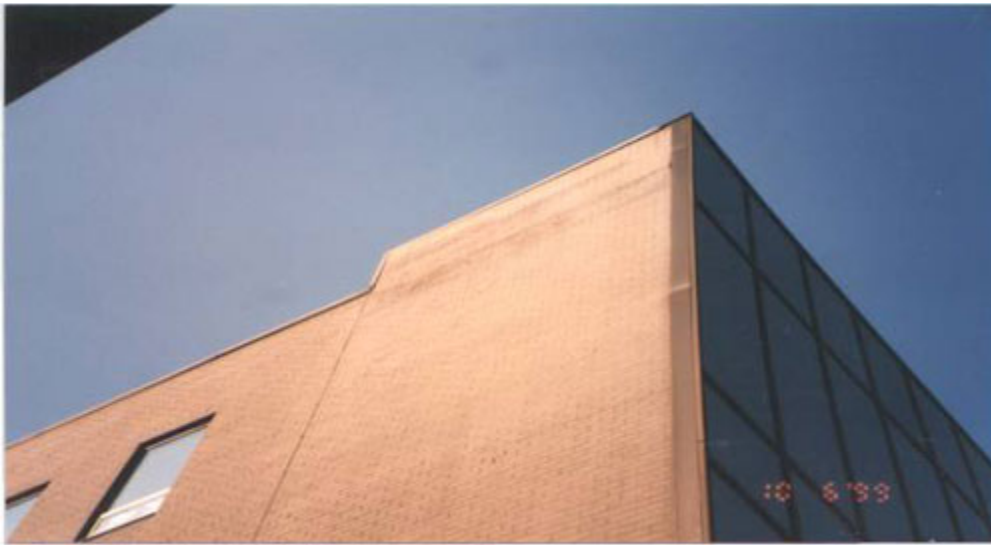
Side of Building Accident Occurred
