## **NIOSH HEALTH HAZARD EVALUATION REPORT:**

**HETA #2002-0347-2910**

**Ocean Bank**

### Evaluation of Magnetic Fields at Ocean Bank

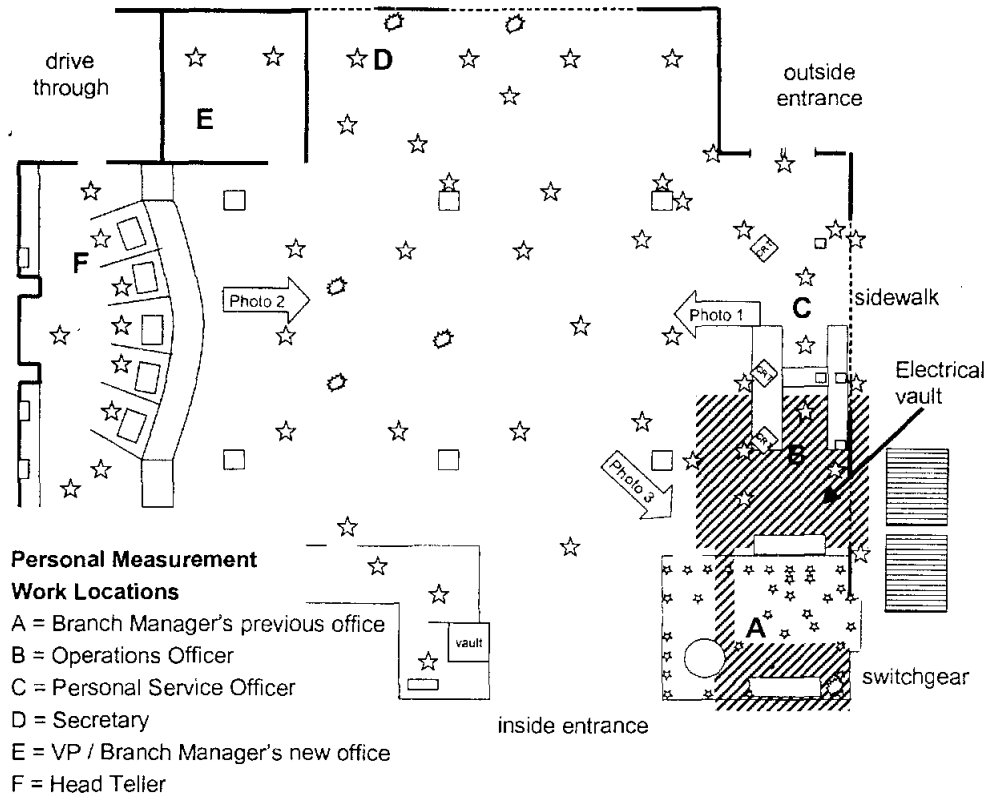
Branch Management office which is above the electrical vault and switchgear equipment (Figures 1 and 2).

**Figure 1.** Ocean Bank Floor Plan. Area and personal magnetic field measurement locations. August 15, 2002.

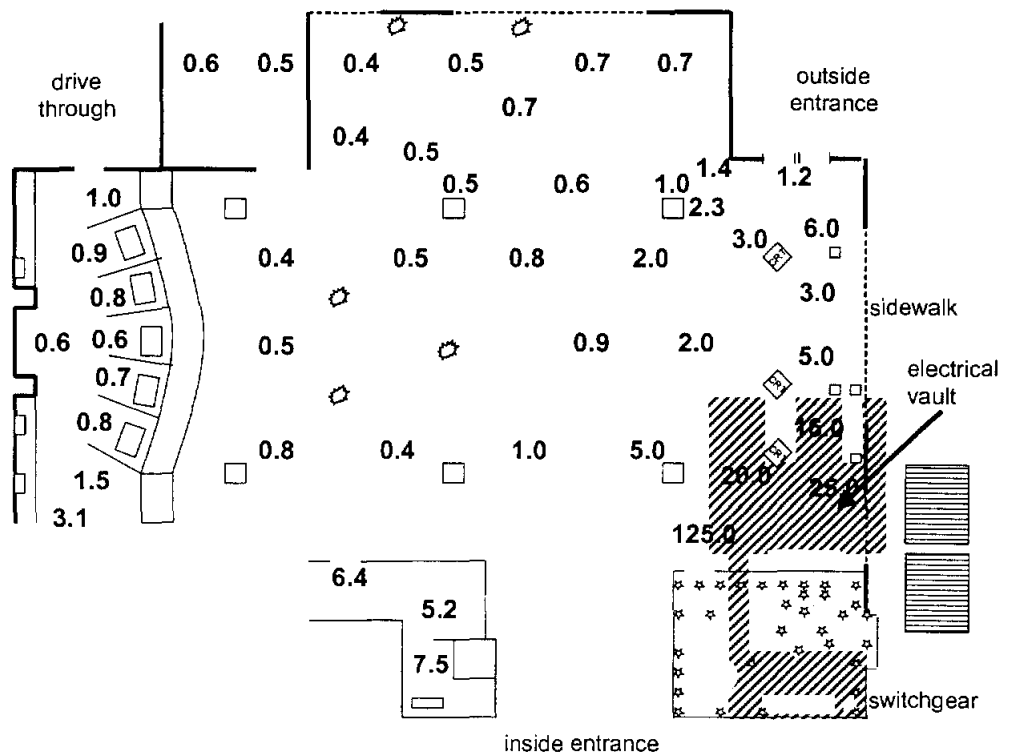
The exposures measured outside the Branch Management office ranged between 0.4 and 125 mG (Figure 2). The highest exposures were measured nearest the Branch Management office which is also located above one of the two electrical vaults servicing this building. The vault below the office is the original vault to the building and the other vault is located on another floor within the building, contributing no EMF exposures within the Ocean Bank.

**Figure 2.** Ocean Bank Floor Plan. Area magnetic field measurement results (milligauss, mG). August 15, 2002. All measurements were obtained about 40 inches from the ground.

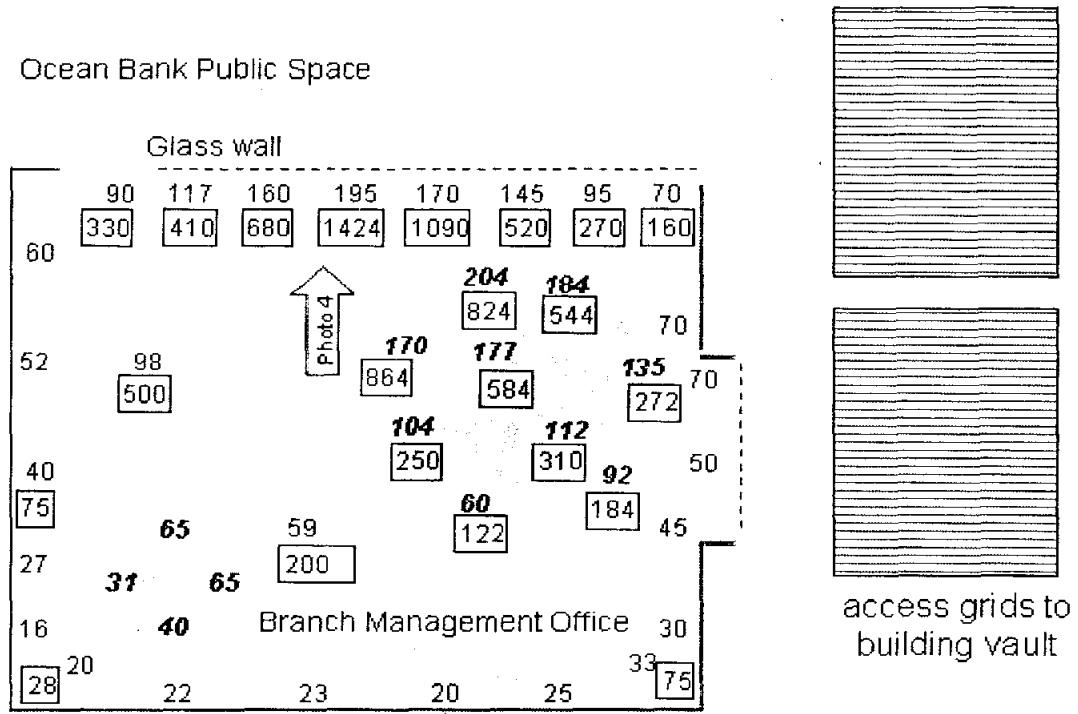
The exposures measured inside the Branch Management office ranged between 16 and 1,424 mG (Figure 3). The highest exposures were measured at the floor level and followed a pattern consistent with the location of the electrical vault and the connection line to the switchgear equipment.

**Figure 3.** Ocean Bank, Branch Management Office magnetic field measurement results. August 15, 2002. HETA #20020347.

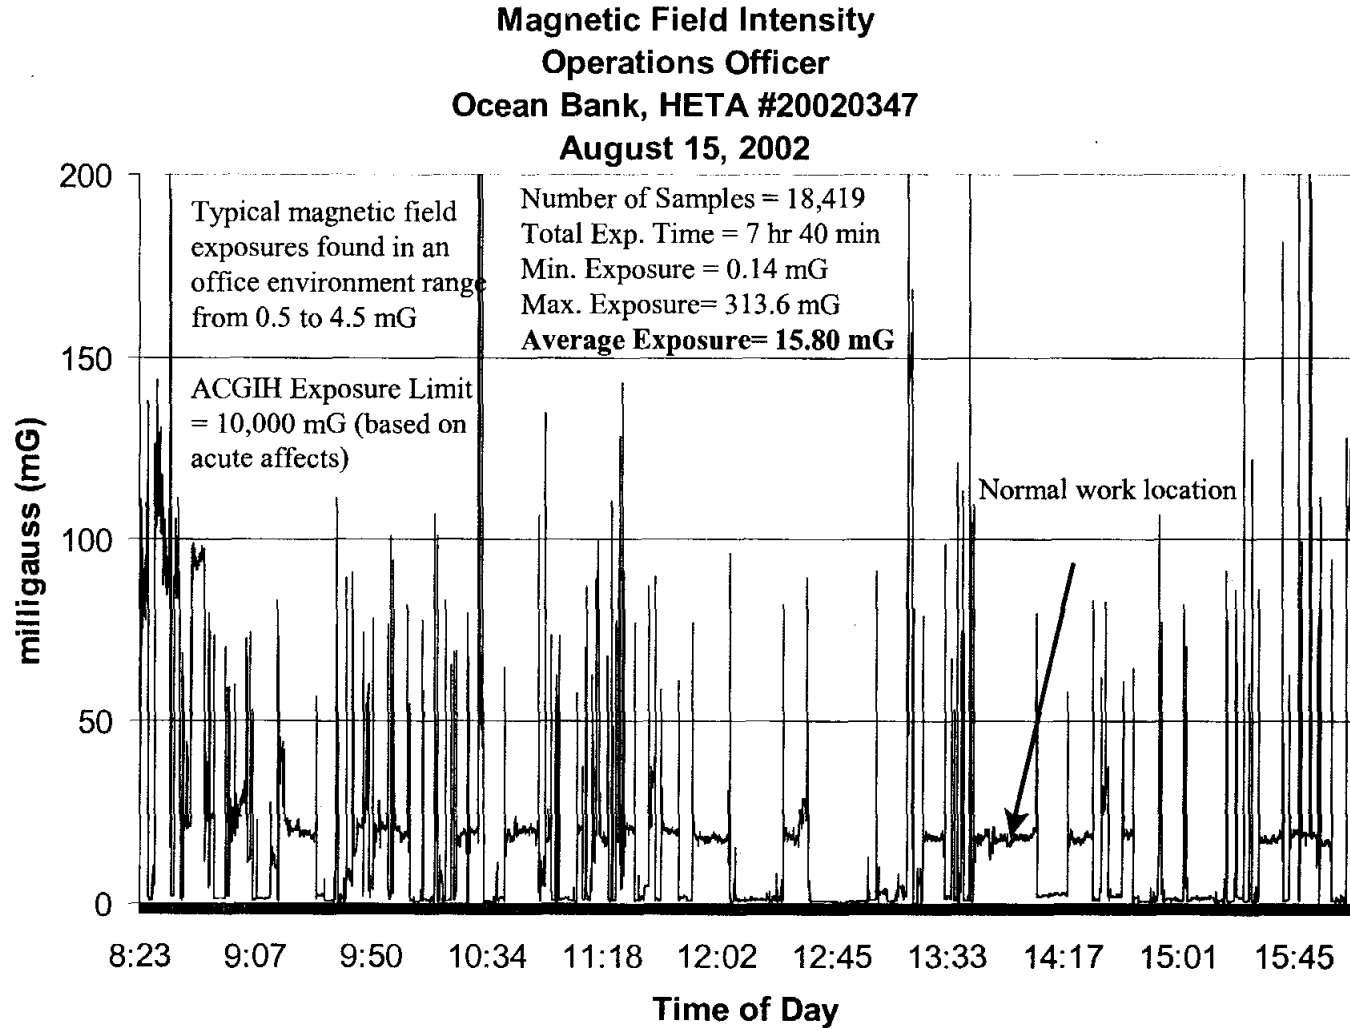
locations throughout the bank. The movement patterns during the monitoring period (7 hours and 40 minutes) are illustrated in Figure 4. The average personal magnetic field measurement was 15.8 mG, ranging between 0.14 mG and 313.6 mG. The personal exposure profile shows that the area and personal magnetic field measurements correlate when the worker was at the normal work station.

**Figure 4.** Time-magnetic field intensity relationship for Operations Officer. Work location is designated as B on Figure 1.

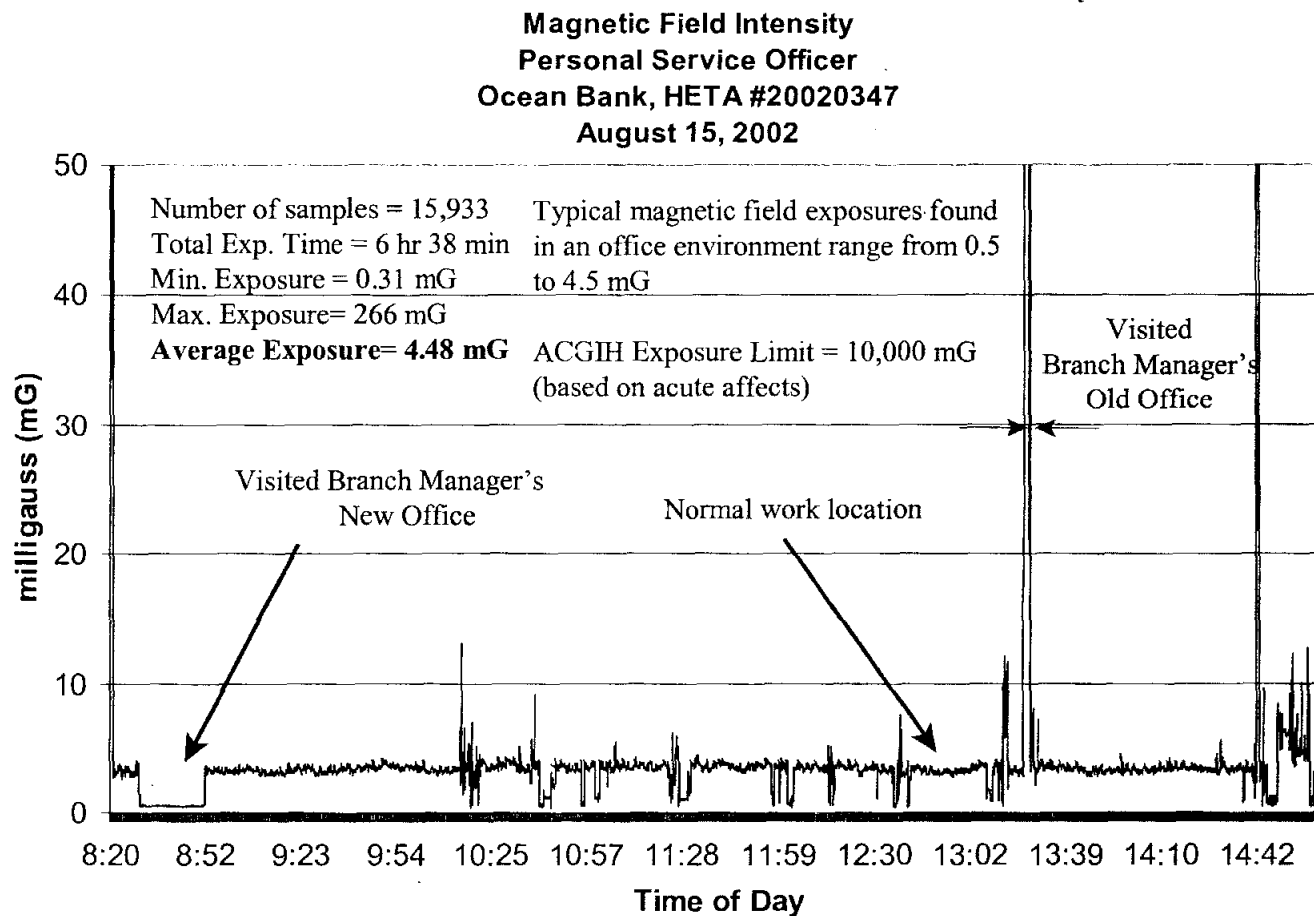
The Personal Service Officer work location is designated as “C” on Figure 1 and is near the public entrance. Area magnetic field measurements (40 inches above the floor) in this general work area ranged between 0.7 mG and 1.4 mG. The Personal Service Officer activities were completed primarily at this work location and resulted in an average personal exposure of 4.48 mG, ranging between 0.31 mG and 266 mG. The movement patterns during the monitoring period (6 hours and 38 minutes) show that the area and personal magnetic field measurements correlate with the worker’s normal work station (Figure 5).

Figure 5. Time-magnetic field intensity relationship for Personal Service Officer. Work location is designated as C on Figure 1.

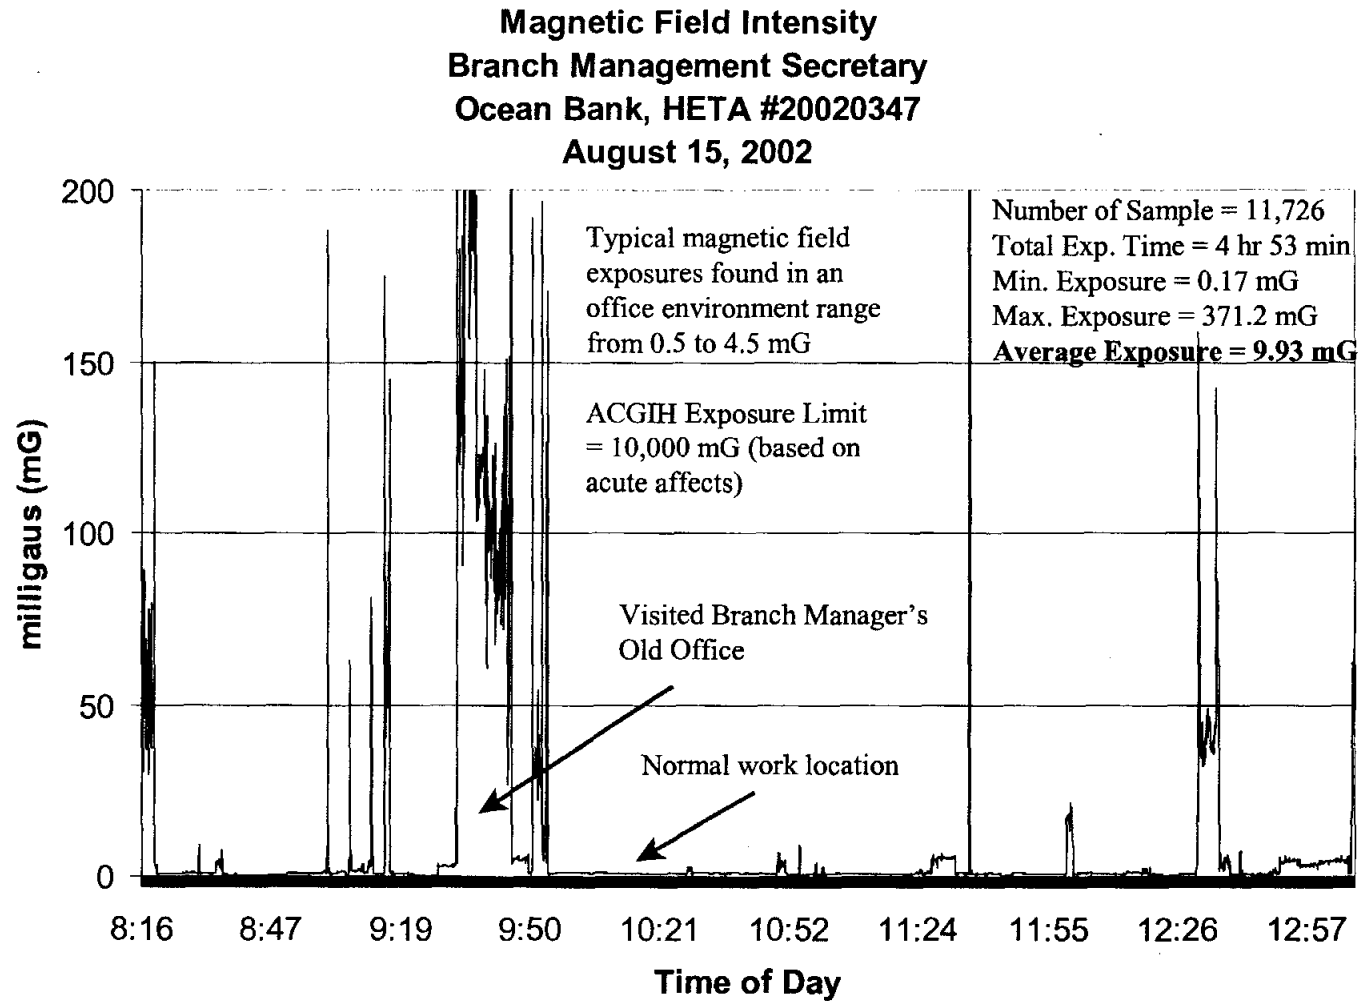
The Branch Management Secretary work location is designated as “D” on Figure 1. Area magnetic field measurements (40 inches above the floor) in this general work area ranged between 0.4 and 0.5 mG. The Branch Management Secretary activities were completed primarily at this work location and resulted in an average personal exposure of 9.93 mG, ranging between 0.17 mG and 371.2 mG. The movement patterns during the monitoring period (4 hours and 53 minutes) show that the area and personal magnetic field measurements correlate with the worker’s normal work station (Figure 6). During periods of high magnetic field exposures (9:30 to 10:00 a.m.), this individual met with the NIOSH investigator in the vacated Branch Management office. Other periods with smaller but elevated magnetic field exposures resulted from the worker’s movement in or around the vacated Branch Management office.

**Figure 6.** Time-magnetic field intensity relationship for Branch Management Secretary. Work location is designated as D on Figure 1.

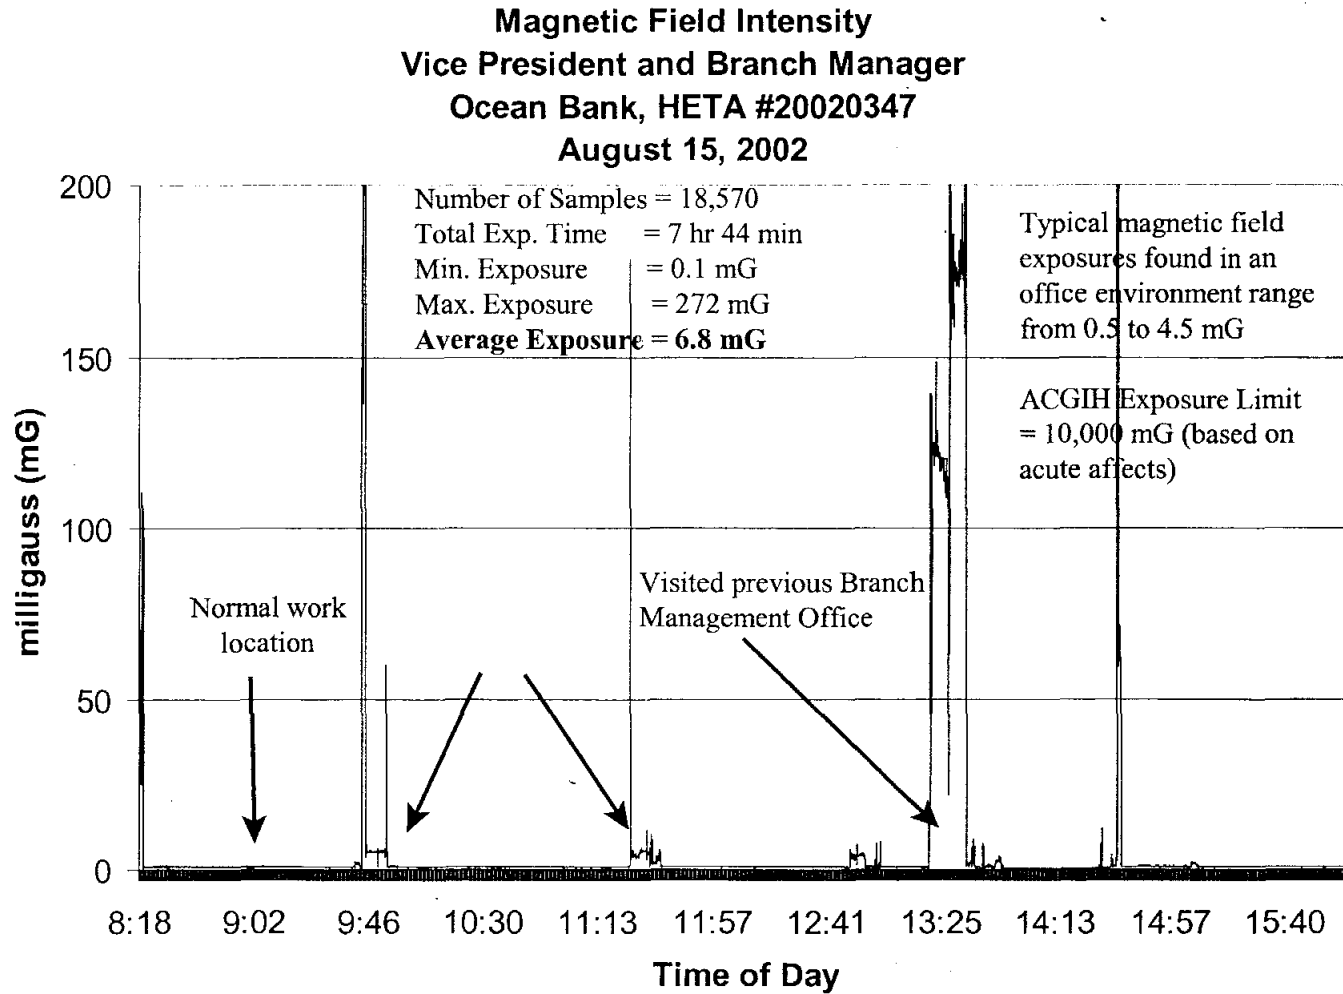
The Vice President and Branch Manager work location is designated as "E" on Figure 1. Area magnetic field measurements (40 inches above the floor) in this general work area ranged between 0.5 and 0.6 mG. The work activities were completed primarily at this work location and resulted in an average personal exposure of 6.8 mG, ranging between 0.1 mG and 272 mG. The movement patterns during the monitoring period (7 hours and 44 minutes) show that the area and personal magnetic field measurements correlate with the worker's normal work station (Figure 7). During periods of higher magnetic field exposures, this individual met with the Operations Officer near the vacated Branch Management office. Other periods with smaller but elevated magnetic field exposures resulted from the worker's movement in or around the vacated Branch Management office.

**Figure 7.** Time-magnetic field intensity relationship for Vice President and Branch Manager. Work location is designated as E on Figure 1.

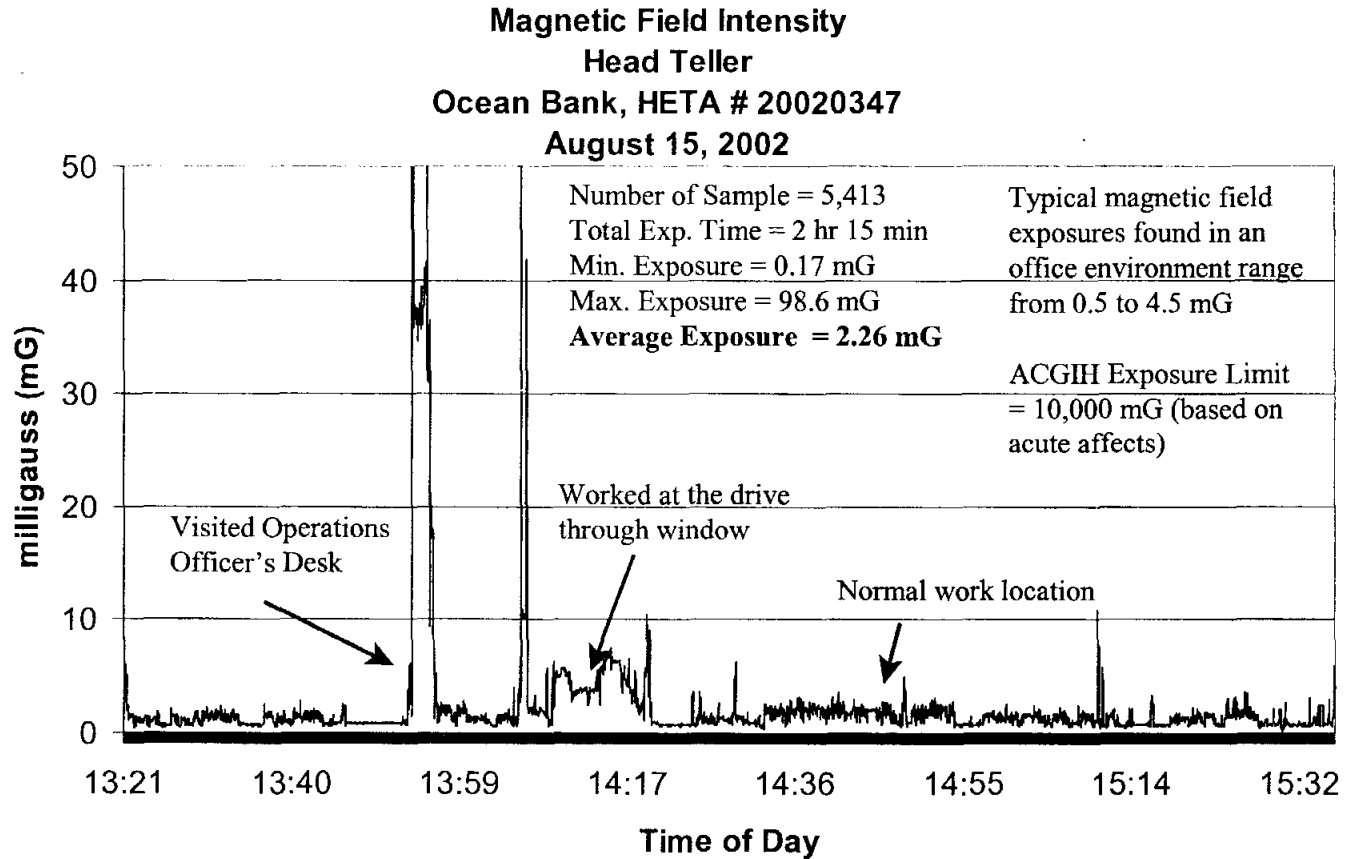
location and resulted in an average personal exposure of 2.26 mG, ranging between 0.17 mG and 98.6 mG. The movement patterns during the monitoring period (2 hours and 15 minutes) show that the area and personal magnetic field measurements correlate with the worker's normal work station (Figure 8). During periods of higher magnetic field exposures, this individual met with the Operations Officer near the vacated Branch Management office. Other periods with smaller but elevated magnetic field exposures resulted from the worker's movement in or around the drive-through window office space.

**Figure 8.** Time-magnetic field intensity relationship for Head Teller. Work location is designated as F on Figure 1.

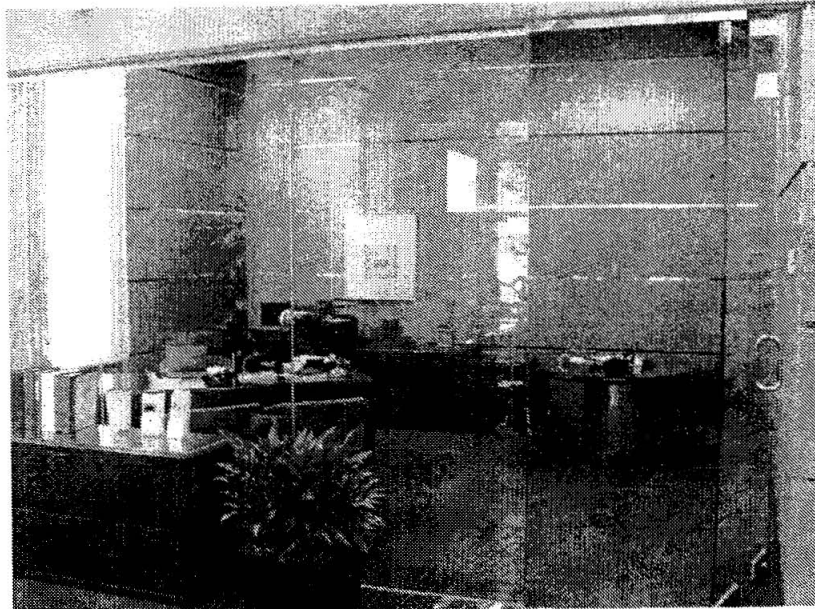
**Photo 3.** View looking into Branch Management Office. The electrical vault that services the building is below this space. August 15, 2002. HETA # 2002-0347.

1. Installing magnetic shielding on the floor of the bank.
2. Increasing the distance from, and reducing the time workers spend in the high magnetic field area by relocating employees to other work areas within the bank. This may result in unused office space which could be regained if the bank entrance was relocated above the electric vault. This recommendation may be more a reliable and cost effective approach toward reducing worker exposures than installing shielding.
3. Requesting FP&L to rewire the vault to reduce magnetic field emissions.
