Evaluation of respiratory and other health concerns at a law enforcement office building with indoor environmental quality issues

HHE Report No. 2018-0157-3369

February 2020

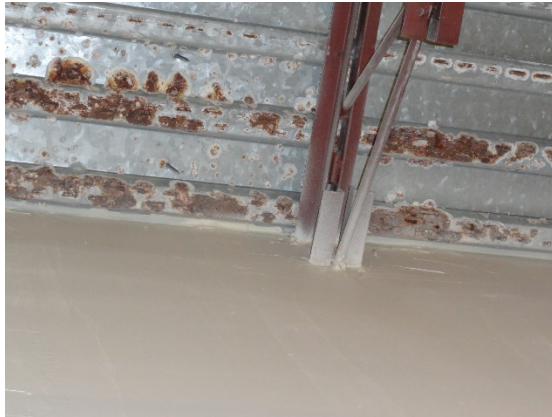
- We observed rust on the metal roof in the evidence room and room 129 (Figures 1 and 2).

Figure 1. Rust on ceiling in the evidence room. Photo by NIOSH.

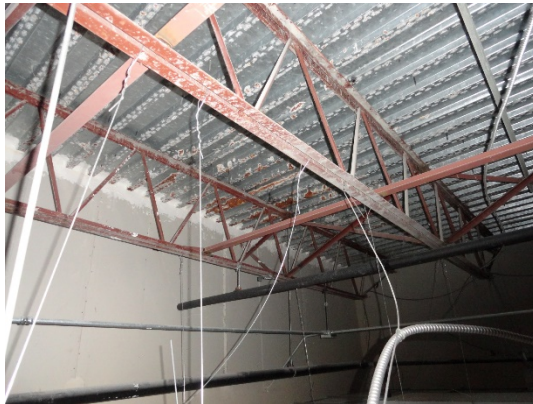
Figure 2. Rust on metal roof above the ceiling tiles in room 129. Photo by NIOSH.

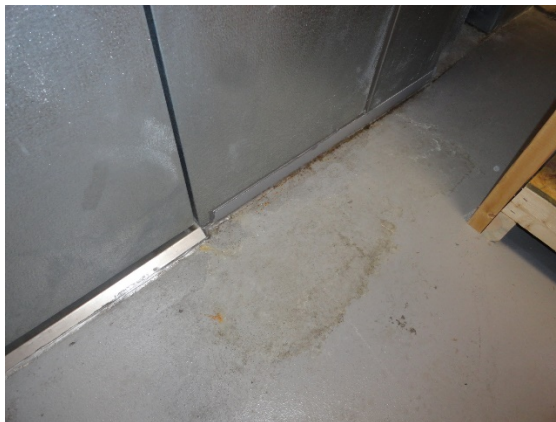
- We observed visible water damage/stains in front of the refrigerator and between the walk-in freezer and refrigerator in the evidence area (Figures 3 and 4).

Figure 3. Visible water damage/stains in front of the walk-in refrigerator in evidence area. Photo by NIOSH.

In Room 138, ESi noted water on the floor from an apparent leak or condensation issues. The wall behind and between the walk-in refrigerator and freezer was damp and had some visible mold. ESi recommended repair of the leak and replacement of damaged drywall. ESi observed significant dust accumulation in the following areas: 1) on a water sprinkler pipe above the files shelves in Room 138 2)

- Ensure dehumidifiers used to dry the evidence are cleaned and maintained regularly according to the manufacturer's recommendations.
 - Continue to work towards eliminating any condensation issues related to the walk-in refrigerator and freezer in the evidence room.

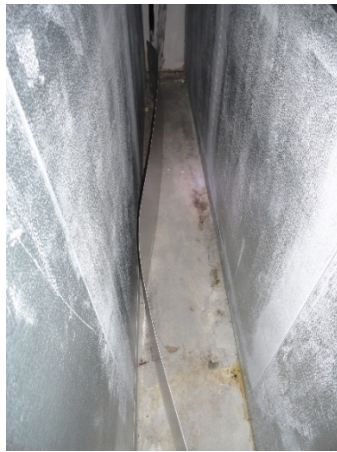
Figure 4. Visible water damage/stains between the walk-in freezer and refrigerator in the evidence area. Photo by NIOSH.

- Hidden moisture, mold, and bat droppings were found in wall cavities.
 - Mold was observed on the backside of drywall in a wall between the evidence refrigerator and freezer. Tape lift samples confirmed mold. Condensation on the coolant piping was causing mold growth on the drywall.

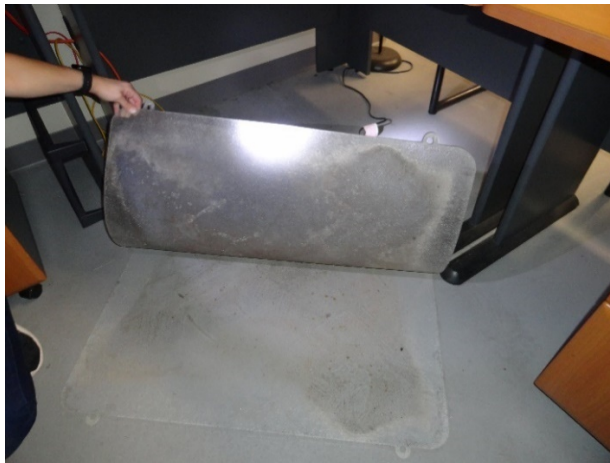
- We observed visible stains and a mold odor under a plastic mat on concrete floor (Figure 5).

Figure 5. Visible stains and mold odor under plastic mat on concrete floor in the evidence room. Photo by NIOSH.

- Visible mold was observed below a vinyl floor tile in the southeast common hallway.
 - A musty odor and visible mold were observed below a plastic floor mat on concrete in the Evidence Reception Room 134.

- The consultants noted that carpet tiles and adhesive created a vapor barrier at the top of the slab resulting in condensation and mold growth on the backside of the carpet tiles. They noted a similar issue was occurring on the backside of the vinyl flooring in the corridor and under plastic mats on concrete in the Evidence Reception Room.

- Remove mold and moisture-damaged flooring and any other damaged materials such as plastic floor mats and vinyl wall base.
- Remediate the mold on the concrete slab and old wood framing in the wall cavities according to the guidance below.

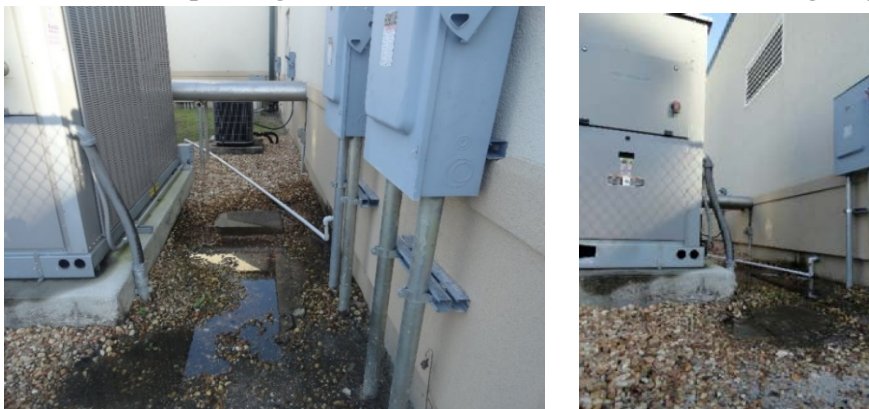
- We observed water pooling under the fresh air intake near the emergency generator (Figure 6).

Figure 6. Water pooling under fresh air intake near the emergency generator. Photos by NIOSH.

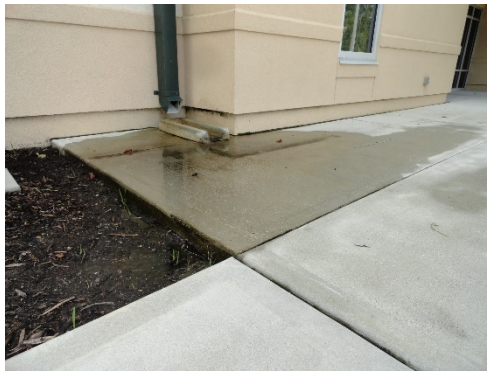
- We observed runoff from the roof accumulating at the foundation of the building allowing for potential water infiltration into the building. Water was pooling in mulch and against the building from some down spouts (Figures 7 and 8).

Figure 7. Water pooling in mulch and against building from downspout at front of building. Photo by NIOSH.

1. Seal penetrations through the EIFS cladding at the rear and west sides of the building.
2. Seal tops and sides of electrical boxes to prevent water intrusion.
3. Regrade the east side to provide a grade level slightly below floor level and positively sloped into the swale. Dig the swale deeper as needed. The consultant report noted the county was performing this work under a separate contract.
4. Cut in and install trench drains at the front and rear paving adjacent to the building to eliminate standing water against the building. The consultant report noted the county was performing this work under a separate contract.
5. Evaluate base of the concrete wall on the south side of the Main Evidence Storage Room and seal as necessary.
6. Evaluate gutter drainage away from the building and repair as necessary.

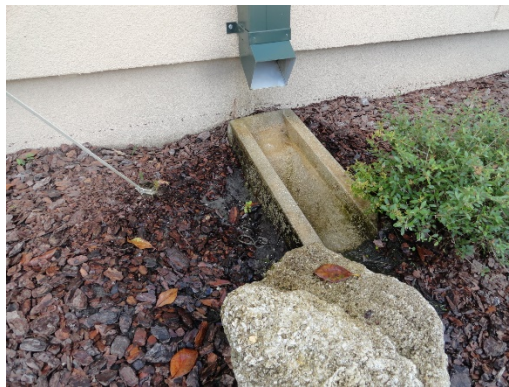
Figure 8. Water pooling in mulch and against building near outdoor patio space. Photo by NIOSH.

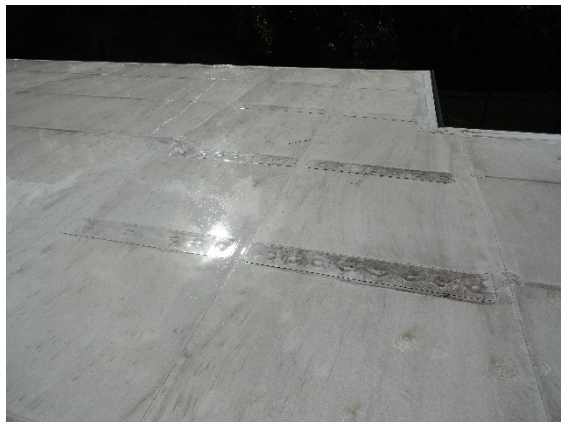
- We observed patches on the roof, indicating a possible mechanism for past water intrusion (Figure 9).

Figure 9. Patching on roof. Photo by NIOSH.

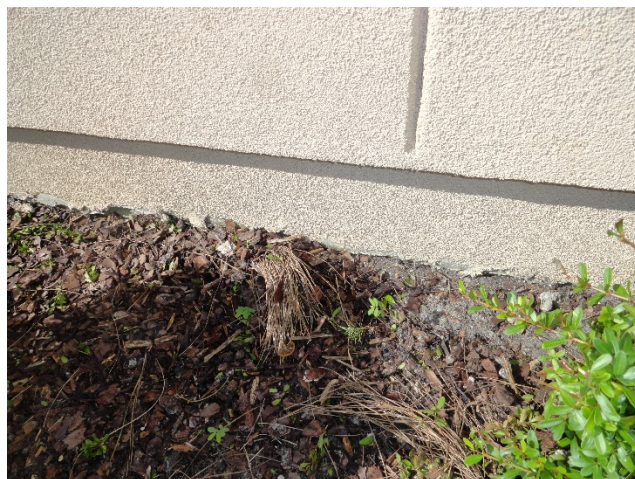
- We observed areas of exposed cement block at the base of the exterior wall, allowing for potential water infiltration into the building. (Figure 10).

Figure 10. Exposed cement block near the base of exterior wall. Photo by NIOSH.
