# Evaluation of Odors and Surface Residues in a Medical Center Research Facility

HHE Report No. 2013-0117-3247  
March 2016

U.S. Department of Health and Human Services  
Centers for Disease Control and Prevention  
National Institute for Occupational Safety and Health

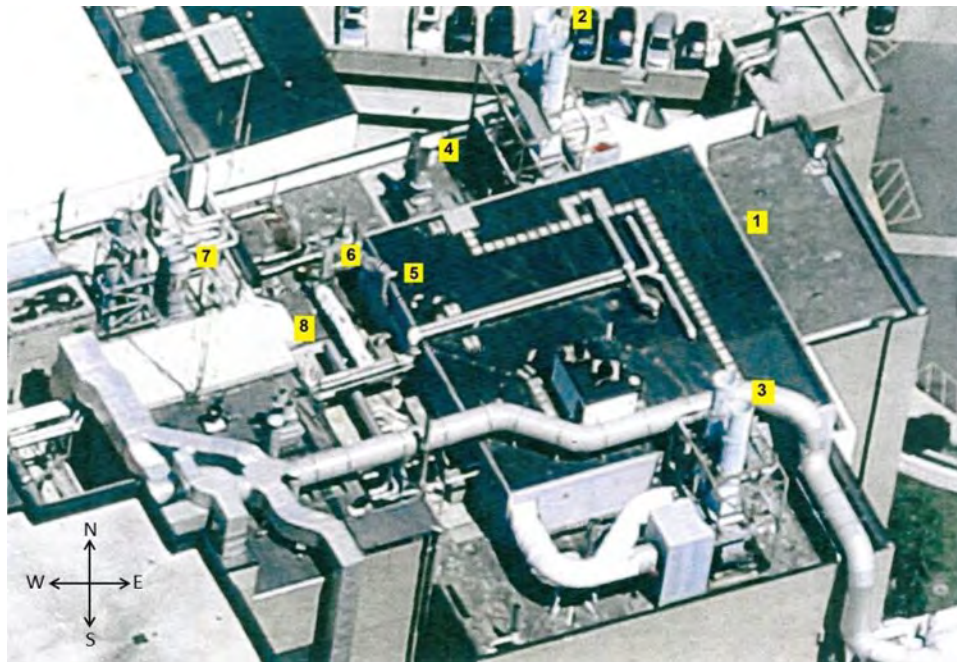
Figure 1 shows a rooftop view of the research building complex, locations of AHUs, and exhaust stacks from the research buildings. At the time of our evaluation, the facilities department did not have performance guidelines or standards for the HVAC system of the research building complex. They relied on institutional knowledge among facilities employees about how the system had operated in the past.

1. Supply air intakes for NRB air handling units 1, 2, and 3.
2. NRB exhaust – north and east
3. NRB exhaust – south and west
4. Animal cage wash wet exhaust
5. Unidentified exhaust stack
6. NRB common restroom exhaust
7. General veterinary research exhaust
8. Supply air intake for air handling unit NRC-AHU-5

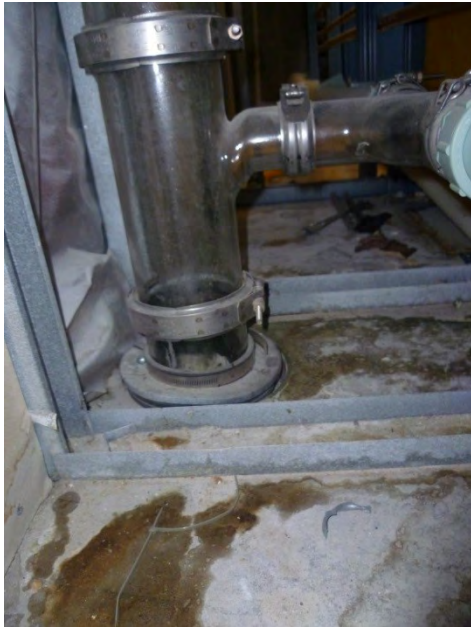
Ventilation smoke testing under the laboratory bench cabinets along the exterior wall in laboratory 3032 demonstrated that air flowed into the space under the laboratory bench cabinets from a gap between the floor and a utility drain pipe, which ran vertically between floors along the outside wall (Figure 2). Additionally, we observed that air from the gap around the utility drain pipe moved through the laboratory bench cabinet space into the laboratory through gaps around the laboratory bench cabinet drawers, doors, and access panels. Because of the differential between exhaust and supply rates in laboratory 3032 the gap around the utility pipe was an unanticipated supply air pathway from neighboring laboratories on other floors.

Figure 2. Photo of gap between utility drain pipe under laboratory cabinet and floor provided unplanned pathway for movement of air from floor below. Photo by NIOSH.

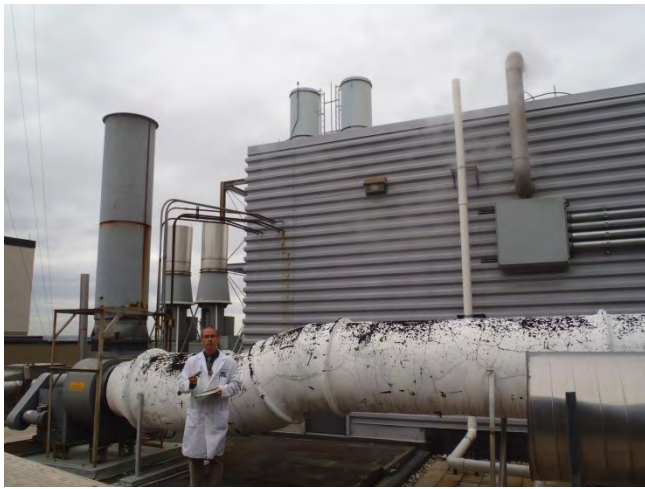
During our site visit on November 15, 2013, we noted an “animal cage” odor while we were taking air samples on the roof. Facilities staff also noted the odor and reported that it was similar to the “animal cage” odors previously reported on the second, third, and fourth floors of the NRB. We also saw re-entrainment of exhaust on the penthouse roof from an unidentified exhaust pipe into NRC-AHU-5. HVAC staff were unsure where the pipe exhausted from. Figure 3 shows the exhaust pipe, and Figure 4 shows NRC-AHU-5.

Figure 3. Rooftop penthouse exhaust pipe (shown in the upper right corner of the figure), which was located adjacent to NRC-AHU-5. Prevailing winds carried exhaust from the pipe toward the NRC-AHU-5 supply air intake. Photo by NIOSH.

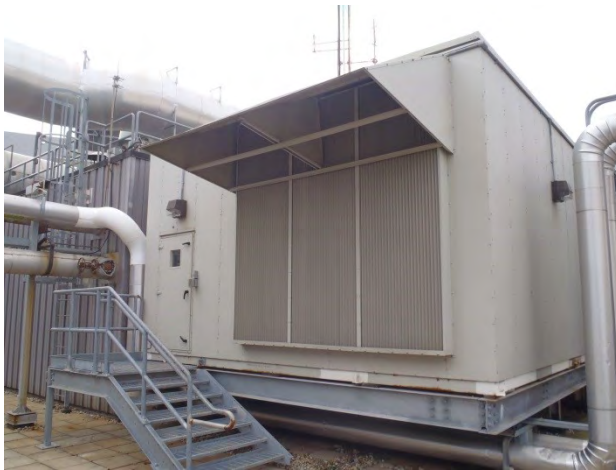
Figure 4. Photo of a supply air intake for rooftop air handling unit, NC-AHU-5, where building exhaust air was observed being captured by the intake. Photo by NIOSH.

The mixtures of chemicals, including anesthetic gases, were similar across sample locations. These data, along with our observations of re-entrainment on the roof suggest that building exhaust air is being captured by a building air intake, NRC-AHU-5 and circulated throughout the NRB. On the third floor of the building we found that the supply airflow and exhaust air flow did not meet the reported design specifications. We also found that pressure differentials between third floor hallways, laboratories, and offices were not as designed. Specifically, many laboratories were under positive pressure relative to adjacent hallways and this can lead to unplanned migration of air contaminants and odors from one area to another. We found unplanned pathways of air movement into a laboratory through floor gaps around a drain pipe. All of these findings may be contributing to the occasional odor in laboratory 3032. Our analysis of residue from shelving in some third floor laboratories indicates that the residue is likely composed of a synthetic polymer produced by degradation of the shelving laminate rather than deposition of something onto the surface of the shelving.

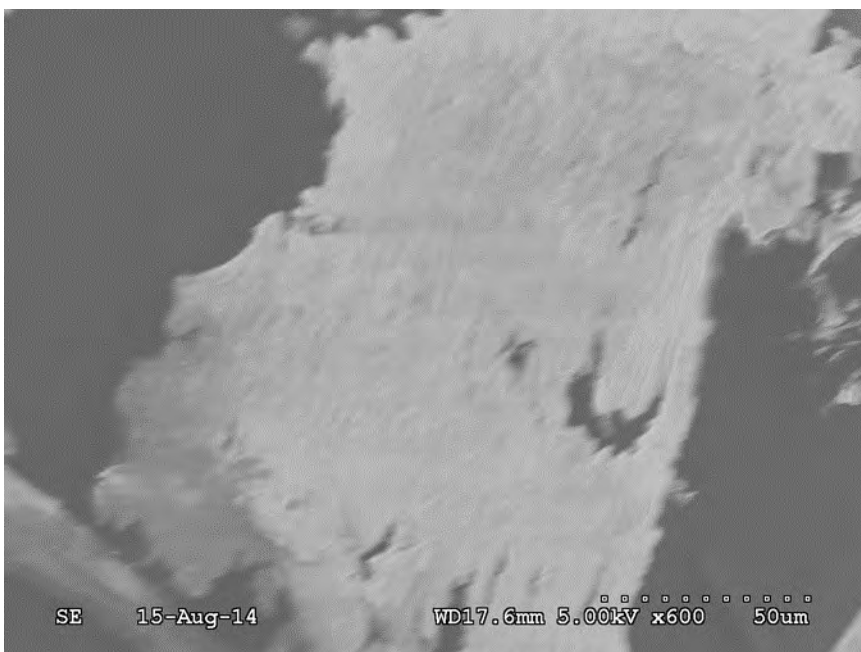
Figure 5. Scanning electron microscope image of a residue sample. Photo by NIOSH.

Analysis via stereomicroscopy, scanning electron microscopy and polarized light microscopy revealed the residue is likely a synthetic polymer with plastic-like characteristics and some synthetic fiber and glass fiber contamination. The bulk samples contained colorless (cellulose) and dark (synthetic) fibers. The residue matrix was translucent brown and displayed properties associated with polymers or plastic. The sample had an uneven thickness and a stretched look which typically comes from smearing or attempting to grind or flatten a plastic or plastic-like material. Organic material is difficult to analyze by scanning electron microscopy because contrast is almost impossible to obtain while maintaining image quality and interpretability. The scanning electron microscope image (Figure 5) shows an area near the center where the sample has thinned and appears stretched. Linear features parallel to the stretching indicate that the substance is a polymer.

On the basis of GC-MS, elemental, and microscopic analyses, we concluded that the residue on shelving is more likely a product of laminate degradation rather than deposition of something from the environment. Some laboratory employees we spoke with noted that after the residue was cleaned off shelves in laboratory 3032, the residue was found on the shelves a month later, even though the ventilation supply air diffusers and exhaust air grilles were covered to prevent air flow. This finding is further support for our conclusion. However, the cause of the degradation cannot be completely determined using these results. Oxidative degradation of the laminate could be caused by age, environmental parameters (temperature and relative humidity), or other factors.
