# Evaluation of Ventilation in Aircraft Maintenance and Restoration Hangars

Report No. 2014-0067-3243  
October 2015

U.S. Department of Health and Human Services  
Centers for Disease Control and Prevention  
National Institute for Occupational Safety and Health

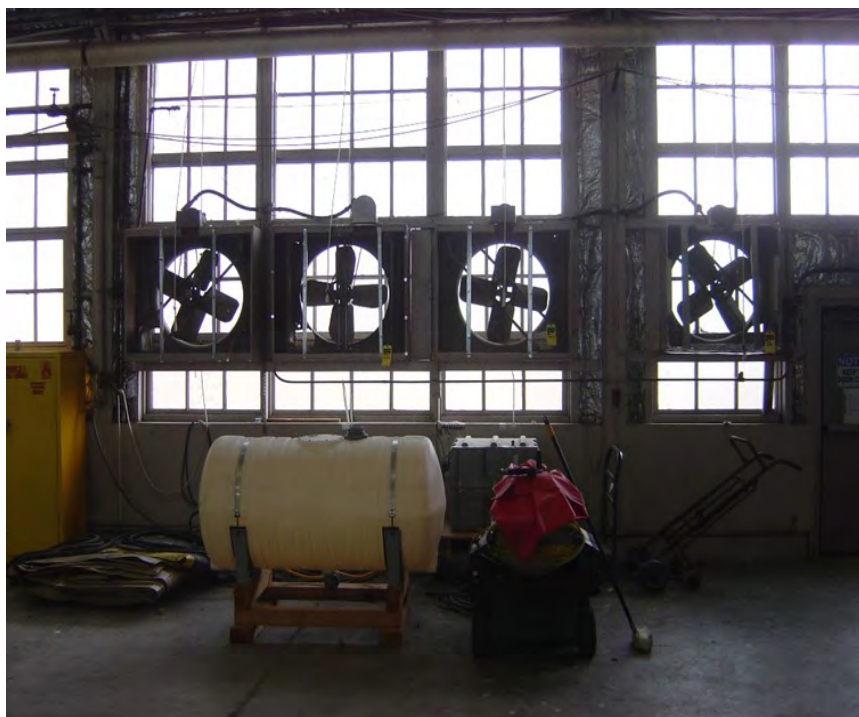
Figure 4. Photo of window-mounted wall exhaust fans inside a restoration hangar. Photo by NIOSH.

The restoration hangars have variable air movement created by portable cooling fans, which provide some comfort during warmer days. However, the inoperability of the window-mounted exhaust fans may lead to a buildup of air contaminants. Because the air movement

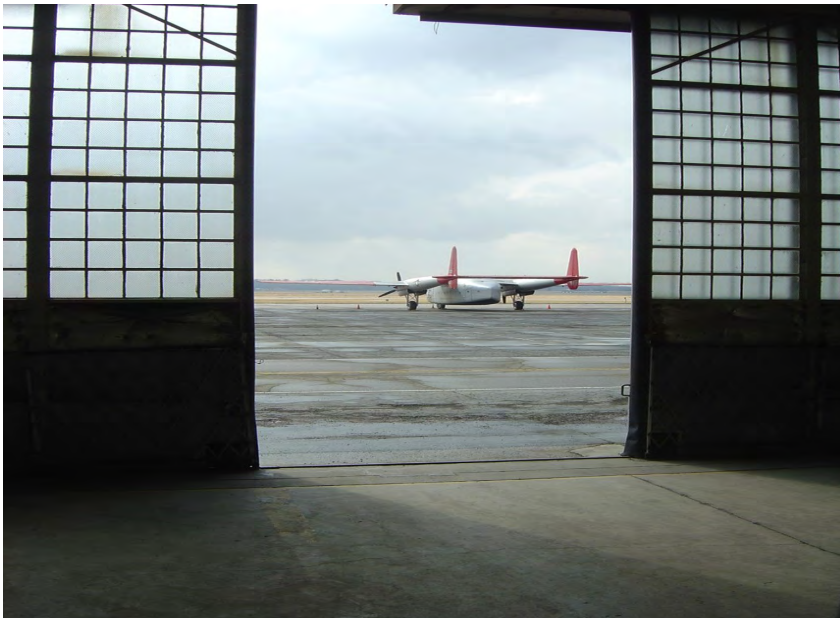
Figure 6. Photo of restoration hangar front bay doors that were opened to provide some supply air. Photo by NIOSH.

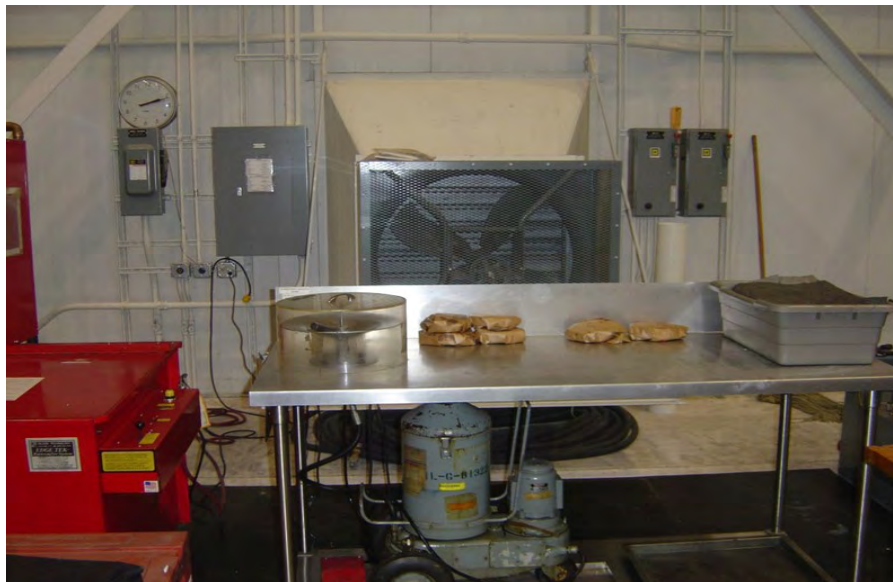
Upon closer investigation, we found in each maintenance hangar a supply air fan that was either not functioning or had a louver stuck in the closed position. Additionally, we noticed tables, equipment, and hangar supplies that were blocking some of the exhaust fans (Figures 10 and 11). When any fan is blocked, the air velocity is reduced, and the flow pattern becomes more turbulent. Such effects are shown in Tables A1 and A2 as well as Figures B1 and B2. Air velocities were always higher on the supply side of the aircraft than the exhaust side because the supply air fans were not blocked. These fans also operated closer to design specifications. The lowest air velocities were above the aircraft, which can be attributed to the supply air fans being oriented downward towards the floor. Ideally, the air from individual supply fans would spread and combine to create a consistent air mass that would “wash” the entire aircraft work zone and move air towards the exhaust fans.

Figure 10. Photo of table and equipment blocking exhaust fan outlet. Photo by NIOSH.

1. Move equipment and supplies that block any fan so that airflow is not impeded.

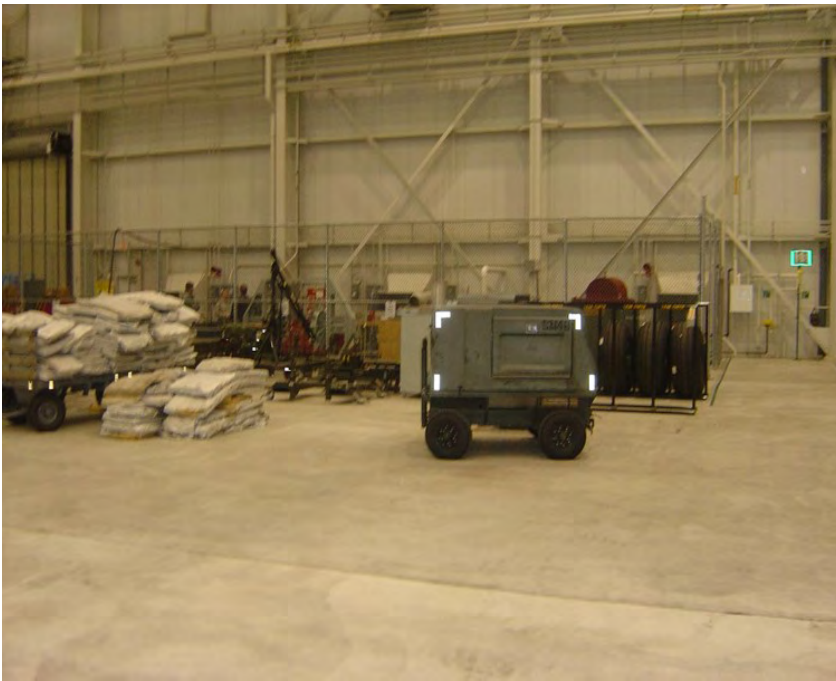
Figure 11. Photo of fenced area blocking three exhaust fans. Photo by NIOSH.

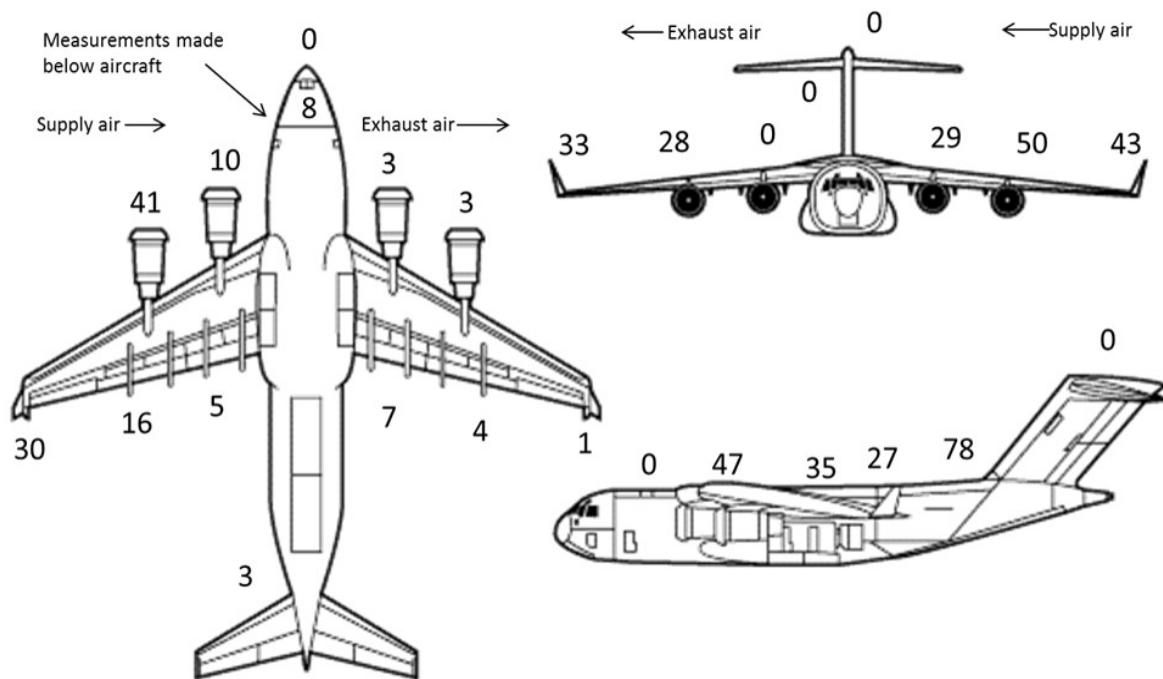
specification. Air velocities around the C17 aircraft in building 4015 ranged from 0 to 78 feet per minute (Figure B1). Air velocities around a C17 aircraft in building 4016 ranged from 0 to 227 feet per minute (Figure B2). Clearly, there were areas of no air movement (confirmed by the smoke tests) and areas where the air from a supply fan reached the aircraft work zone. Most areas of little to no air movement were noticed in the area above the wings and fuselage and also on the exhaust fan side of the aircraft (Figures B1 and B2).

Figure B1. Building 4015: Air velocity in feet per minute around C17 aircraft.

1. Repair, adjust, and maintain all fans associated with the ventilation system in the maintenance hangars. Two supply fans, one in each maintenance hangar, were inoperable while another unit had louvers stuck in the closed position. The ventilation system should operate according to design specifications. Once the fans are repaired, test each fan to verify proper operation according to design specifications.
2. Repair the exhaust fans in the windows of the restoration hangars and perform area and personal air monitoring for possible air contaminants associated with each work task.

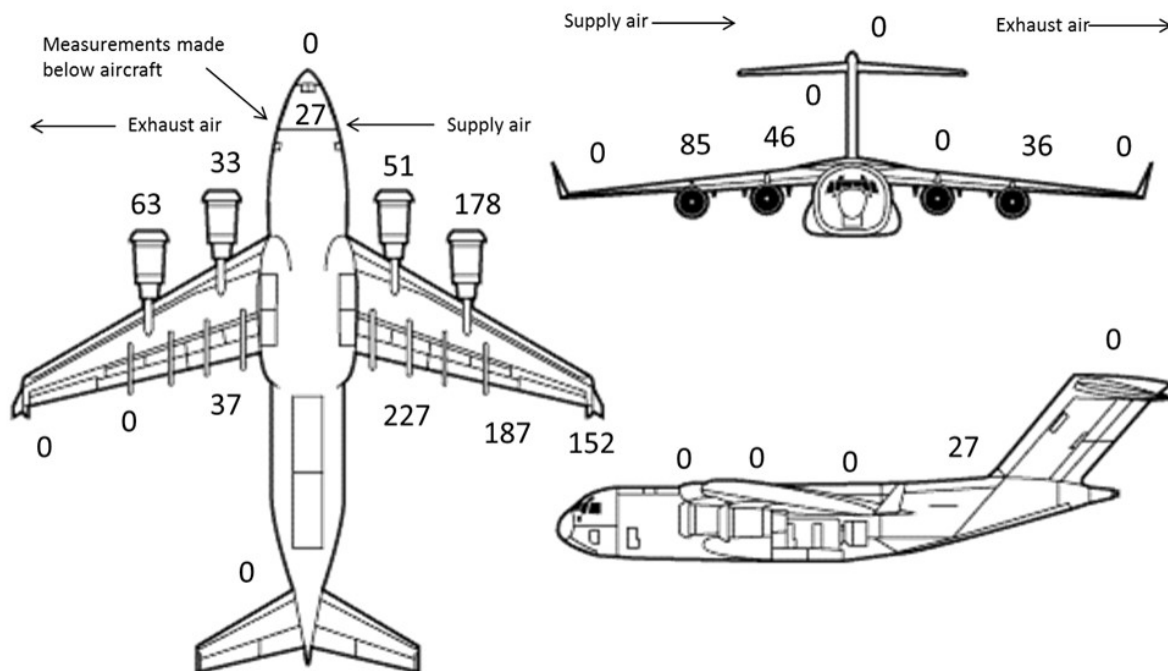
Figure B2. Building 4016: Air velocity in feet per minute around C17 aircraft.

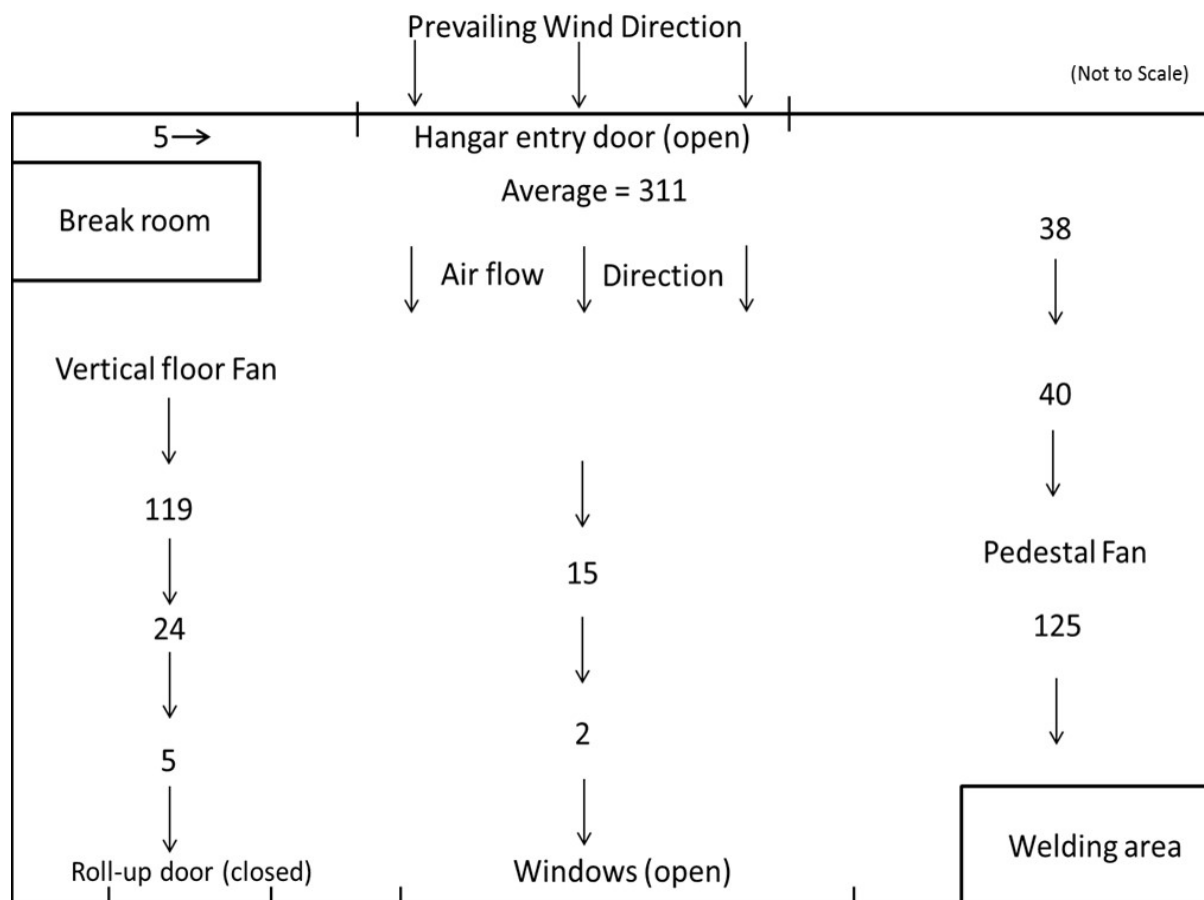
Airflow patterns and velocities were highly variable within both restoration hangars (Figures B3 and B4) as a result of the absence of a conventional supply and exhaust ventilation system. Also, the use of portable fans of different sizes in different locations resulted in variable air velocities and increased turbulence. In general, air velocities decreased with distance away from each fan, with the lowest values measured near the back wall of each restoration hangar.

Figure B3. Building 20004 C: Air velocity in feet per minute in restoration hangar.

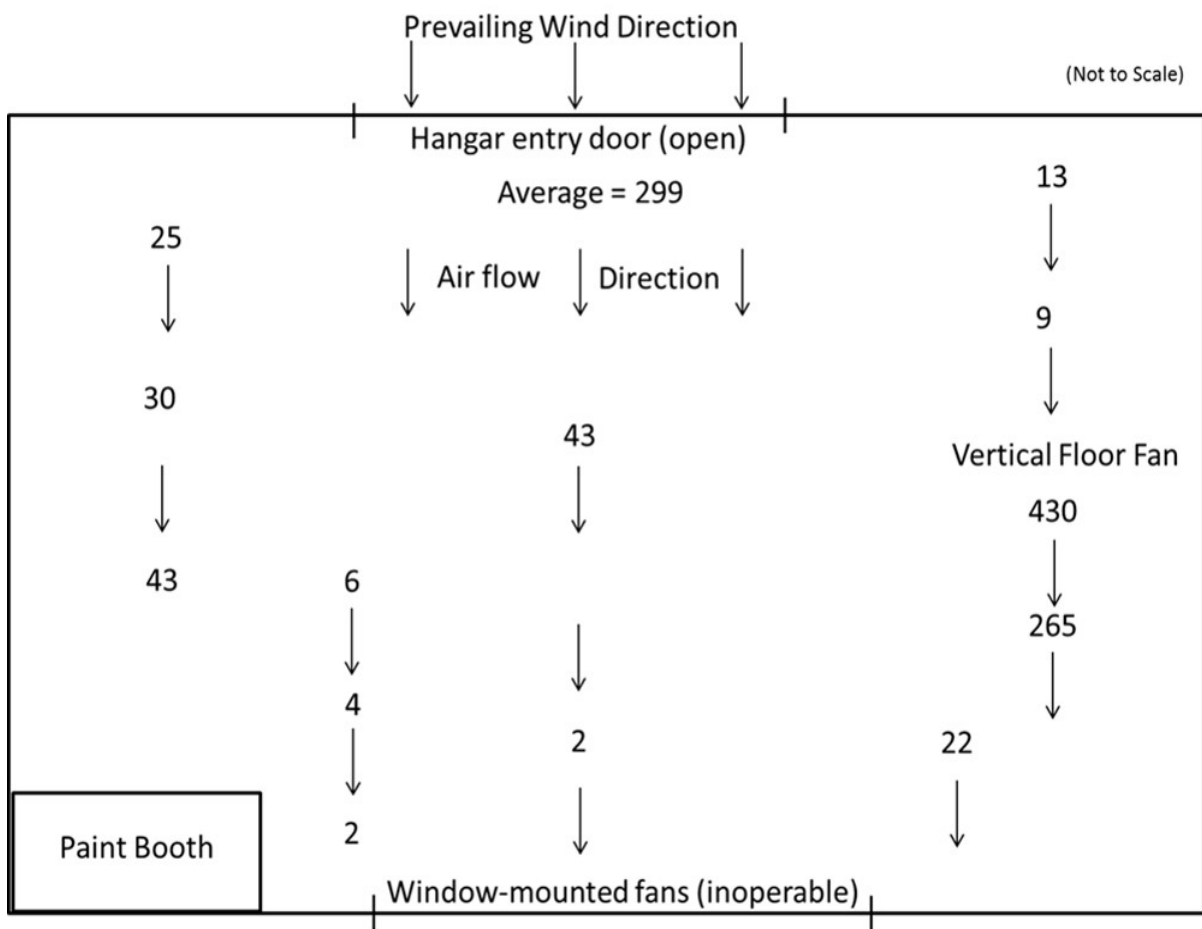
Figure B4. Building 20004 D: Air velocity in feet per minute in restoration hangar.
