Health Hazard Evaluation Report

HETA 83-112-1309
SAINT FRANCIS HIGH SCHOOL
MORGANTOWN, WEST VIRGINIA

HETA 83-112-1309
MAY 1983
SAINT FRANCIS HIGH SCHOOL
MORGANTOWN, WEST VIRGINIA

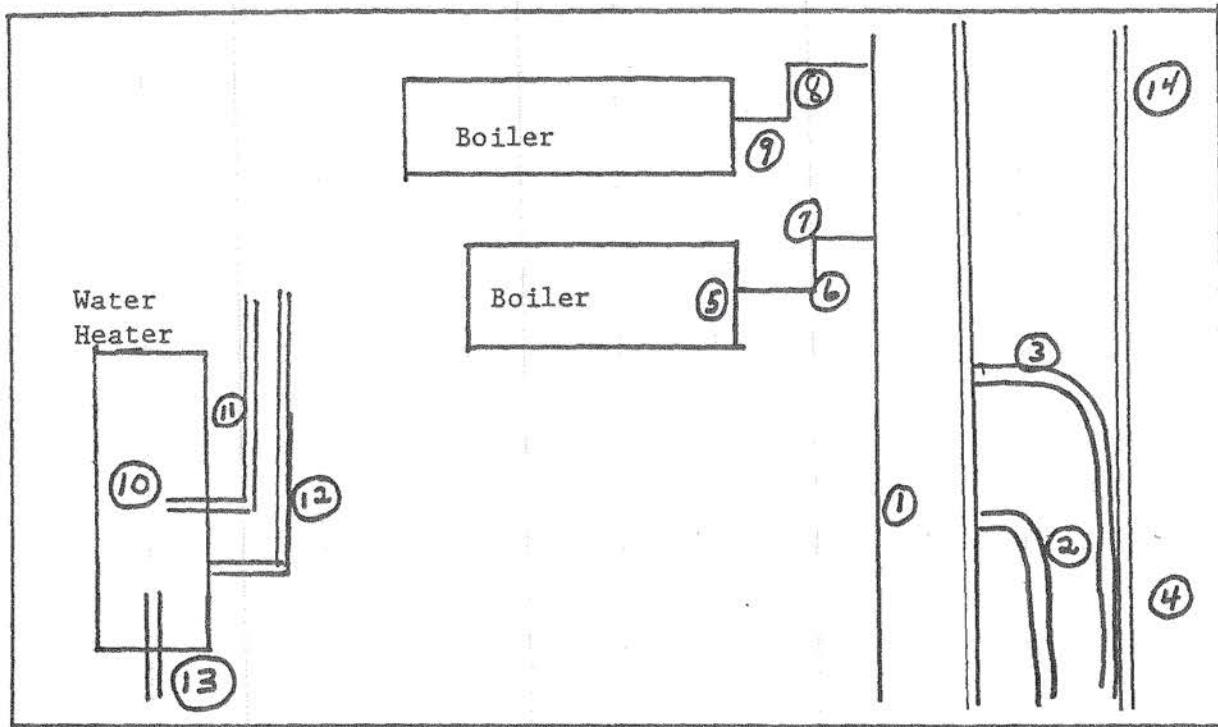
Boiler Room Samples. See diagram.

1	Asbestos	
2	Asbestos	
3	Asbestos	
4	Asbestos	
5	NONE	
6	NONE	
7	NONE	
8	NONE	
9	NONE	
10	Asbestos	
11	Asbestos	
12	Asbestos	
13	Asbestos	
14	Asbestos	
15	Ceiling sample outside boiler room	Asbestos
16	Cafeteria ceiling	Asbestos
17	Women's bathroom ceiling	Asbestos
18	Room 103 ceiling sample	Asbestos
19	Library ceiling sample	Asbestos
20	Insulation on steam pipe	Asbestos
