SURVEY REPORT

OPTIONS FOR THE CONTROL OF BORDER AGENTS EXPOSURE TO VEHICLE EMISSIONS: RECOMMENDATIONS FOR A PILOT STUDY

**United States Port of Entry
Calexico, California**

**REPORT NO.:
EPHB 010-04a**

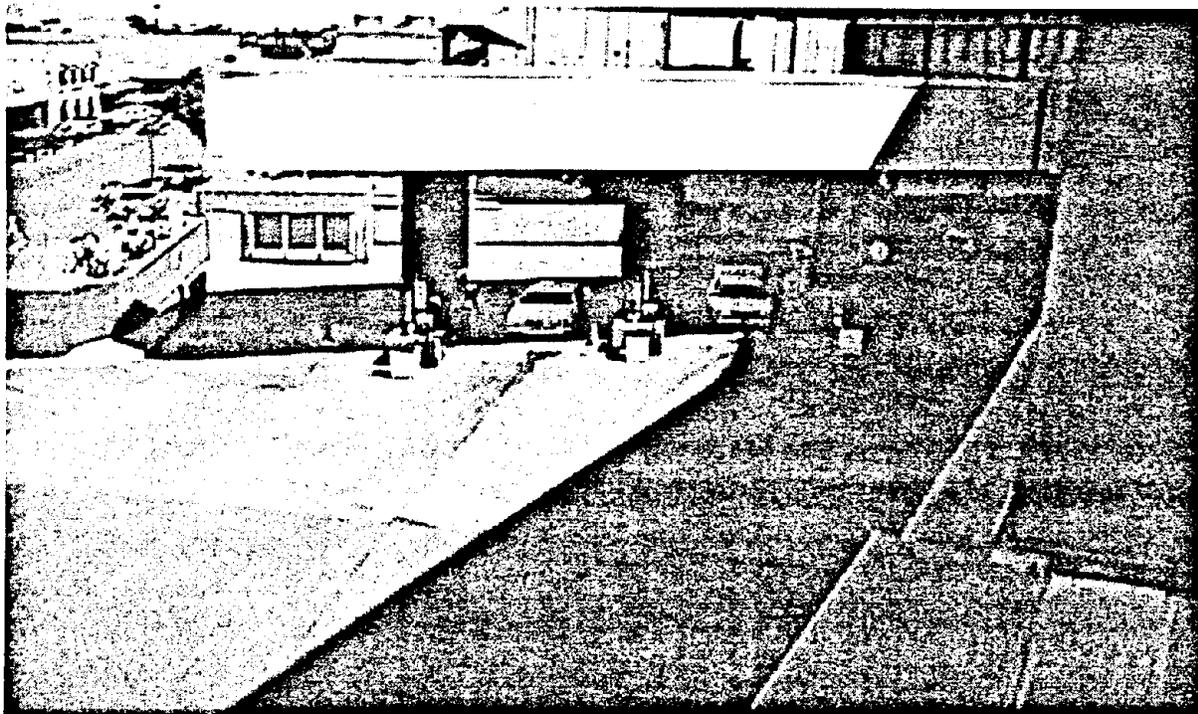
Figure 2. Canopy Roof over Lanes 1-3.

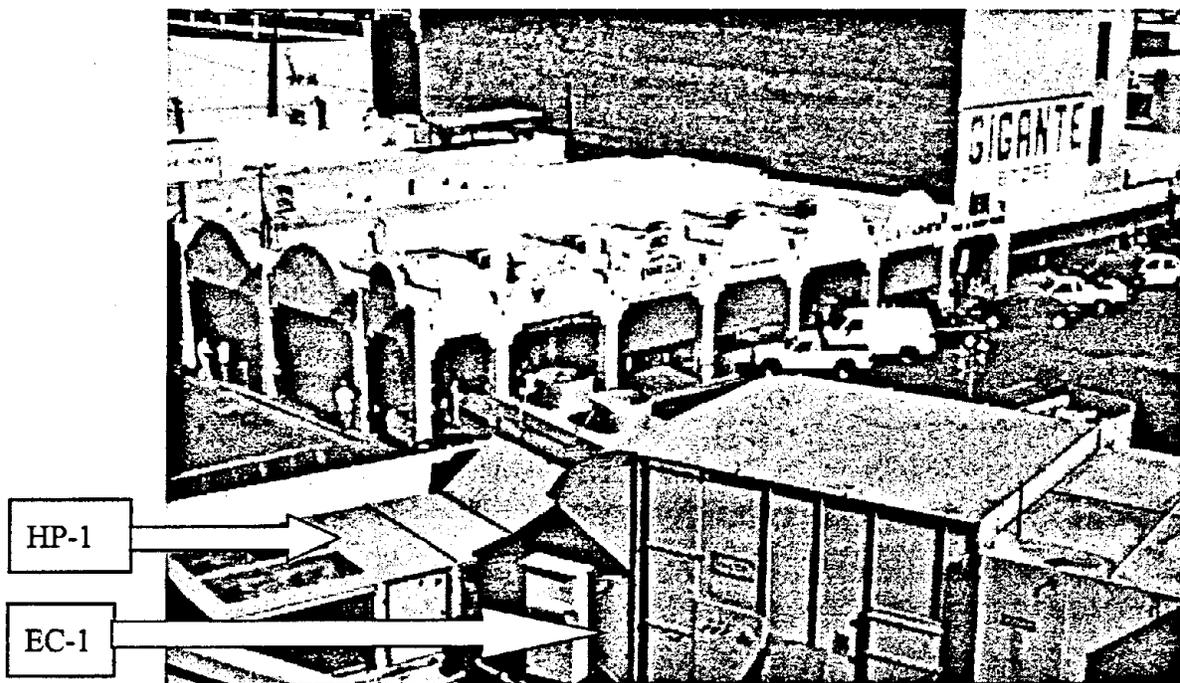
Several concerns with the facility were noted during the survey. No current facility drawings were available on site. We were told that one set of as-built drawings were on file at the GSA office in San Francisco but several modifications to the facility have been made since the facility opened. The ventilation system appears to have been modified and the facility upgraded to accommodate additional traffic over the years but the effects of these changes on the overall ventilation system performance is not known. The lack of current facility drawings not only affects the ability to best utilize existing resources but it also hinders the proper maintenance of the facility. General information on the performance of the system is also not available. A test and balance report had been completed of the heating, ventilating, and air conditioning (HVAC) system for the general office area but not for the ventilation to the primary inspection area. This report would provide important information such as air flow rates for each booth, pedestal and air shower. Also, the inlet to EC-1 was blocked by HP-1 which was unfortunately placed directly in front of the intake for EC-1 (see Figure 3). This degrades fan performance by restricting airflow and causing lower overall flow to the booths served by EC-1.

Figure 3. HP-1 and EC-1 Blower Intake Configuration.

- Remove the blockage of the HVAC unit located on the roof above lanes 1-3 and the pedestal fan inlet near lane 1. Changes should be made to eliminate any blockage in front of the intake for the HVAC unit (EC-1 and HP-1) located on the roof above lanes 1-3. Both of the units have an intake that is partially blocked which can adversely effect fan performance.

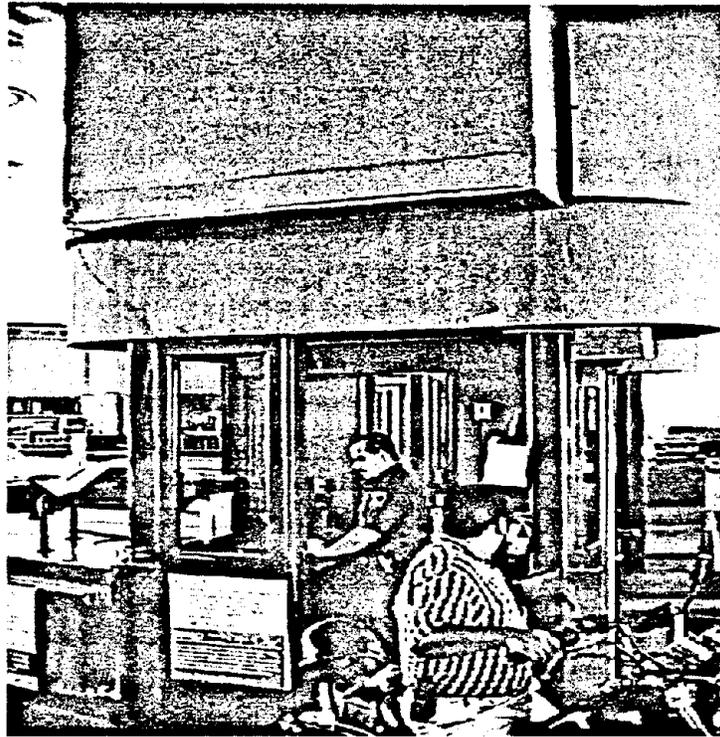
Figure 4. Air Shower Over Lane 4.

- Install air showers outside of the inspection booths. The air shower should be implemented as an air supply register that extends outside of the booth where agents spend much of their time. An air shower ventilation system will provide an envelope of clean air around the agent and reduce CO concentration in the primary work area.

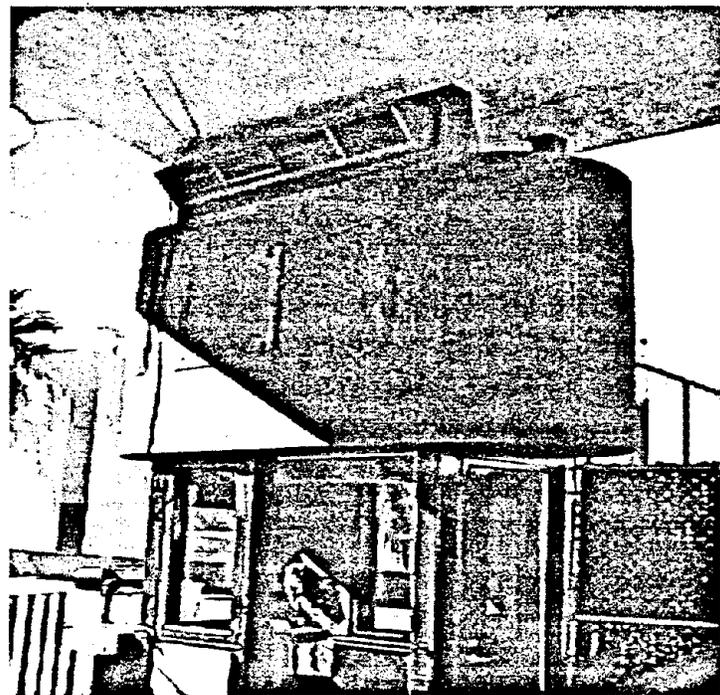
originally installed at a height of approximately 10 feet at all booths but were raised at lanes 5-11 due to vehicle clearance problems. The air showers in lanes 5-11 consist of a register measuring 72 inches in length by 10 inches in width. Also, a series of registers are installed in the canopy roof and are connected to exhaust fan, S-3. The soffit fans exhaust the contaminated air under the canopy to a stack on the roof over the main building (see Figure 6).

Figure 5. Raised Air Showers over Lanes 5-11.

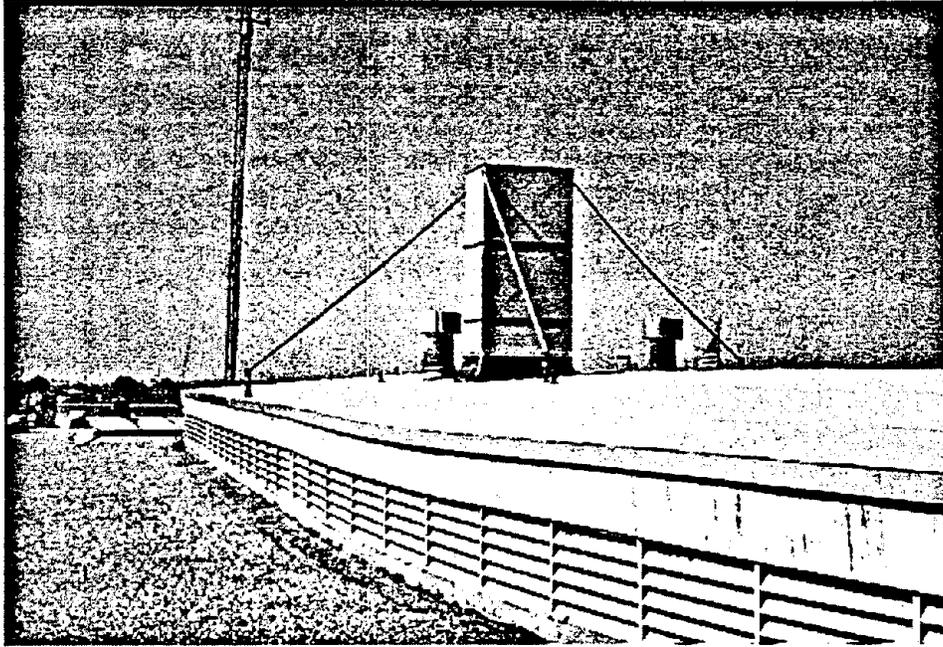
The roof top CO measurements showed low CO concentrations during the day and much higher concentrations during the evening period. For November 16, from 8:56 a.m. to 9:50 a.m., the three rooftop area CO concentrations were low with averages of 0 ppm. The afternoon time frame on November 15, from 12:02 p.m.- 3:32 p.m. showed averages of 1 ppm or less. The evening time period, from 4:35 p.m. to 12:35 a.m. showed averages of around 7 ppm for all sensors. The CO concentration trace shown in Figure 22 shows all sensors tracking together during this time period. This indicates that the concentration of CO was fairly homogeneous throughout the roof area. It also indicates that CO concentration increases during the period when car traffic increases and as winds subside consistent with evening atmospheric inversion. This phenomenon is important in that a source of fresh air may not be available during the evening hours at the roof top level. It may be necessary to build a stack or research pollutant removal options for the fresh air supply to reduce CO concentrations in the primary inspection area. It would also be prudent to evaluate the exposure of office workers during the swing (4 p.m.- 12 a.m.) and graveyard shifts (12 a.m.-8 a.m.). The source of fresh air for those areas is also on the rooftop and may be contaminated during periods of inversion, high traffic, or if the exhaust from the soffit fan stack is re-entrained.

Figure 6. Soffit Fan Exhaust Stack.

- The height of the roof exhaust stack for soffit fan, S-3, should be thoroughly evaluated to prevent cross-contamination of nearby air supply inlets. The effective stack height is the portion of the exhaust stack that extends above local recirculation zones on the top of the building and upwind and downwind of obstacles. Stacks should not only be located on the highest roof of a building, but should also extend above the height of the flow recirculation zone to prevent contamination of inlet air supplies that may be located on the roof. Exhaust gases exiting the stack within the flow recirculation zone will rapidly diffuse and may be drawn into air intakes.

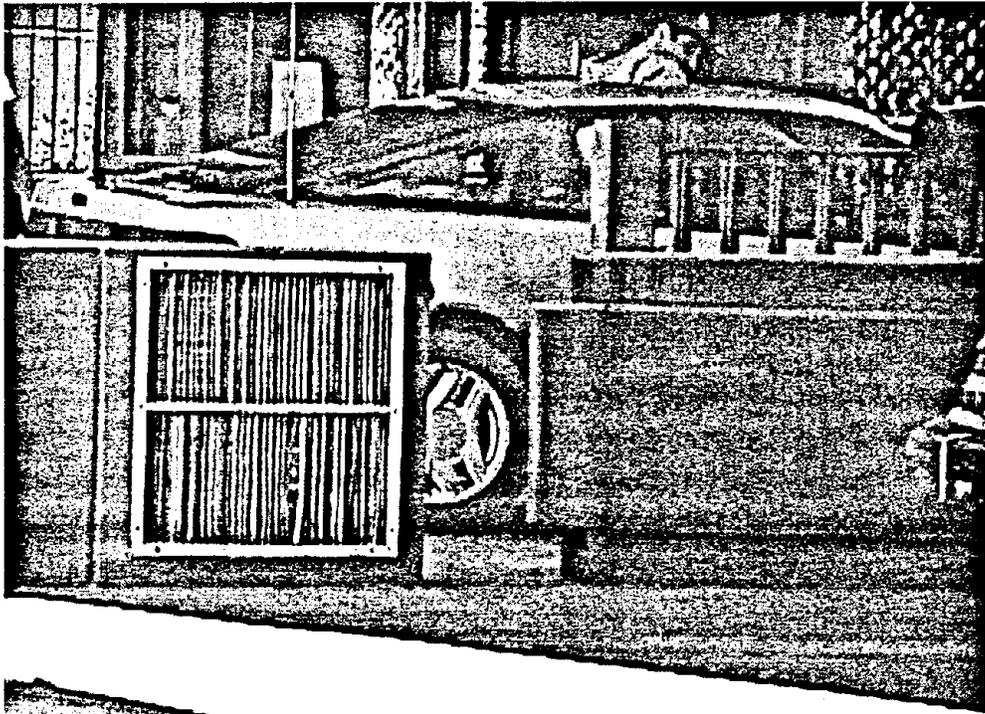
A pedestal supply air blower installed at the front of each lane originally directed air towards the vehicle tailpipe to dilute and disperse the exhaust gases (See Figure 7). The pedestal supply blowers were in operation during the site visit but have not been in operation consistently throughout the years. A damper on the pedestal allows the agents to reduce or shutoff airflow from the pedestal supply register. A central supply fan, SF-1, provides the airflow to all of the pedestals with ducts running underground to each lane. This fan is housed in a brick building at the North end of the primary inspection area (next to lane 1). The inlet to SF-1 is located at ground level and faces the area around lanes 1-3.

The design and operation of the pedestal blowers is also a concern. The current system is not located or directed properly, has not been well maintained, and the inlet is located in an area that is easily contaminated with vehicle exhaust. The primary problem with the current system is the placement of the pedestal with respect to the tailpipe. This current system is ineffective at blowing the vehicle exhaust away from the inspection stations and diluting the contaminants. The louvers on all of the pedestal blowers were damaged and the airflow dampers were not labeled as to which position was open and which was closed. Further, the supply for these blowers is taken from supply fan, SF-1, which is located at ground level in the primary inspection area near lanes 1-3 (see Figure 1). The inlet location is in an area that is easily contaminated with vehicle exhausts. The CO monitor which was placed at the inlet to SF-1 showed a peak concentration of 86 ppm with a 3 hour average of 5 ppm. Each of these problems must be addressed in order to improve the performance of the current system.

Figure 7. Pedestal Exhaust Blower.

- Modify pedestal blowers near the vehicle tailpipe locations to evacuate/dilute vehicle exhausts. Pedestals 7 through 10 should all be positioned to blow in a southwest direction, and air flow should be directed towards the rear of the vehicles. This could be accomplished by reconfiguring the existing system. All louvers on the pedestal blowers should be replaced with louver made of durable heavy gauge material and the system serviced. Manual dampers on the pedestals should be clearly labeled “on/off.”

- Modify the intake for the pedestal fan to provide a clean air source. Modifications are required near the inlet for the pedestal fan because it is drawing in contaminated air from the vehicles that pass near lane 1.

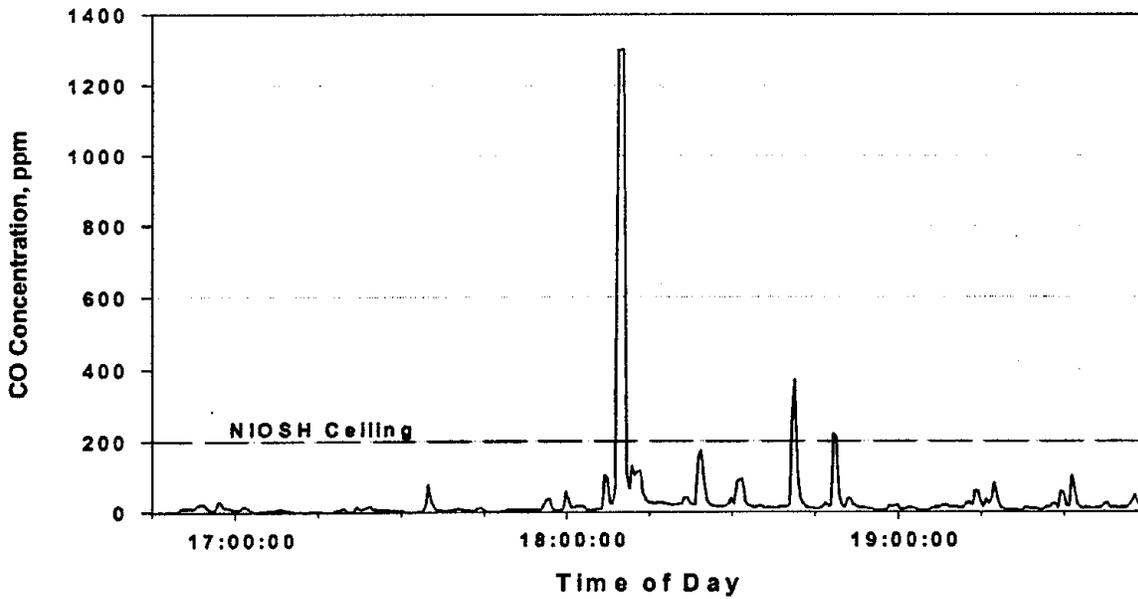
During the monitoring period, there were three peaks above the NIOSH ceiling of 200 ppm with one peak exceeding the upper limit of the instrument (1000 ppm). Although this concentration was transient, it should not be encountered within the occupational environment. All of these high readings were measured inside the booth at primary inspection lane 8 (see Figure 9).

Figure 9
CO Concentrations-Area Sample
Primary Inspection Lane 8-Inside Booth
November 15, 2000

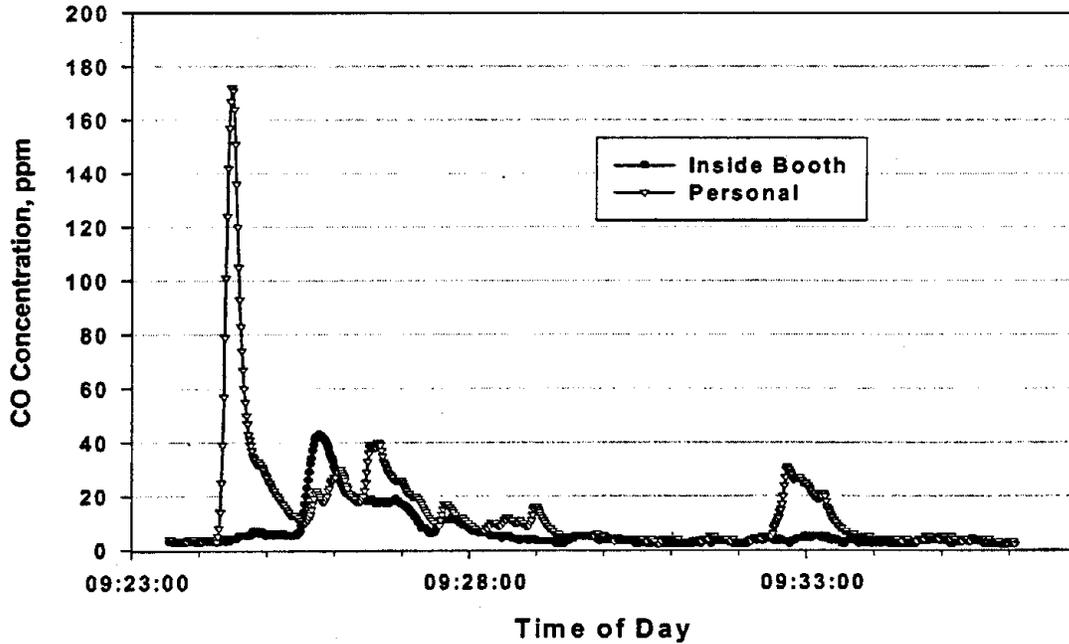
Figures 17, 19 and 20, however, tell a different story. One can see from these figures that the concentrations in booths 8 and 9 provide minimal protection. This may be due to several different factors: 1) the agents may have turned off the booth ventilation; 2) Booth ventilation may be inadequate in these booths; 3) the supply fan, EC-1, may have been turned off for maintenance during the evaluation period; or 4) the intake to the pedestal blower, SF-1, may have been contaminated with CO from the primary inspection lane area. The representative from One Source, the facility maintenance contractor, indicated that the supply fan to booths 8-10 was turned off for part of the day for service. However, the exact source of the poor ventilation performance is not known and should be evaluated further to identify the cause. It was also noted that booth ventilation is turned off regularly by the agents due to high impingement velocities generated by the supply. A number of agents complained of draftiness inside the inspection booths.

Agent's exposures were evaluated using video exposure monitoring during inspection of cars with visible emissions, AKA "smokers." After identifying smoking cars, CO monitors were placed on the inspectors during routine checks. During the evaluation period, fewer "smokers" than typical were encountered. Those which were identified and evaluated are shown in Figures 19 and 20.

Figure 19
CO Concentration-Area and Personal
Primary Inspection Lanes 8 and 6
November 16, 2000

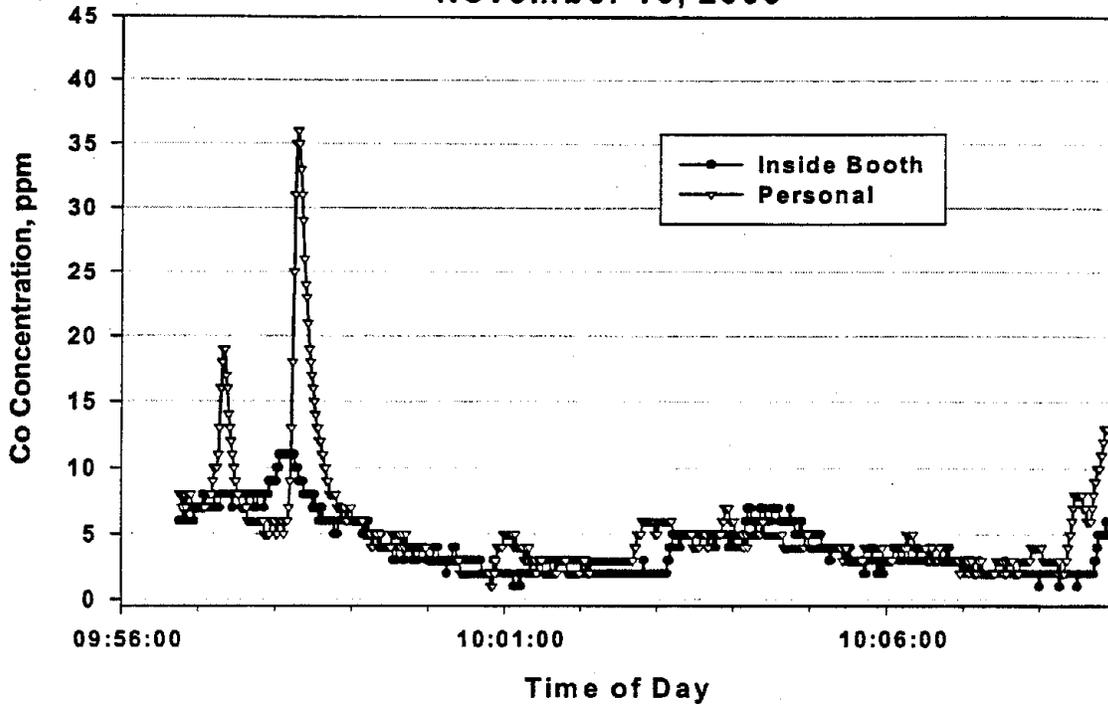
Figure 20
CO Concentration-Area and Personal
Primary Inspection Lane 9
November 16, 2000
