FIBROUS GLASS DUST  
AND  
INDUSTRIAL HYGIENE SURVEY

GENERAL ELECTRIC APPLIANCE PARK  
Louisville, Kentucky

January 18, 1973

Environmental Investigations Branch  
Division of Field Studies and Clinical Investigations  
NATIONAL INSTITUTE FOR OCCUPATIONAL SAFETY AND HEALTH

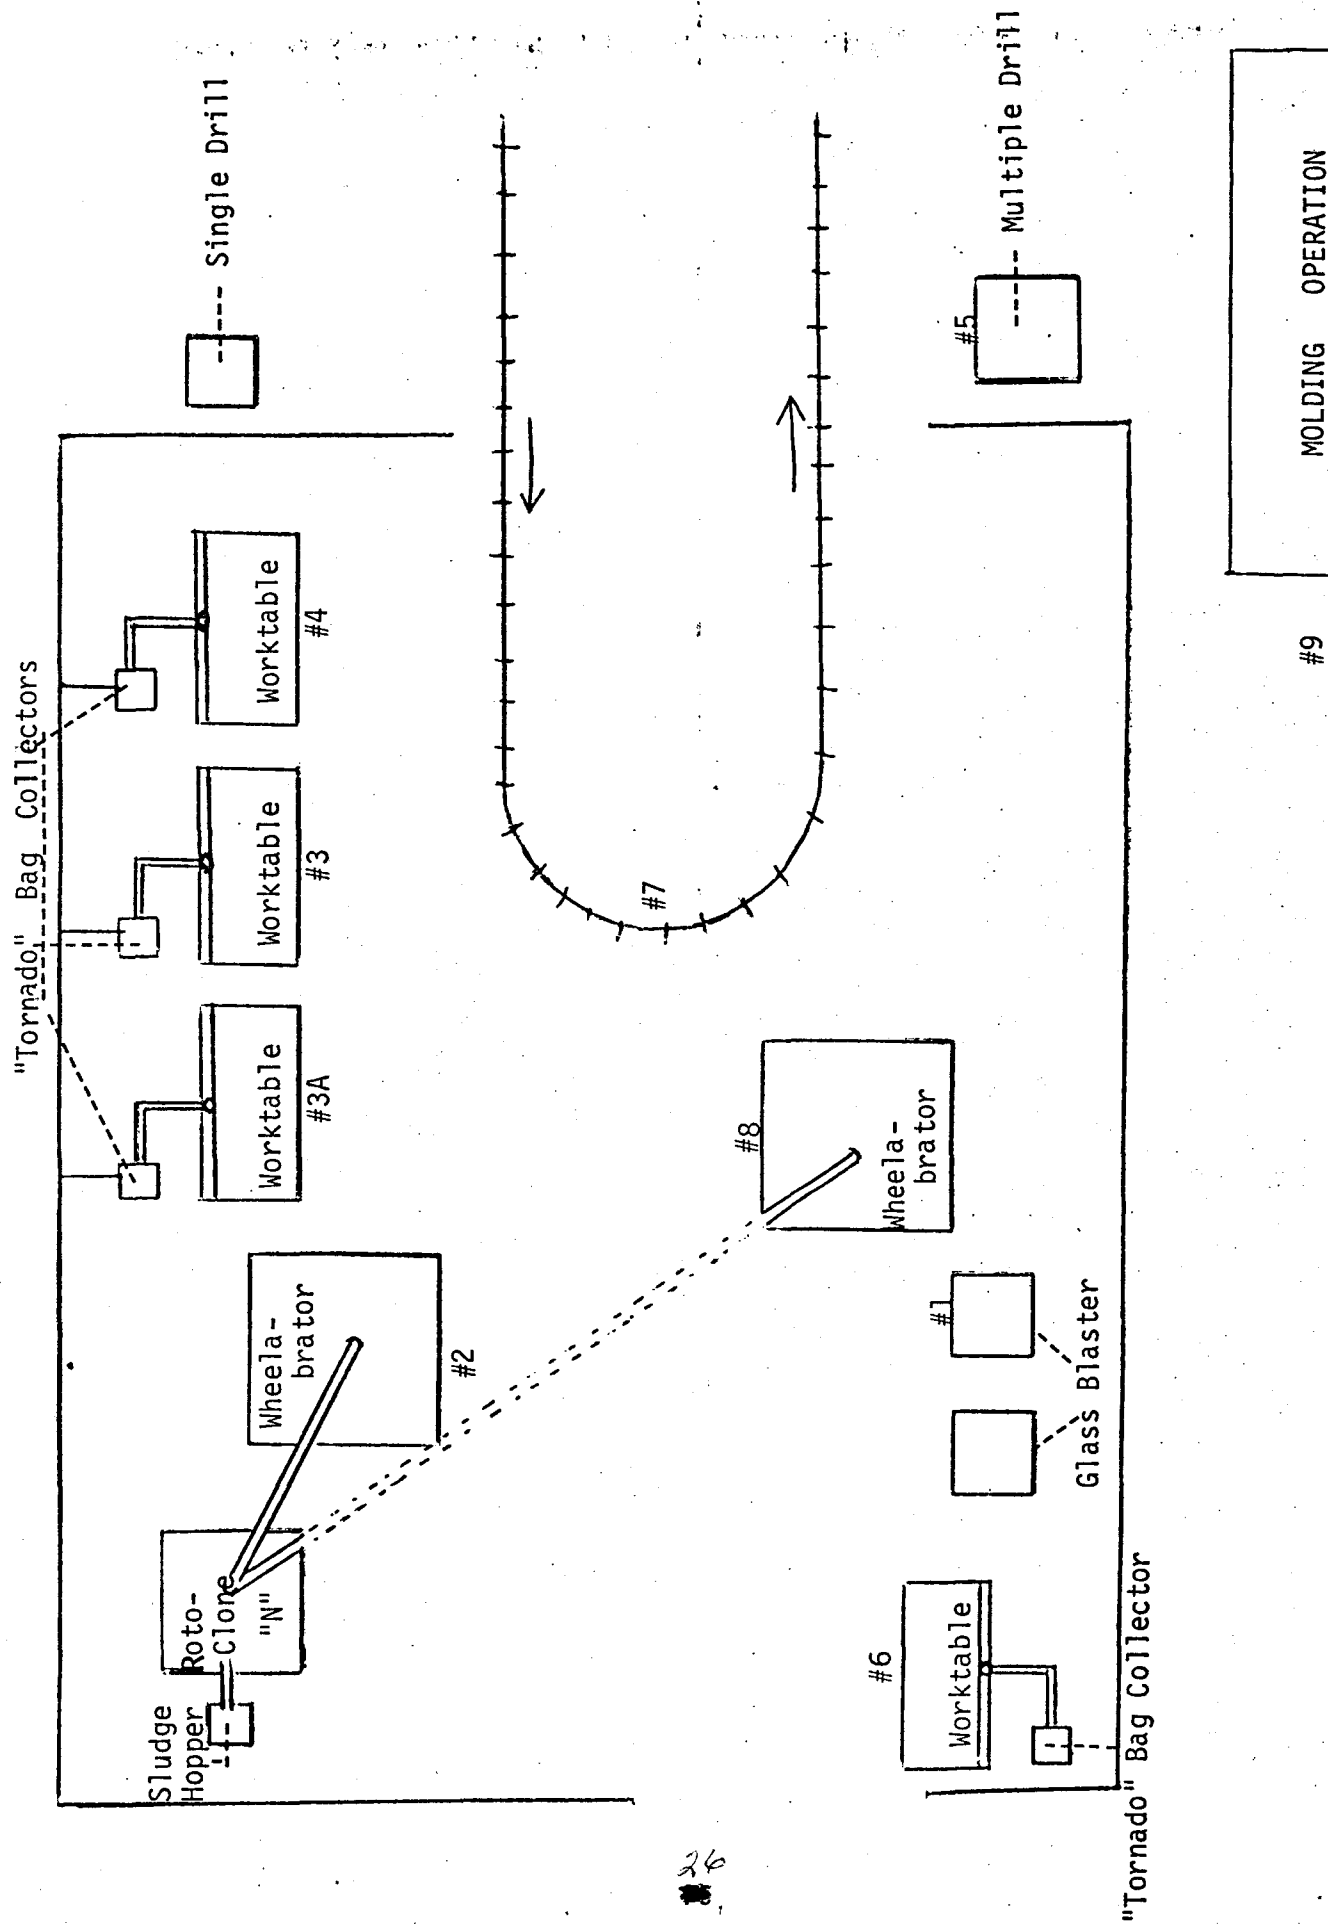
FIGURE 2

The deflashing room (Figure 2) is approximately 30 feet adjacent to the molding area and enclosed on four sides with two large openings at either end. The overhead conveyor enters at one end of the room, circles the room and carries the finished castings from the area.

Measurements taken in the deflashing room were limited to the four (4) work tables. Each work table is approximately 5' x 3' with a short back wall and a partial hood. At the back and the middle of each table there is a 2" diameter local exhaust intake located 4" from the surface of the table. These ventilation systems are vented to individual dust collectors known as a "Tornado". The "Tornado" is essentially a bag type collector with its discharged air vented back into the room. The recorded face velocities of the four work tables can be found in Table 3.

From the results of the noise survey, two areas apparently exceeded the 90 dBA standard. These two areas, multiple drill and hand grinding, had peaks of 91 dBA. Even though these were peak values, the consistency of this sound level should warrant some type of hearing protection for those exposed. When comparing the "A" and "C" scale measurements in Table 2, it is noted that all "C" scale readings are higher, indicating a prevalence of low frequency noises probably below 600HZ<sup>5</sup>.

The ventilation hoods at the present worktables are extremely inefficient. Even though the face velocities ranged from 1200 to 7000 fpm the actual capturing velocity at the work site was only a small fraction of this. It is noted that this is one of the items listed in Appliance Park's proposed changes (Attachment I). The installation of new downdraft worktables (illustrated in Attachment II) should eliminate most of the dust problems.

In Attachment I a list of proposed improvements, for the installation of new equipment in the deflashing room, has been compiled by both the union and management. Since the greatest single source of noise in that room is caused by the "Tornado" bag collectors, the new addition of worktables with enclosed collectors should eliminate most of this noise. It would be advisable to recheck the sound levels after the improvements have been made.

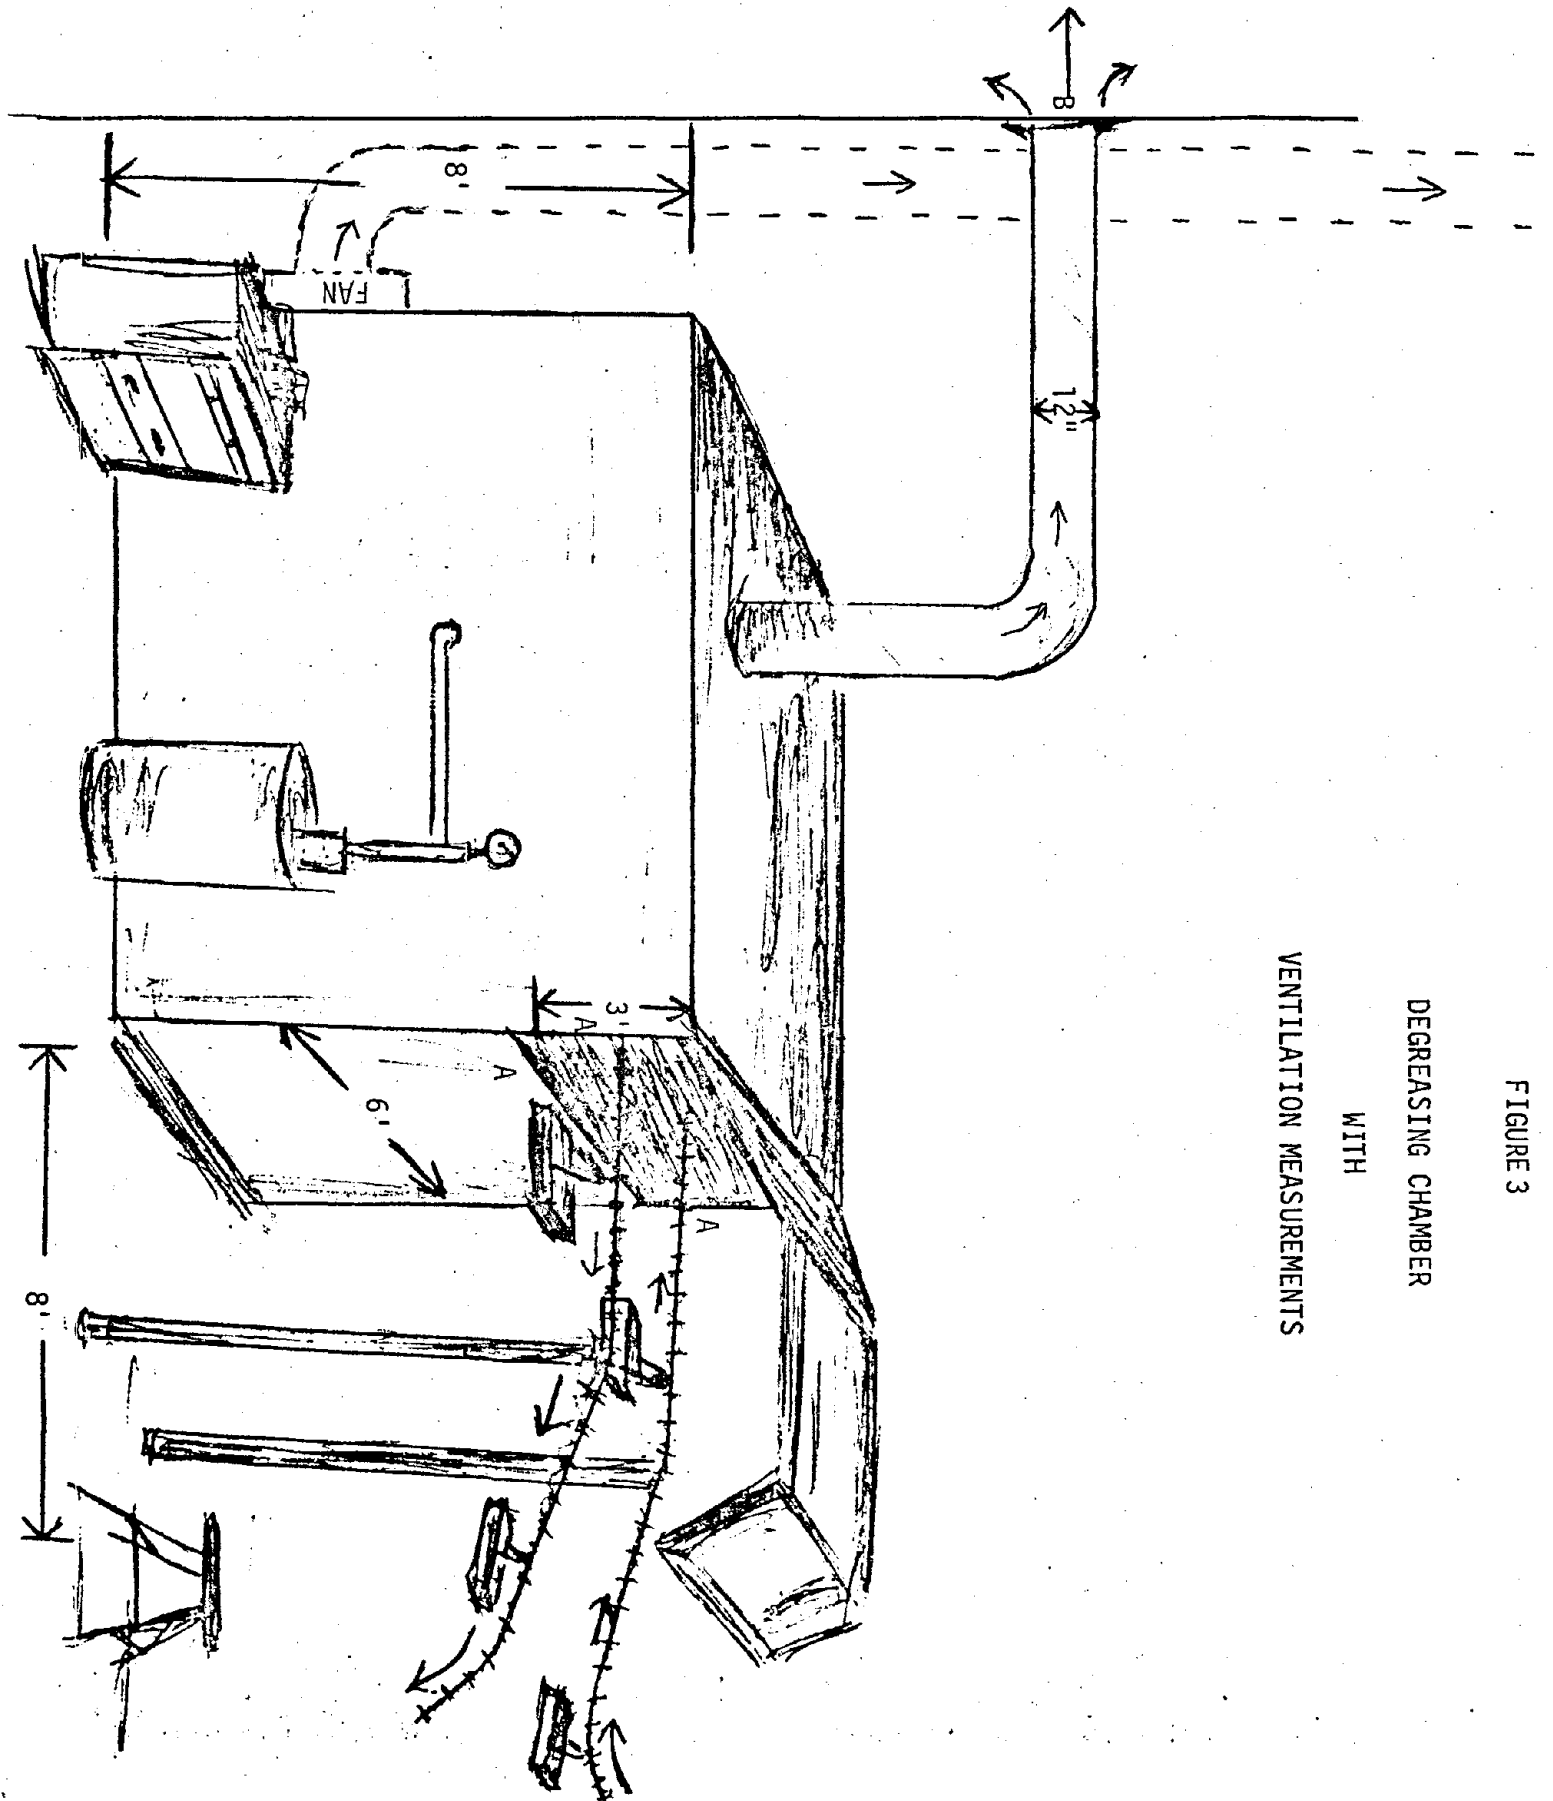
FIGURE 3

Another area in Building #6 that was evaluated was an operation in which the internal mechanisms of the air conditioners were degreased and assembled. (Figure 3) The operation of concern is a degreasing chamber in which the parts pass through a spray of Freon (TMC). Because of the low tolerance work performed, the room was humidity and temperature controlled (72°F, 28% relative humidity).

Ventilation measurements also were taken in the degreasing (pump) room. Face velocity measurements were made at the opening of the degreasing chamber and at the exhaust of the chamber. Location of measurements are illustrated in Figure 3. Air movement through the chamber resulted from a constant positive pressure maintained in the degreasing room. Some measurements were attempted along the opening of the chamber but no reading could be obtained. The opening into the chamber was approximately 3' x 6'. A measurement also was made at the exhaust of the chamber which was being vented into the adjoining room. The opening of the exhaust was approximately 9" x 12". The air velocity at the exhaust had a face velocity of 180 to 220 fpm. Measurements at the exhaust were taken both with the degreasing room door open and closed. Under both conditions there was no visible change in the air flow measurement, indicating that a constant static pressure was maintained in the room. Knowing the air flow and the size of the opening at the exhaust the predicted intake velocity at the opening of the chamber was calculated and found to be approximately 8-10 fpm. This low velocity would account for the inability to obtain a measurement.

The results of the ventilation measurements on the degreasing chamber indicates an inefficient flow rate of 8-10 fpm at the hood opening. It is recommended that a minimum velocity of 50 fpm be maintained in order to keep the vapors from escaping. Since Freon 113 has a molecular weight 4 to 5 times greater than that of air it would be advisable to vent the vapors from a lower position in the chamber. In doing so a fan should be installed in the exhaust so as to maintain the necessary velocity at the hood opening.

As a matter of good practice, the vapors from the chamber should not be exhausted into nearby work areas. The present arrangement has the vapors being vented into the next room; this problem can be easily remedied by extending the duct work to the ceiling and into the overhead exhaust. These suggestions are illustrated in Figure 2.
