## COLLECTION AND ANALYSIS OF WORK SURFACE ACCIDENT PROFILE DATA

Final Report

Prepared for  
National Institute for Occupational Safety and Health  
Under  
Contract 210-76-0150

December 1977

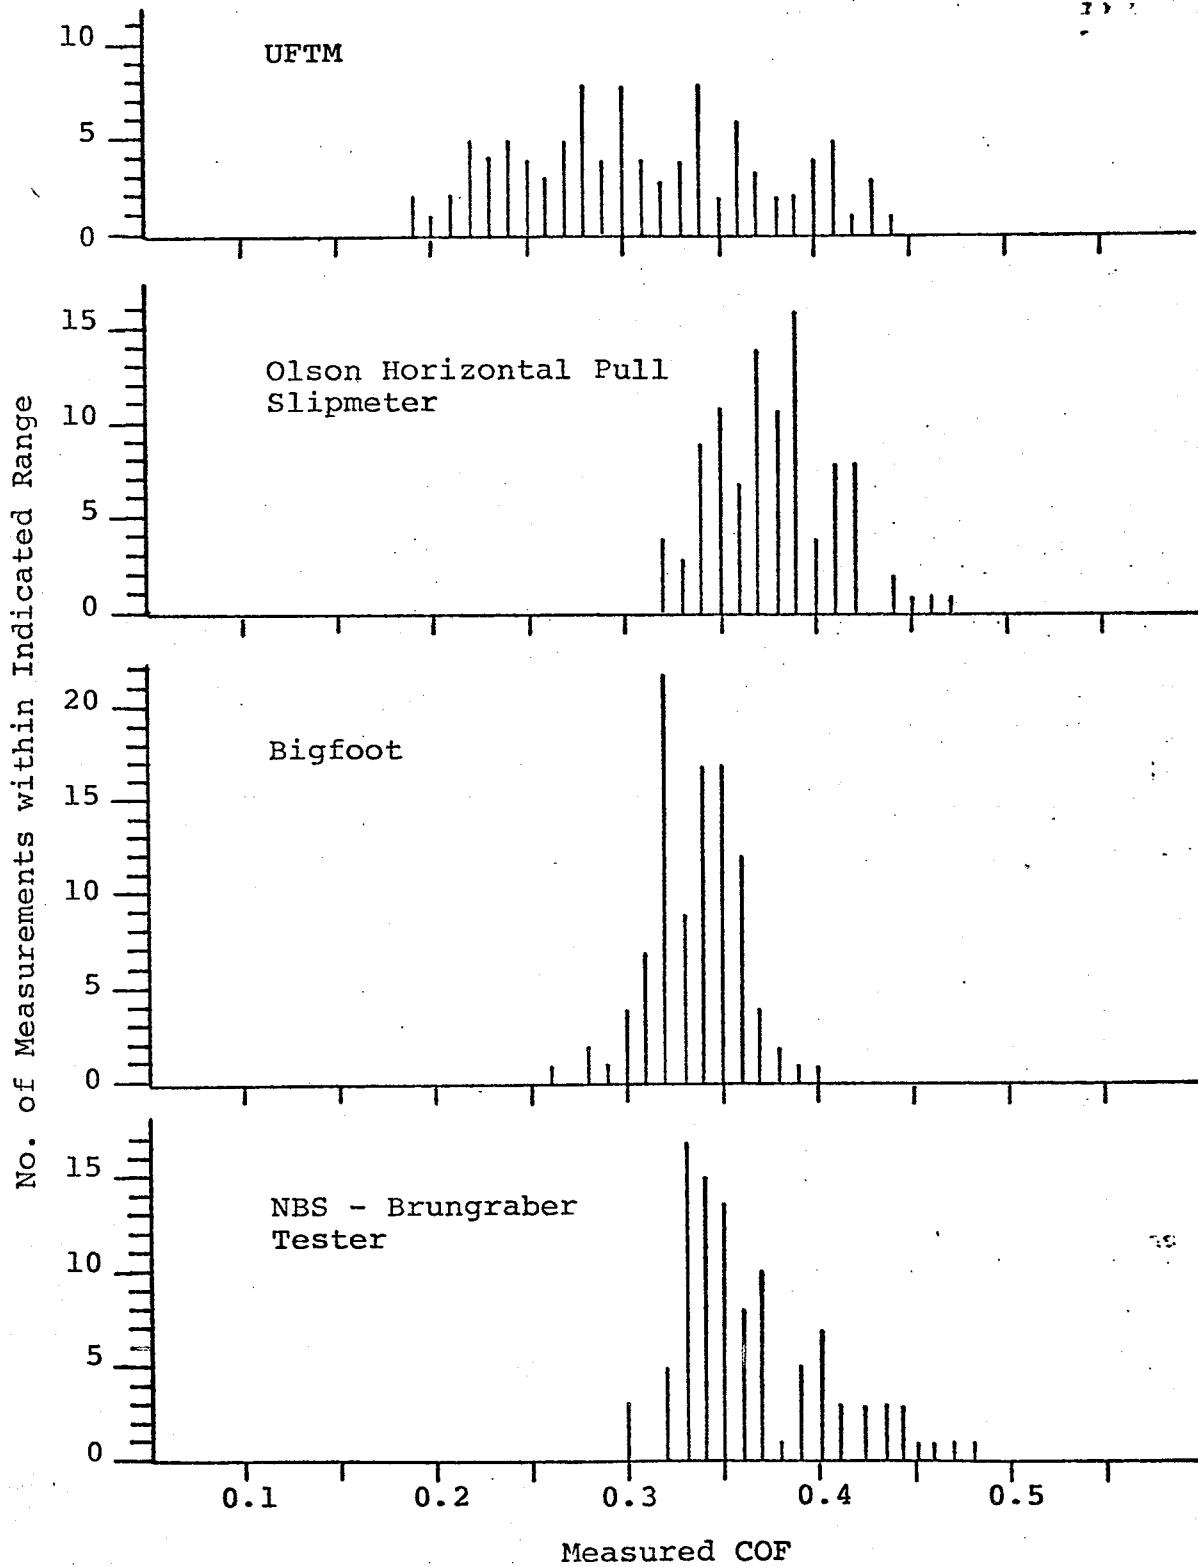
FIGURE 2-2

Measurements obtained using the UFTM were found to have excessive scatter requiring a greatly increased number of replicates in order to obtain a desirable statistical level of confidence in the measured value of COF. One hundred measurements made with leather sole samples (surface restored after each measurement) on a formica table top with all parameters constant had a range of COF from .19 to .44 and a standard deviation of .064.

HISTOGRAMS SHOWING SCATTER IN MEASURED  
COF FOR FOUR INSTRUMENTS

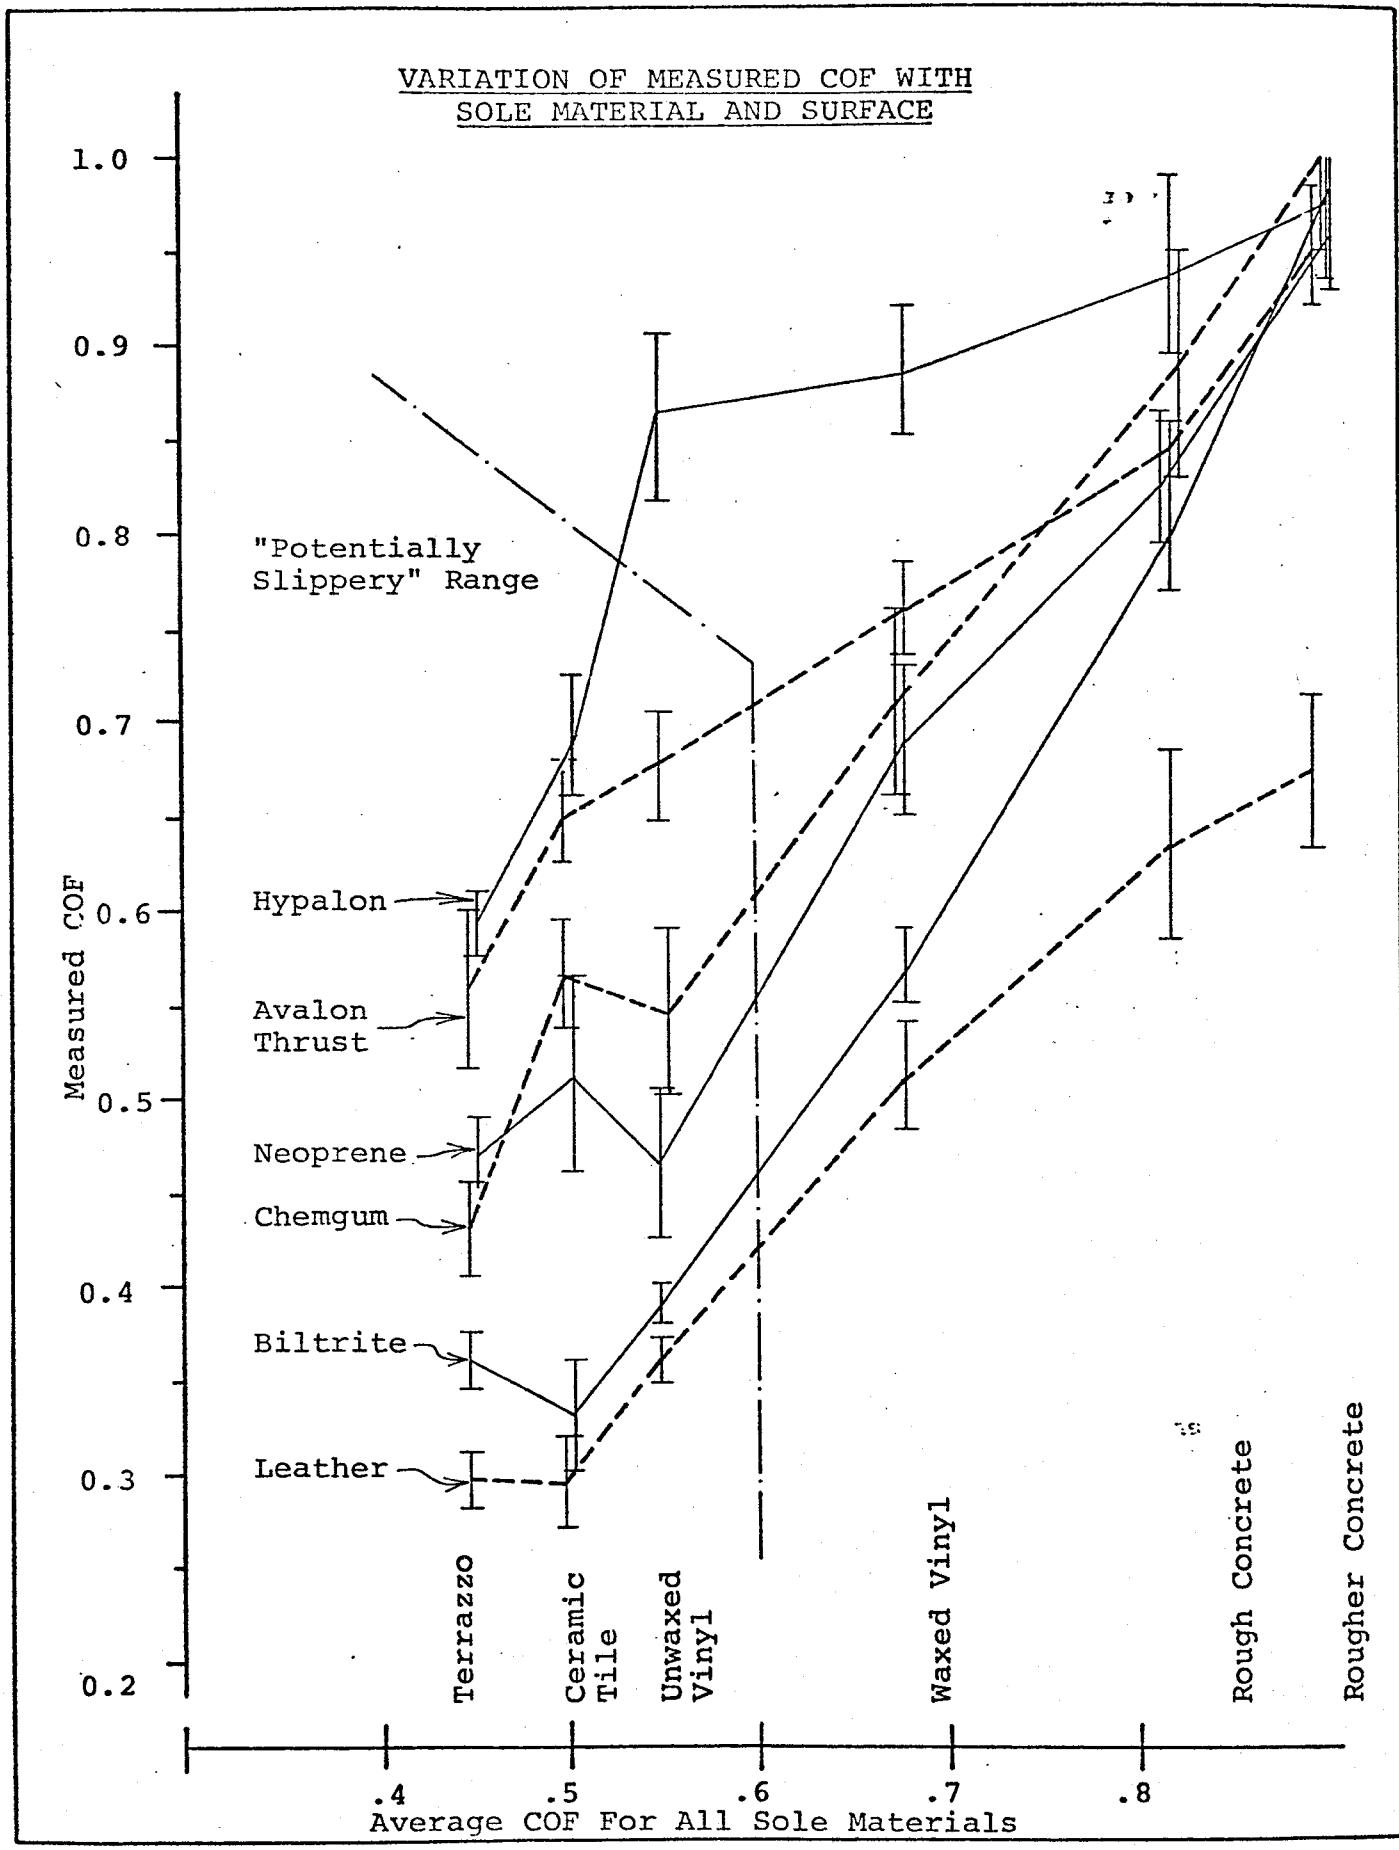
Examination of FIGURE 2-3 shows that the measured COF generally decreased as subjective slipperiness of the surface increased. The sole materials also show generally consistent COF behavior as the surface is varied. In this sense, some surfaces, and some sole materials can be described loosely as "high COF." An interesting observation is that the high COF sole materials appear to show a more rapid drop off in COF as the surface becomes more slippery than is shown by the lower COF materials. A line is drawn in FIGURE 2-3 to indicate the range considered to be "slippery." It should be noted that slipperiness may be related not only to the absolute value of the COF but to the difference in COF "felt" by a worker between one location and another. If the worker does not adjust his gait, a slip may occur even with a high absolute value of COF, while a worker habituated to working with a low shoe-floor COF may be able to avoid slips.

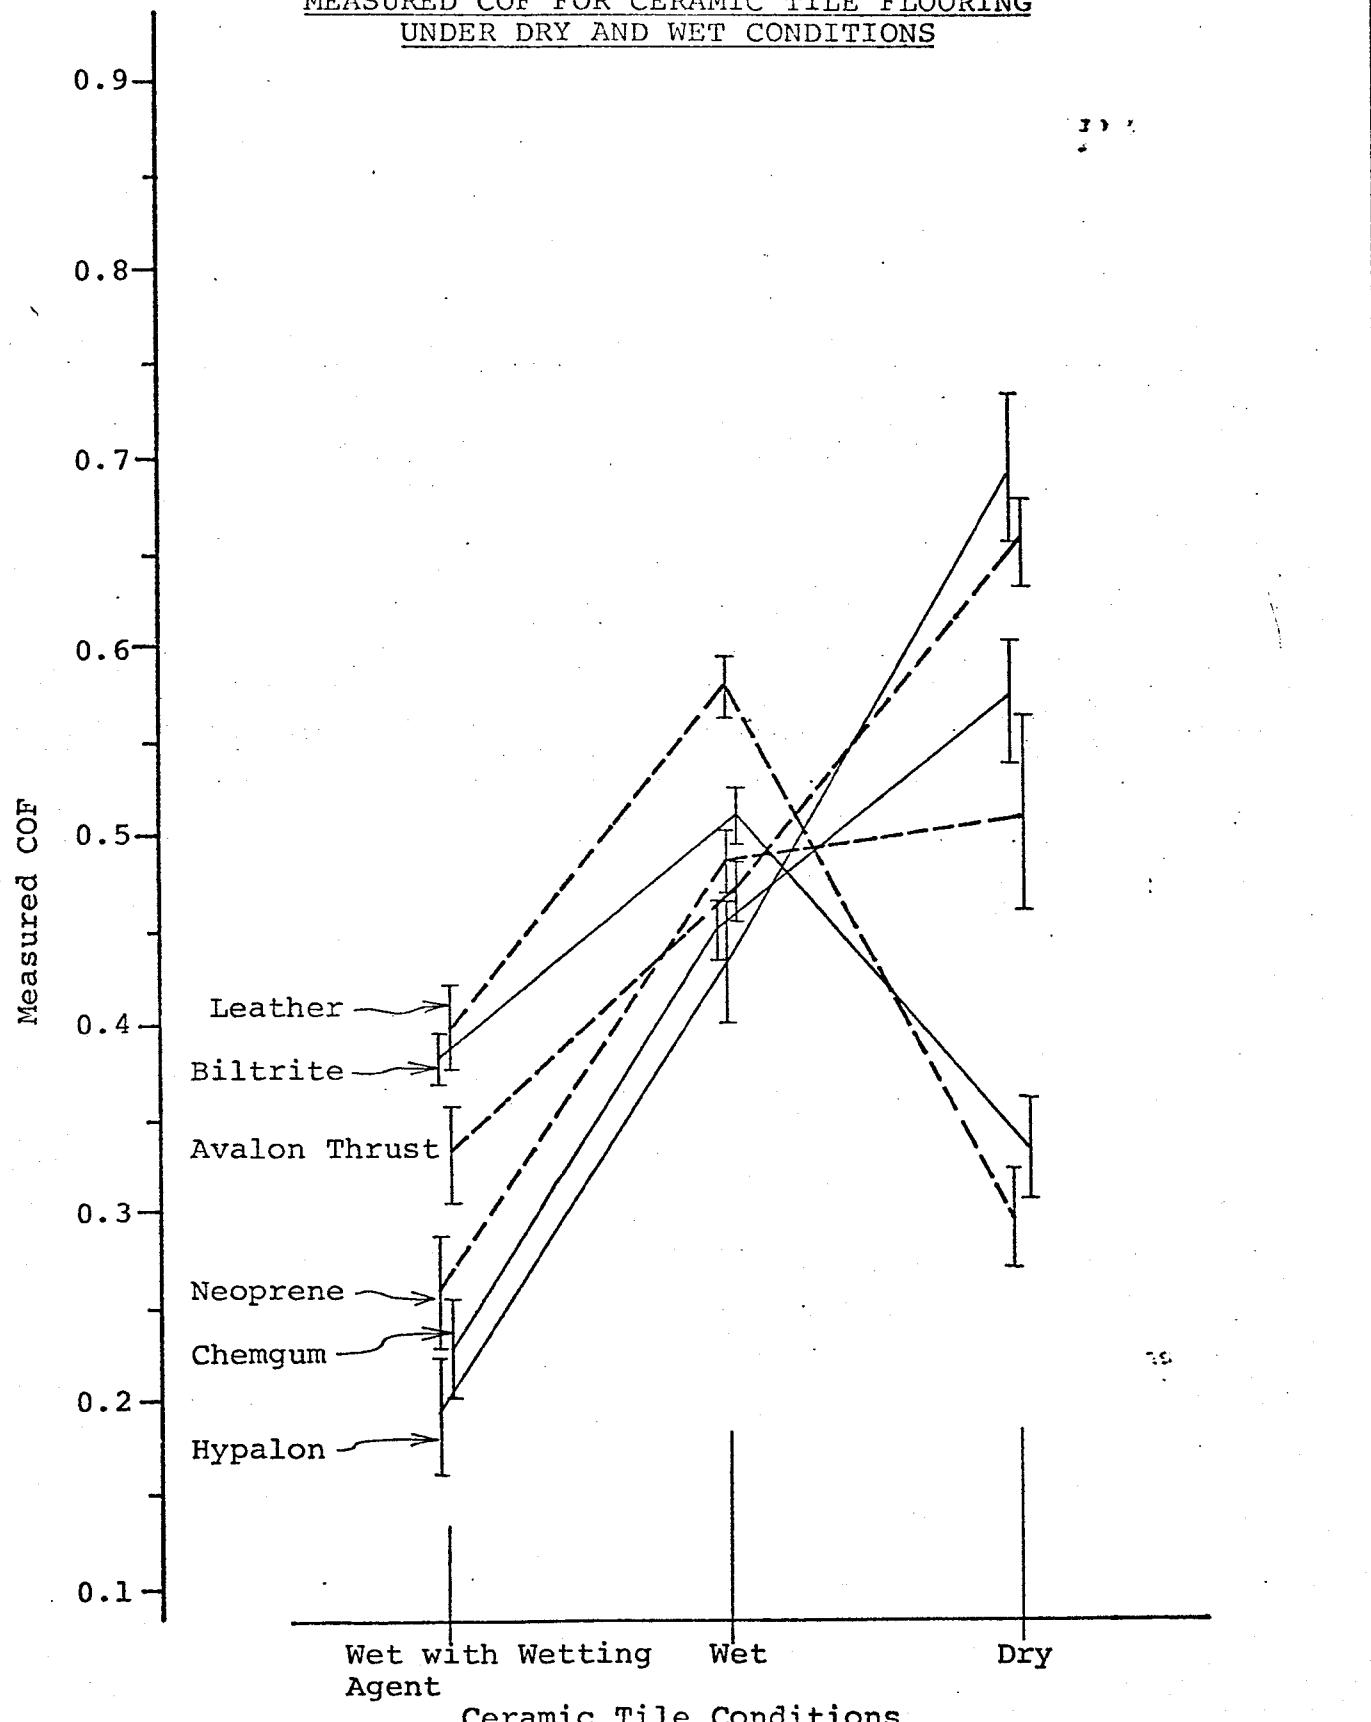
FIGURE 2-4

MEASURED COF FOR CERAMIC TILE FLOORING  
UNDER DRY AND WET CONDITIONS

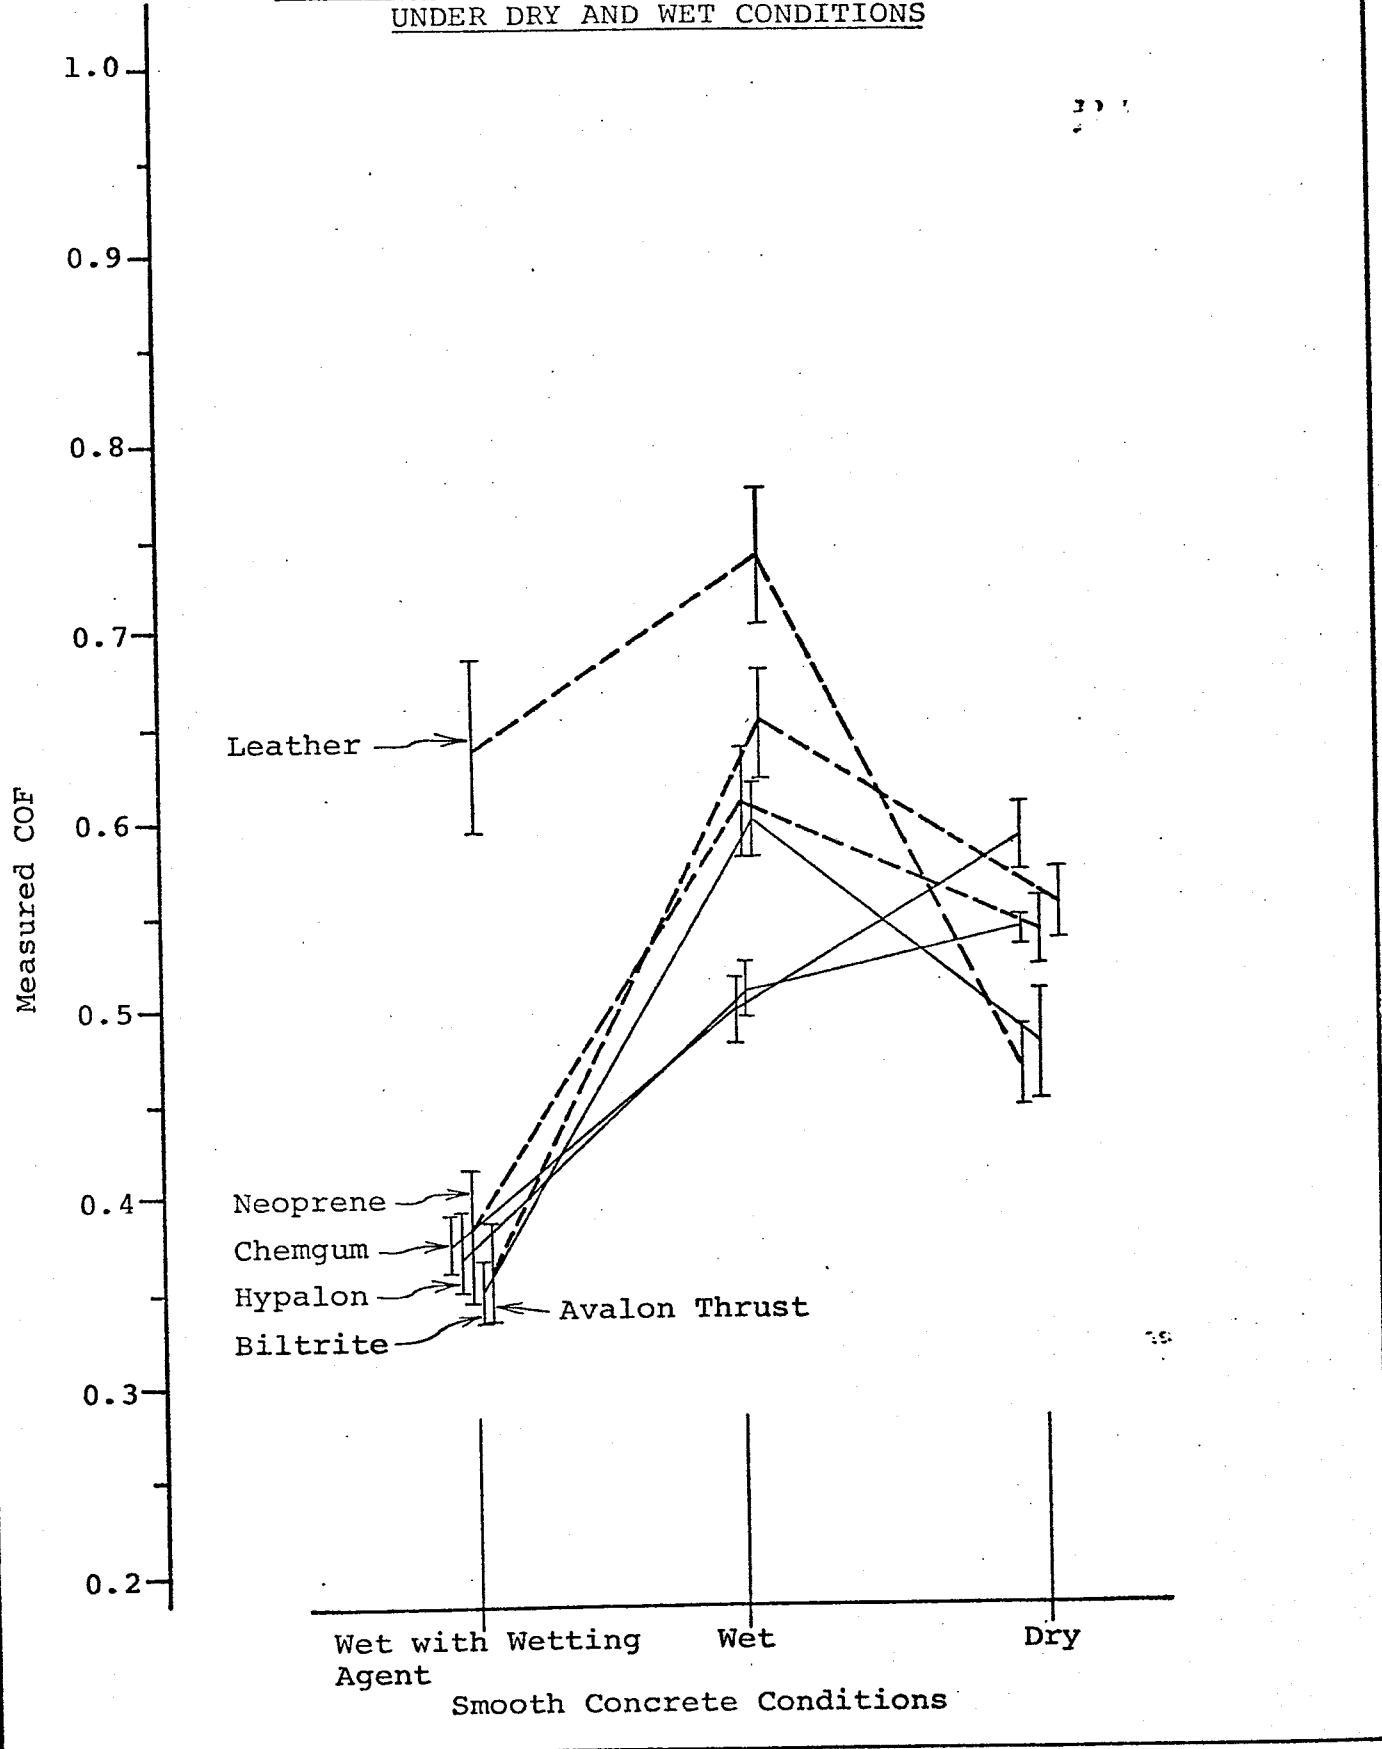
FIGURE 2-5

MEASURED COF FOR SMOOTH CONCRETE FLOORING  
UNDER DRY AND WET CONDITIONS

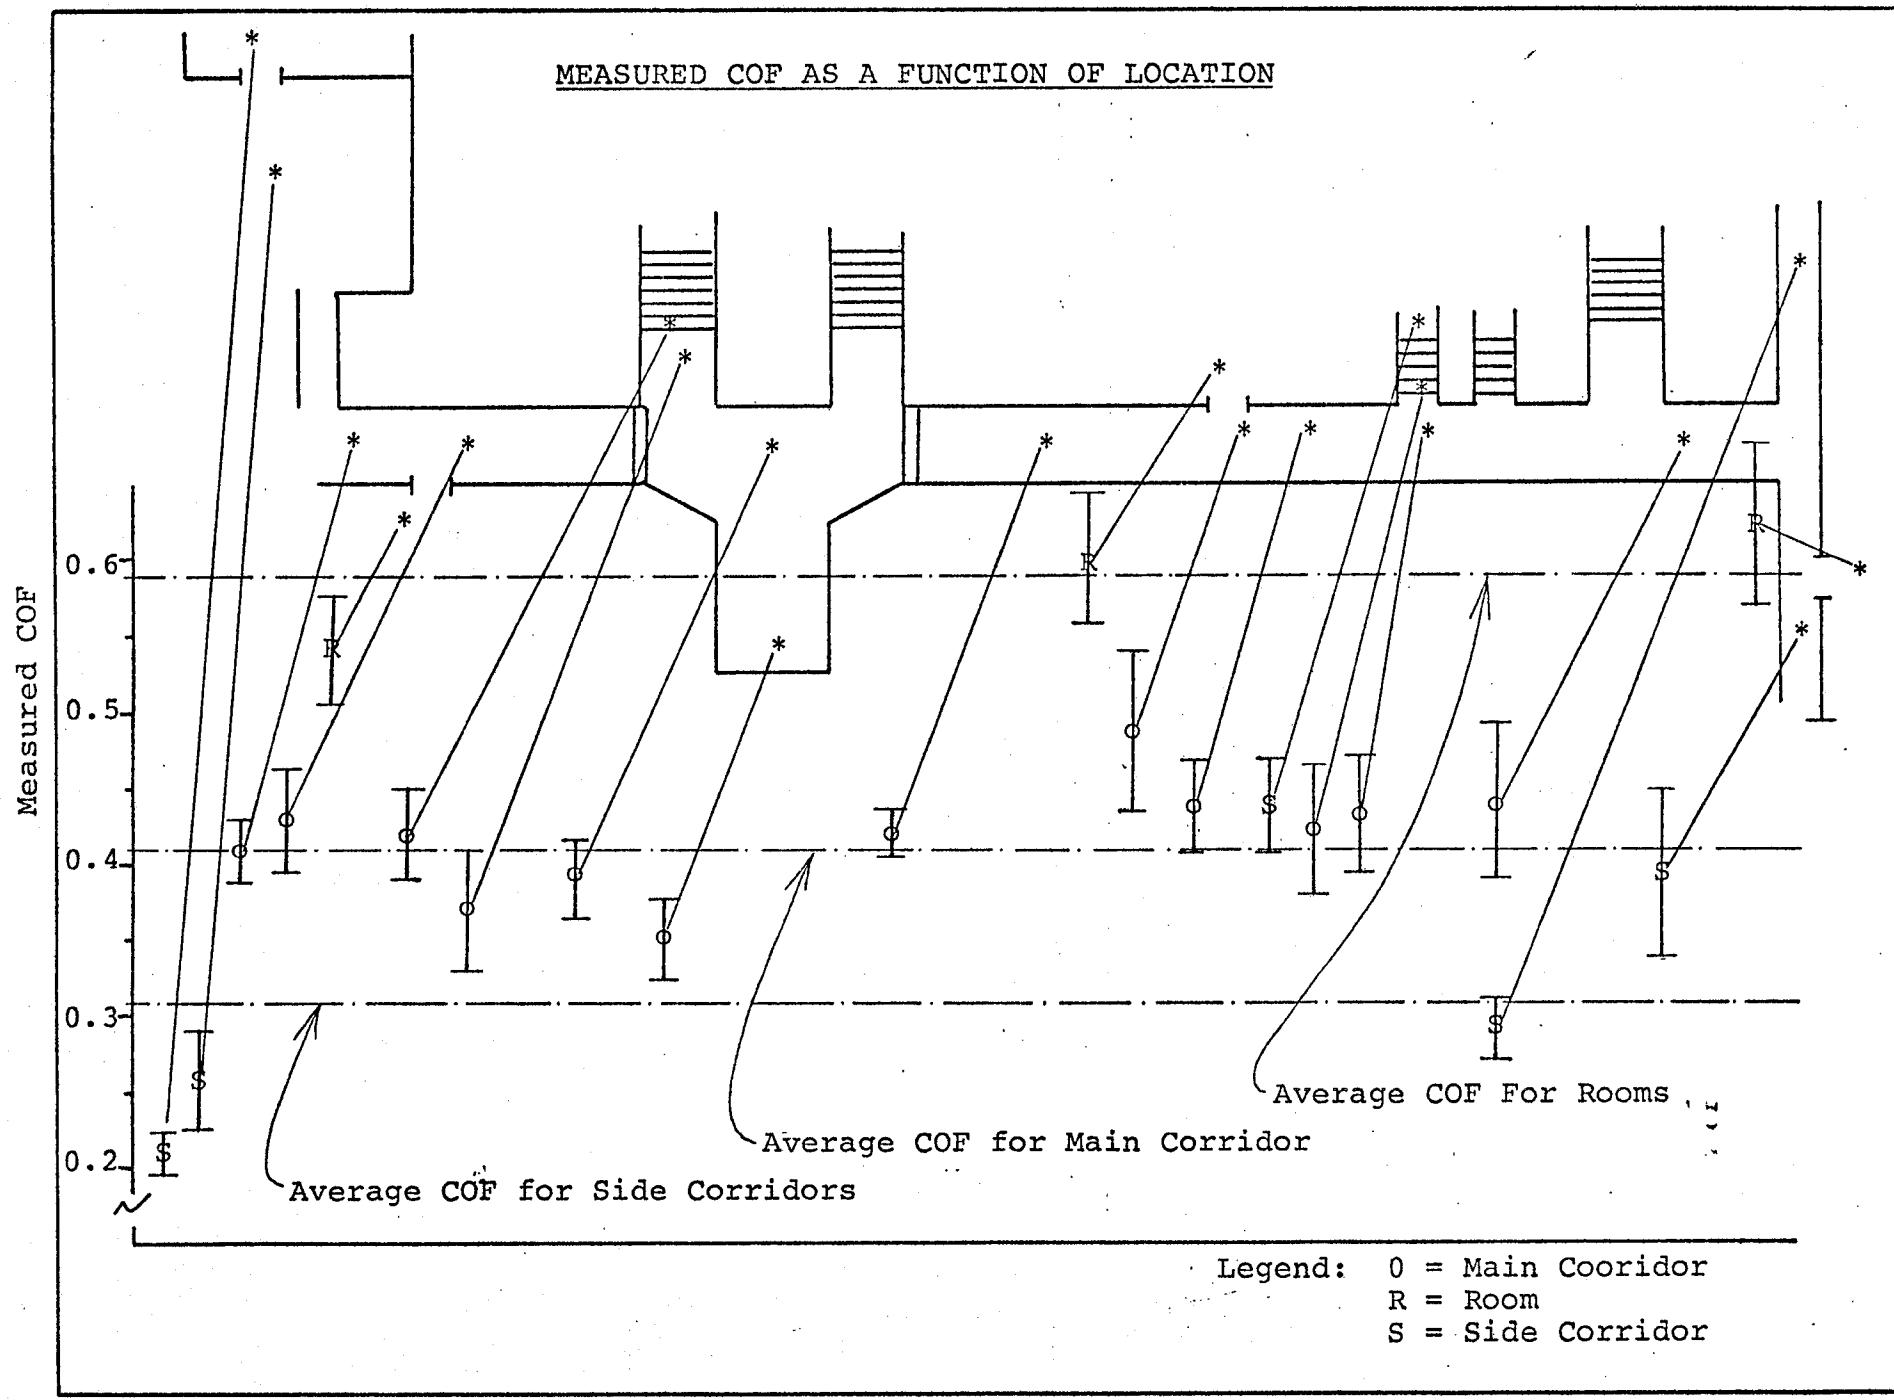
A number of series of measurements were made to compare different sites covering broad areas of selected buildings. An example of the results is shown in FIGURE 2-7 for a corridor and room system, all of which is floored with vinyl tile. As can be seen, the main corridor has values for COF that are approximately uniform. The rooms leading off this corridor tend to have significantly higher values of COF, while the side corridors have significantly lower values of COF. Non-uniformities of this kind impose a burden on walkers to adapt their gait to the circumstances.
