TALC DUST AND INDUSTRIAL HYGIENE SURVEY

PLYMOUTH RUBBER COMPANY
Canton, Massachusetts

Environmental Investigations Branch
Division of Field Studies and Clinical Investigations
National Institute for Occupational Safety and Health
1014 Broadway
Cincinnati, Ohio

April 26-27 & May 10-11, 1972

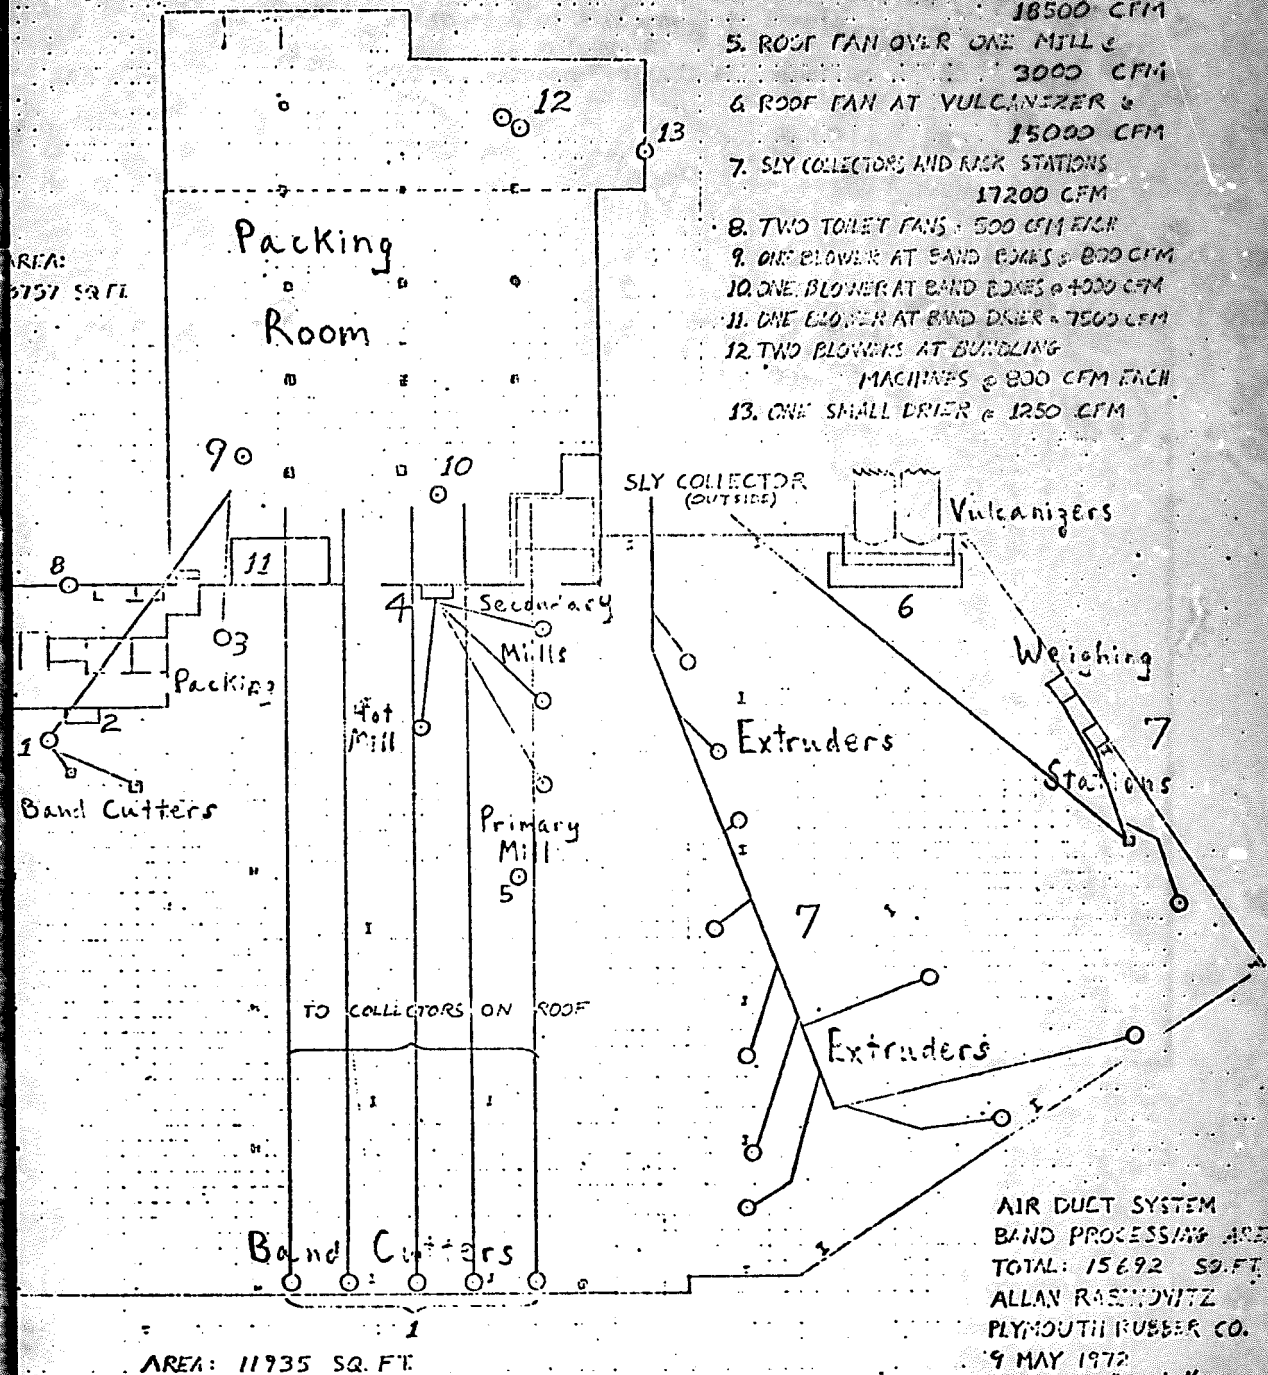
Figure 1 Ventilation System, Plymouth Rubber Company

Ventilation: A line diagram of the Band Room ventilation layout, together with the capacities of the various fans and blowers was supplied by Plymouth Rubber and is included in the Appendix to this report. This also gives some idea of the general layout of the equipment in the room. The Massachusetts Department of Labor and Industries has done a survey previously

(see Appendix) in which hood velocities were checked and no recommendations for ventilation improvements made. However, in our opinion, the systems provided are poorly designed and generally located too far from dust generation points to be effective.

There is floor ventilation at the weighing stations near the vulcanizer, but the hoods are too far from the dustiest operation in the area, the removal of the rods from the cured rubber tubes, to be effective. The hoods at the extruding stations are unflanged and are located approximately one foot above the machine. Talc is sprayed downward onto the extruded tubes, therefore, the ventilation must overcome additional inertia to capture the dust. A better solution might be to enclose the spraying operation and use downdraft ventilation to capture the created dust.

The canopy hooding over the calendars is effective in venting dust in the general air, but can not be as effective as properly designed local exhaust ventilation. There is some general ventilation in the packing area, but nothing immediately in the vicinity where the workers handle the dust laden rubber bands to pack them. All local exhaust ventilation is vented to a Sly bag type collector rated at 17,200 cfm. The collector is located outside and appeared to function properly.

3. Ventilation in the area is extremely poor. Local exhaust hoods should be provided in the packing, vulcanizing, and milling areas. Hoods at extruding stations should be re-designed to enclose the spraying operation and down draft ventilation provided.
