AIR SAMPLING
&
INDUSTRIAL HYGIENE SURVEY

GENUINE PARTS COMPANY
RAYLOC DIVISION
ATLANTA, GEORGIA

Environmental Investigations Branch
Division of Field Studies and Clinical Investigations
NATIONAL INSTITUTE FOR OCCUPATIONAL SAFETY & HEALTH
1014 Broadway
Cincinnati, Ohio 45202

August, 1972

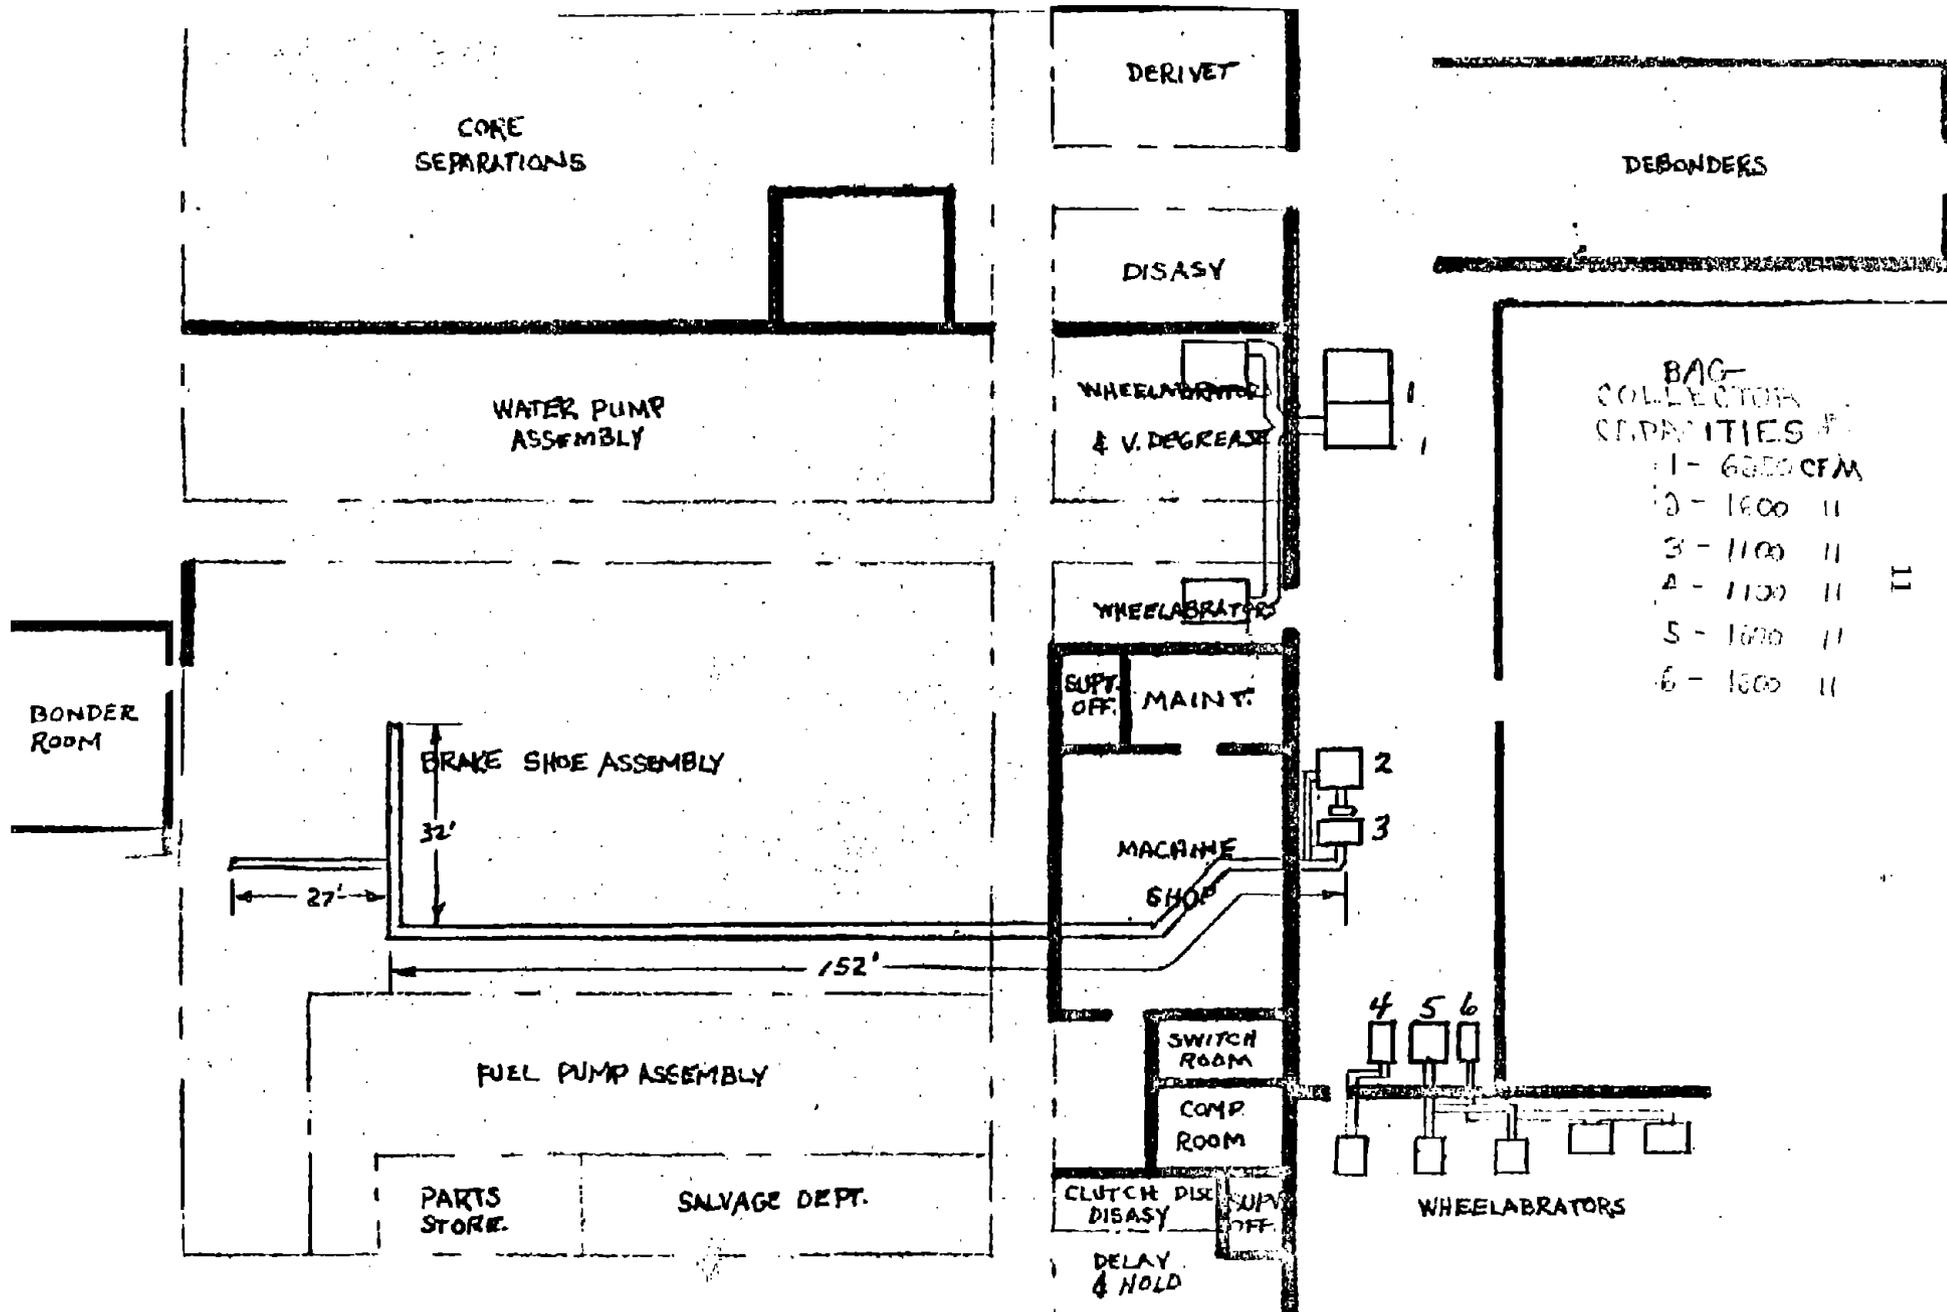
FIGURE 1: FRICTION PRODUCT LAYOUT WITH COLLECTORS

Local exhaust ventilation is provided on all 3 brake lining grinders and on all 5 "Wheelabrator" cleaning machines. These machines are vented to 6 "Wheelabrator" bag dust collectors.

Figure 1 shows a layout of the friction products area of the plant along with locations of the dust collectors and their respective capacities.
