PLACE VISITED: Goodyear Tire and Rubber Co.
Cast Film Division
St. Marys, Ohio

DATE OF VISIT: February 9-10, 1976

PURPOSE OF VISIT: To determine if a suitable population
exists for an environmental-epidemi-
ological study of workers exposed to
benzene.

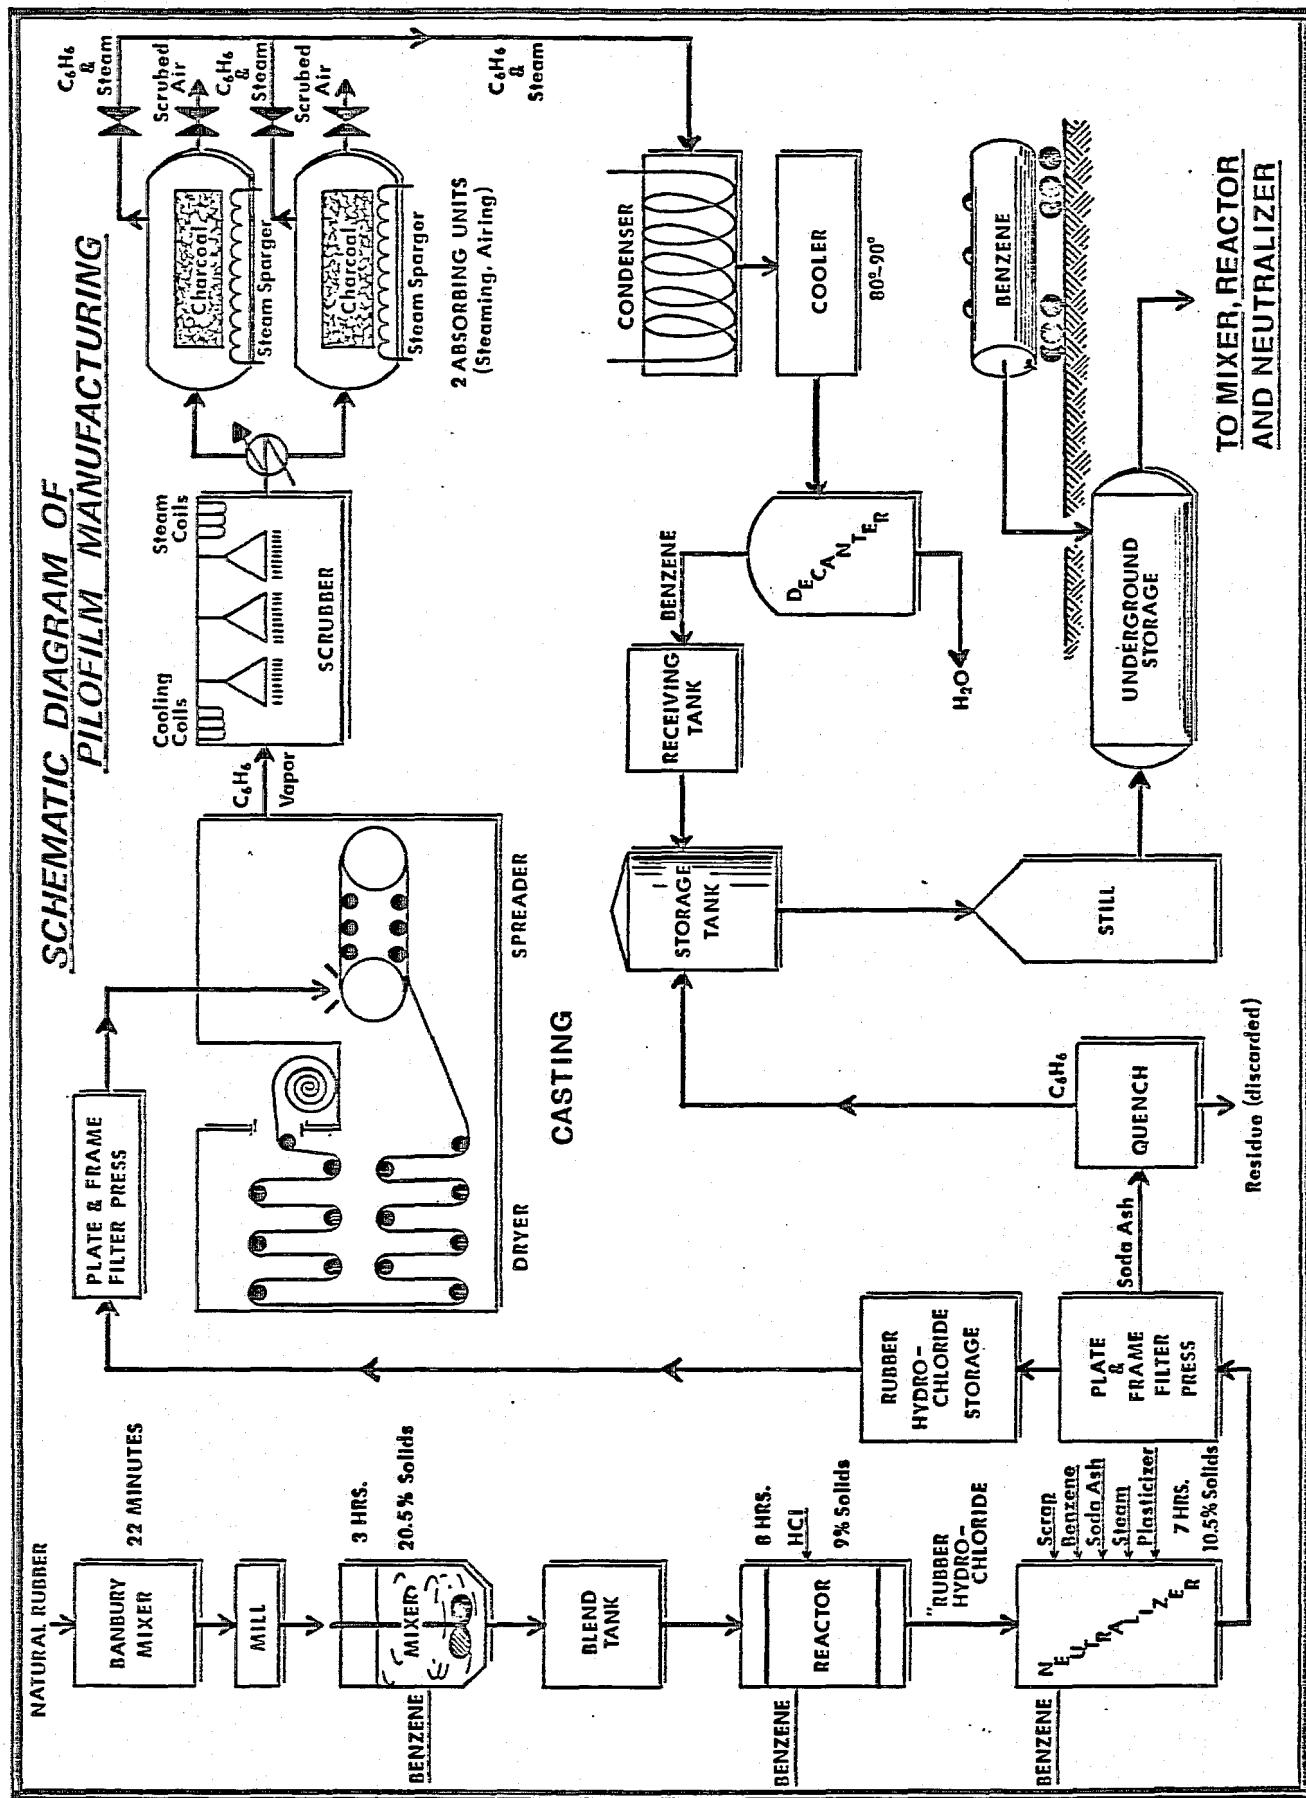
A schematic diagram of the process is shown in Figure 1. Natural rubber is uncrated and dumped in a Banbury mixer for approximately 22 minutes. The rubber from the Banbury passes through a mill and is conveyed to agitated mixing tanks where benzene is added. During this three hour mixing process, the rubber is dissolved in the benzene. This liquid is then piped to blending tanks where further mixing takes place. These tanks also serve as a hold tank for the reactor. As the process continues, the solution is introduced to the reactor, where hydrochloric gas (HCL) is added. Also, measured amounts of benzene are added to reduce the percent solids from 20% to 9% or less. From the reactor tanks the rubber hydrochloride is dropped into neutralizing tanks. Film scraps, soda ash, plasticizers and additional benzene are added. The mixing is a 6 to 7 hour process, and is adjusted to 10% rubber hydrochloride. Next the mixture is passed through a plate and frame filter press. The
