NIOSH CONTROL TECHNOLOGY ASSESSMENT
at
Uniroyal Tire Company
Ardmore, Oklahoma

Date of Survey:
April 14 - 24, 1980

Report Written by:
Matthew K. Klein, P. E.
William A. Heitbrink, C. I. H.
Date of Report: August 5, 1981

Engineering Control Technology Branch
Division of Physical Sciences and Engineering
National Institute for Occupational Safety and Health
Cincinnati, Ohio

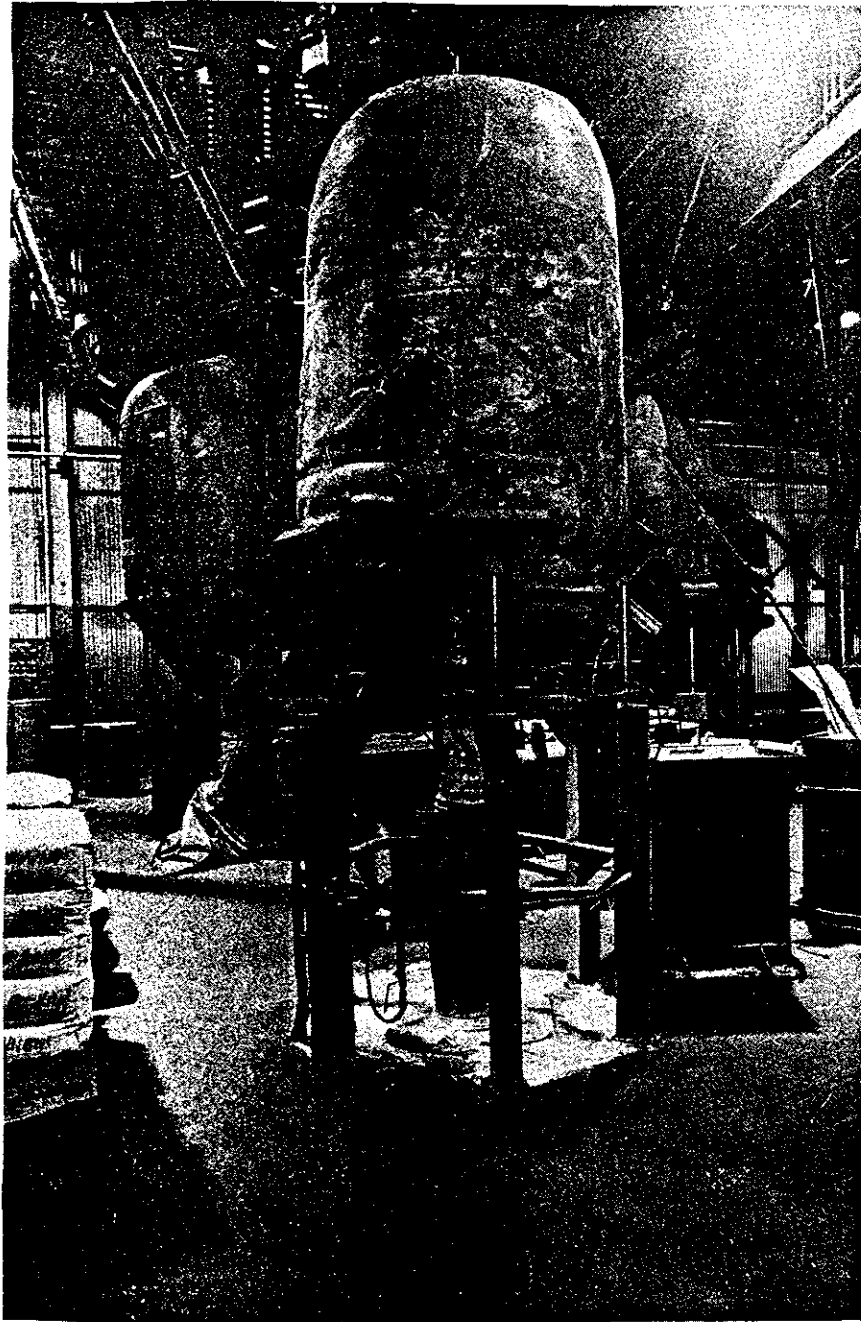
Figure 1-1. Sealdbins^(R) and dispensing stations showing
tilt stands.

Even with the vibrators, the material in the Sealdbin^(R) will sometimes bridge and refuse to flow. In this case, the worker wedges a bar between the cradle ring and the bin and lifts against the bin to try and break the bridge. This was frequently observed with zinc oxide. Once the material starts flowing, however, there does not seem to be any other problems.

One safety problem was observed with the system. When the cylinders that raised the arms of the pneumatic cradle were shut-off, the arms dropped rapidly without warning. The worker operating the cradle controls is responsible for assuring the area around the cradle is clear. But, the Sealdbins^(R) can block his sight of part of the cradle. Severe injury appeared possible should any of the cradle arms hit someone.

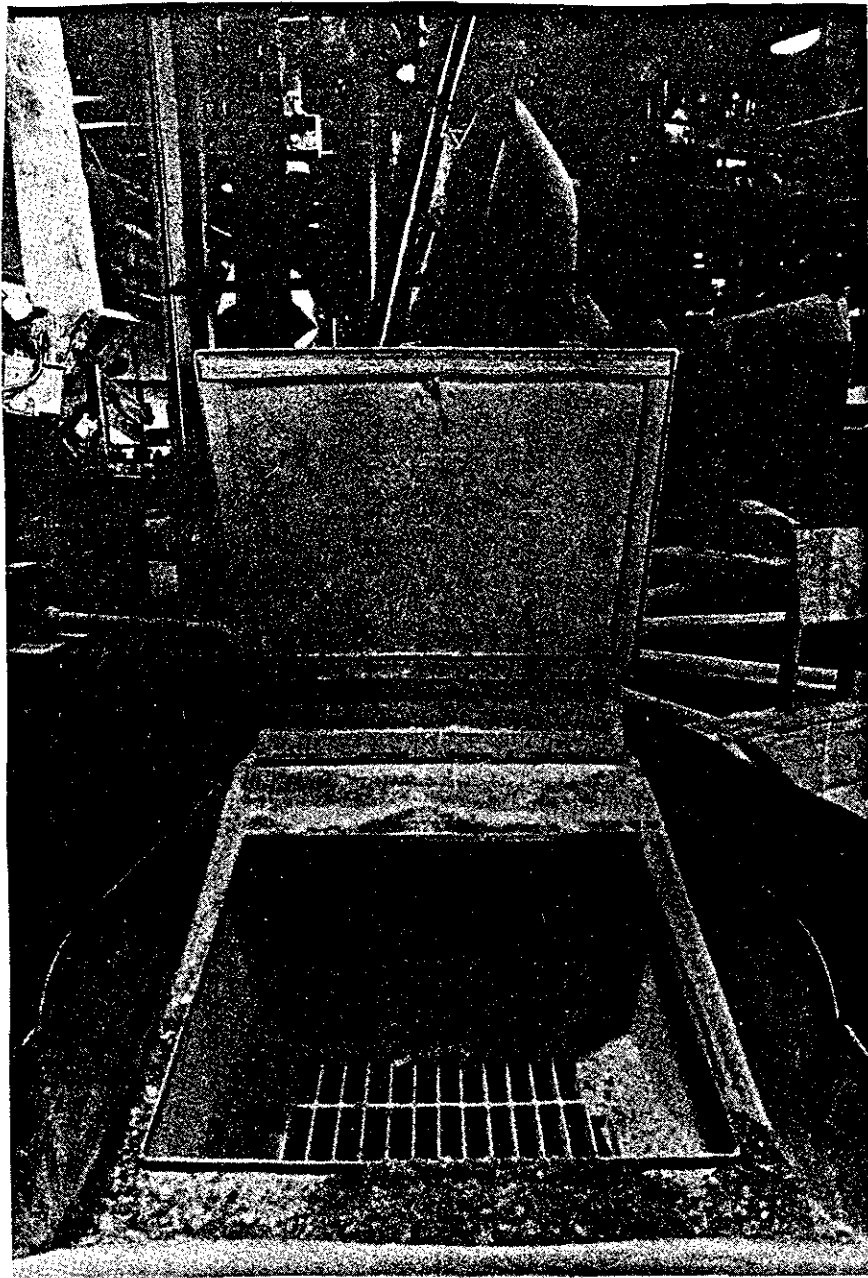
Figure 2-5. Hopper/bin hood for non-explosive materials
showing protective grate and duct entrance.
Also note material accumulated on the edges of the hood face.

Maintenance work practices are felt to be the cause of the decrement in the hood's performance. The damper on the manifold did not appear to work because it was covered with material. Also, some ducts were partially plugged.

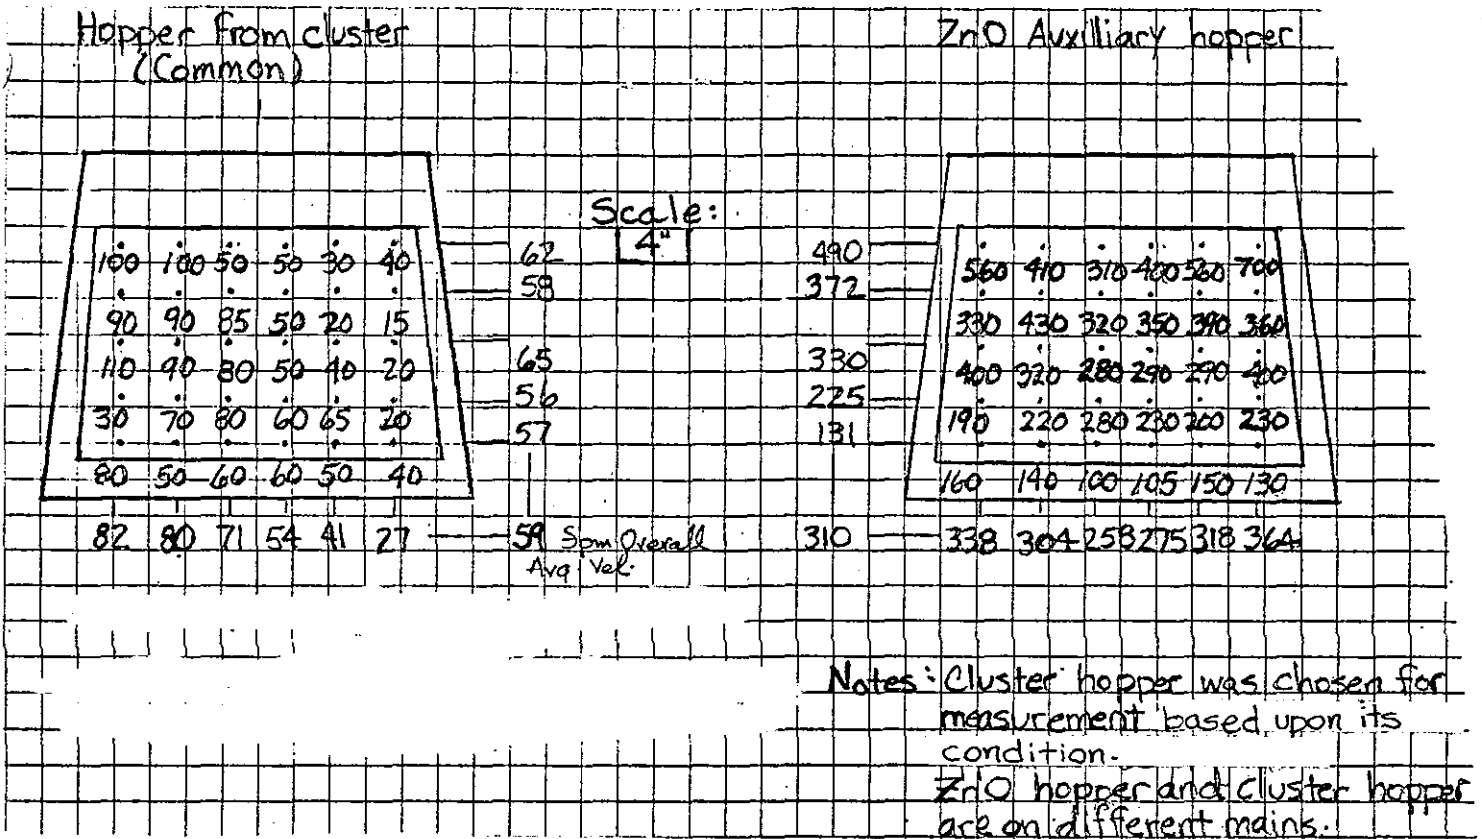
Figure 2-7. Hopper/bin hoods face velocities.

The airflow into the hopper/bin hood on the manifold, calculated from the hood face area and face velocity measurements, is about 100 cfm. Yet the airflow measured in the duct for the entire cluster of hoods was about 500 cfm. The difference in the measurements suggests leaks into the ventilation system. These leaks are probably through the damper or the hood door seals.

The hopper/bin hood upon which ventilation measurements were made was found to be operating at only 20 percent of its design. Therefore, judgement of its effectiveness in controlling the dust generated from bag slitting and bin filling cannot be made. A true indication of the ventilation parameters was obtained from a hood which was operating at its design.
