NIOSH CONTROL TECHNOLOGY ASSESSMENT
AT
GENERAL TIRE AND RUBBER COMPANY
CHARLOTTE, NORTH CAROLINA

Date of Survey:
November 26-30, 1979

Date of Report:
May 13, 1981

The purpose for this study is to evaluate and document effective controls for air contaminants in the tire manufacturing industry. (SIC 3011)

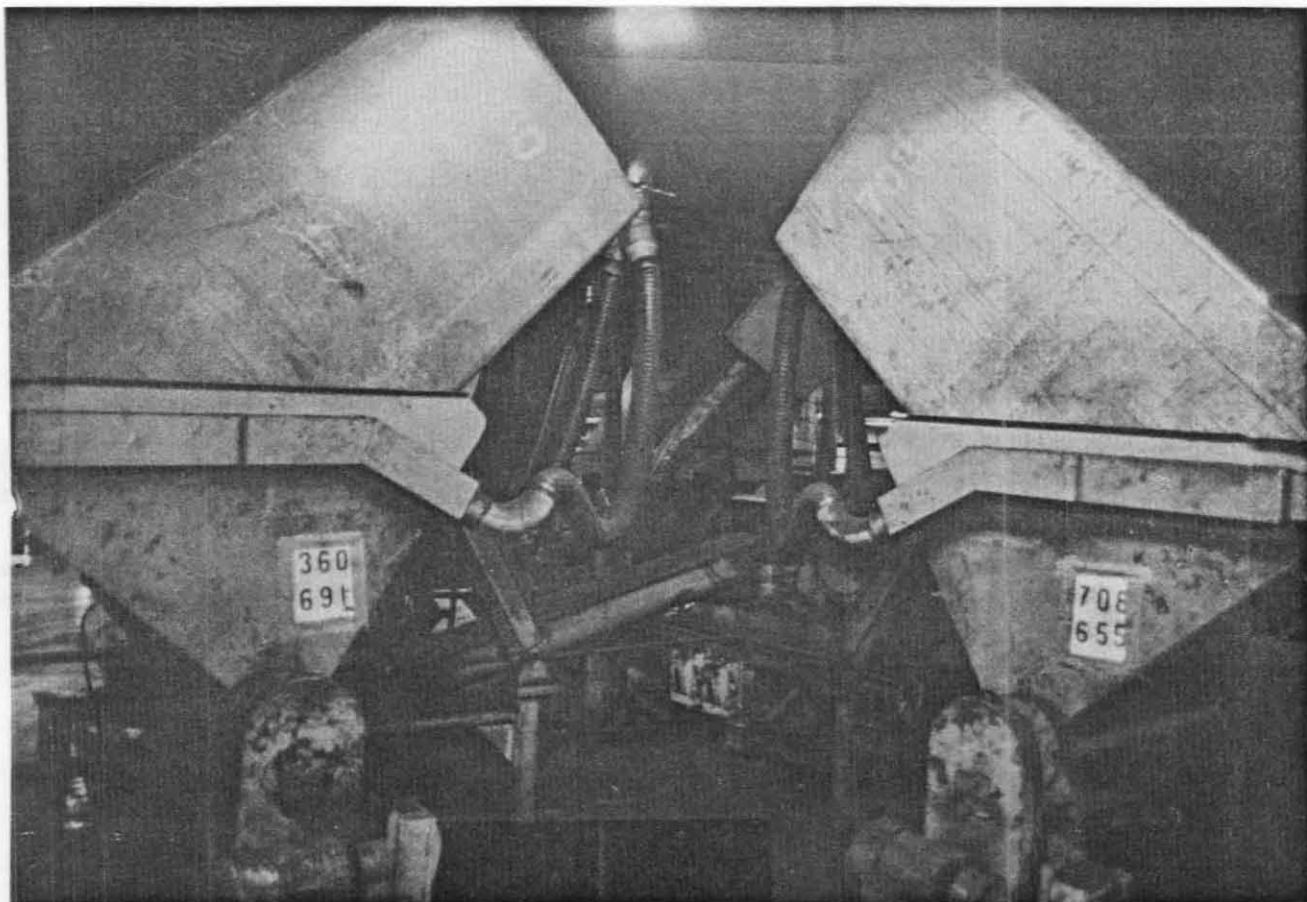
Figure 2-2. Carbon black charging station showing tilt stands, Tote™ bins, and conveying systems.

4. The combination of 90° elbows and too long flexible ducting for the tilt stand branch ducts caused kinks in the flexible ducts whenever the tilt stand was in the non-tilt position. A difference of about 160 cfm exists between the flow calculated from the slot velocities and that from the duct velocities. The former was measured with the tilt stand in the non-tilt position and the latter in the tilt position. Additionally, this combination could cause extra losses to the system with the tilt stand tilted by creating "artificial elbows," as shown in Figure 2-2.

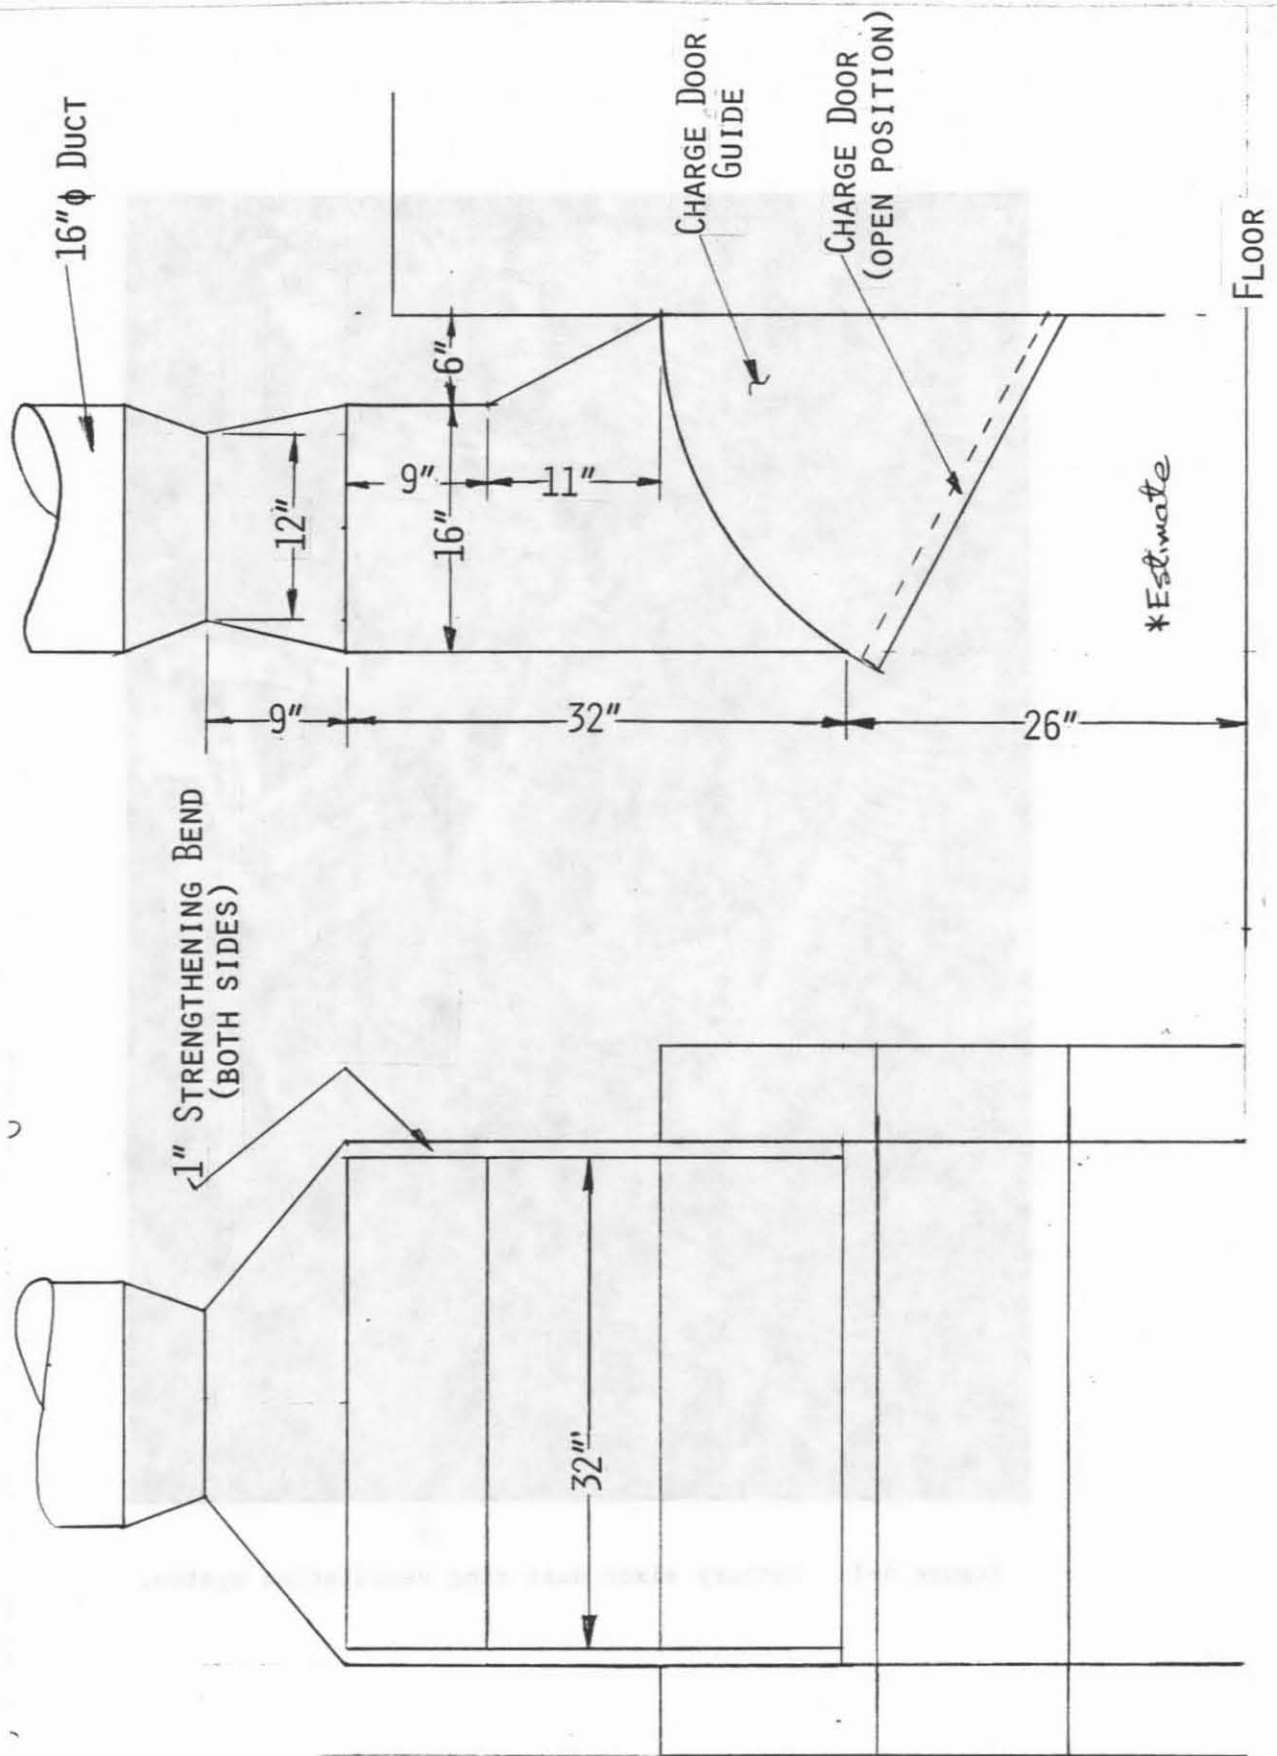
Figure 4-2. Banbury mixer charge door hood detail.

Turbulent air was encountered for the lower vertical foot of the charge door hood. Air velocity measurements and smoke tube tracers in the proximity of the hood showed that the effect was caused by the make-up airflow. Therefore, to get an accurate indication of the line average velocities in the area, the upper four line averages and the corresponding distance from the top of the hood face were used to derive the last three line averages by an exponential curve fit. The values and calculations based on them are shown in parenthesis

1. The positioning of the make-up air diffuser was close enough to the charge door hood so that make-up air caused turbulence at the lower portion of the hood face.

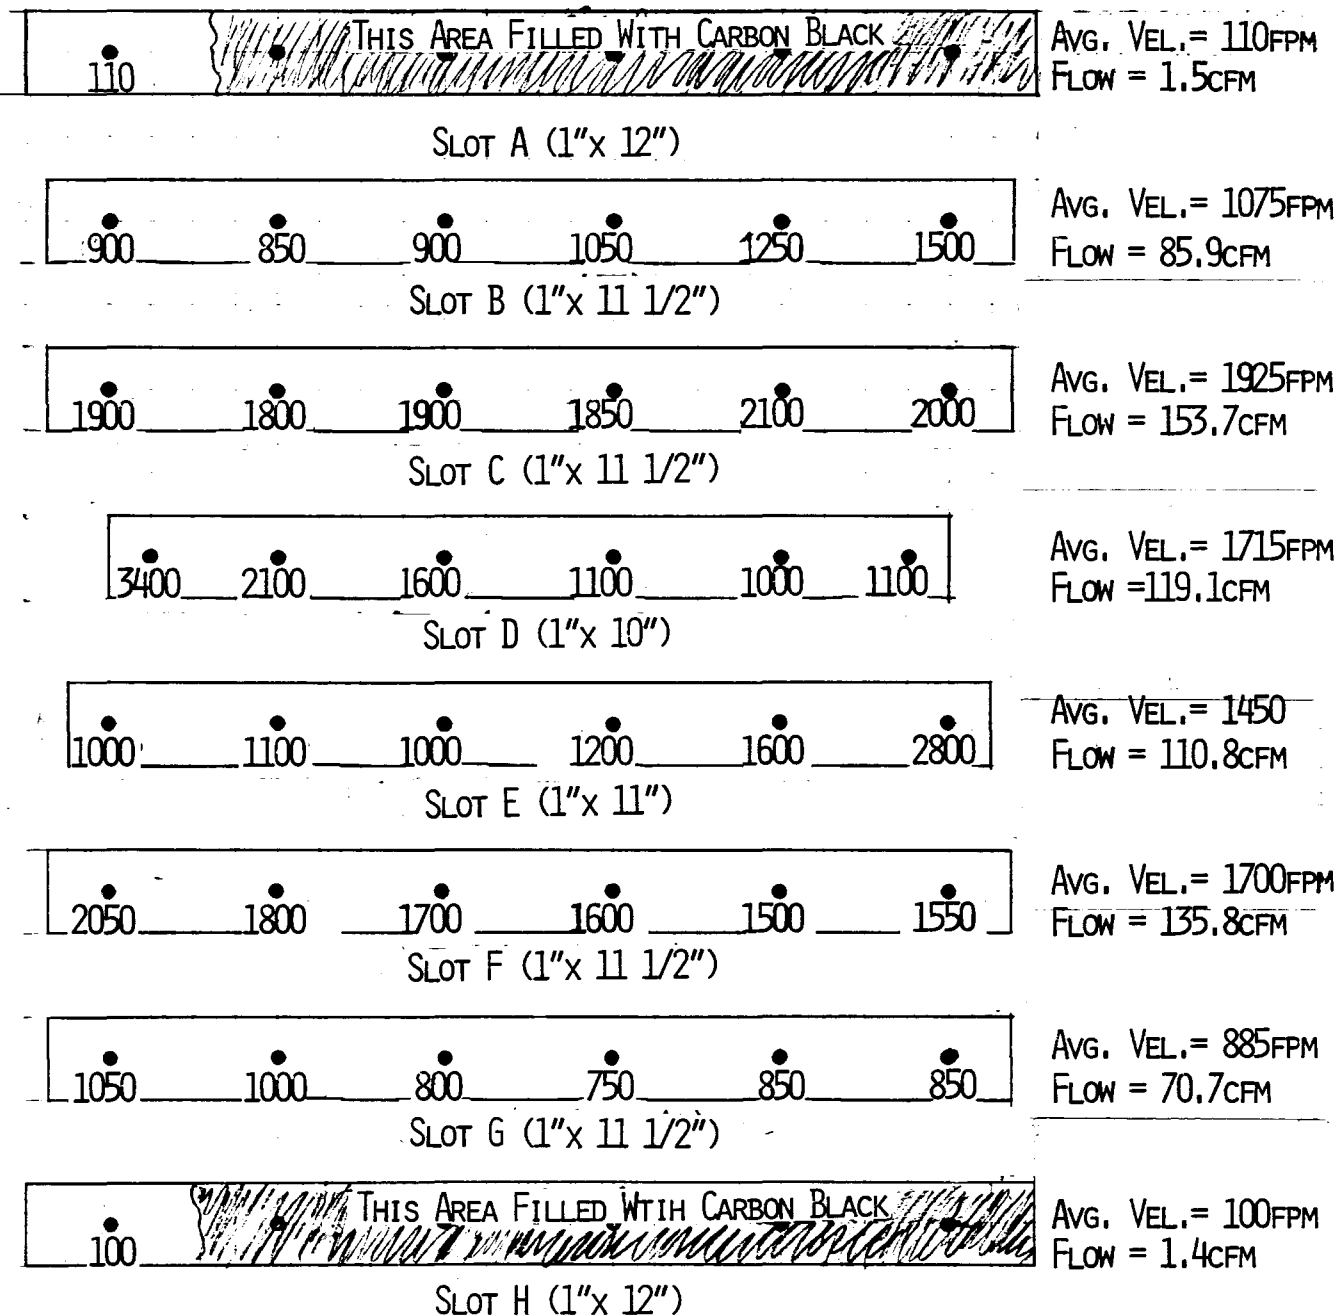
Figure 2-7. Tilt stand ventilation slot velocities.

TOTAL FLOW FOR SLOTS = 678.9CFM
 AVG. VEL. OF SLOTS B THRU G = 1460FPM

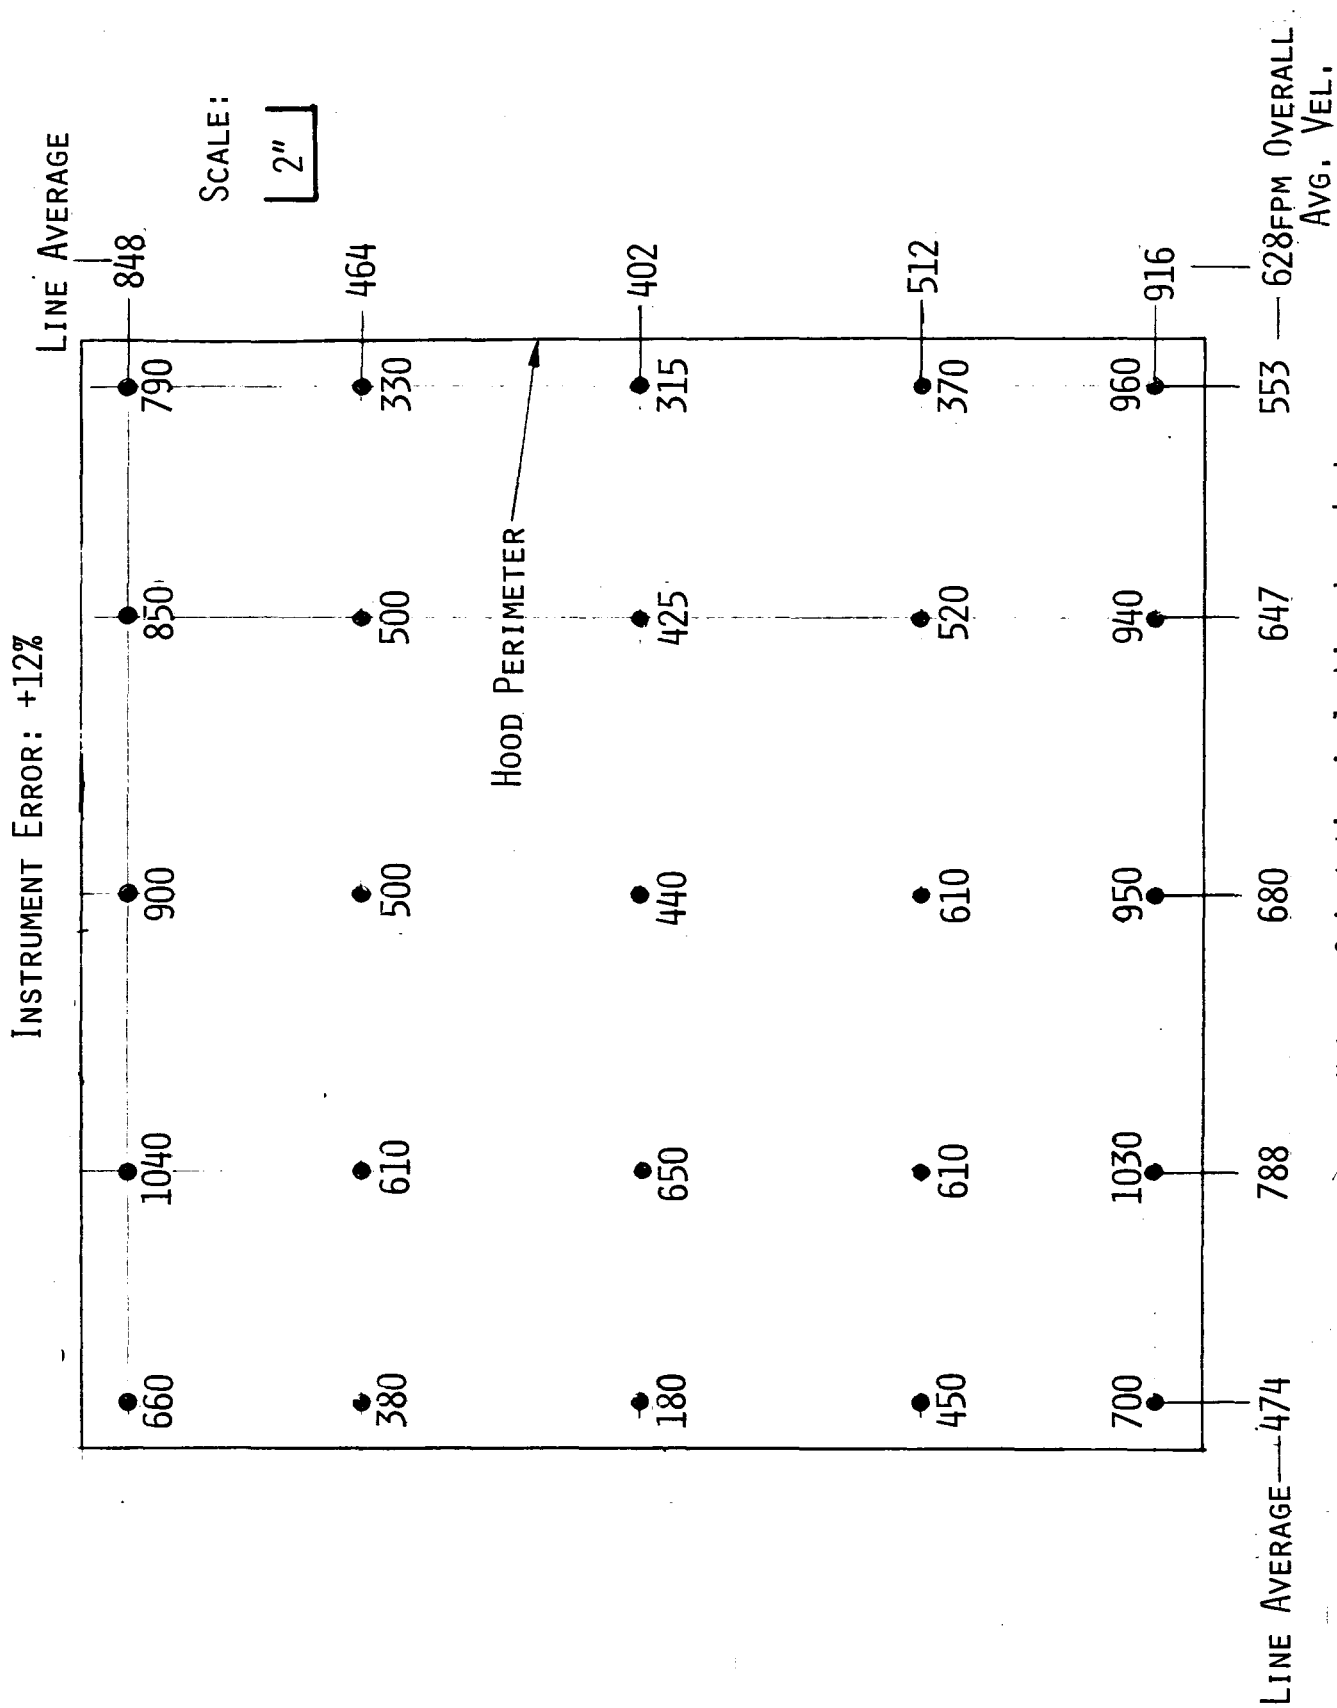
Figure 2-8. Surge hopper hood face velocities.

Notes: Orientation is looking down duct toward hood face.
Measurements made with tilt stands in tilt position. Flow thru hood may be greater if stands are in non-tilt position.

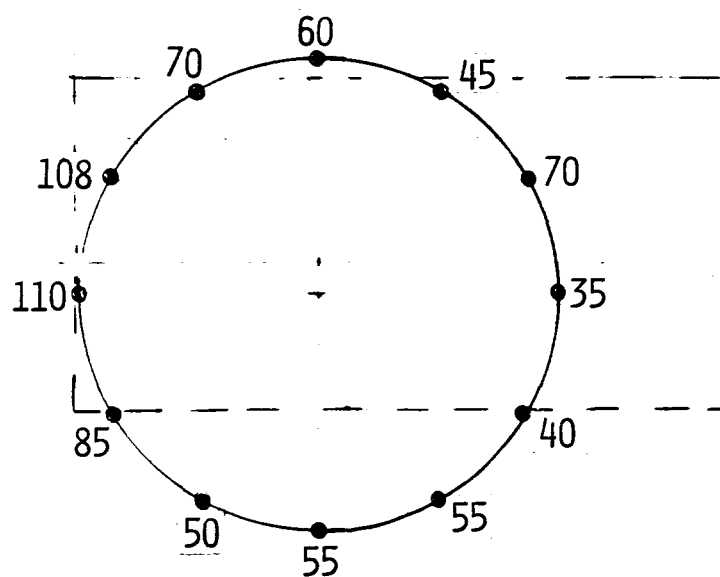
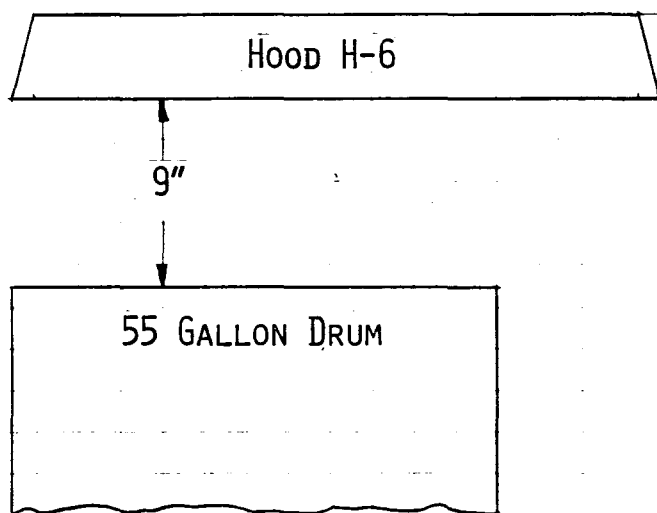
Figure 7-12. Cement house holding tank outlet hood capture velocities.

Notes: Worker positioned drum beneath hood.
Draft from MD-1 disturbed air flow into hood. Vents D-1 and D-5 on MD-1 blocked during measurements.
Air drawn into cement house thru opening in wall near hood caused turbulence at some points at top of drum.
