WALK THROUGH SURVEY REPORT
OF THE
CENTRAL BRASS MANUFACTURING COMPANY
Cleveland, Ohio

DATE OF SURVEY:
March 20, 1987

DATE OF REPORT:
November 1988

REPORT NUMBER:
158.12

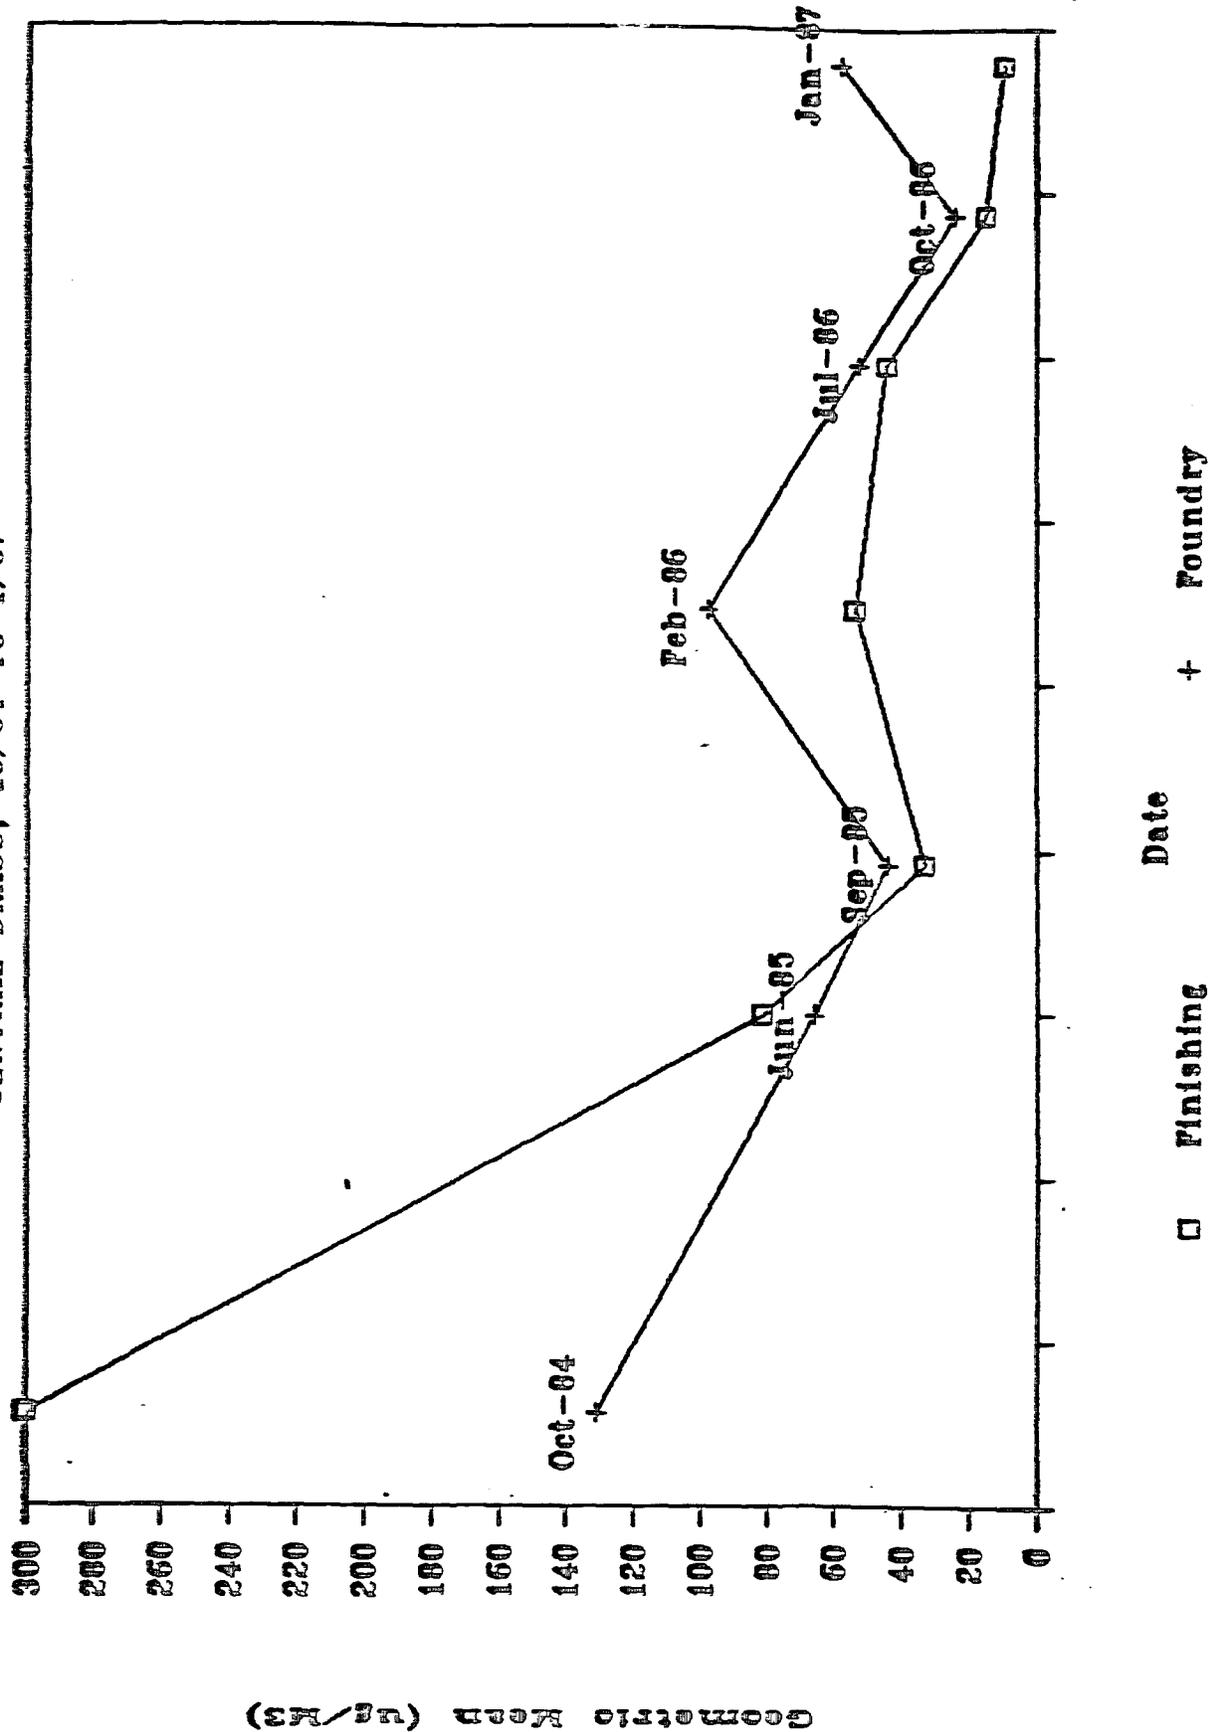
FIGURE 1.

Personal air monitoring for lead was begun in 1984. The results of the company's monitoring in both the foundry and finishing area are shown in Appendix A, Figure 1. The results shown represent the trend over time since October 1984 through January 1987. Each data point is the geometric mean (GM) of breathing-zone concentrations obtained in either the foundry or the finishing area for the time indicated.

As shown, the overall trend in concentrations is downward. In the foundry, GM concentrations decreased from approximately 130 ug/m³ in October, 1984, to under 50 ug/m³ in January, 1987. Similarly, the decrease in GM concentrations in the finishing area was even more dramatic, decreasing from 300 ug/m³ to approximately 10 ug/m³. For polishers in the finishing area, a direct correlation between air lead exposure and blood lead levels was observed demonstrating the impact of the reduction of airborne lead exposure on PbBs (Appendix A, Figure 2). Each of the six points is the geometric mean of 3 to 24 air concentrations in polishers vs. the geometric mean of blood lead levels measured in polishers, grouped by quarter, between June 1985 and January 1987. Sufficient data did not exist to make similar statistical comparisons for other jobs.

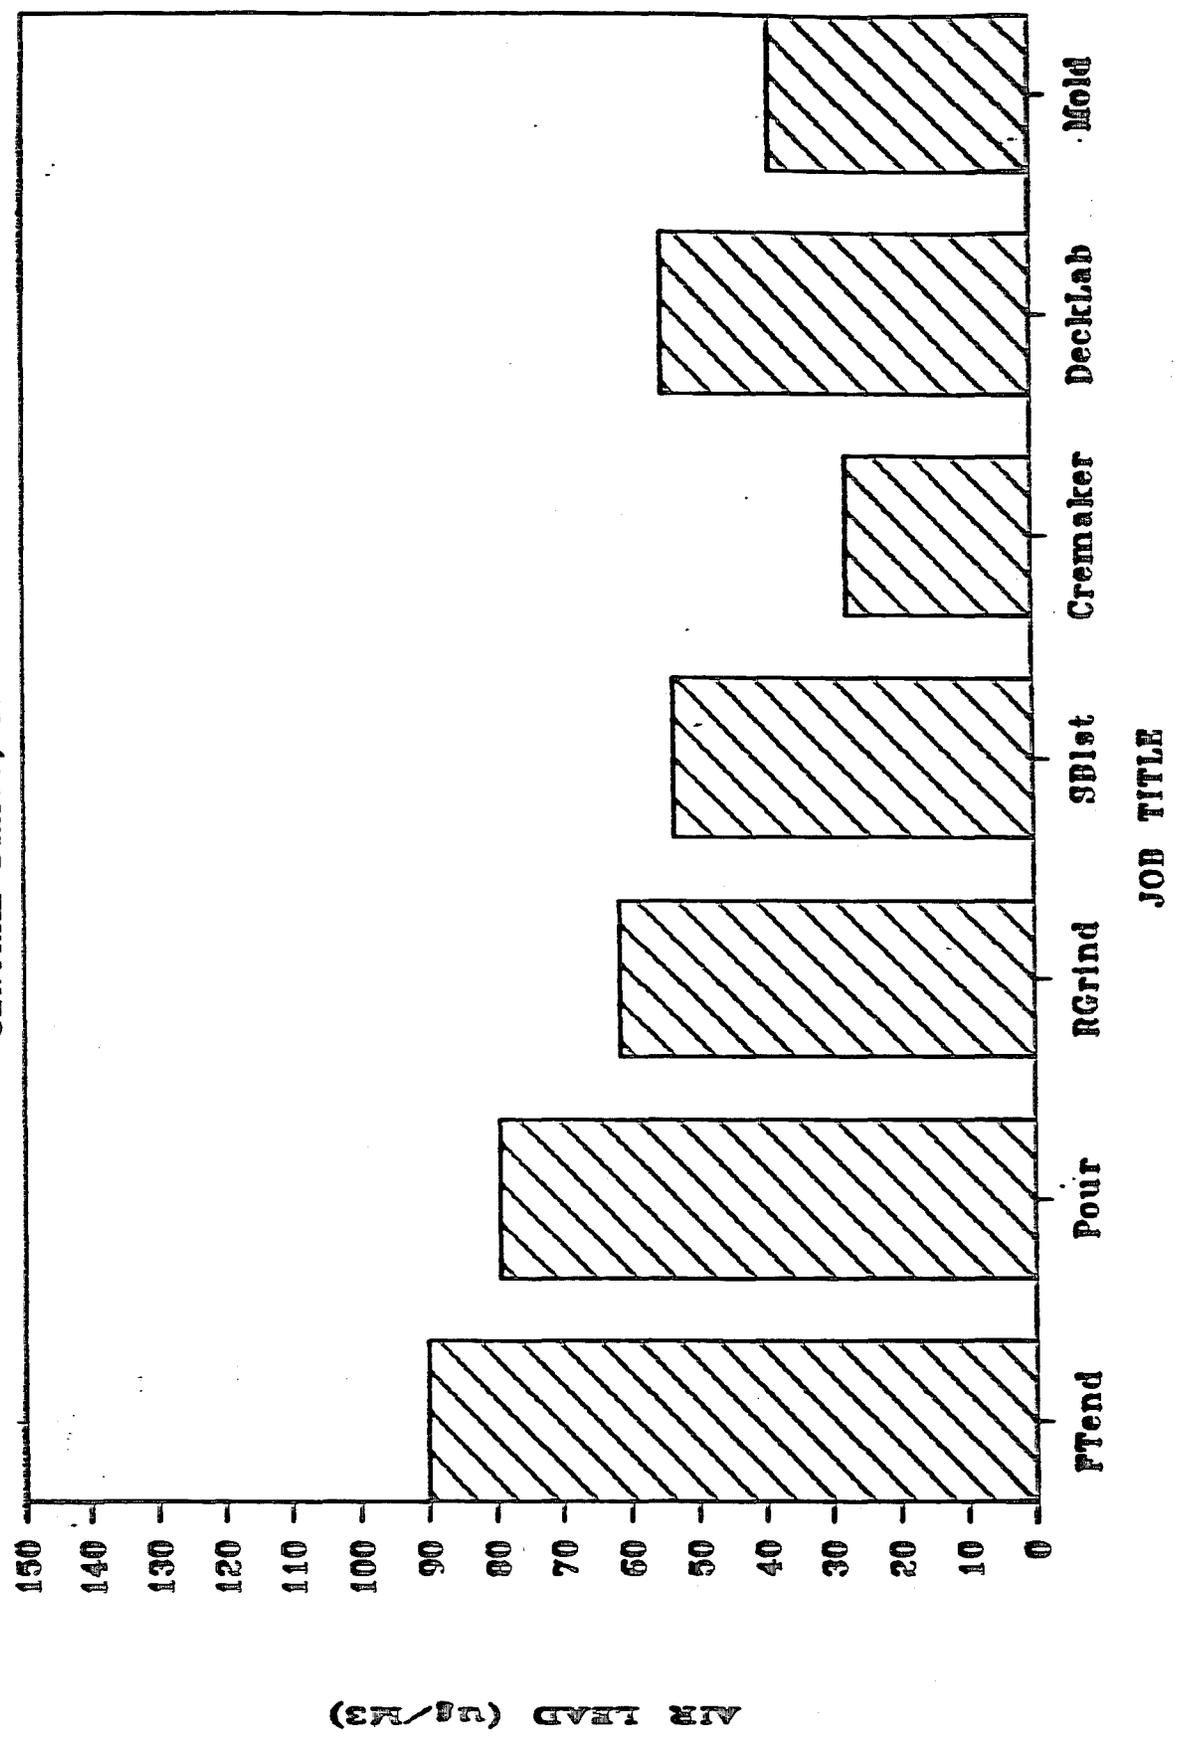
FIGURE 3.

For the two-year period, 1985 through 1986, exposure to lead in the foundry was greatest among furnace tenders (GM exposure = 90 ug/m³), followed by pourers, rough grinders, deck laborers, sandblasters, molders, and coremakers (79.1, 61.4, 55.1, 53.3, 38.7, and 27.6 ug/m³ respectively, Appendix A, Figure 3).
