**NIOSH**  
Fire Fighter Fatality Investigation  
and Prevention Program

***July 8, 2015***

## ***4 Career Fire Fighters Killed and 16 Fire Fighters Injured at Commercial Structure Fire – Texas***

*Revised on April 5, 2017 to update the Executive Summary and the Cause of Death*

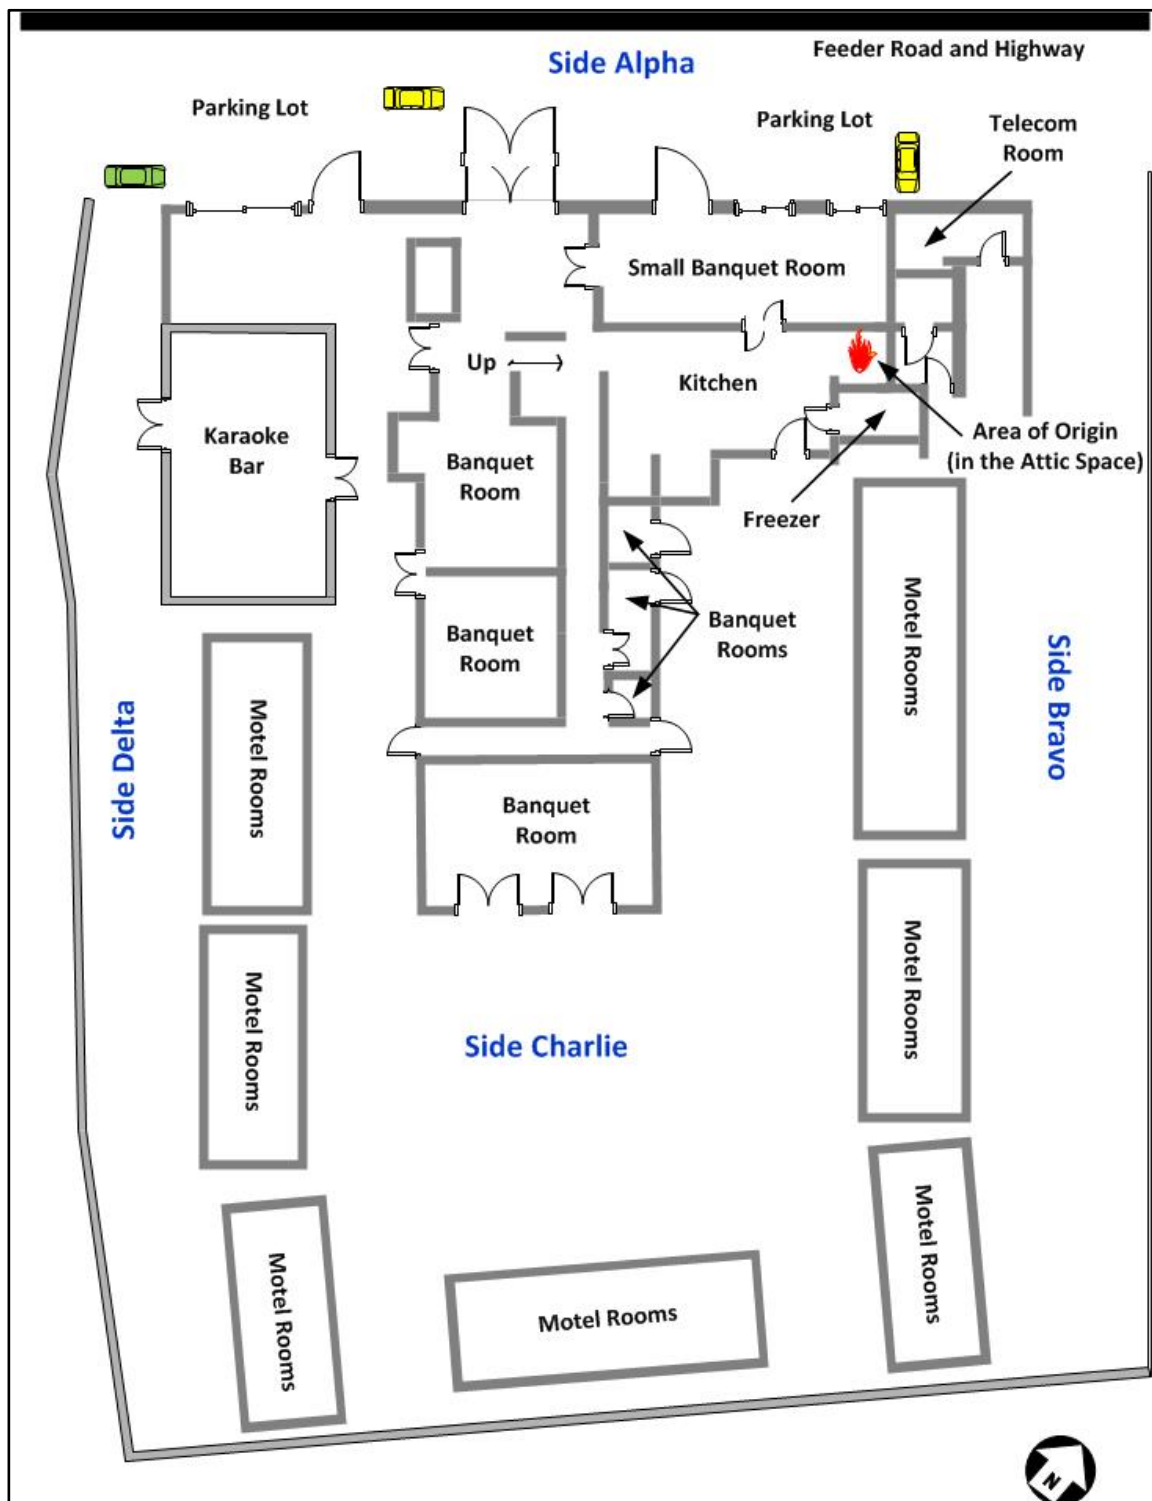
Diagram 1. The site plan for the motel, restaurant, and bar. The area of origin was determined to be in the attic/crawlspace above the kitchen.

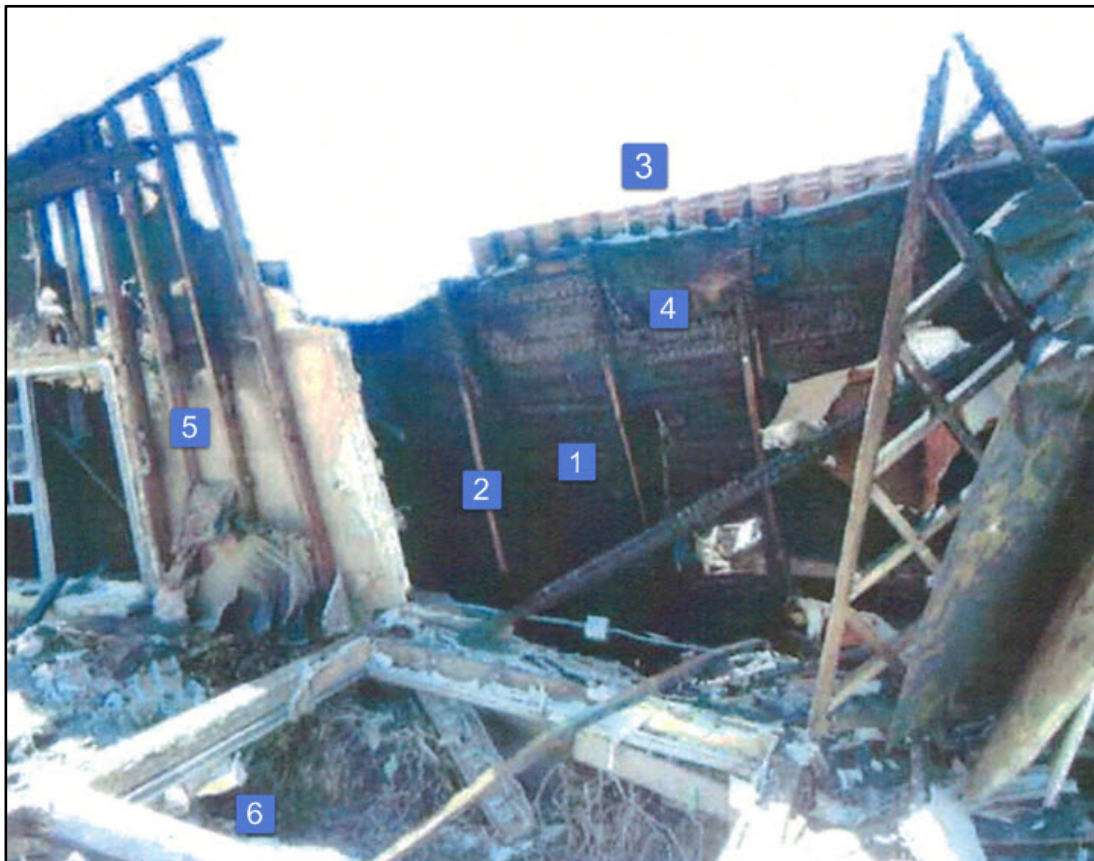
**Photo 1. View of Division Alpha Perimeter Wall & Lean-To Roof Collapse**  
*(Fire Department Photo/ Diagram Courtesy of Buildingsonfire.com)*

- [1] Roof Sheathing-underside
- [2] Edge of Roof Truss Bottom Cords (24 inch on-center)
- [3] Edge of Roofing Tiles
- [4] Charring from flame impingement
- [5] Restaurant Perimeter wall
- [6] Secondary Collapse Management Zone (SCMZ)

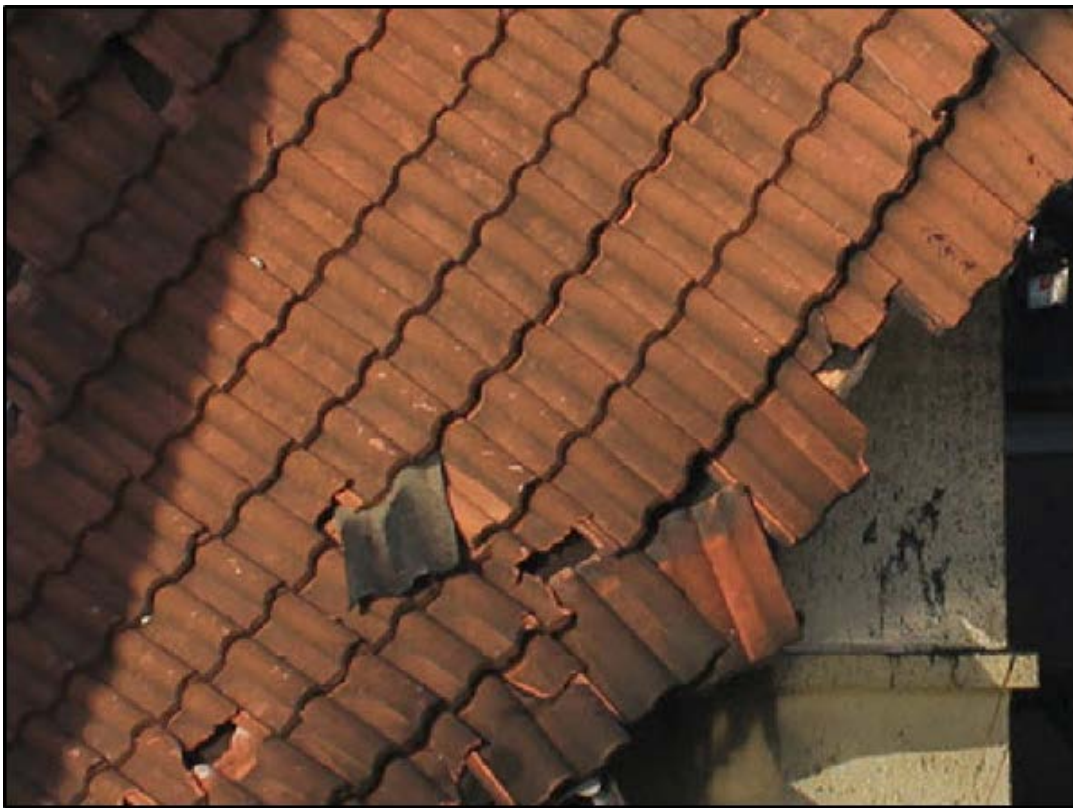
**Photo 2. Concrete Roofing Tiles - Post Fire**  
***(NIOSH Photograph)***

Due to the absence of historical construction records and specifications, the roofing tile was identified based on the roofing tile manufacturer imprint. This is typically found on the underside of each tile unit. A likely tile unit style was identified, which is consistent with the figures developed and specifications.

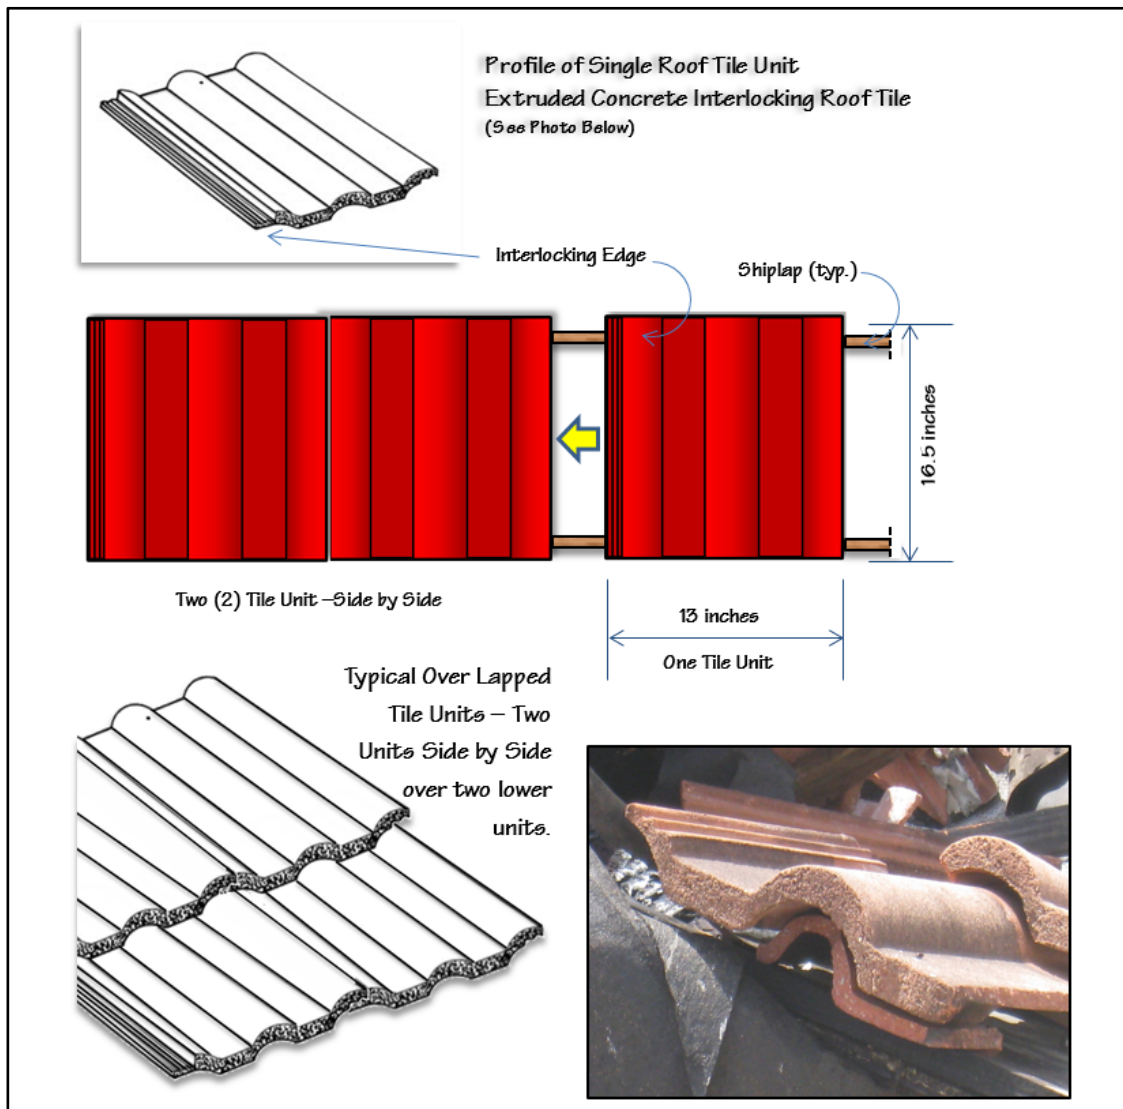
**Diagram 3. The concrete roofing tile details which were on Side Alpha of the Small Banquet Room.**

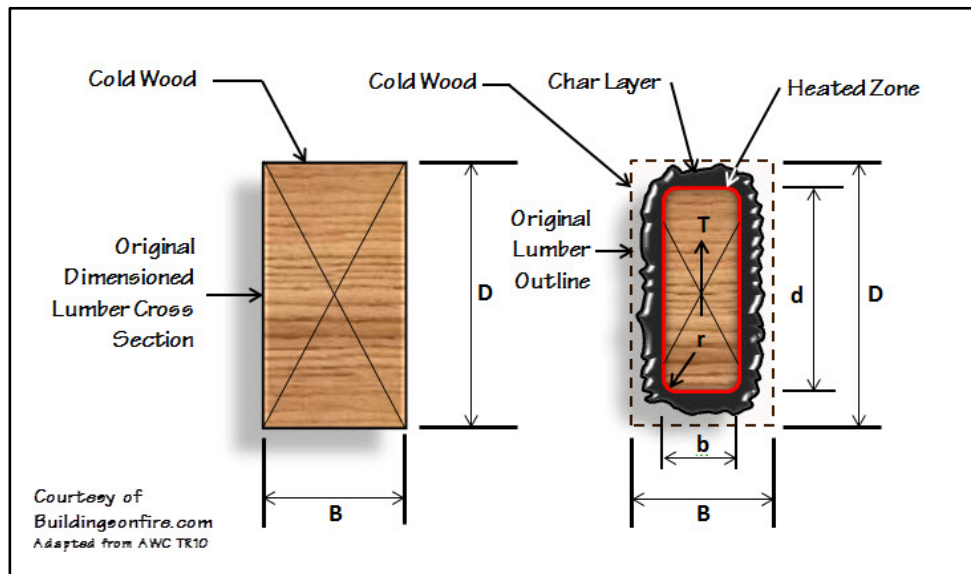
- The surface to mass ratio of the exposed wood truss members with the increased surface area results in increased consumption and degradation of the wood, leading to decreased cross sectional dimensions and decreased load-bearing capacity of the structural components. [8, 9, 21](#) (See Diagram 4.)

**Diagram 4. Reduction in Wood Component Breadth and Depth over time,**  
(Diagram Courtesy of Buildingsonfire.com)  
[Adapted from AWC Technical Report #10 (2012)]

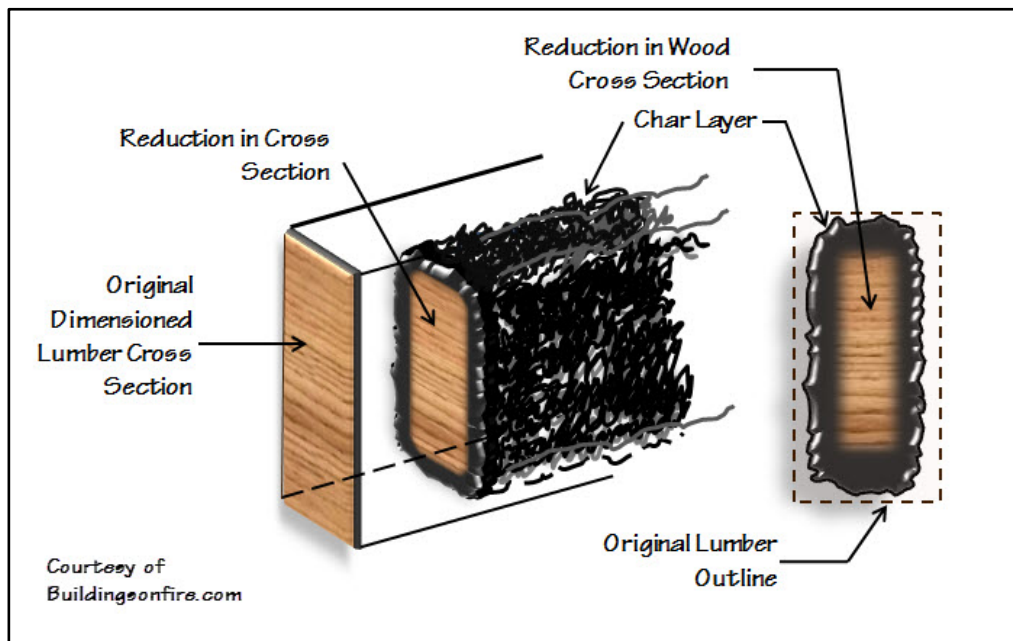
**Diagram 5. Charring Effect on Wood Component and Cross Section**  
(Diagram Courtesy of Buildingsonfire.com)

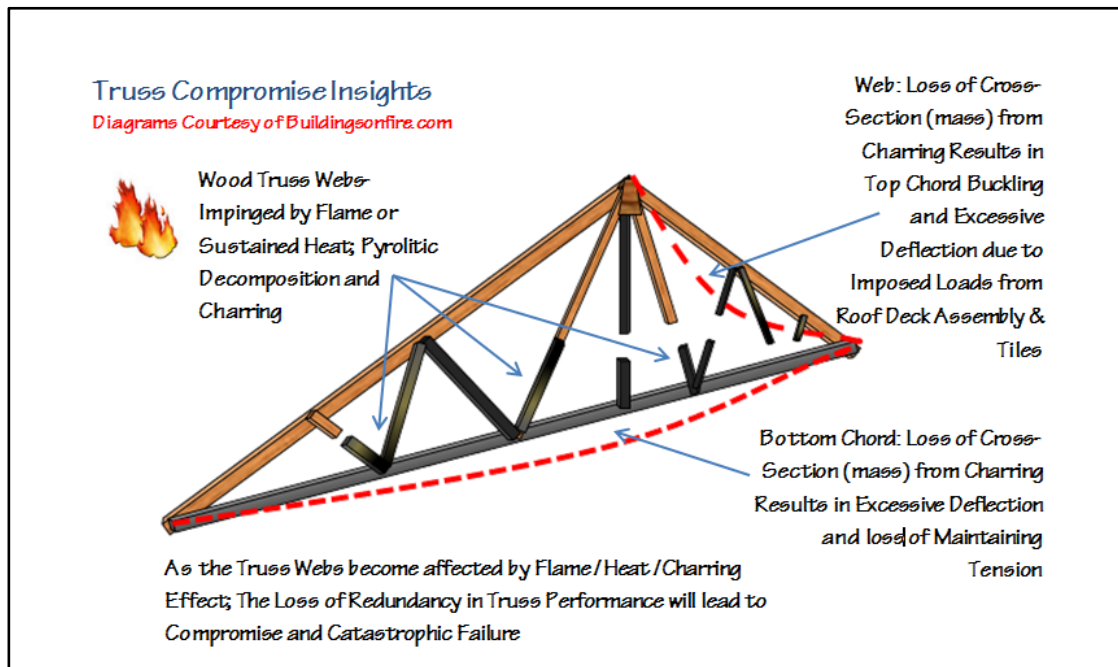
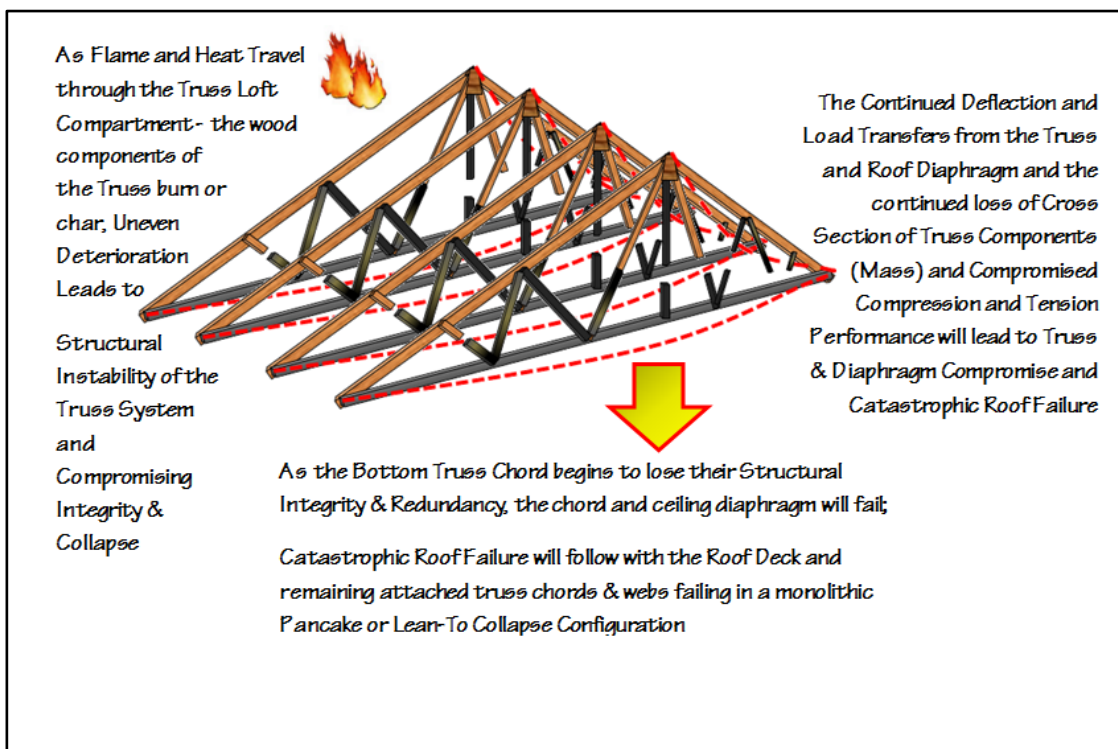
**Diagrams 6 and 7. Anatomy of a Truss - Assembly Compromise and Collapse**  
(Diagram Courtesy of Buildingsonfire.com)

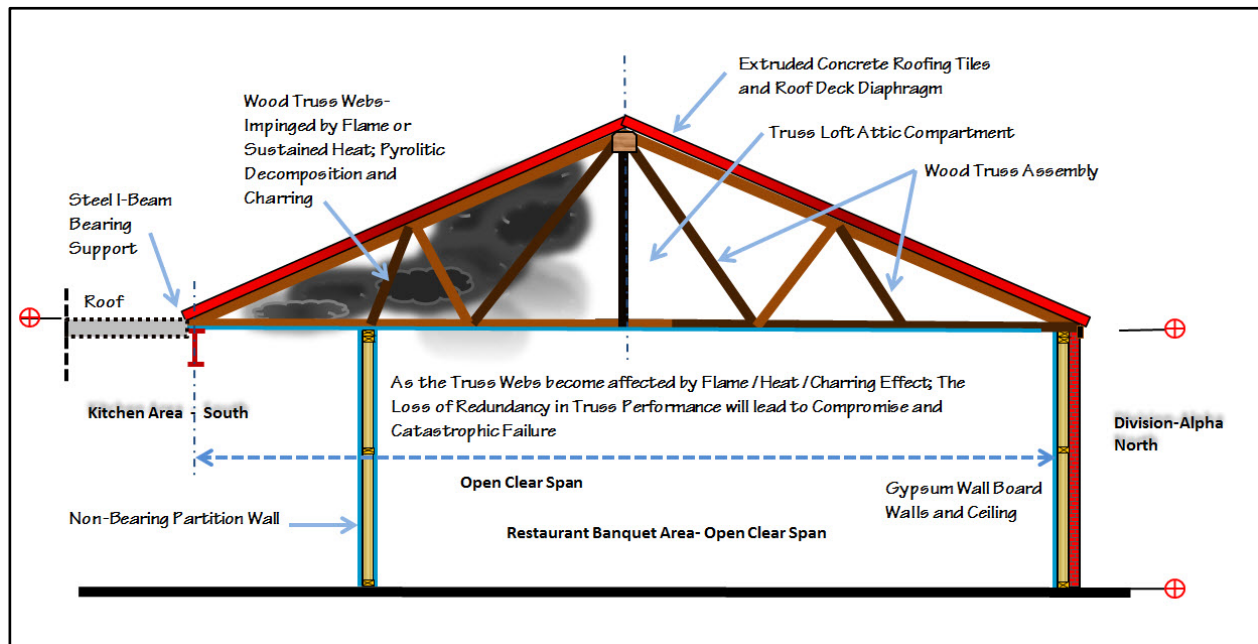
- Based on the postulated mechanism of collapse and the resulting lean-to collapse configuration of the partial roof diaphragm along the Alpha Division (North perimeter wall), the condition of post-fire truss components likely generated uneven burning and increased structural compromise of the truss components occurred along the south perimeter or area of the restaurant roof than did along the north perimeter.

- This increased level of deterioration and/or loss of web performance or materials (due to fire) would cause the wood truss to fold in on its self-downward, and forward toward the front perimeter wall. This series of structural compromise and failure results in a mechanism of collapse that pulls and deflects the roof diaphragm downward, bucking remaining truss components with momentum that results in a pancake collapse of the southern roof deck from the ridge to the south eave line and a lean-to collapse of the roof deck from the ridge to the north eave line. (**See Diagrams 8, 9, 10, and 11.**)

**Diagram 8. Anatomy of the Restaurant Roof Collapse**  
(Diagram Courtesy of Buildingsonfire.com)

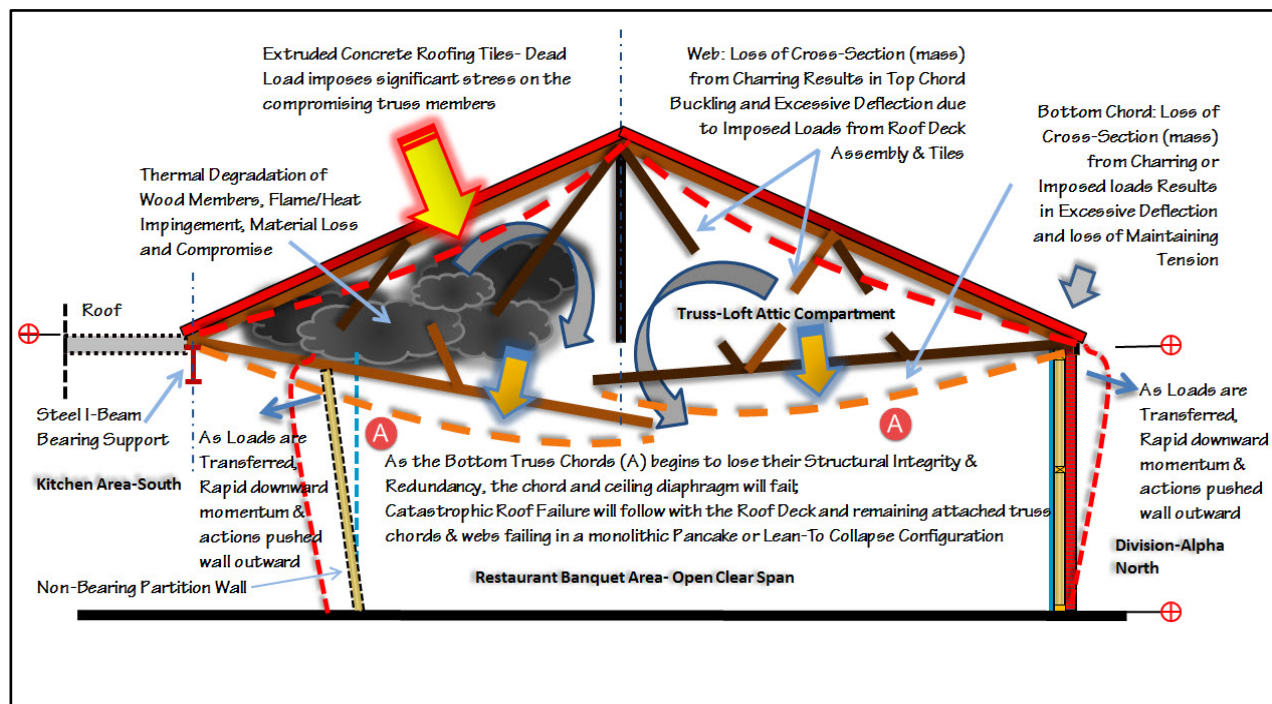
**Diagram 9. Anatomy of the Restaurant Roof Collapse**  
(Diagram Courtesy of Buildingsonfire.com)

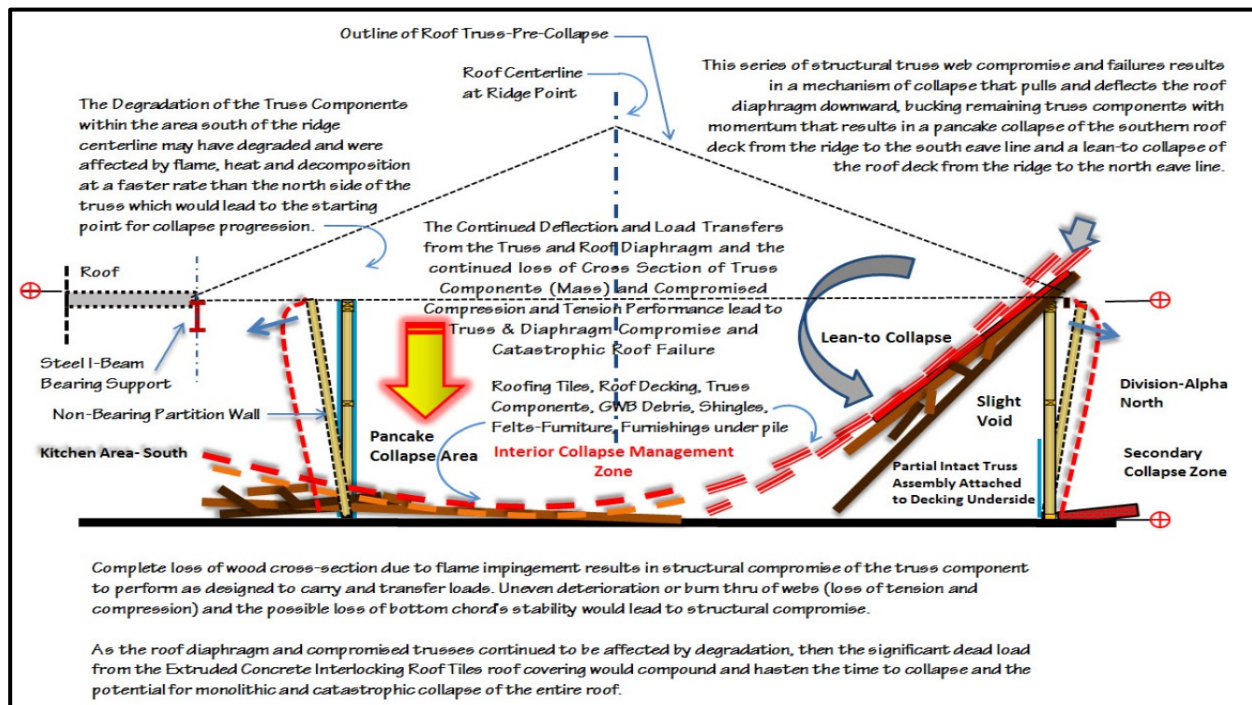
Diagram 10. Anatomy of the Restaurant Roof Collapse  
(Diagram Courtesy of Buildingsonfire.com)

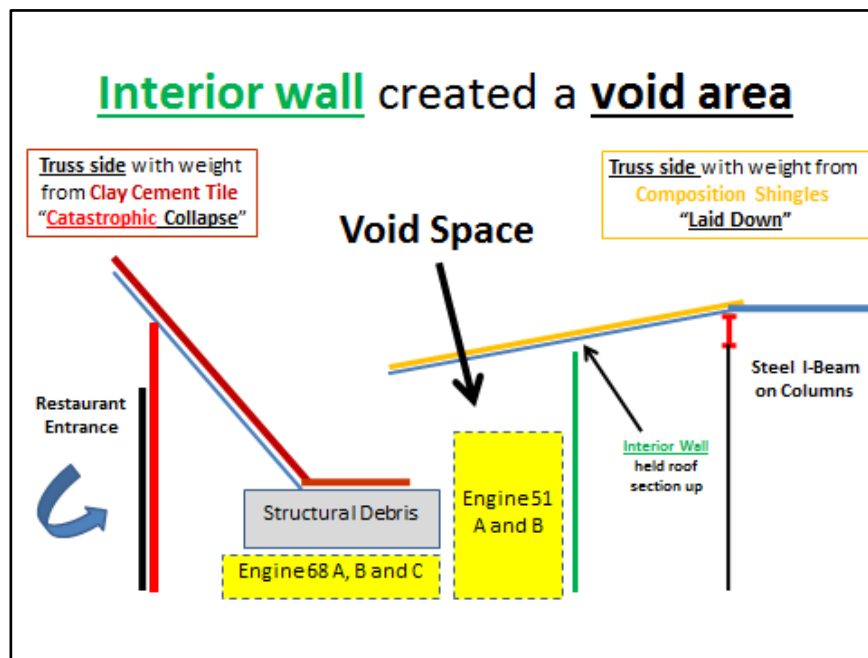
Diagram 11. When the collapse of the roof occurred, it formed a void area trapping fire fighters from E51 and E68  
(Diagram courtesy of the fire department)

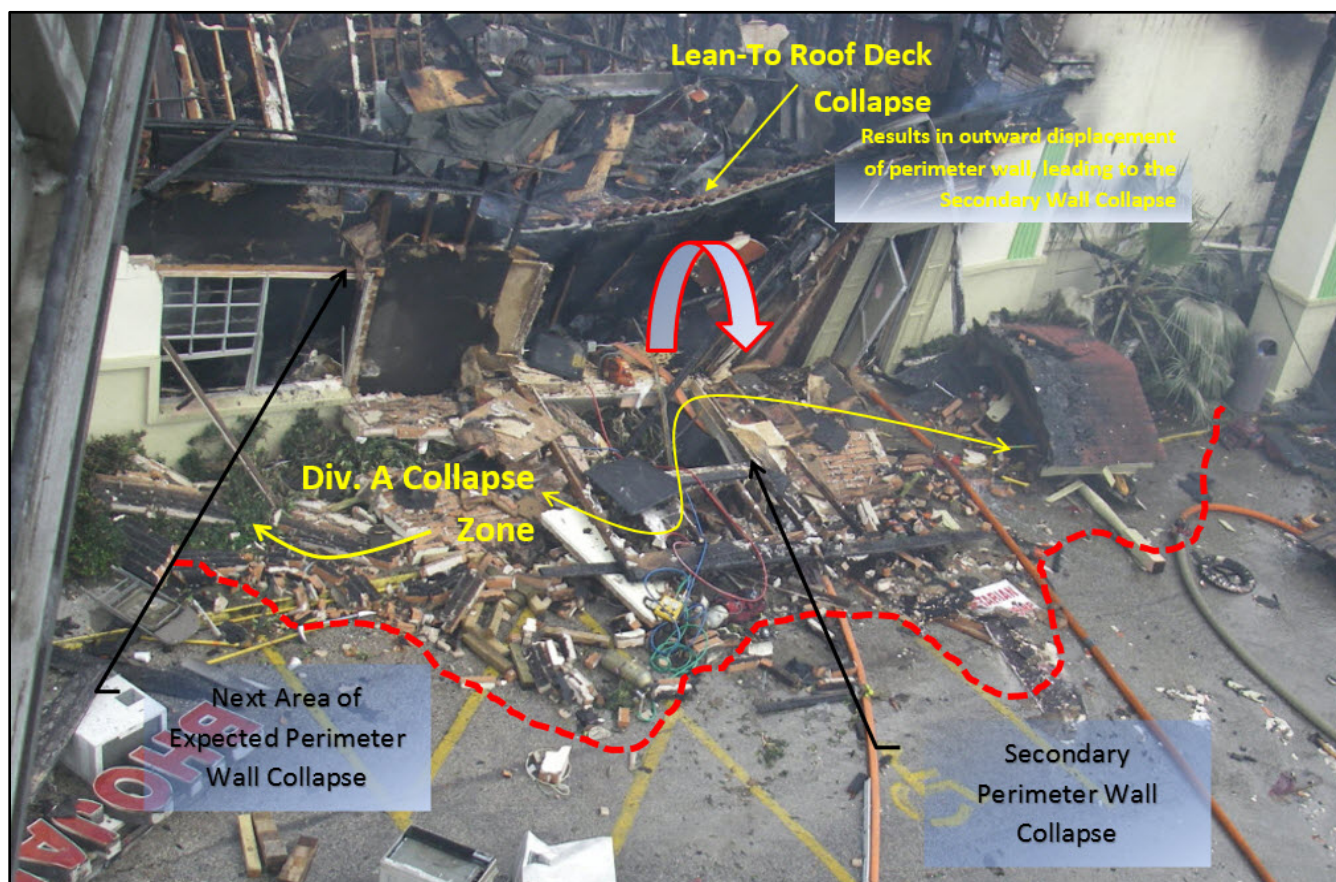
The roof deck came to rest in a slight lean-to configuration creating lateral forces acting upon the outer (north) perimeter wall. This degraded the integrity of the gypsum wall board and wood stud frame wall and caused cracking along the outer wall. Since the primary entry point to the interior of the restaurant was located on the Side Alpha, this was the entry point for the initial handline taken in the building.

**Photo 3. Details of the secondary collapse on Side Alpha.**  
(Photo courtesy of the fire department/Analysis Diagram Courtesy of Buildingsonfire.com)

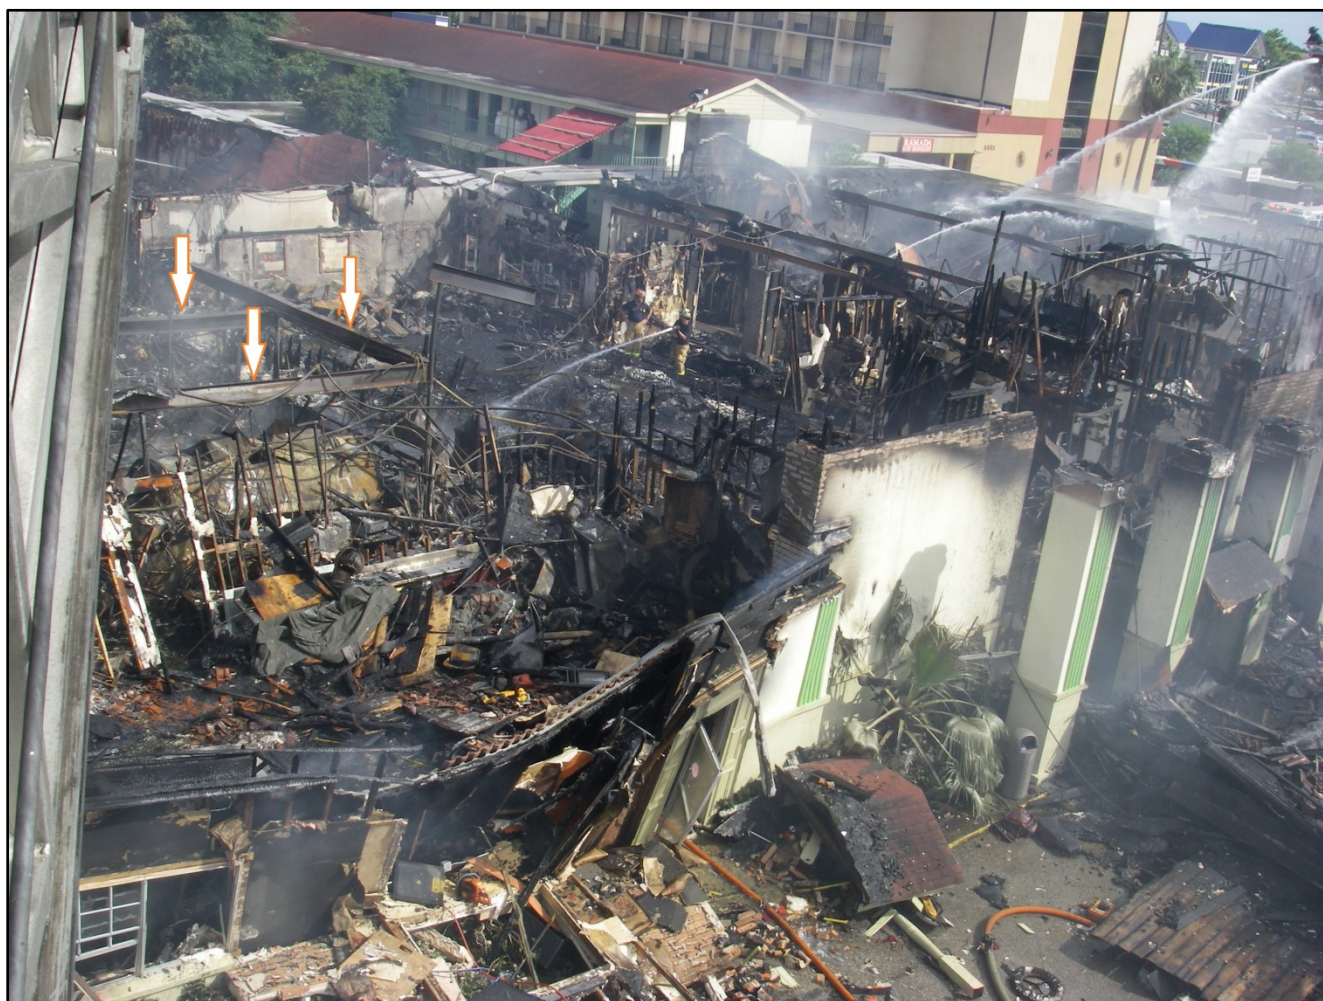
**Photo 4.** The arrows indicate the support system for the 2<sup>nd</sup> floor and void space above the restaurant and lobby area of the motel.

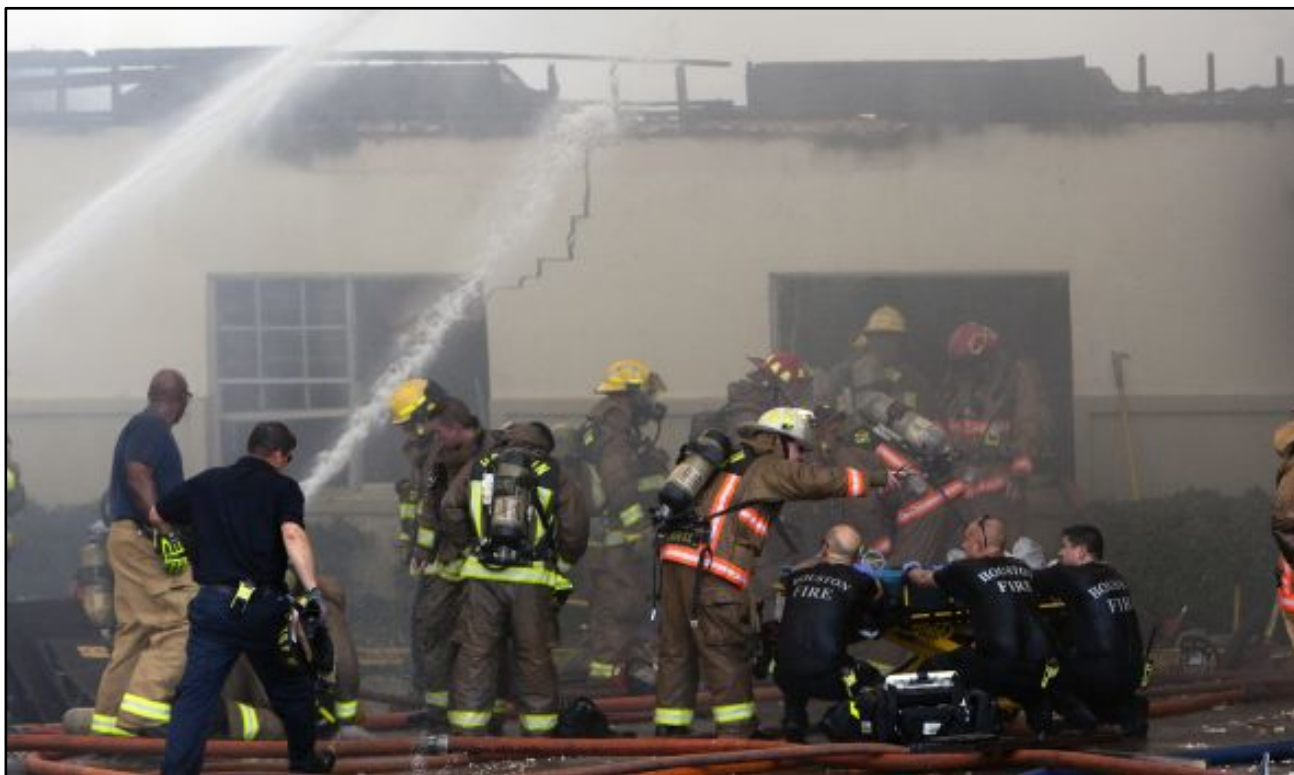
**Photo 6. A 20 ft. x 8 ft. foot section (160 SF) of compromised perimeter wall collapse into the immediate area directly in front of the structure. Three members from the Rescue Group became trapped under falling debris that resulted from the secondary collapse. These firefighters were quickly removed by other members in the immediate area and then taken to awaiting EMS crews. The time is approximately 1225 hours.**

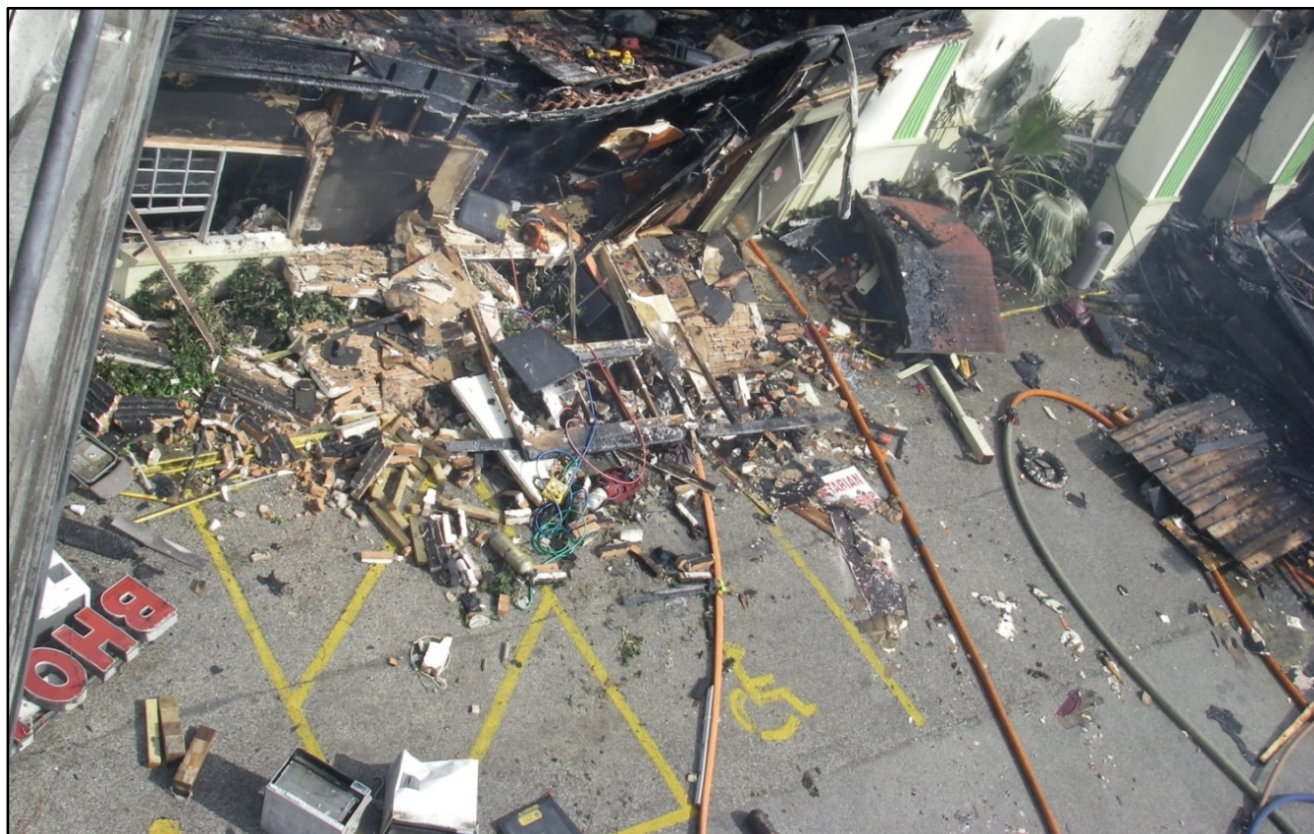
**Photo 7. The front façade collapsed at 1303 hours striking fire fighters and officers assigned to the Rescue Group. These members were quickly removed by other fire fighters who picked up the façade and pulled the trapped fire fighters and officers out.**  
*(Photo courtesy of the fire department)*

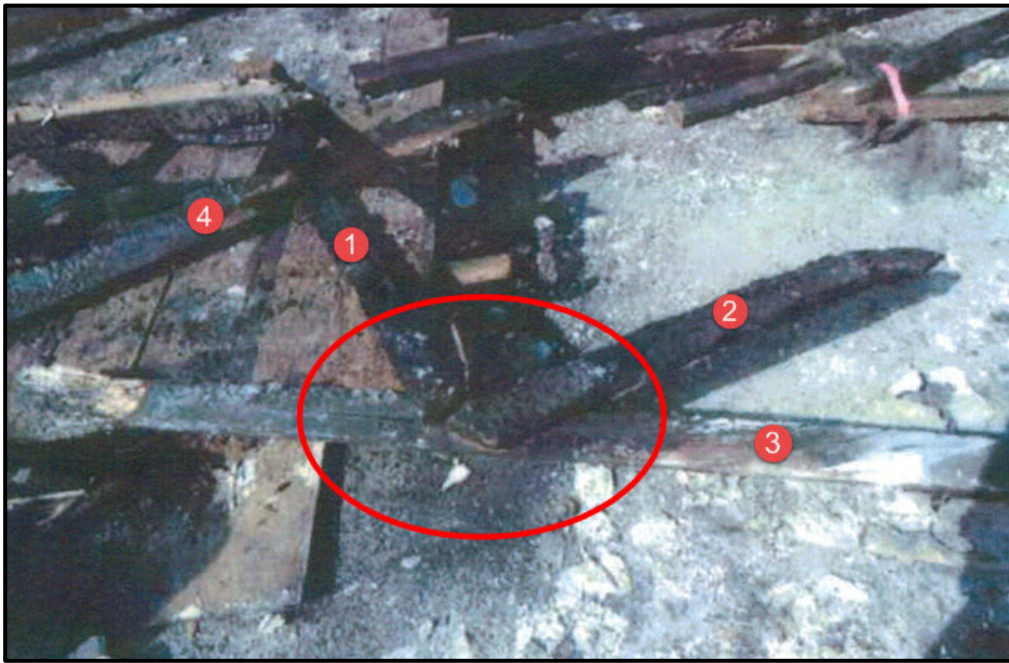
**Photo 10. Bottom Truss Cord and Two-Web**  
*(Photo courtesy of the fire department/ Diagram Courtesy of Buildingsonfire.com)*

- [1] 2 in. x 4 in. Wood Web;
- [2] 2 in. x 4 in. Wood Web; **Note:** See loss of remaining web material
- [3] 2 in. x 4 in. Wood Bottom Chord;
- [4] 2 in. x 6 in. Wood Top Chord;
- [5] **Circle** depicts the typical surface connection point of the truss webs as they are mechanically fastened with nails to the cord, (absent is any MCP, which is typical of most fabricated truss assemblies of that period, and today).

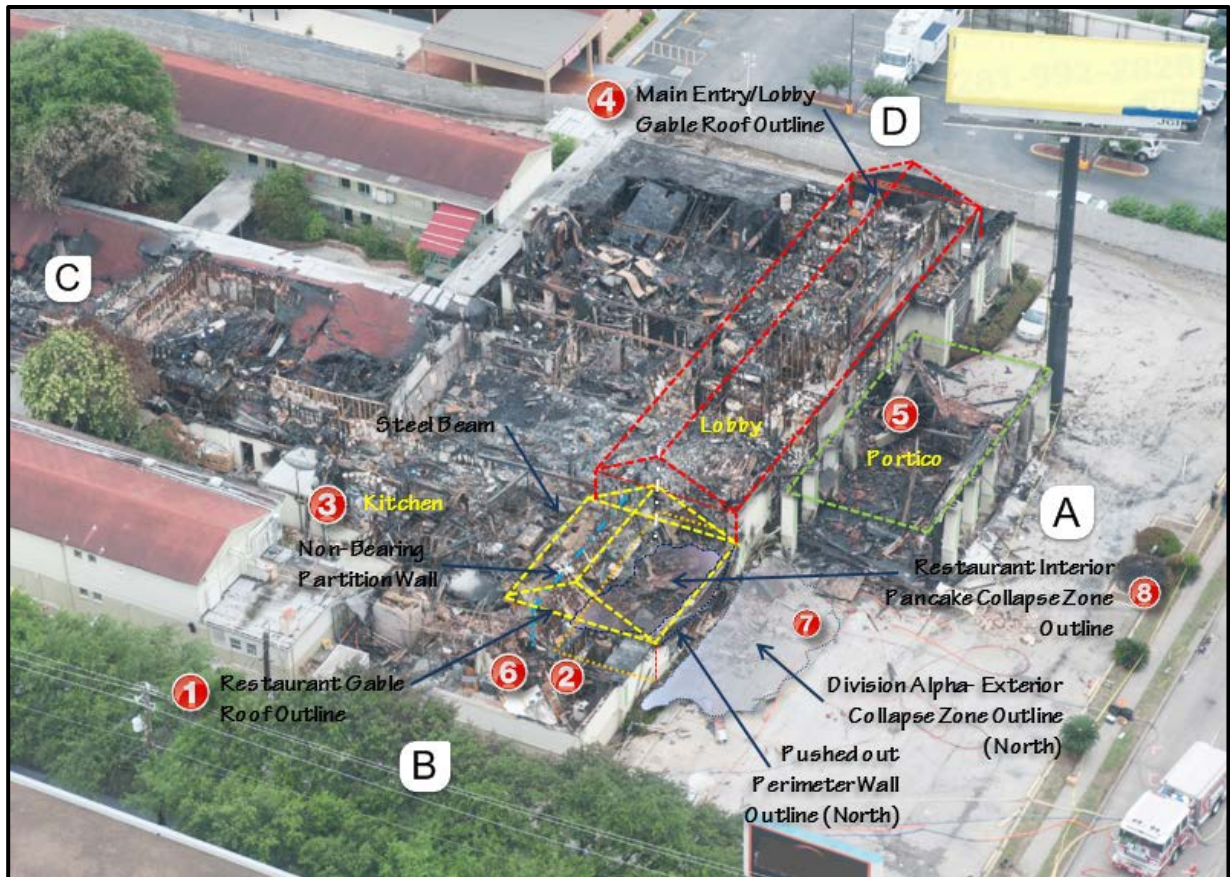
**Photo 12. Post Fire-Collapse Aerial View of Building Complex**  
(Photo courtesy of the fire department/ Diagram Courtesy of Buildingsonfire.com)

- [1] Restaurant Gable Roof - Outline
- [2] Restaurant Floor Outline
- [3] Kitchen Area
- [4] Main Entry and Lobby Gable Roof-Outline
- [5] Main Portico - Canopy Roof Destroyed
- [6] Adjacent Rooms
- [7] Secondary Wall Collapse Zone
- [8] Interior Pancake Collapse Zone
