**REPORT#:** 2014-02

**REPORT DATE:** January 30, 2018

## Laborer, Pipefitter, and Utility Foreman Crushed by Falling Block Wall—Tennessee

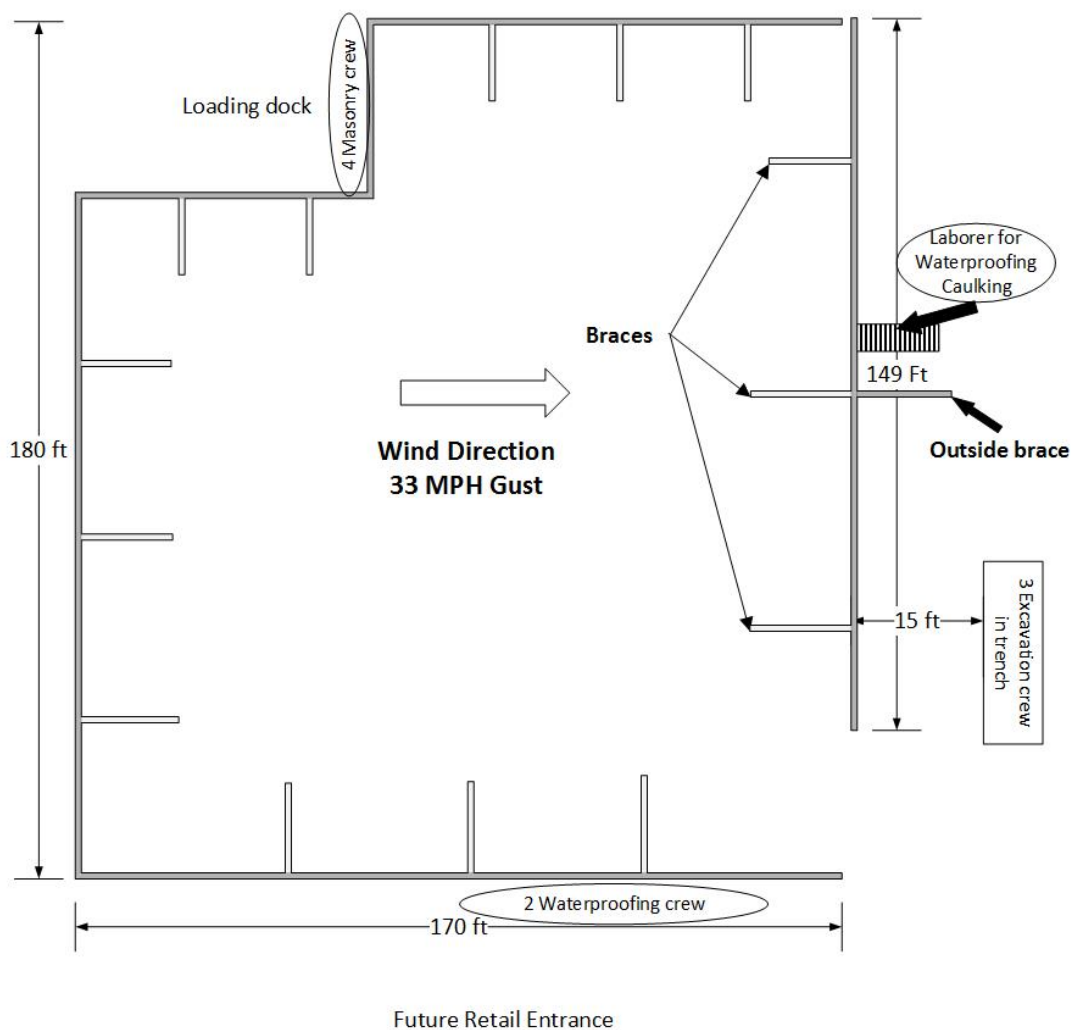
Diagram. Incident scene.

The building being constructed was a 28,000-square-foot retail store in a retail development area. Construction began in March of 2013 with a concrete footer measuring 2 feet wide and 1 foot deep. Rebar was to be placed 40 inches on center in the footer. The walls were constructed of typical concrete masonry unit blocks that were 8 inches tall, 8 inches wide, and 16 inches long. The walls were 36 courses (24 feet) tall and consisted of panels, with masonry control joints between each panel. Masonry control joints prevent the wall from cracking caused by shrinkage, wind, soil pressure, seismic forces, or settlement. The masonry walls were completed at different times so they were all in different stages in their curing process. The west wall was completed on March 26, the east wall was completed on April 3, the north wall was completed on April 5, and the south wall was completed on April 12. On the day of the incident the masonry subcontractor's 5 employees were in the process of constructing the loading dock wall (Diagram).

The east wall, the incident wall, was 149 feet long and was not structurally tied to the other three walls at the time of the incident. The east wall had seven panels, with a control joint between each panel. The east wall was originally braced with three wooden braces on the inside and three wooden braces on the outside, with the braces opposing each other. The braces consisted of three pieces: one vertical scaffold board, positioned on the wall but not attached to the wall; a cleat board measuring 2-inch by 4-inch placed horizontally across the vertical scaffold board approximately 9 to 10½ feet up the scaffold board (Photo 1); and another scaffold board was wedged at an angle between the cleat and a 4-foot long piece of rebar driven into the ground. Two masonry blocks were placed on top of the rebar and board as extra weight for the scaffold board and as protection around the rebar (Photo 2). The spacing between braces varied, as did the angle of the braces (Photo 3). Two of the three outside braces were removed, leaving one brace in the center of the outside wall the day before the incident to allow the waterproofing subcontractor to caulk the control joints. No permanent supporting elements of the structure were in place. A 3 foot deep, 5½ foot wide, and 8 foot long trench ran parallel to the east wall. The trench was positioned 15 feet from the wall and was dug to allow installation of the building's sprinklers back-flow system. There was a 3½-foot tall concrete meter box toward the south end of the trench that was being used as a table (Photo 4).

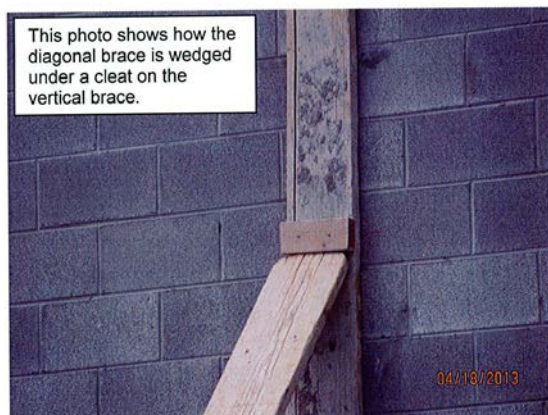
**Photo 1. Top cleat of wall brace.**  
(Photo courtesy of TOSHA.)

The wall bracing system used in this incident was a modified triangle system and composed of two scaffold boards. The vertical board was positioned on the wall but not attached to the wall. The vertical board had a 2- by 4-foot cleat across it horizontally (Photo 1 and Photo 3). The inclined brace boards were wedged at an angle that varied between 34 and 41 degrees. A 4-foot length of rebar was driven into the ground; one masonry block was placed over the rebar with the other placed on top of the inclined board (Photo 2 and Photo 3). There was no permanent tie from the ground to the wall brace. The wall extended between 13½ and 15 feet above the brace.

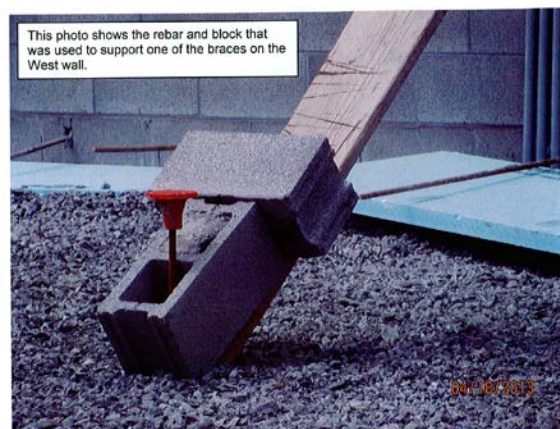
**Photo 2. Blocks and rebar used to secure wall brace.** (Photo courtesy of TOSHA.)

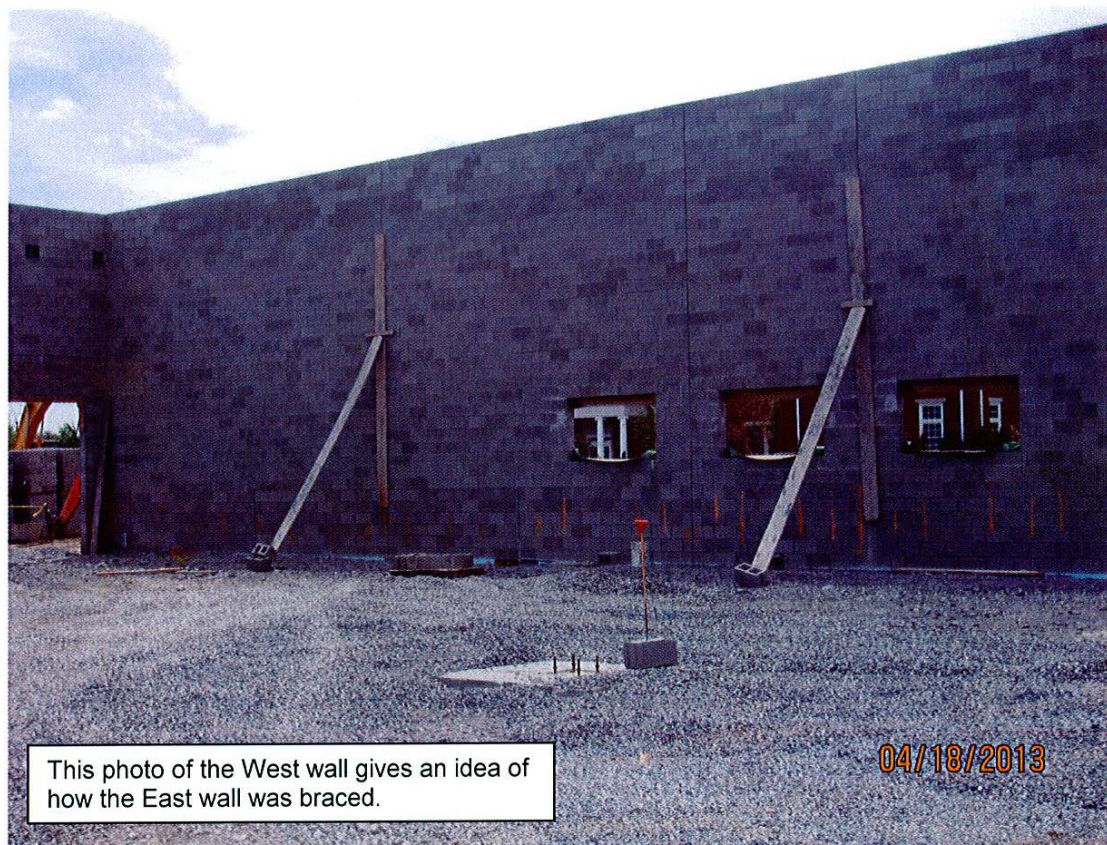
**Photo 3. Interior wall bracing.** (Photo courtesy of TOSHA.)

In this incident, the wall extended more than 8 feet 8 inches above the braces in some instances, and several of the recommended brace system components were missing. If a masonry wall bracing plan had been in place and one of the employers had a trained competent person at the time of the incident, the competent person could have recognized the hazard posed by the unbraced wall and made the appropriate changes to provide a safe bracing system. Since this incident, the masonry subcontractor has trained their employees on proper concrete and masonry wall bracing.

***Recommendation #2: Employers should develop and follow a masonry wall bracing plan, train employees on proper masonry wall bracing, and ensure masonry walls are properly braced throughout the project.***

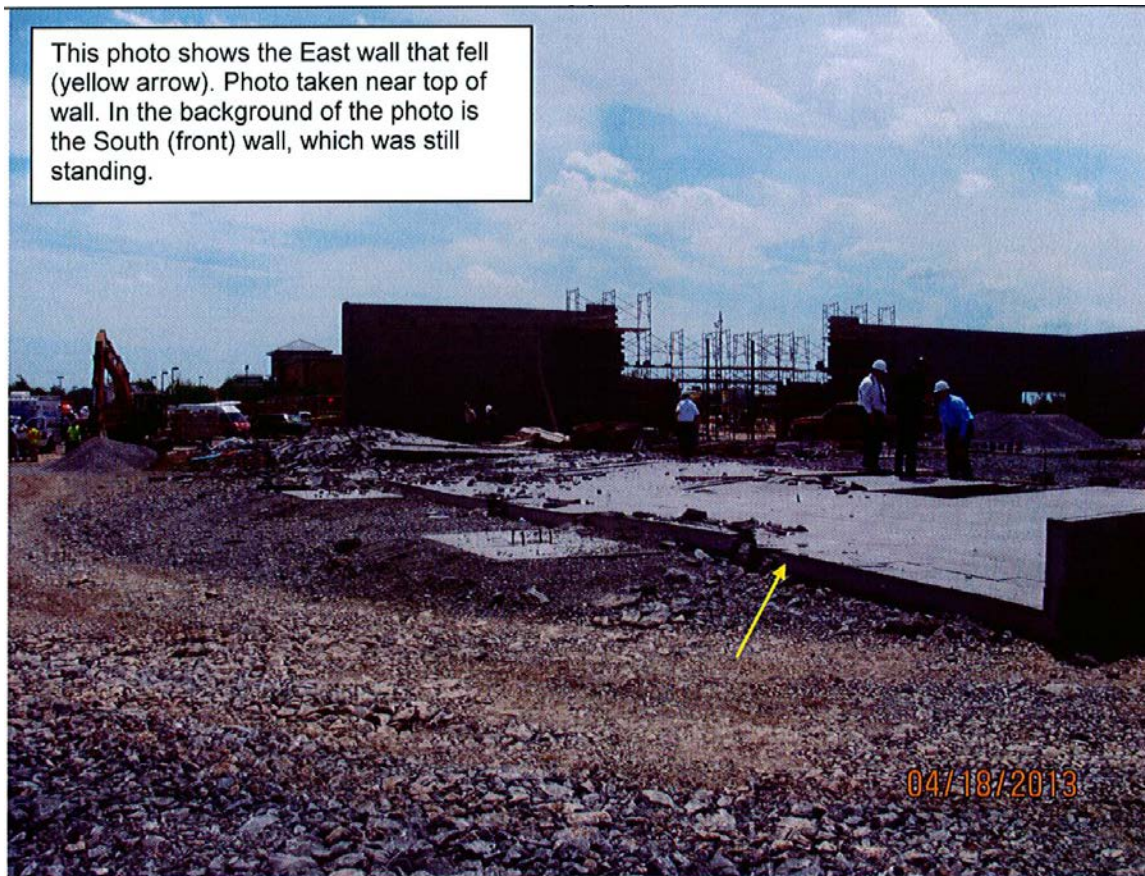
**Photo 5. Collapsed wall.**  
(Photo courtesy of TOSHA.)

At 9:45 a.m., the east wall fell during a 33-mph wind gust, on top of the waterproofing laborer, the pipefitter, and the utility foreman (Photo 5). The excavation foreman was able to run to safety. Once the wall fell, the project superintendent called 911 and emergency medical services (EMS) were dispatched and arrived within four minutes. Several crew members ran to remove the block wall from the utility foreman before EMS arrived. The laborer and pipefitter were pronounced dead at the scene. The utility foreman was airlifted to a local hospital.

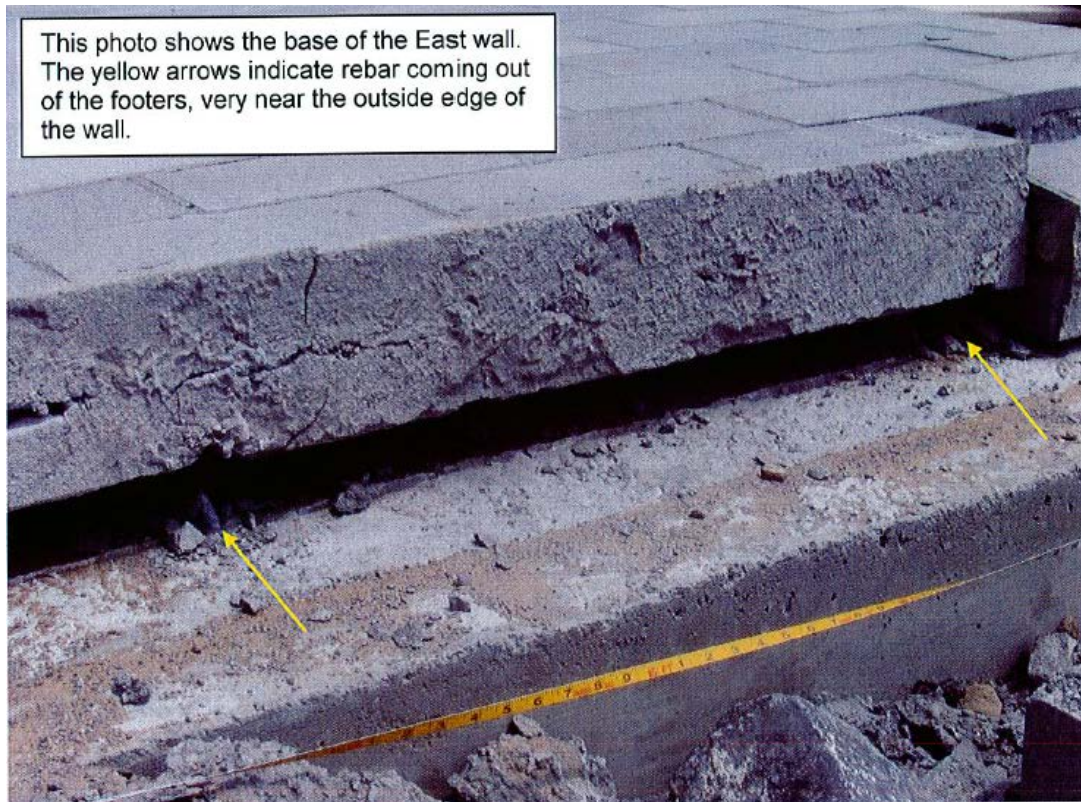
Prior to building the east wall, the masonry subcontractor noticed the rebar in the east wall footer was not positioned in the center of the footer according to the engineering drawings, but was 2 to 4 inches off center, positioning them near the exterior of the wall. The masonry subcontractor notified the prime contractor of the error, and the prime contractor instructed the masonry contractor to fix it by bending the rebar toward the center of the footer so it would fit inside the center of the blocks. The out-of-place rebar went unnoticed by the engineer during inspection and the engineer was not notified of the change in the rebar.

Discussion: Based on the original engineering drawing, with rebar placed in the center of each block and secured with grout, the unsupported block wall in the intermediate period should have been able to sustain wind speeds up to 35 mph [[MIOSHA 2010](#); [MCCA 2012](#); [NMCA 2005](#); [NCMA 2014](#)]. Additionally, masonry control joints were designed to prevent wall damage due to cracking caused by shrinkage, wind, soil pressure, seismic forces, or settlement. The wall panels were designed to fail independently in the event of a wind gust. The rebar dowel coming out of the footer for the east wall was not placed in the center of the footer as specified in the engineering drawings, but was off-center by 2 to 4 inches toward to exterior edge [Photo 6]. The engineer did not notice the misplacement of the rebar during inspections. The masonry subcontractor brought the rebar placement issue to the attention of the general contractor. The masonry subcontractor was instructed to fix the problem by bending the rebar toward the center of the footer to fit within the centers of the concrete masonry blocks. The resultant rebar/grout combination was no longer strong enough to resist the lateral loads of the wind coming from the west, based on an analysis conducted by the OSHA Directorate of Construction, Engineering Services section, at the request of TOSHA, and the wall presented properties similar to an unreinforced wall design. This rebar misalignment was consistent across all seven wall panels that failed. Procedures to address this issue include placing the rebar dowels in the center of the blocks according to the engineering drawing or correcting the misalignment by drilling correctly positioned holes in the grout and epoxying rebar in place.

**Photo 6. Rebar coming out of footer.**  
(Photo courtesy of TOSHA.)

***Recommendation #1: Employers should ensure that employees follow the engineering/architectural drawings during building construction and obtain engineering approval before plan changes are made.***
