**HAZARD IDENTIFICATION AND RISK ASSESSMENT (HIRA)
FOR SMALL MINES IN WESTERN US**

**Dr. Felipe Calizaya and Dr. Michael G. Nelson
University of Utah**

ANNUAL REPORT 2005 - 2010

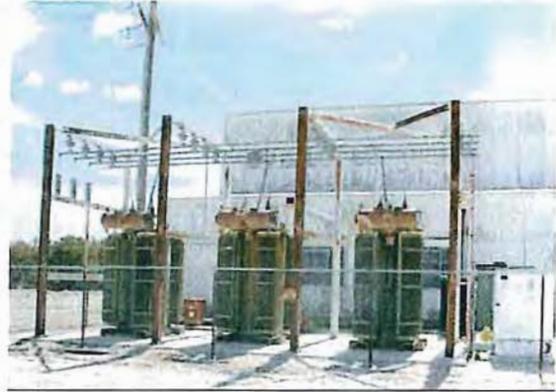
Transformer protected adequately

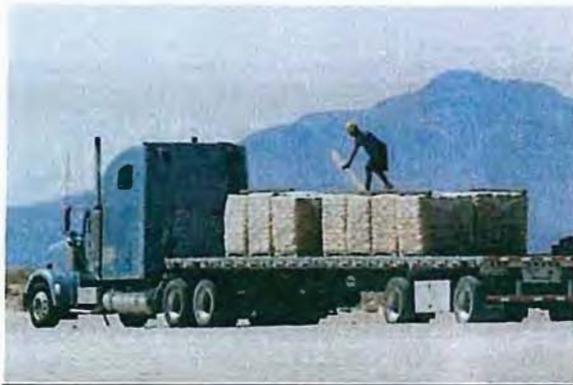
Improper practice of working in elevated areas

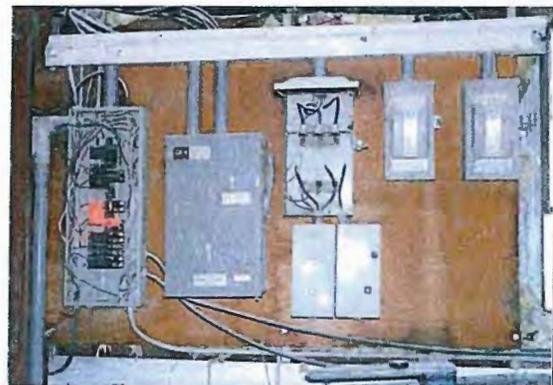
Unprotected electrical control board

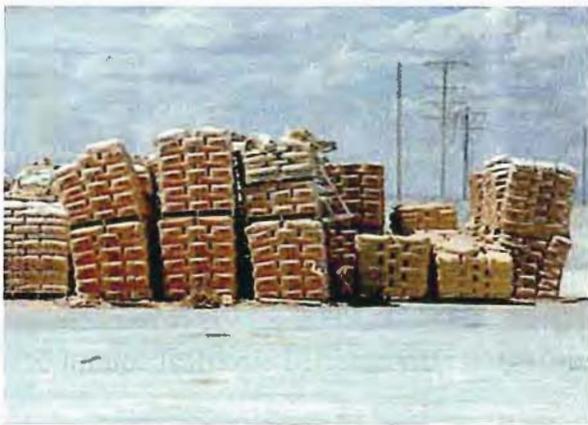
B. Material storage

2009: Improper stacking practice

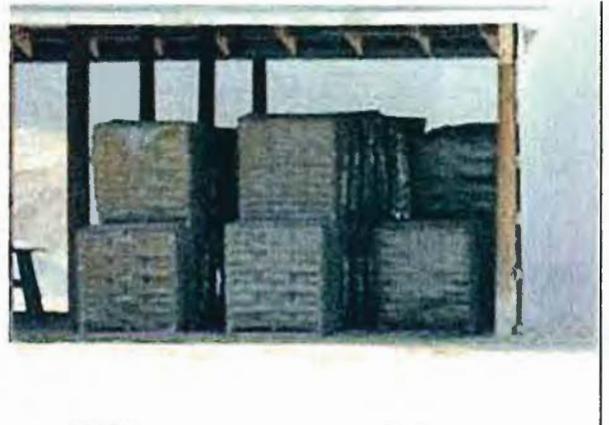
2010: Adequate stacking practice

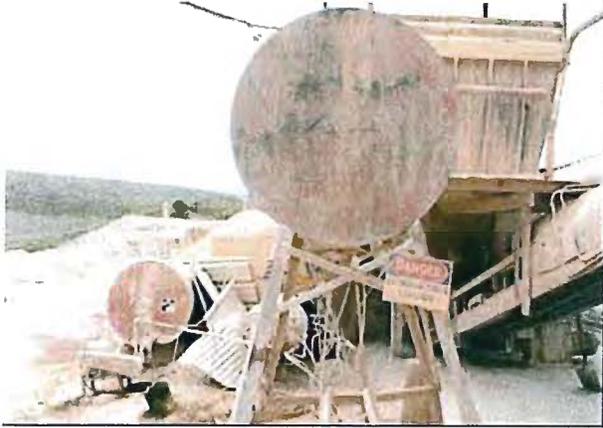
C. Fire hazards

2009: Inadequate number of fire extinguishers

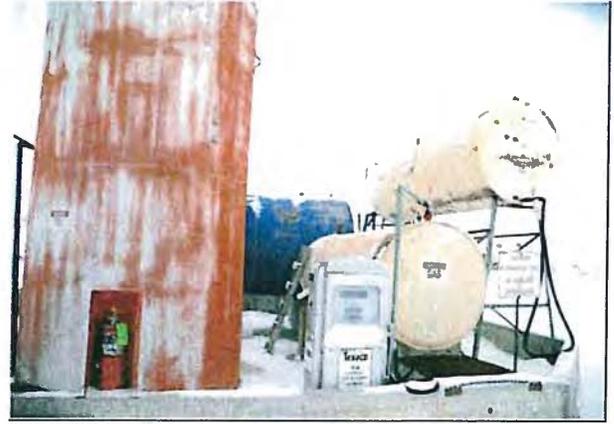
2010: Adequate number of fire extinguishers

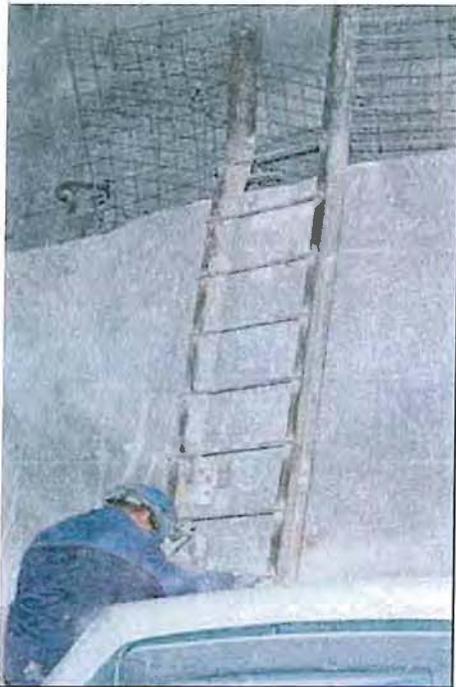
D. Ladder

2008: Unsafe ladder & installation

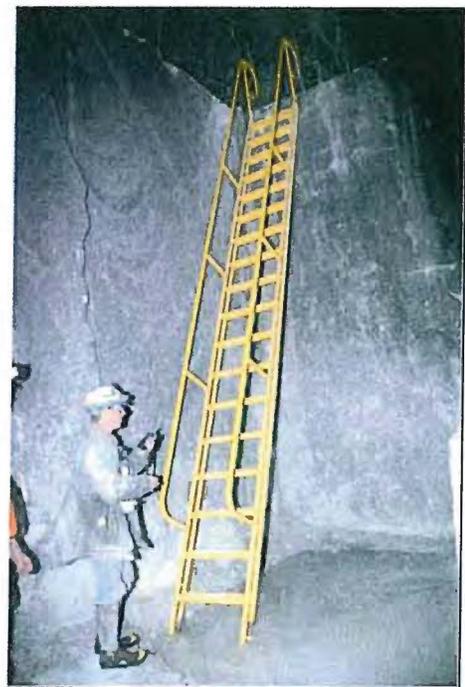
2009: Adequate ladder installation
