PPE CASE

Evaluation of a Self-Contained Breathing Apparatus for Potential Contribution to a Fatal Event in the Fire Service

Hamilton, Ohio Fire Department Request for Survivair Panther 30 minute, 4500 psig unit with NIOSH Approval Number TC-SU-5134-310 (August 3, 2016)

NIOSH Task Number 20731

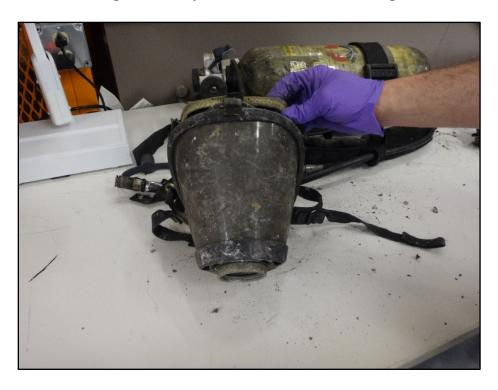
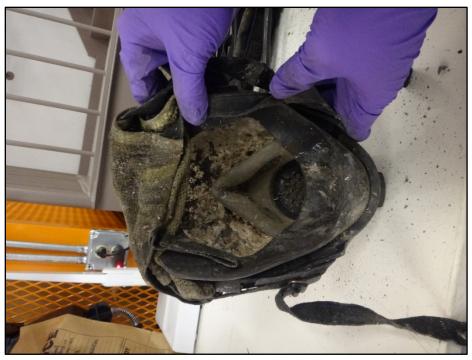
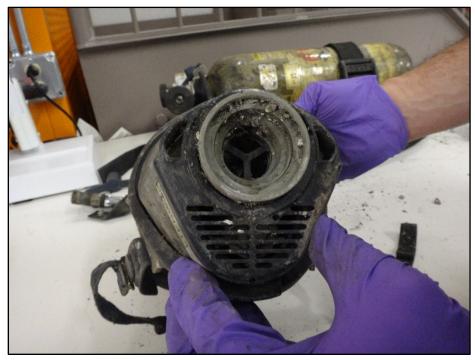
- Overall condition is dirty, covered in drywall dust
- Lens and rings are dirty, covered in debris
- Lens appears to be covered in debris

Figure 4: Overview of facepiece, covered in debris

Figure 5: View of inside of facepiece, covered in debris

Figure 6: Bottom view of facepiece, debris inside

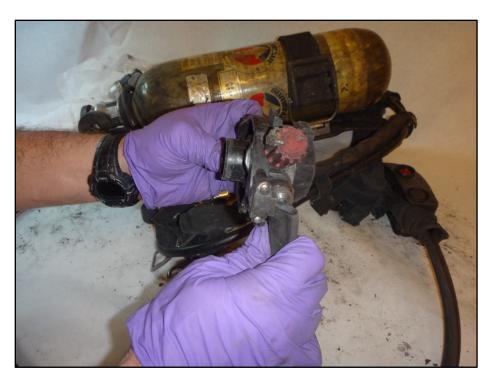
- HUD INCLUDED
- Secured to low pressure line
- Bypass is closed, covered in debris
- Inside flange has no scratches and appears in good condition
- Sealing area is dirty; Patent #5097826
- Regulator can be attached and removed
- Locking assembly does function
- Quick disconnect not present

Figure 11: Heat damage to air supply valve

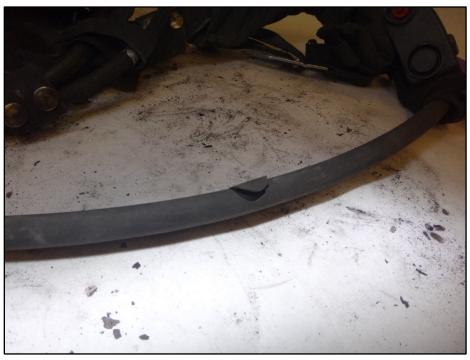
- Secured at all attachments points
- Quick disconnect not present
- Line runs through the shoulder strap to the reducer
- Tear in protective cover

Figure 12: Tear in protective cover of low pressure hose

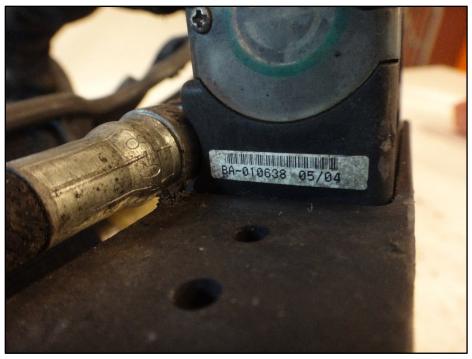
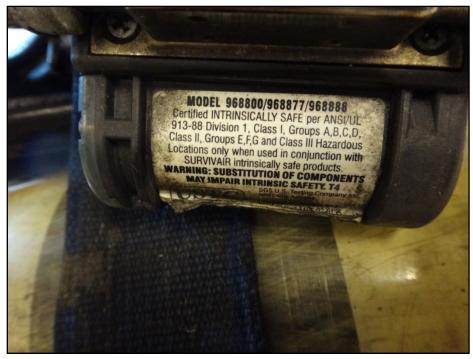
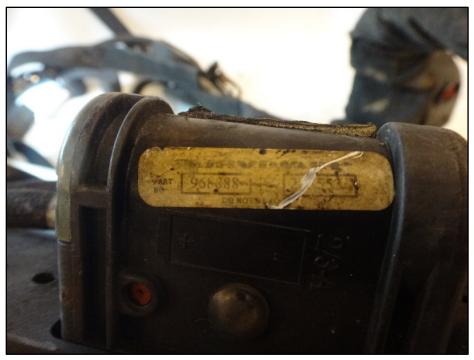
- Barcode marking is present- BA-010638 05104
- Overall condition is fair to good, but dirty with scratches
- All airline connections are secure
- Disconnected from belt

Figure 13: Pressure reducer assembly with markings

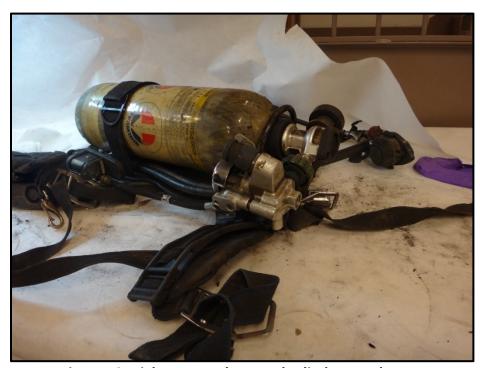
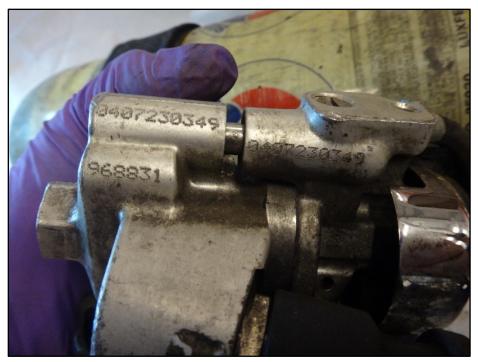
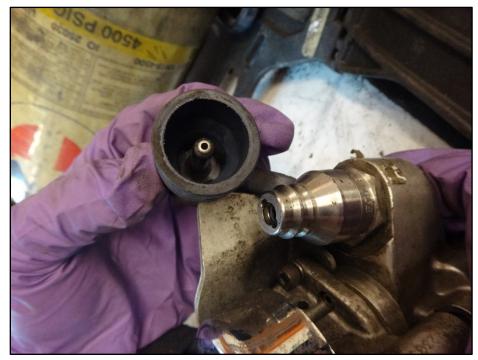
- Overall condition is good with slight scratches
- Cylinder attachments thread corroded, threads on and off, "O" ring in place, but dirty
- Relief valve SVA 45K
- Eaton FD17-1002-10-04
- Three lines:
 - One goes to first stage regulator
 - o Two low pressure lines go to auxiliary with male and female attachment points
 - One line goes to stand alone gauge

Figure 16: High pressure hose and cylinder attachment

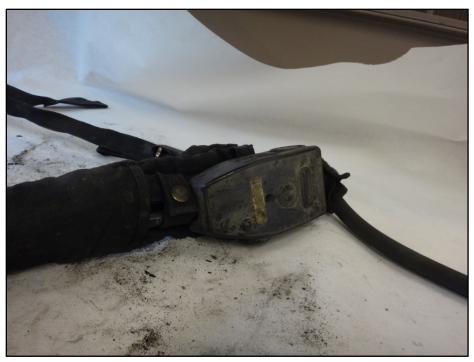
Figure 19: PASS console

- Overall condition is good
- Lines are in good shape—pressure/electrical
- Protective casing slightly dirty; normal wear and tear
- SEI Label attached NFPA 1992, 1998 ed.
- PASS did turn on
- Additional port on PASS device has steel plug

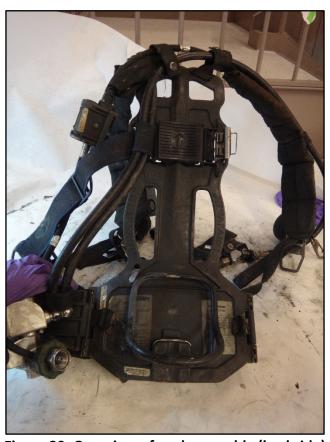
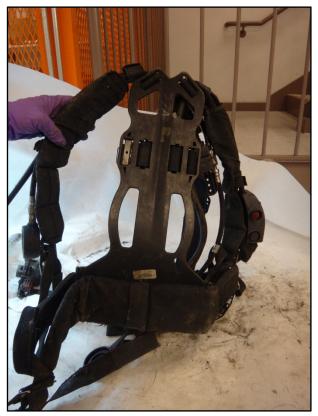
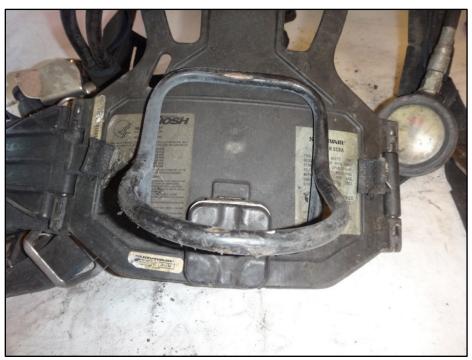
- Overall condition is good, but dirty
- Shoulder straps were attached to the frame
- Cylinder strap intact

Figure 20: Overview of pack assembly (backside)

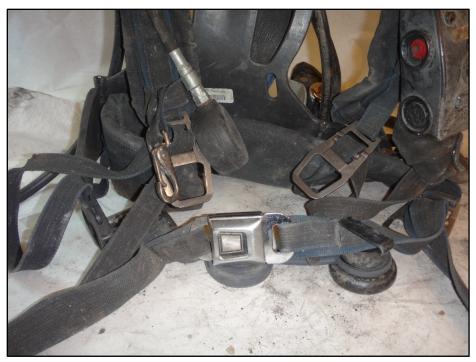
- Overall strap condition is dirty with some dye sublimation
- Shoulder strap attachment connected both sides
- Hose lines and wires pass through shoulder straps
- All adjustable buckles move and hold in place
- Waist area buckle latches and releases
- Heat damage to plastic latch on cylinder strap

Figure 23: Overview of buckles and straps

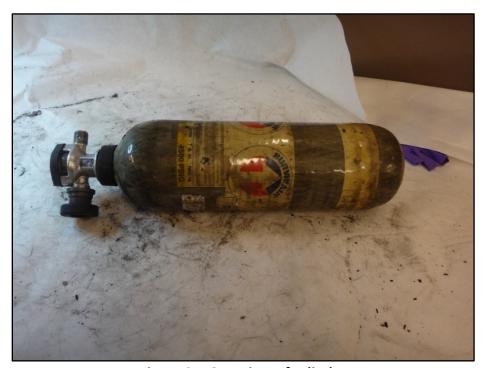
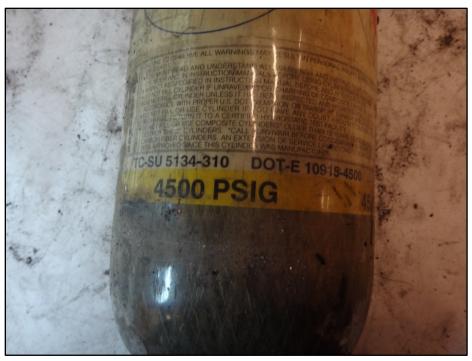
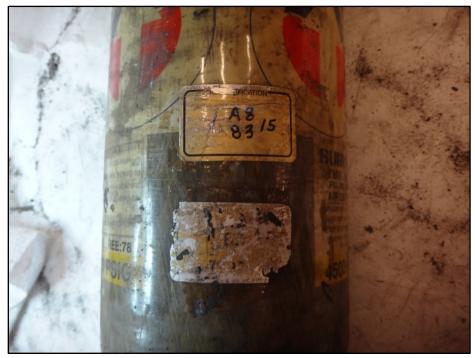
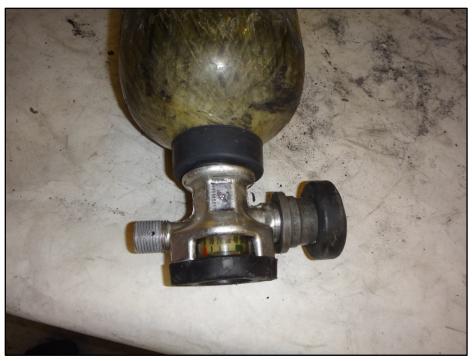
The unit was provided with a corresponding cylinder which was found to also be in testable condition, however it was missing a date for hydrostatic testing. Under the applicable Department of Transportation (DOT) exemption, the air cylinder is required to be hydro tested every five years. For the air cylinder on this unit, the hydro date was not found, therefore, a retest would need to take place before it would be deemed safe to test this unit.

- Overall condition is fair to good as there are some surface scratches and dirt present
- Gauge is readable
- Threads are dirty and corroded
- As received cylinder valve open and empty
- Rubber bumper at base on cylinder valve is in OK condition
- Rehydro/inspection date: Not found

Figure 24: Overview of cylinder

Figure 27: Cylinder threads with readable cylinder gauge

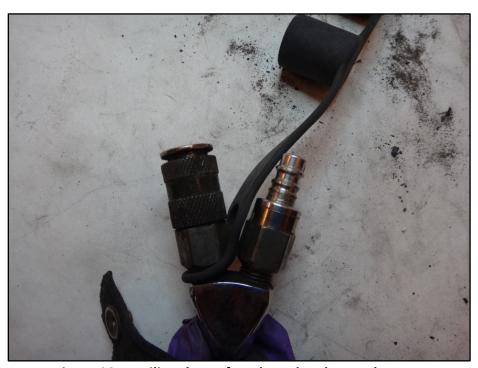
- Female and male attachment points
- Cover in place, but off
- Quick disconnect on female port is stuck
- AISI303 on male port R1.4305
- On quick disconnect RECIUS type 25 NW 7.4

Figure 28: Auxiliary hose, female and male attachments

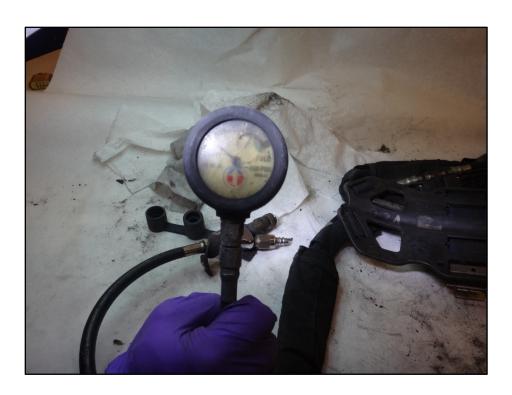
- Lens is scratched and dirty, but readable
- 9806-41

Figure 29: Standalone gauge, lens scratched but readable
