An Indoor Environmental Quality Investigation of the Fayette County (Pennsylvania) Courthouse

Stephen B. Martin, Jr Christopher C. Coffey

Department of Health & Human Services, Centers for Disease Control and Prevention
National Institute for Occupational Safety and Health, 1095 Willowdale Road, Morgantown
WV 26505-2888, USA

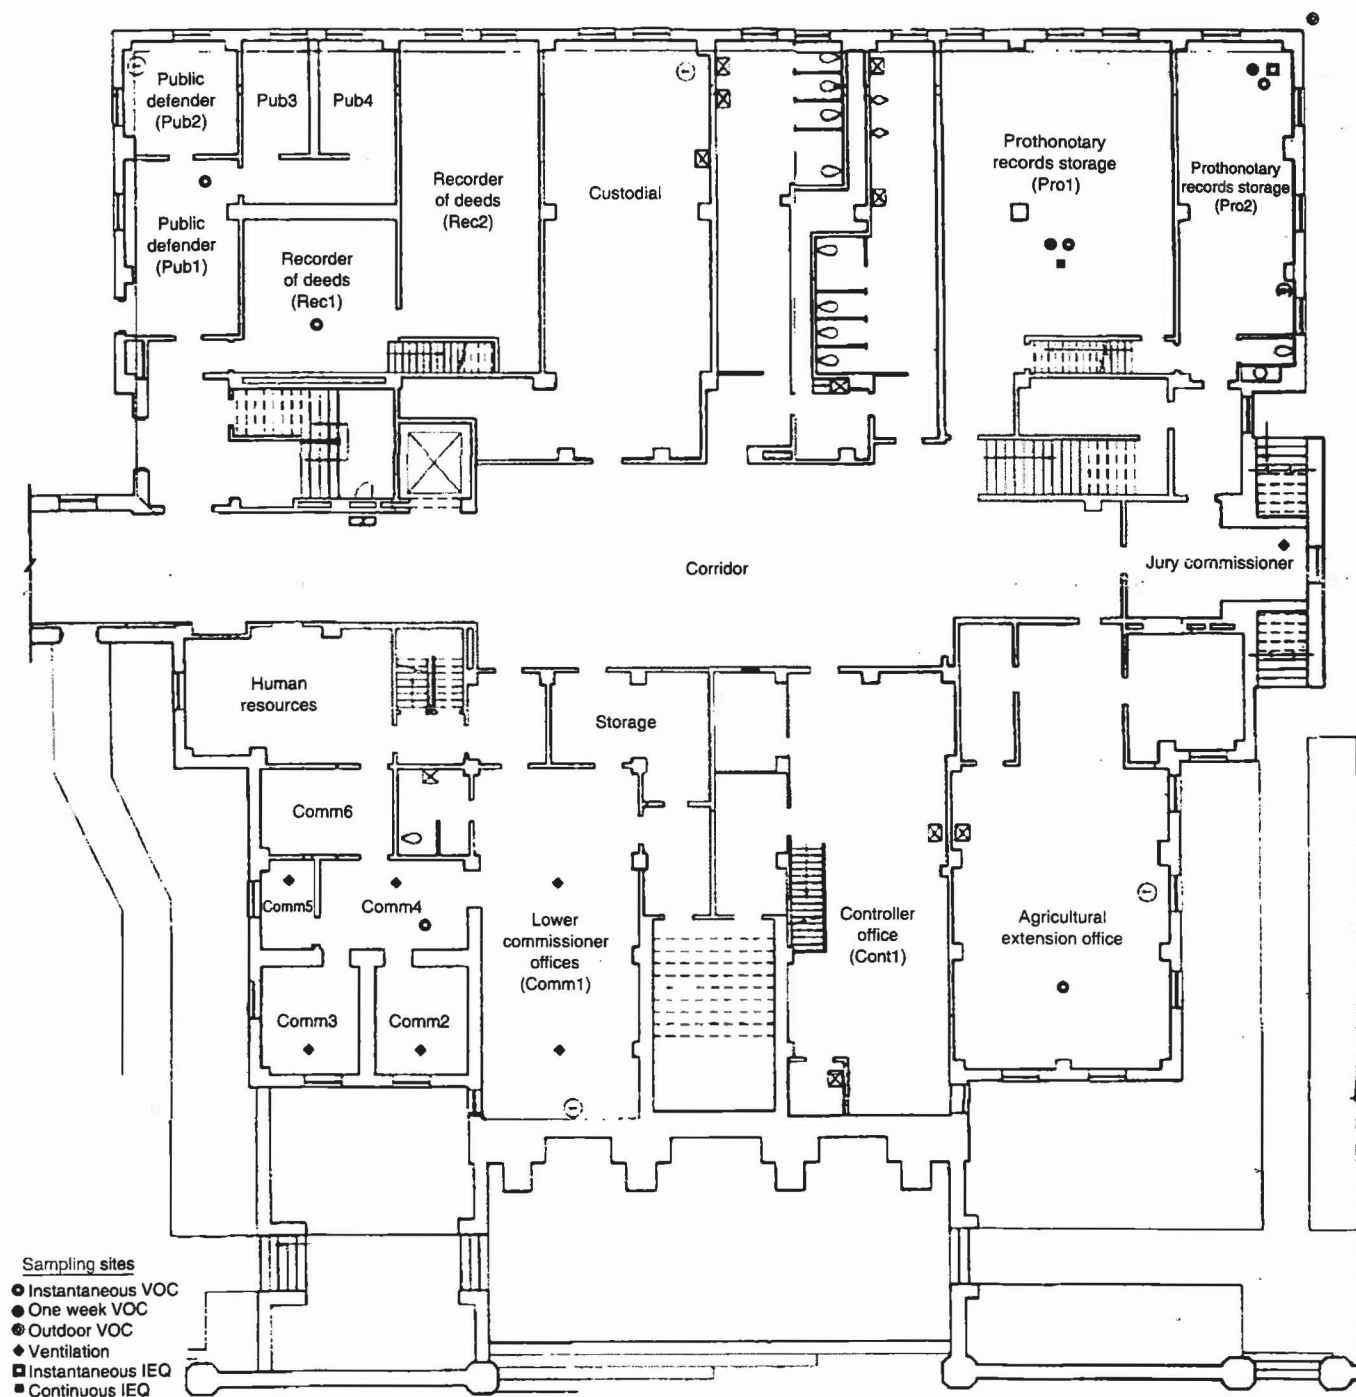
Fig. 1. Sampling locations in basement of the Fayette County Courthouse annex.

Continuous IEQ parameters were monitored in the Prothonotary Records Storage Area (Pro1 in Figure 1). The CO₂ levels ranged from 440 ppm to a maximum of 762 ppm (average of 503 ppm). The two spikes are probably due to courthouse employees being in the storage room searching for and obtaining files. At the beginning of the sampling period, the temperature was approximately 71.2°F (21.8°C), which was the minimum over the entire period. The temperature immediately started to increase and generally continued to rise over the rest of the sampling period. The maximum temperature reached 79.4°F (26.3°C) (average of 77.0°F, 25.0°C). The relative humidity in the area fluctuated daily over the sampling period with a minimum of 27.3% and a maximum of 46.0% (average of 39.3%).

remained below the maximum recommended level of 800 ppm for the entire week-long sampling period. However, the temperature exceeded the ASHRAE and OSHA recommended maximum temperatures on two occasions (the readings were taken in the fall, so both summer and winter recommendations were considered). During one afternoon, the relative humidity was <30% with a minimum of 27.3%. Otherwise, the relative humidity level was within the recommended range during the sampling period.

The instantaneous temperatures taken with the temperature/humidity pens ranged from 72.5–78.8°F (22.5–26.0°C). The instantaneous humidity readings were ranged from 42 to 53%. The back of the Prothonotary Records Storage Area (Pro2) exceeded the recommended temperatures by approximately 3.0°F. The instantaneous humidity readings were all within the recommended values.

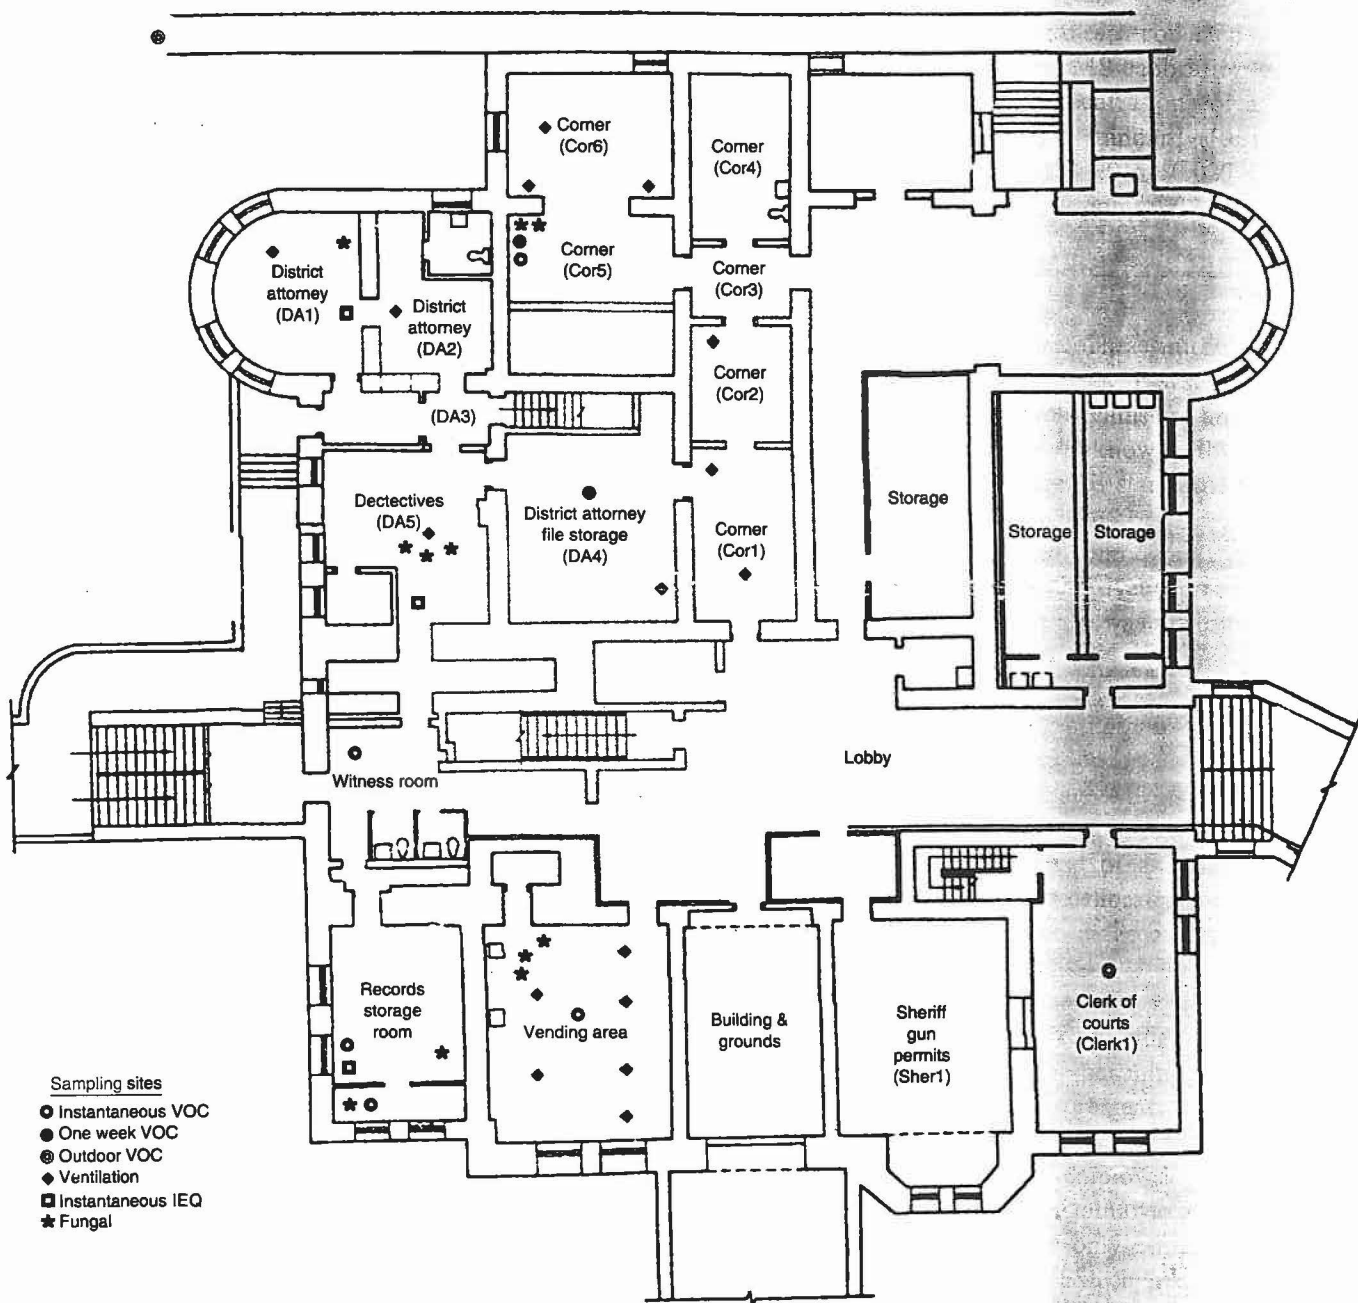
Fig. 2. Sampling locations in basement of the Fayette County Courthouse main building.

lished odour thresholds. The exception was an instantaneous sample in the Coroner's Office (Cor5 in Figure 2), where the concentration of toluene exceeded the odour threshold but remained orders of magnitude below either the REL or PEL. The outside air samples (Figures 1 and 2) contained many of the same compounds found in the indoor samples. Benzene, 2-butanone, 1,2-dichloroethane, dichlorodifluoromethane, methylene chloride, toluene, trichloroethene and xylenes were found in all four outside air samples taken. Ethylbenzene, 4-methyl-2-pentanone and vinyl acetate were found in only one sample each. The concentrations of the compounds found in the outside air samples were very low (0.001–0.003 ppm). None of the other compounds listed in Table 1 were detected in any of the outside air samples.

The potentially contaminated area on the wall in the Coroner's Office (Cor5) appeared to consist of two different species of fungi. Part of the area was very light in colour while the rest was very dark, almost black. A swab sample was taken from each of these areas. The sample of the lighter contamination yielded 4,300,000 CFUs (95% *Scopulariopsis*). The sample of the black contamination from in the same area yielded 800,000 total

CFUs (50% *Scopulariopsis*, 20% *Sporothrix*, 17% *Penicillium*, 10% *Aspergillus*). These are some of the most common indoor fungi [7]. Since the outside of the wall was apparently heavily contaminated with fungi, a boroscope was used to look inside the wall. The boroscopic examination revealed that the inside of the wall was also heavily contaminated.
