Applied Occupational and Environmental Hygiene

Hard Metal Exposures. Part 1: Observed Performance of Three Local Exhaust Ventilation Systems

Steven E. Guffey,¹ Nancy Simcox,¹ Derrick W. Booth, Sr.,² Richard Hibbard,¹ and Arlene Stebbins³

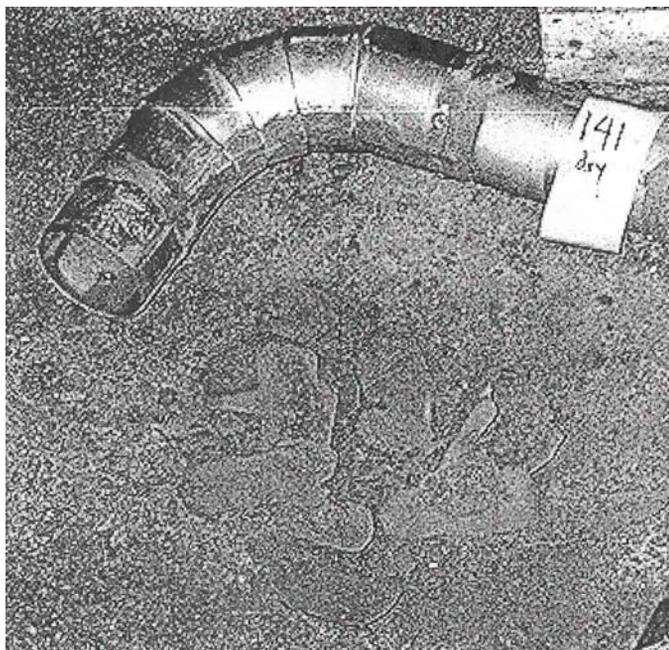
**FIGURE 5**

The buildup of sticky material was a widespread problem. In general, the worst cases in each of the three systems were associated with grinding, which tended to fill ducts quickly with compacted clumps of grinding materials (see Figure 5). The grinding wheels contained a binder that when abraded released a sticky resin that bound the metal dust into increasingly large hardened clumps. These clumps easily blocked the duct work, almost always within 10 diameters of duct length near elbows and at the hood entrances. No settling was observed beyond the most upstream vertical duct in branches or in submains or mains. The investigators themselves sometimes cleaned out the branch ducts; otherwise, the incidence of plugging in ducts may have been greater. Because the investigator cleaning was done after measurements were taken on a given day, the beneficial effects of that cleaning were lost in the re-accumulation of materials during the following month. At six months it was clear that cleaning

Settled material partially plugging duct number 12 in Roundsaw Dry.

should be done on a weekly basis. The authors counseled the management and demonstrated cleaning to the employees. In succeeding months substantial accumulations still were evident by even casual external inspection.

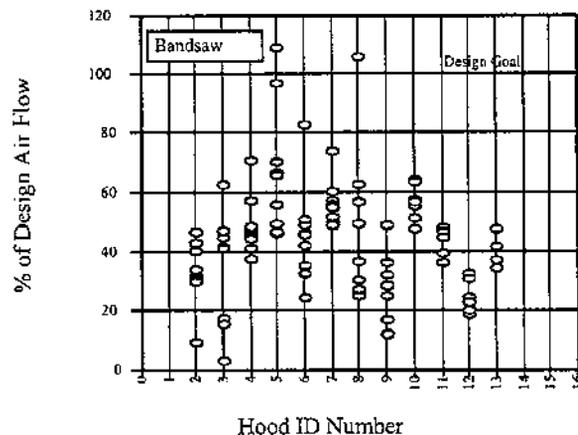
**FIGURE 6**

Air flow statistics for Bandsaw ventilation system by hood.

The stellite grinder/welder used hoods 8, 9, and 10 and the steel grinder used hoods 3 and 4. Remaining hoods were used by other employees (1, 2, 5–7) or not used at all (11–13). Although airflows were low and poorly distributed even immediately after installation (Table I), distribution later was exacerbated by chronic partial plugging. The products of grinding the steel bands tended to compact into clumps just inside and downstream of the plain duct openings used as hoods (see similar materials shown in Figure 5). Removing these materials required removing sheet metal screws and pulling the ducts apart and banging them forcefully, a time-consuming and tiresome task.

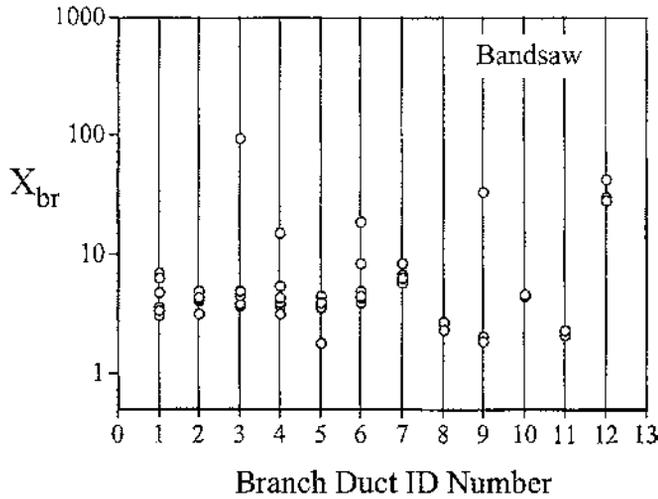
FIGURE 7

Bandsaw branch resistances (X_{br}) to flow over time.

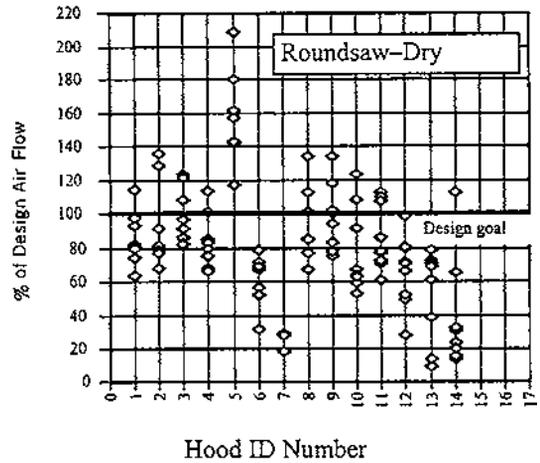
FIGURE 8

Air flow statistics of Roundsaw-Dry ventilation system by hood.

The air flows through hood 5 were consistently much higher than intended, but all other hoods' air flows were below design levels for at least half of the months sampled (see Figure 8). The hood air flows were highly variable, but less than 10 percent of the variance was explained by the declining total air flows (see Table II). The coefficient of variation was 24 percent for changes in hood air flows due to shifts in relative distribution as some branch ducts were partially plugged or cleaned to differing degrees than others.

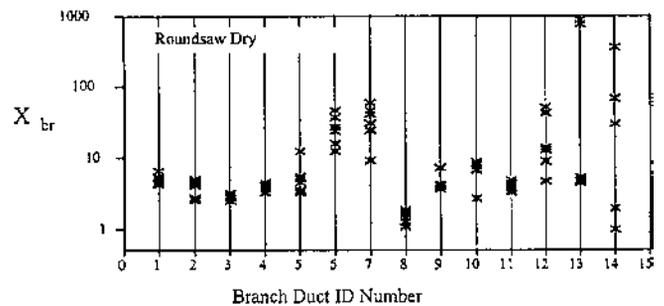
FIGURE 9a

Hoods 6, 7, and 12 were grinders with integral hoods having very narrow duct inlets that easily clogged and were difficult to access for cleaning. Their chronic heavy plugging (see Figure 5) produced the high X_{br} values shown in Figures 9a and 9b. As shown in Figure 9c, all three appeared to benefit from a thorough cleaning just after the tenth month. The brazing hoods (ducts 10 and 13) were lightly coated with brazing residues but had little buildup. The bimodal distribution of X_{br} values for duct 10 (see Figure 9a) was due to a change in hood design. The initial high values for duct 13 (see Figure 9c) dropped to a much lower, nearly constant value when a rag inside the duct was discovered and removed.

Roundsaw Dry branch resistances for each branch duct.

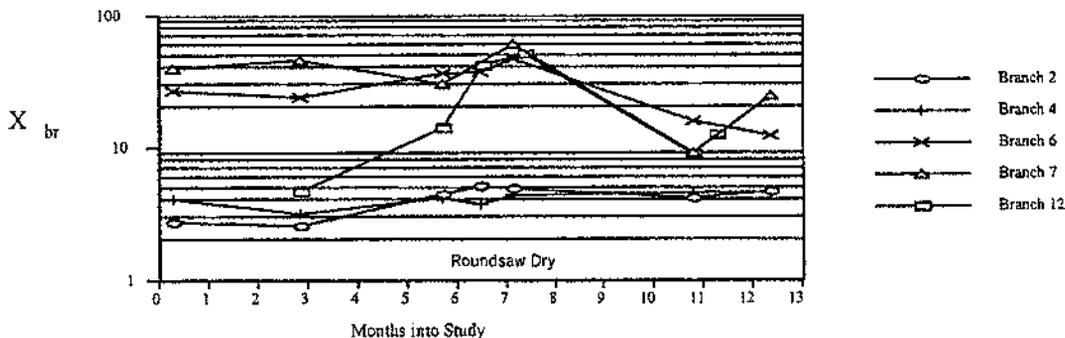
FIGURE 9b
 X_{br} for branches 2, 4, 6, 7, and 12.

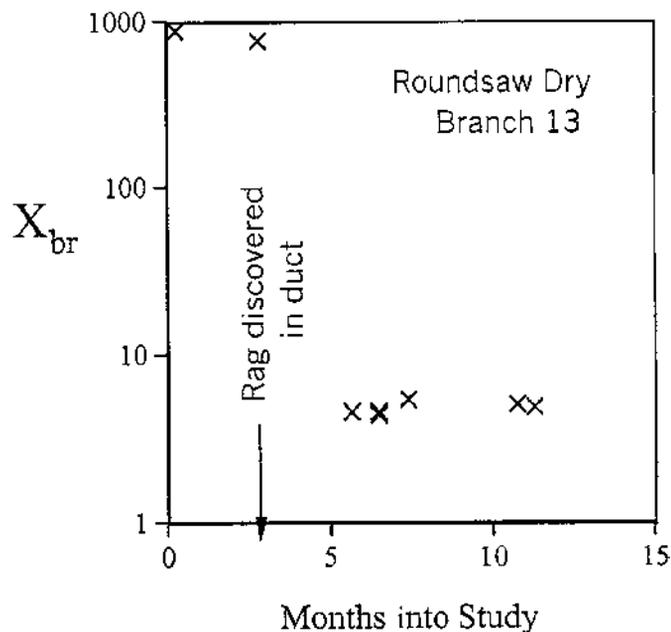
FIGURE 9c
 X_{br} for branch 13.

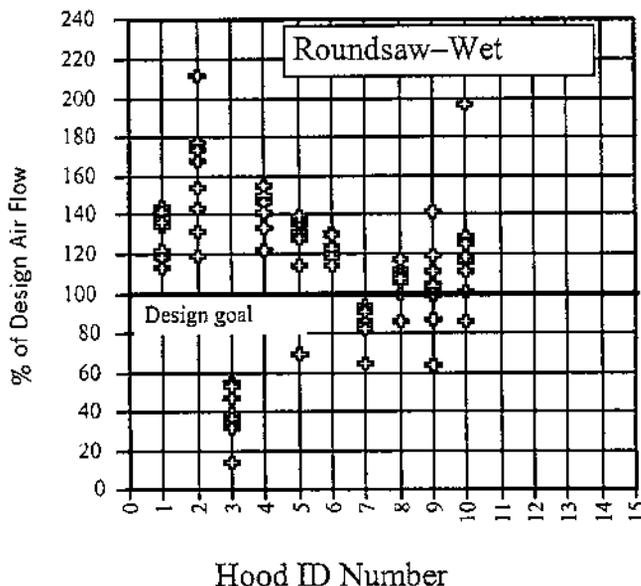
FIGURE 10
 Air flow statistics of Roundsaw-Wet ventilation system by hood.

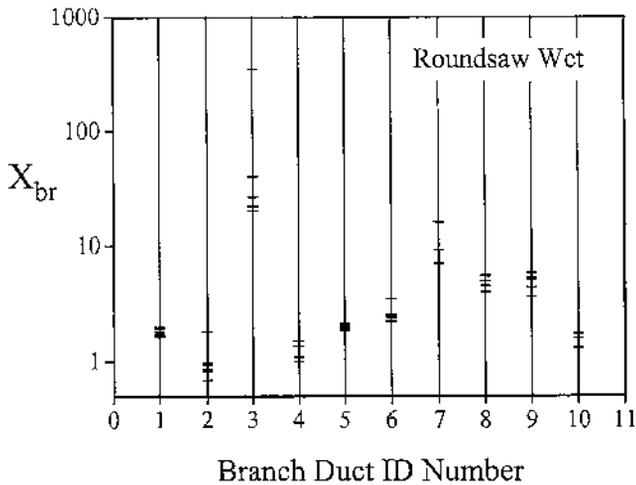
FIGURE 11

Although some ducts experienced sharp changes in resistance to flows (see Figure 11), the changes to resistance were much more modest for this system than for the other two, indicating

Roundsaw Wet branch resistances to flow over time.
