Journal of Agromedicine

Results From Inspections of Farmer-Installed Rollover Protective Structures

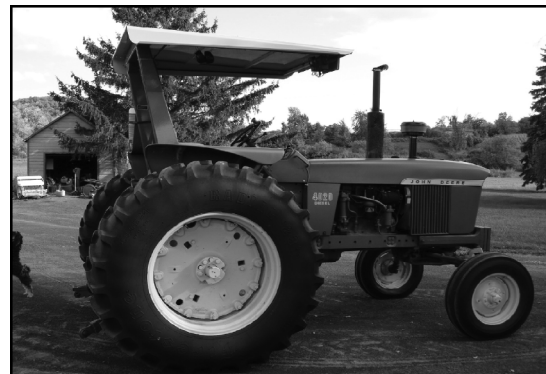
Thirty-one percent were supplied with correct parts and installed according to manufacturer specifications. Of the ROPS installed on the 51 tractors selected for self-install inspections, 16 ROPS were supplied with all of the necessary parts/instructions and were installed by the farmers without any deviations or complications, (12 were John Deere, 1 Laurin, 1 White, and 1 Saf-T-Cab, 1 Bare Co.). Figure 2 shows a John Deere ROPS installed on a John Deere 4020.

FIGURE 2. John Deere ROPS installed on a John Deere 4020.

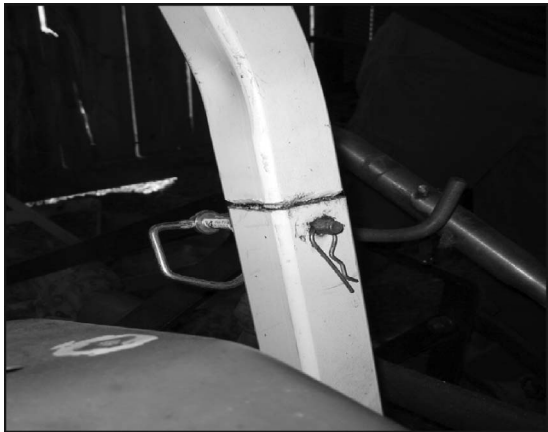
FIGURE 3. ROPS installed on a Satoh 650G that has been cut and pinned together.

tractors, the installed roll bar was cut in half and pinned together with an internal tube to make it removable for low clearance (depicted in Figure 3). These five are among the eight cases in which substitution or modification of parts were noted by the inspectors. Such changes included using different washers or substituting bolts that were either the wrong length or had stripped during installation. Among those not referred to a dealer was a ROPS with a cross bar that was too short. Solid steel extensions were added to make up the difference (Figure 4). This farmer was not referred to a dealer, because the alterations were suggested by the ROPS supplier.

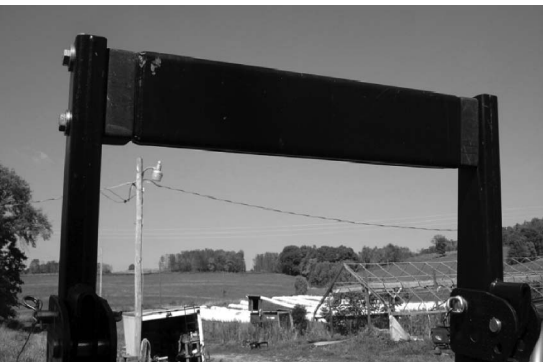
FIGURE 4. Foldable ROPS installed with solid steel extensions (red).

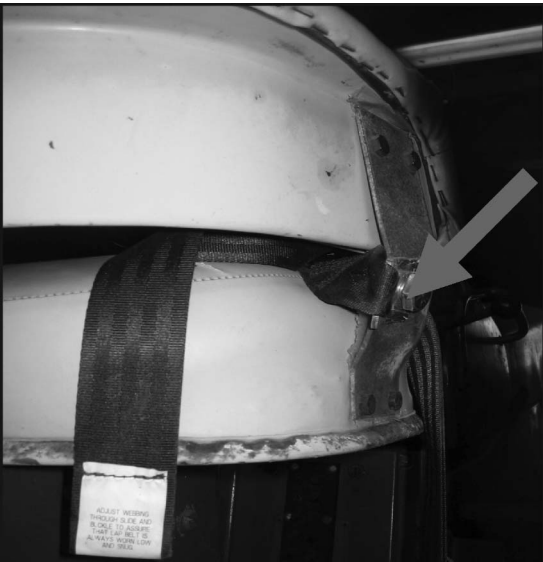
installed at the time of inspection. Most of these seatbelt issues were caused by a misunderstanding regarding seatbelt mounting locations. On some John Deere models this was due to the fact that the proper threaded hole in the seat structure was hidden by the vinyl upholstery, whereas a visible, useable hole of the correct diameter for the seatbelt mounting bolt was present in the arm rest bracket (Figure 5). That appeared to be the perfect location for the seatbelt, even though the instructions pointed out the location of the proper mounting hole beneath the vinyl. In order to install the seatbelt, a small hole or “X” had to be cut into the seat so the bolt would

FIGURE 5. Seatbelt improperly installed.

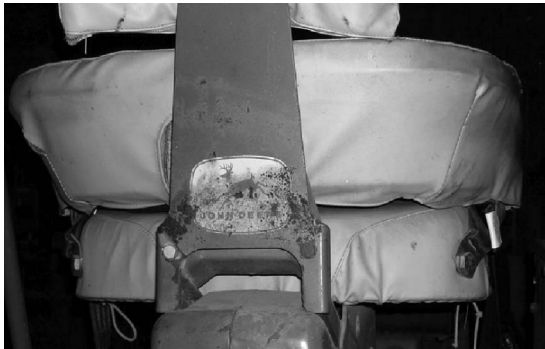
FIGURE 6. Seatbelt properly installed.

go though the covering into the metal seat body (Figure 6).

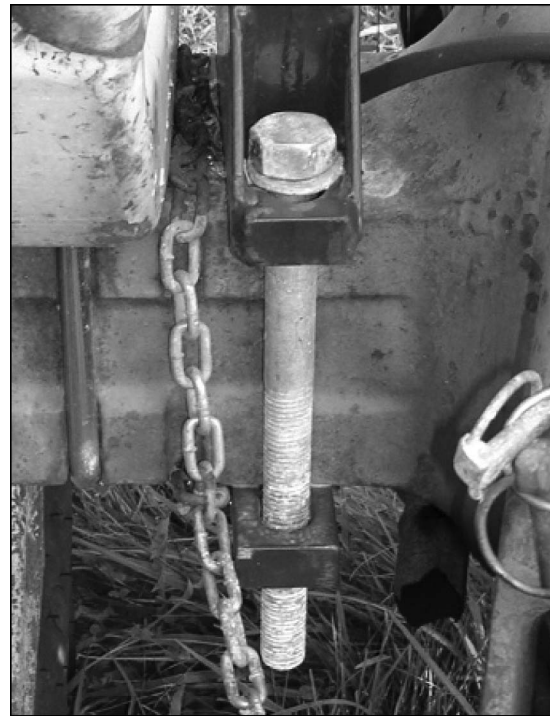
Twelve percent were sent with bolts that were either the incorrect size or grade, or of questionable quality. During the course of inspections, unmarked bolts (Figure 7) and defective bolts (Figure 8) were detected in several ROPS kits. Following discussions with the manufacturer, improper bolts were replaced and unmarked bolts were marked with standard markings.

FIGURE 7. Unmarked ROPS mounting bolts.

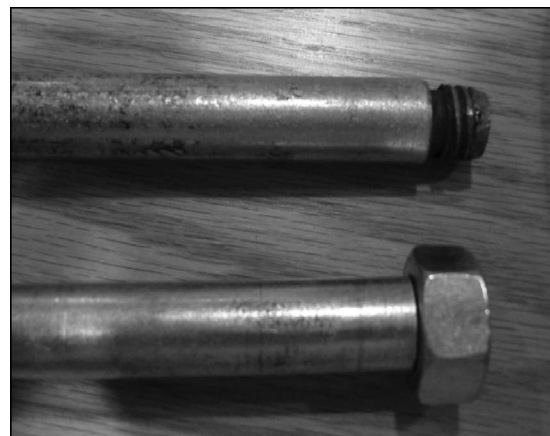
FIGURE 8. Defective ROPS mounting bolts.
