## Ozone Exposure at a Construction Site

# Ozone Exposure at a Construction Site

Reported by Ronald M. Hall and Elena Page

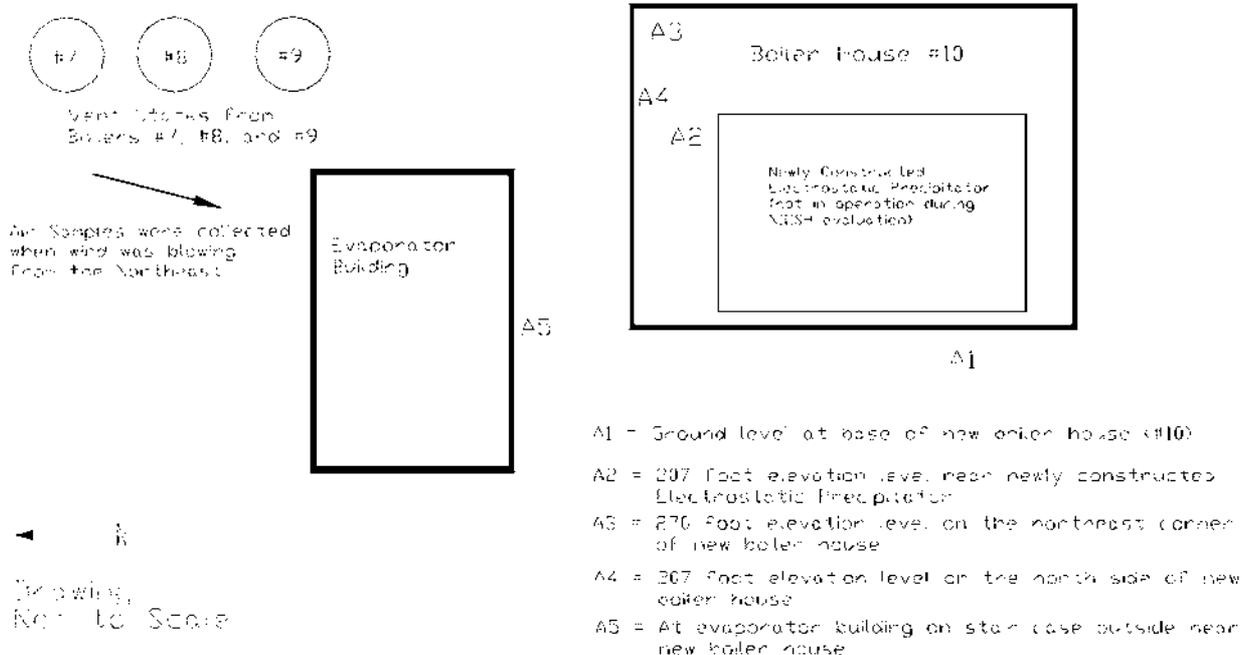
**FIGURE 1**

Area sample locations (Elevations are from ground level).

area locations (see Figure 1 for area sample locations): (1) ground level at the base of the new boiler house on the west side of the construction area (location A1); (2) at the 207-foot elevation level near the newly constructed electrostatic precipitator (location A2); (3) at the 270-foot elevation level in the northeast corner of the new boiler construction area (location A3); (4) at the 207-foot elevation level on the north side of the new boiler house (location A4); and (5) outside the evaporator building on a staircase near the new boiler house (location A5).

Ozone samples were collected in two separate areas at the new boiler construction site. The first monitoring site was located on the north side of the new boiler house at area location A2 (see Figure 1). The electrostatic precipitator located on the new boiler (Boiler #10) was still under construction and was not yet operational. The second monitoring site was on a stairwell at area sample location A3 (see Figure 1). These two area locations were selected based on the drifting of smoke (from the operational boiler stacks adjacent to the construction site) through the construction area. Chlorine

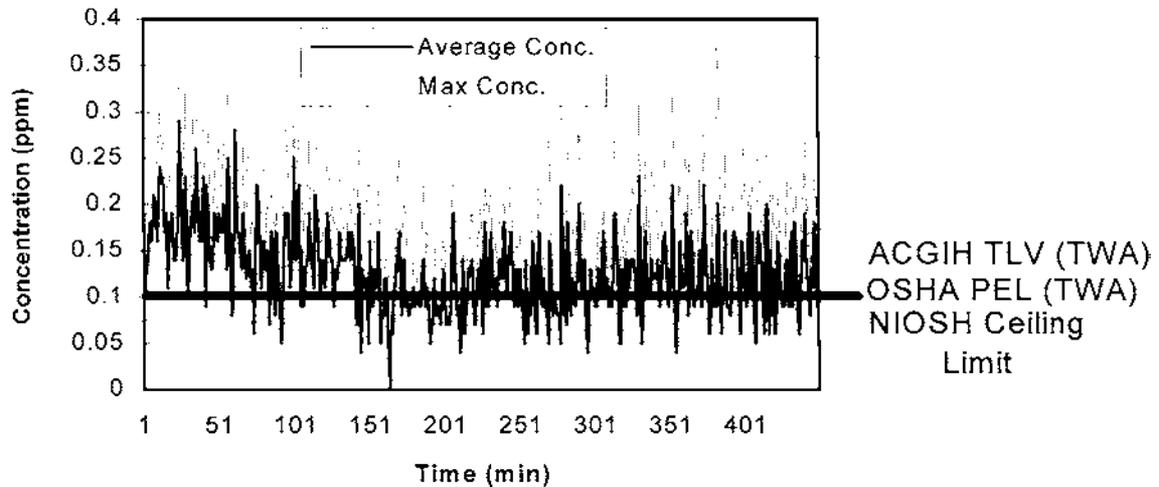
**FIGURE 2**

Ozone average and maximum concentrations plotted each minute during the sampling period at area sample location A2 (207-foot elevation).

*Ozone.* Figure 2 presents the average and maximum ozone concentrations collected each minute during the sam-

pling period at location A2. The peak ozone concentration measured at this location was 0.37 ppm. This is nearly four times the NIOSH ceiling limit of 0.1 ppm. The TWA ozone concentration at this area location was 0.12 ppm. These values indicate that there is a potential to exceed the OSHA PEL (0.1 ppm) and the ACGIH TLV for light work (0.1 ppm), moderate work (0.08 ppm), and heavy work (0.05 ppm) at this area location.

1. The risk of exposure to ozone and other respiratory irritants may be increased by emissions from the adjacent boiler stacks migrating into the construction area. To help reduce the migration of smoke emissions into the new boiler construction area, it was recommended that the siding on the north and east side of the new boiler house be completed first.

2. To target all sources of ozone emissions (boiler vent stacks and/or welding operations), it was recommended that additional ozone monitoring be conducted by the company. The company should identify any areas where ozone concentrations may exceed the established evaluation criteria (i.e., NIOSH REL, ACGIH TLVs, or OSHA PEL). Ozone samples should be collected during welding operations and environmental worst-case scenarios such as thermal inversions and wind blowing from the north that forces smoke emissions (from adjacent boiler vent stacks) toward the construction site. These samples should be collected in any areas where work activities are conducted. If samples indicate that exposure criteria may be exceeded, steps need to be taken by the company to reduce worker exposures.
