Scand J Work Environ Health 1999;25(3):227-232

### **Ozone-induced respiratory illness during the repair of a portland cement kiln**

by Sanderson WT, Almaguer D, Kirk LH III

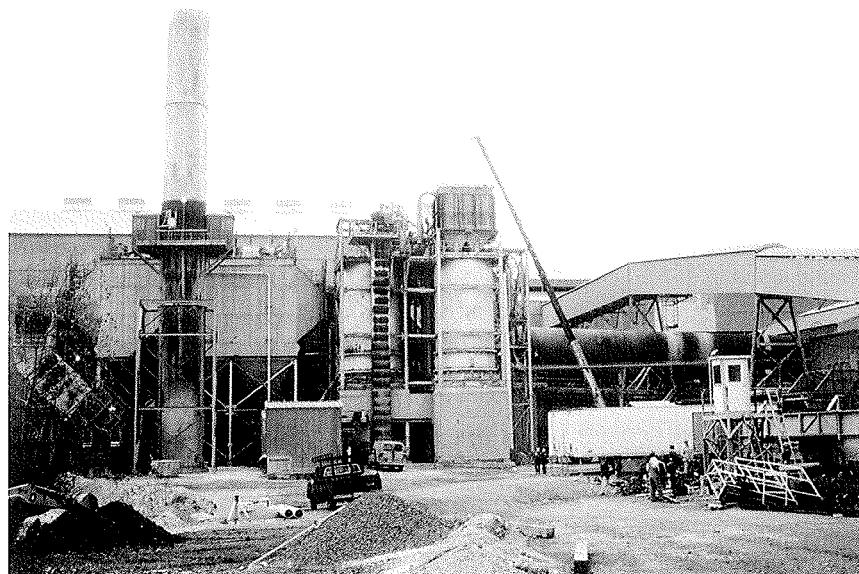
system and exhaust stack, but kiln 4, which began operation in 1970, had a separate dust control system and exhaust stack. In 1995, the height of the exhaust stacks was increased due to excessive, in-plant sulfur dioxide exposures from the combustion of coal in the kilns. Since that time no further problems with excessive sulfur dioxide exposure have been reported. Figure 1 shows the exhaust stack and electrostatic precipitators at the inlet end of kiln number 4.

**Figure 1.** Back end of kiln number 4 showing exhaust stack and electrostatic precipitators.

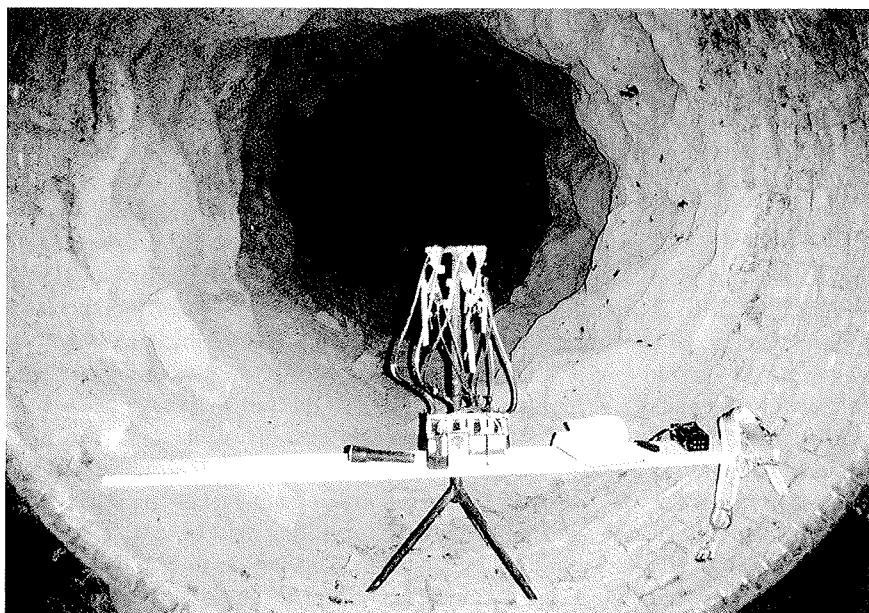
Area samples were collected for chlorine, inorganic acid, sulfur dioxide, respirable, and total dust by attaching sampling media to tripods positioned near the front, middle, and rear of the kiln (figure 2) (5). Short-term samples for ozone were collected frequently at various locations inside the kiln, using direct-reading color indicator tubes and a Metrosonic Toxic Gas Monitor™ direct-reading monitor. Since a bleach-like odor had been

Figure 2. Area sampling station inside the front end of kiln number 4.
