# Hazards At Your Auto Dealership (Including Everything You Ever Wanted to Know About a Tail- Pipe Exhaust Ventilation System)

## Case Studies

Reported by Alan Echt, Charles Hayden, II, and Ova Johnston

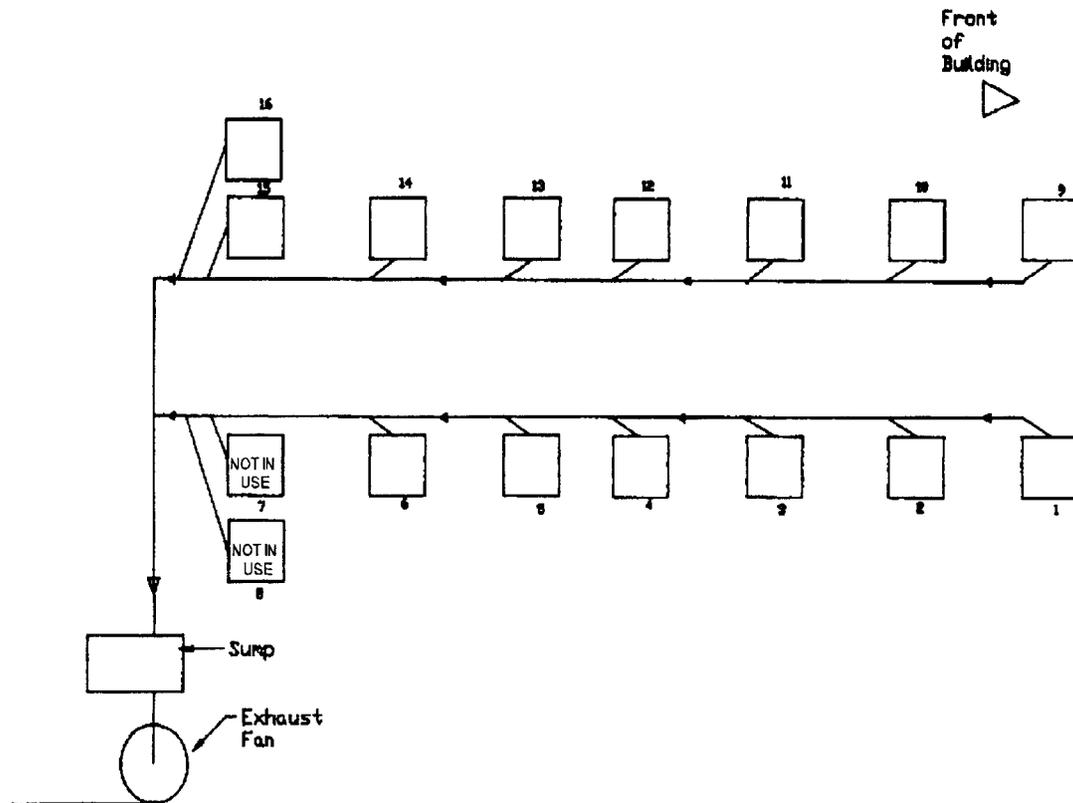
As shown in Figure 1, there were 16 steel-framed engine exhaust ports in the garage floor. Two ports (7 and 8) were bolted closed. The remaining 14 exhaust ports, 1 at each service bay area of the garage, directed vehicle tail-pipe exhaust gases from a flexible exhaust hose into a

common duct under the service area floor. Tail-pipe exhaust passed through the under-floor duct to a sump where any liquids in the ventilation system were trapped and pumped to waste. Exhaust gases were then directed outside the building through an exhaust fan. Hinged steel cover plates, flush to the garage floor, capped the individual exhaust ports when not in use.

FIGURE 1. Line diagram of carbon monoxide removal system.

1. The exhaust port covers should be replaced with covers having self-closing caps. The exhaust ports covers and caps should provide an airtight seal when not in use.

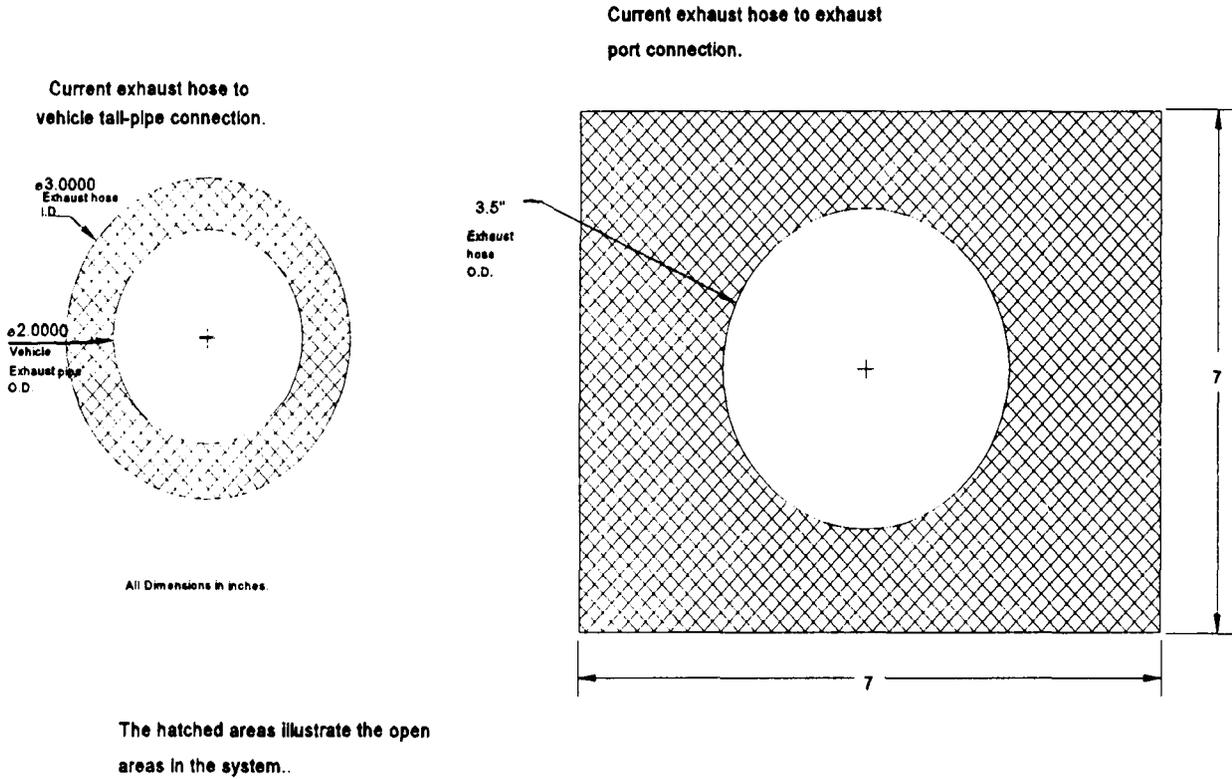
The 3½-inch outside diameter flexible garage exhaust hose varied in length from 6 to 10 feet. One end of the hose fit over the vehicle's tail-pipe (an average tail-pipe diameter is about 2 inches). The other end was placed into the 7-inch square exhaust port. When the hose was connected between a vehicle tail-pipe and the exhaust port, approximately 4 square inches (in<sup>2</sup>) of leakage area existed between the tail-pipe and the flexible hose. Forty square inches of leakage area existed between the exhaust port and flexible hose (Figure 2). In addition, a total of 12 in<sup>2</sup> of leakage area existed through two ¾-inch diameter finger holes, in each of the 14 functional cover plates. The finger holes provided access to lift the cover plate during exhaust port use. A loose fit between closed cover plates and exhaust ports provided leakage area into the exhaust system. Warped or bent exhaust port frames and cover plates exacerbated the loose fit.

FIGURE 2. Existing flexible garage exhaust hose to tailpipe and export port leak areas.

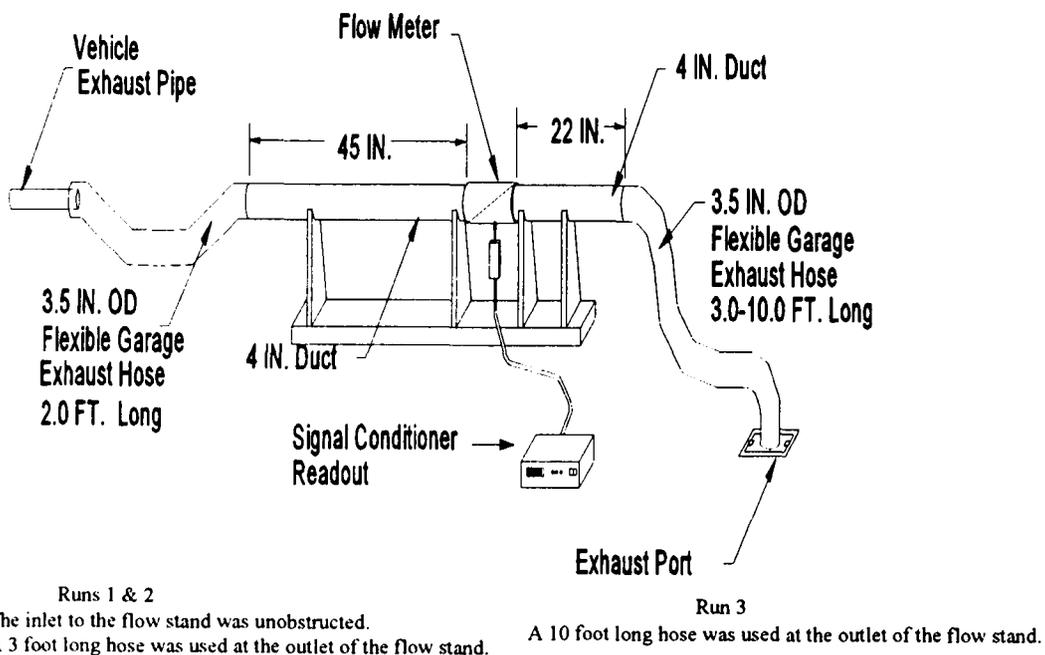
During two subsequent engineering evaluations, exhaust port flow rate measurements were made using a flow measuring stand constructed as shown in Figure 3. The flow measuring stand used an Accu-mass™ model 730-N7-1 thermal anemometer flowmeter. The flowmeter output to a FloBox™ model 904M signal conditioner/digital readout device that indicated flow rate in cubic feet per minute (cfm). On both of these occasions, flow rate measurements were obtained with and without temporary modifications (described below) in place which eliminated unnecessary leakage.

FIGURE 3. Flowstand used in taking tail-pipe exhaust removal system flow rate measurements at the exhaust ports.

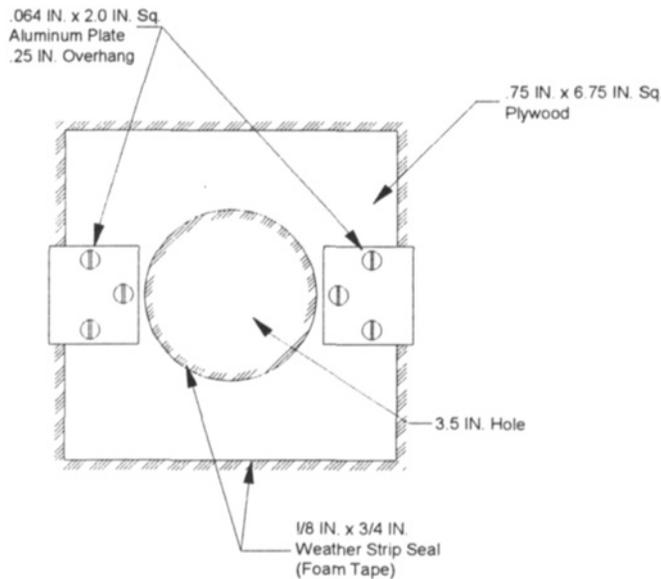
Temporary modifications to eliminate unnecessary leakage included taping 3-mil plastic sheets over exhaust ports not in use and installing exhaust port/flexible hose adapters (designed and fabricated by engineers at NIOSH) in exhaust ports in use (Figure 4). The adapters are  $6\frac{3}{4}$ -inch square  $\times$   $\frac{3}{4}$ -inch thick plywood pieces with  $3\frac{1}{2}$ -inch diameter round holes cut into the center. The outer perimeter of the wood piece was fitted with  $\frac{1}{8}$ - $\times$   $\frac{3}{4}$ -inch weather strip seal (foam tape). The weather strip sealed the contact point between the exhaust port adapter and the exhaust ports. Weather stripping is also provided on the inside diameter of the adapter's round hole to reduce leakage between the exhaust hose/adapter contact point. The

semi-tight fit between the exhaust hose and the round passage through the adapter ensured the duct would not drop through the exhaust port into the com-

mon duct, blocking off upstream exhaust ports. Two aluminum brackets were attached to opposite sides of the adapter to hold the adapter in the exhaust port.

FIGURE 4. Flexible garage exhaust hose to exhaust port adapter.
