# Fire incidents involving regulators used in portable oxygen systems

F Washenitz II, J Stoltzfus, B Newton, L Kubinski

## Abstract

**Objectives**—To address the causes and prevention of fire incidents involving aluminum bodied oxygen regulators used by firefighters or emergency medical technicians.

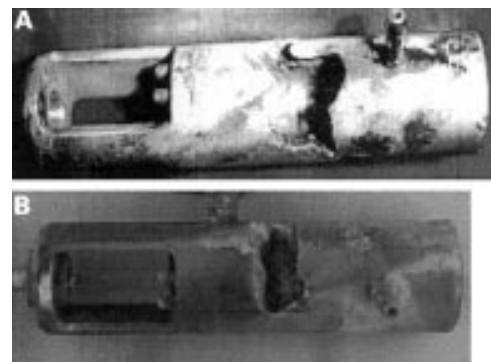
Independent testing and review of the incident revealed the most probable ignition mechanism was particle impact on the filter during the initial oxygen flow transient (a temporarily unstable oxygen flow) after the firefighter opened the cylinder valve. This ignition led to the burning of the regulator's aluminum body, which caused the flash. Particle impact ignition occurs when a metallic particle contained in the oxygen flow contacts a rigid surface and ignites, which then promotes ignition of the surrounding material. Particle impact has been shown to be one of the most efficient mechanisms for directly igniting metallic components in a high pressure oxygen environment.

In case 2 in South Carolina, the origin of fire could not be isolated with certainty because of extreme damage to the regulator's component parts. However, the melt-flow patterns and propagation paths were consistent with an origin either at the cylinder's valve seat or in the high pressure section of the regulator. Because of the presence of a gauge protector (that blocked the regulator vent ports), the propagation patterns and blowback condition (burning in a backwards direction into the cylinder) would have been expected for initial ignition at either location. Considering the extreme flammability of aluminum under these service conditions, the combustion event would be strongly dominated by aluminum ignition in the regulator in the very early stages of the fire.

Cylinder valve seat ignition caused by frictional interaction with the metallic nozzle, or particle impact ignition against the regulator's stainless steel screen, were the most likely ignition mechanisms. Multiple ignition mechanisms are active in normal oxygen systems, and several of these have been associated with regulator fires with promoted ignition of the aluminum body. This regulator fire was

The provisional standard was accepted by the committee and became available to the oxygen regulator community in December 2000.<sup>7</sup> Figure 2 illustrates how results of the phase 2 test duplicate what is found in actual regulator fires.

Figure 2 Pictures of (A) oxygen regulator after actual fire and (B) after phase 2 testing.

Based on investigations and available test data, FDA/NIOSH recommended the material in the high pressure section of an oxygen regulator be comparable to or equivalent to brass.<sup>1-4</sup> In addition, NIOSH concluded that fire departments should implement the following procedures for working with portable oxygen systems to reduce the occurrence of similar incidents.

- During maintenance and inspection procedures, place the cylinder in an upright position with the post valve pointed away from the operator. Open then close the post valve before attaching to the cylinder.
- When opening a cylinder post valve with the regulator attached, open slowly and point away from self and other people.
- Train firefighters in safe handling procedures of portable oxygen systems.
- Store oxygen cylinders and regulators in a cool area free of dirt, oils, and grease.
- Locate oxygen filling stations and maintenance areas in a locked, air conditioned room that is clean and free of dirt, oils, and grease.
- Install added components, such as gauge guards, so they do not block regulator vent holes.
- Ensure that manufacturers provide a warning that clearly indicates that the vent ports on the regulator should not be occluded.
