Survey of Lead Contamination in an Office Building

Reported by Christopher F. Lovelace, Mary T. Giguere, John J. Curran, Peter D. Morris, Luanne K. Williams, and Paul A. Matson

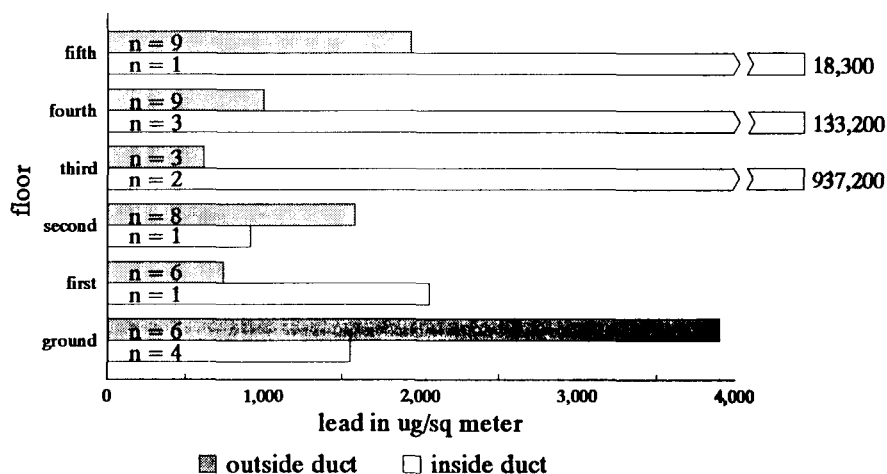
FIGURE 2. Wipe samples from highway building.

In the Highway Building, wipe samples were collected at multiple locations on all floors ($n = 8$ inside ductwork, $n = 29$ outside ductwork) and showed that lead in dust was present inside the ductwork and on various

surfaces outside the ductwork (Figure 2). The amount of lead present inside the ductwork ranged from 764 to $1,653,812 \mu\text{g}/\text{m}^2$. The amount of lead present on surfaces such as floors, file cabinets, and desk tops ranged from nondetectable to $6607 \mu\text{g}/\text{m}^2$.

After comprehensive sampling, the findings that lead dust was present throughout the Highway Building and Annex Building prompted us to make specific cleaning recommendations to NCDOT facilities management. The cleaning project, including generalized building cleaning and HVAC ductwork cleaning, was completed in early August 1992.

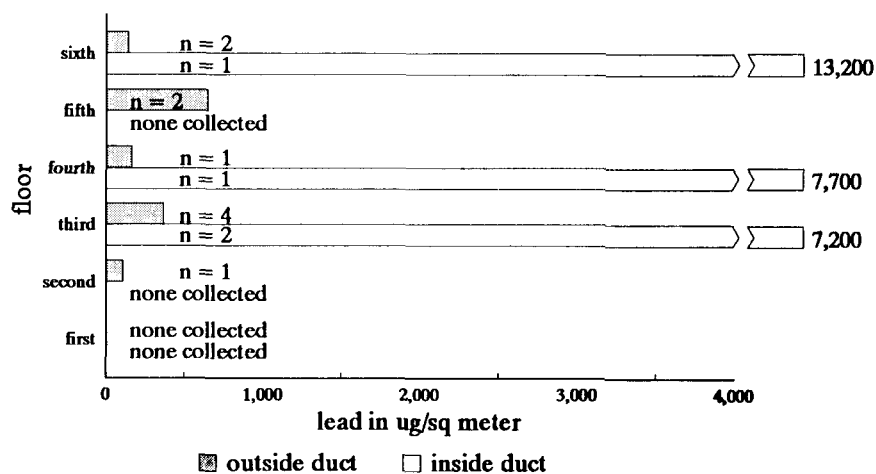
In the Annex Building, wipe samples collected at multiple locations on floors 2–6 ($n = 3$ inside ductwork, $n = 12$ outside ductwork) showed that lead in dust was present inside the ductwork and on various surfaces outside the ductwork (Figure 3). Lead inside the ductwork ranged from 7661 to $13,235 \mu\text{g}/\text{m}^2$. Lead on surfaces such as floors, file cabinets, and desk tops

FIGURE 3. Wipe samples from annex building.

ranged from nondetectable to 1173 $\mu\text{g}/\text{m}^3$.
