Bureau of Mines Information Circular/1976

# Roof-Fall Resupport Accidents, A Study

Information Circular 8723

By Juel H. Stears, John P. Conway, and Robert C. Bates  
Spokane Mining Research Center, Spokane, Wash.

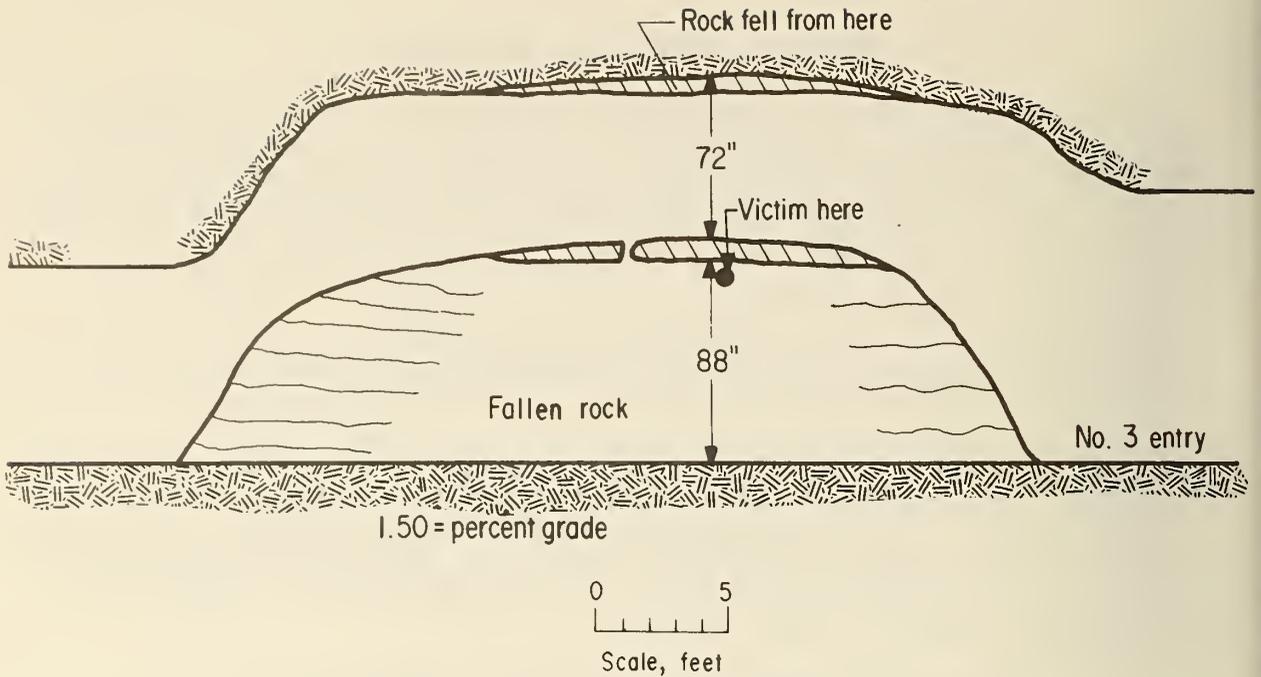
FIGURE A-1. - Accident 1.

The victim and a coworker had loaded four cars of rock when the foreman came by and instructed them to examine the main roof and take down a piece of rock that was hanging on a roof bolt on the right side of the entry. After the foreman left, they began scaling and breaking the piece of rock on the roof bolt. The victim moved up on the fall, struck upward with his slate bar to sound the roof, and was immediately caught by a rock fall. The second fall measured 14-3/4 feet long, 19-3/4 feet wide, and ranged in thickness from 7 inches to a featheredge.

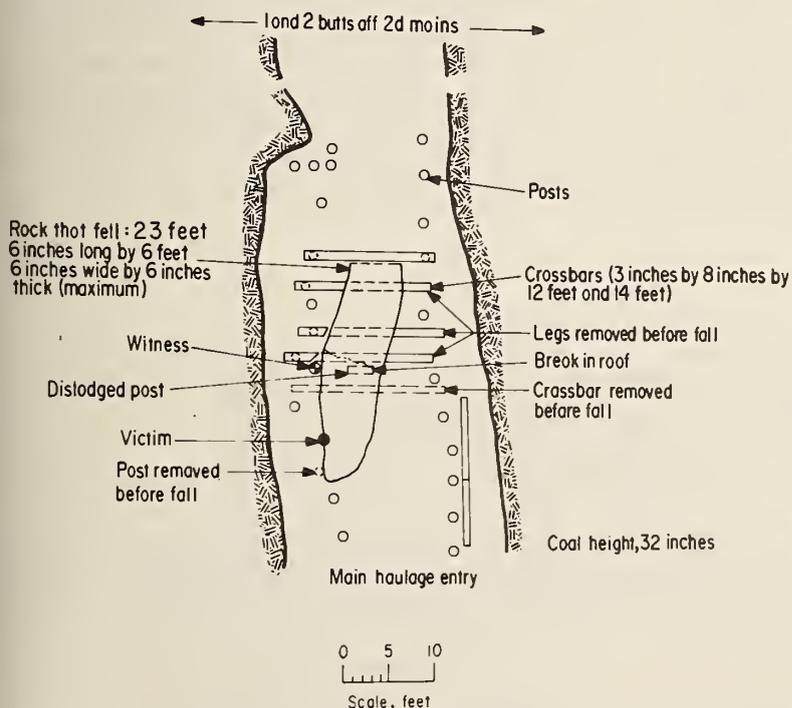
The crossbars at the accident location indicated considerable weight, and a decision was made to correct the condition by removing some of the crossbars and taking down the loose roof (fig. A-2). The outby crossbar was removed, and the legs on the right side were removed from three additional crossbars. Considerable roof was barred down. Two 1-1/2-ton mine cars were loaded out, and two large pieces of rock were pulled out with a locomotive. After loading the second car, two men removed a permanent timber on the left side of the roadway and set a safety post near the center of the rock brow, which they intended to leave in place and support with permanent timbers. A break in the roof was visible at this location. Some loose rock remained on the mine floor, and the two men were in the process of breaking and removing the rock when the roof fell without warning. The fall dislodged the three partially supported crossbars and the one safety post. The fall was 23-1/2 feet long, 6-6/10 feet wide, and up to 6 inches thick.

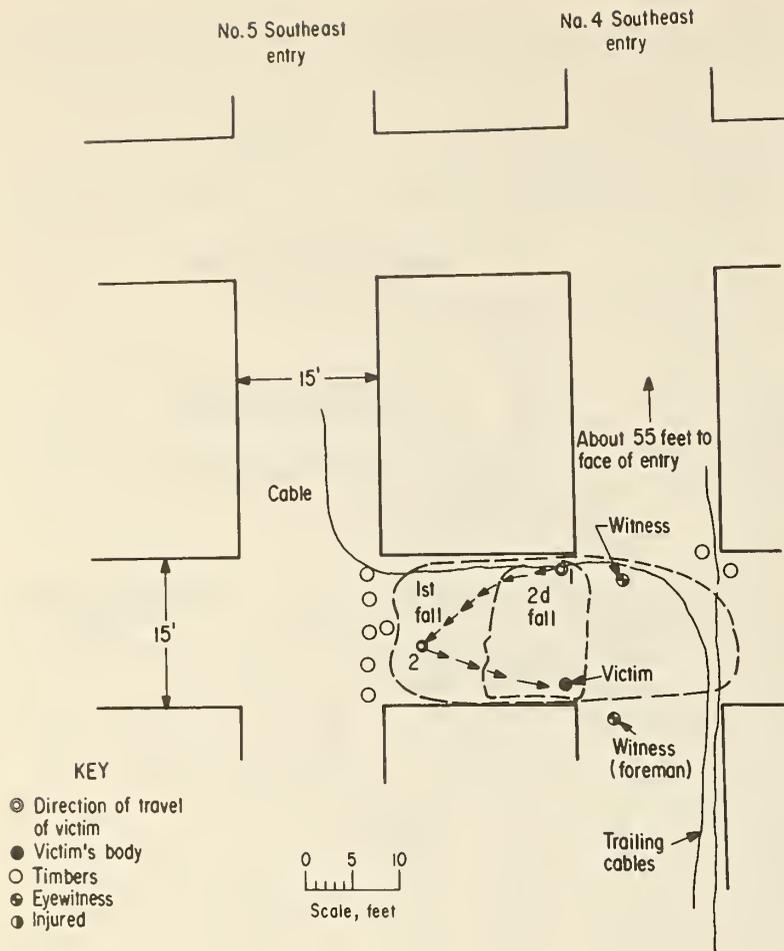
FIGURE A-4. - Accident 4.

After making several roof tests that failed to reveal any unusual conditions, the miners attempted to free, by breaking and moving rock, two trailing

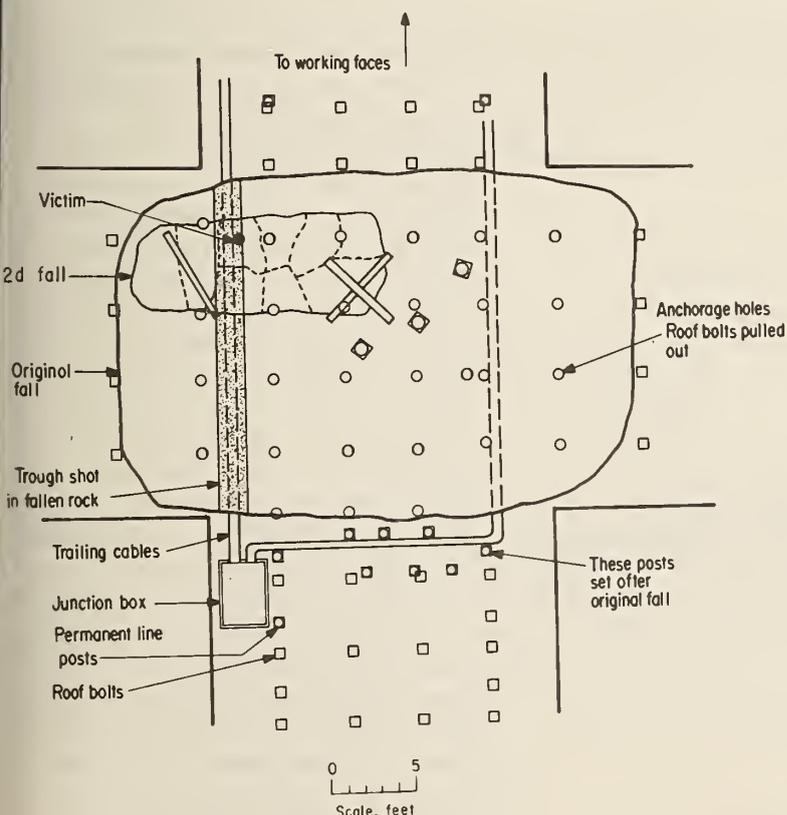
FIGURE A-5. - Accident 5.

Failure to reset promptly the temporary roof supports dislodged by blasting was the cause of the

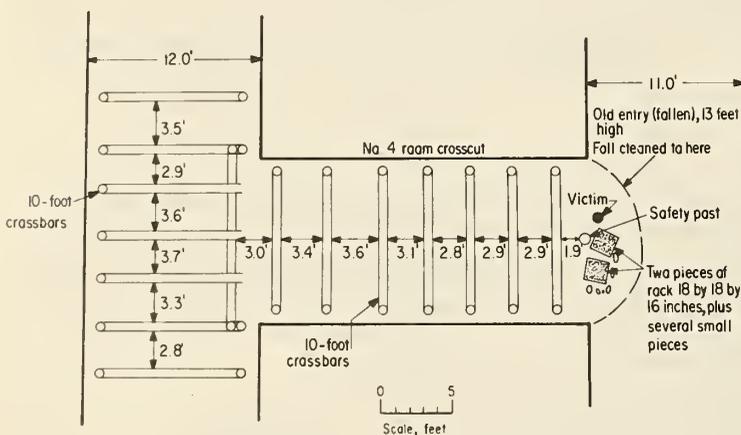
FIGURE A-6. - Accident 6.

five 2-ton cars of material. Prior to loading operations, the miners installed the inby crossbar and scaled down loose roof material in the old entry. During this time, the mine foreman visited the area on three occasions. He stated that conditions were normal; loose material was not observed, and he considered the place safe. On his last visit, the foreman suggested that another crossbar be installed and another safety post set. After eating lunch, the victim entered the accident area alone to prepare a place to set the safety post. Immediately after entering the area, he

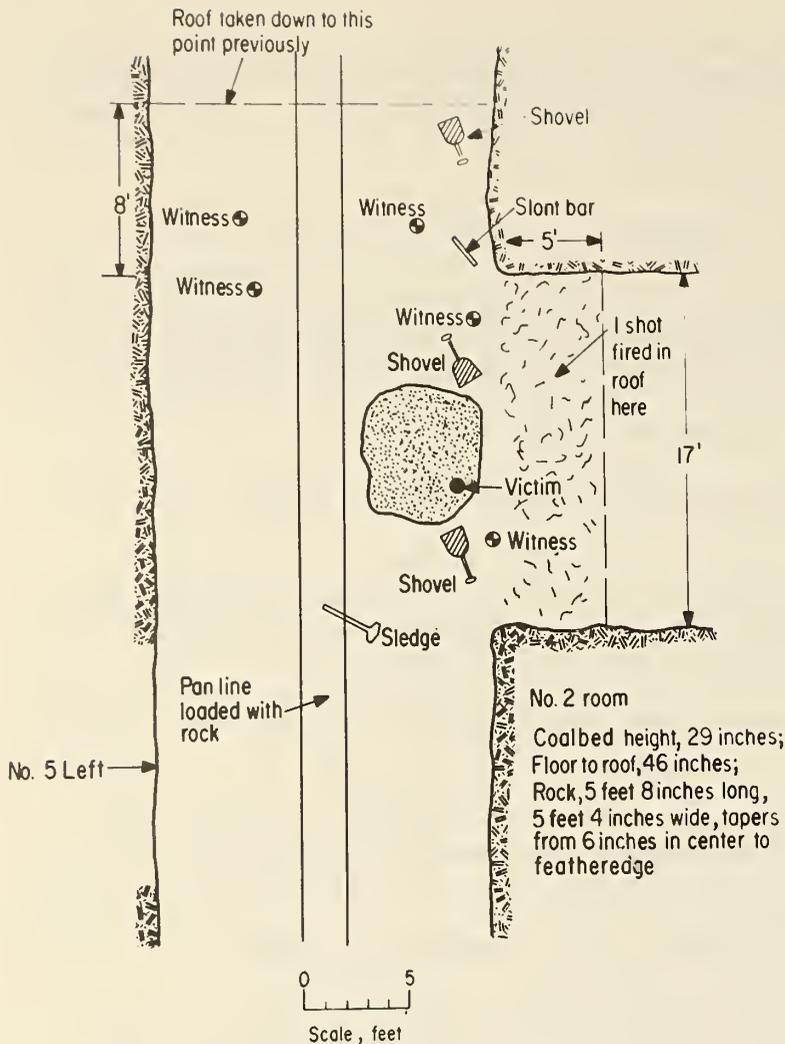
FIGURE A-7. - Accident 7.

A crew of seven men was taking roof rock at the entrance to the No. 2 room turnout off the No. 5 Left entry for additional height, so that a new shaker-conveyor drive could be installed (fig. A-7). About 18 inches of roof rock had already been taken in the No. 5 Left entry to the inby end of the No. 2 room turnout. A previously drilled blasthole was charged and fired, and, reportedly, all loose material was taken down in the blasted area. The foreman tested the roof and considered it safe. Five crewmen had begun loading rock on the pan line when a slab of rock fell on the victim. The rock measured 5 feet 8 inches long, 5 feet 4 inches wide, and 6 inches thick in the center, tapering to a featheredge.

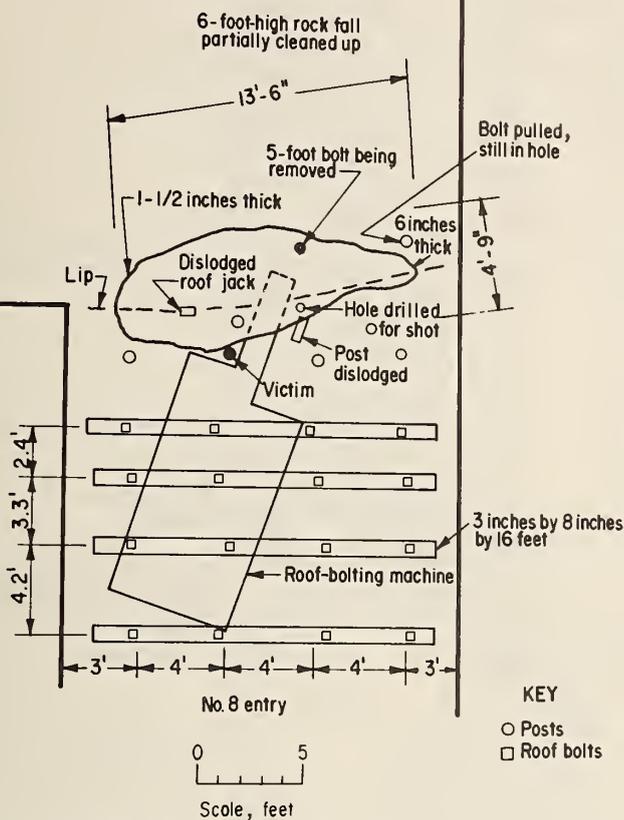
FIGURE A-8. - Accident 8.

A general laborer was injured so severely that he died 14 days later. He was 54 years old and had 29 years of mining experience. The mine was located in the

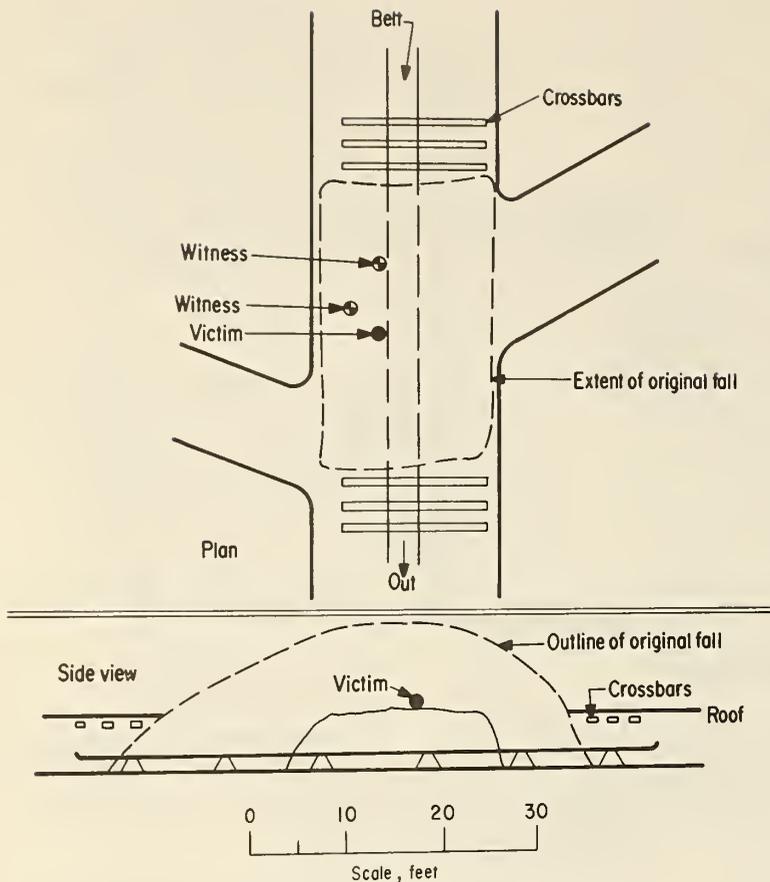
FIGURE A-9. - Accident 9.

The crew of six men and the mine foreman were cleaning up a roof fall along the belt haulageway (fig. A-9). After completing his assigned duties on the surface, the victim joined the cleanup crew to complete his shift. Because of the restricted working room, the victim and two other miners were working on top of the fall, shoveling rock into the crosscuts. A piece of rock 30 inches long, 16 inches wide, and 6 inches thick fell from the cavity and struck the victim. A second miner, working alongside the victim, suffered

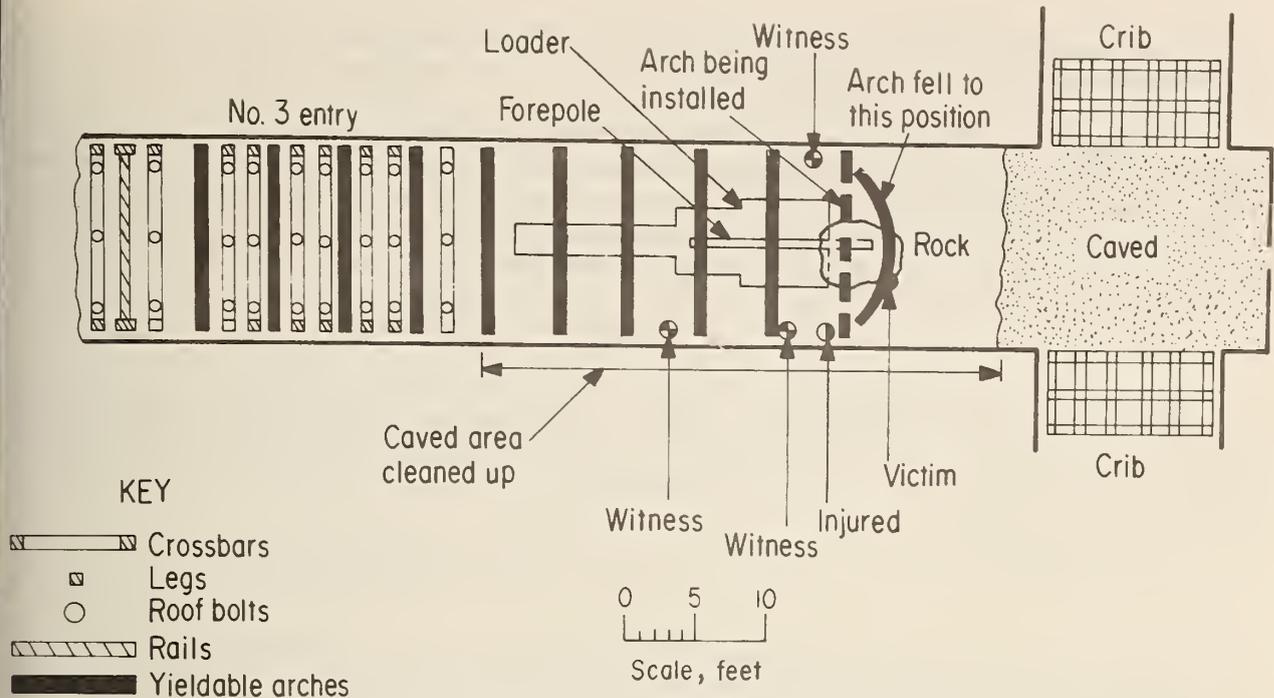
FIGURE A-11. - Accident 11.

The section foreman had visually examined the roof early in the shift. Twelve shuttle cars of rock had been loaded out (fig. A-11). The edge of the fall was 15 feet inby the last permanent arch support, and the operator controls of the loader were 5 feet inby this support at the end of the loading cycle. The crew was in the process of installing a yieldable steel arch support. The victim was standing at the right center of the arch cap and balancing the arch cap, which was being supported with a 4-inch by 5-3/4-inch by 13-foot-long timber used as a forepole. The forepole was attached to the underside of the two adjacent arch caps already installed. Three other men were installing spacers when a piece of rock fell onto the arch cap. The rock knocked the arch to the floor and came to rest on top of it with the victim being caught under the arch. The piece of rock was 5 feet long by 4-1/2 feet wide by 12 inches thick. The arch cap was 12-1/4 feet long and weighed 206 pounds.

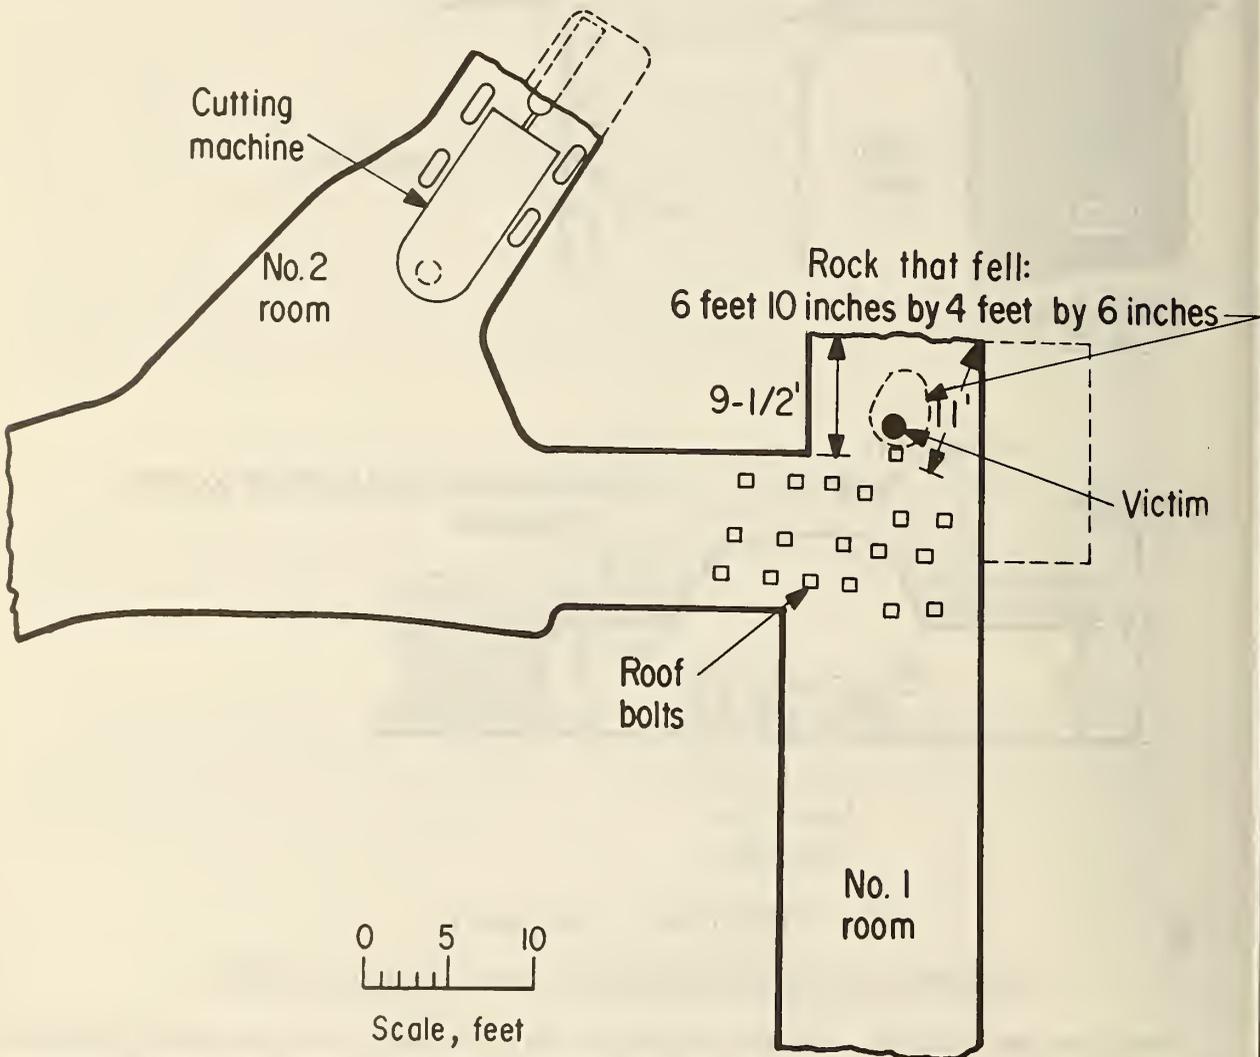
FIGURE A-14. - Accident 15.

The cutting-machine crew had just completed a crosscut right off the No. 1 room and were trammung the machine out of the place when a piece of rock measuring 5 feet long by 4 feet wide by 10 inches thick, fell near the face of the No. 1 room (fig. A-14). The victim was instructed to blast the rock before blasting the coal face so that the fallen rock could be loaded with the loading machine. The victim obtained a pick and proceeded to the No. 1 room to dig a hole in the fallen rock for blasting. Shortly thereafter, the cutting-machine operator helper returned to the No. 1 room and found the victim under a new fall of rock near the face. The victim was sent to the hospital where he died later that night. While at the hospital, the victim stated that he had tested the roof with the pick, had placed explosives on the

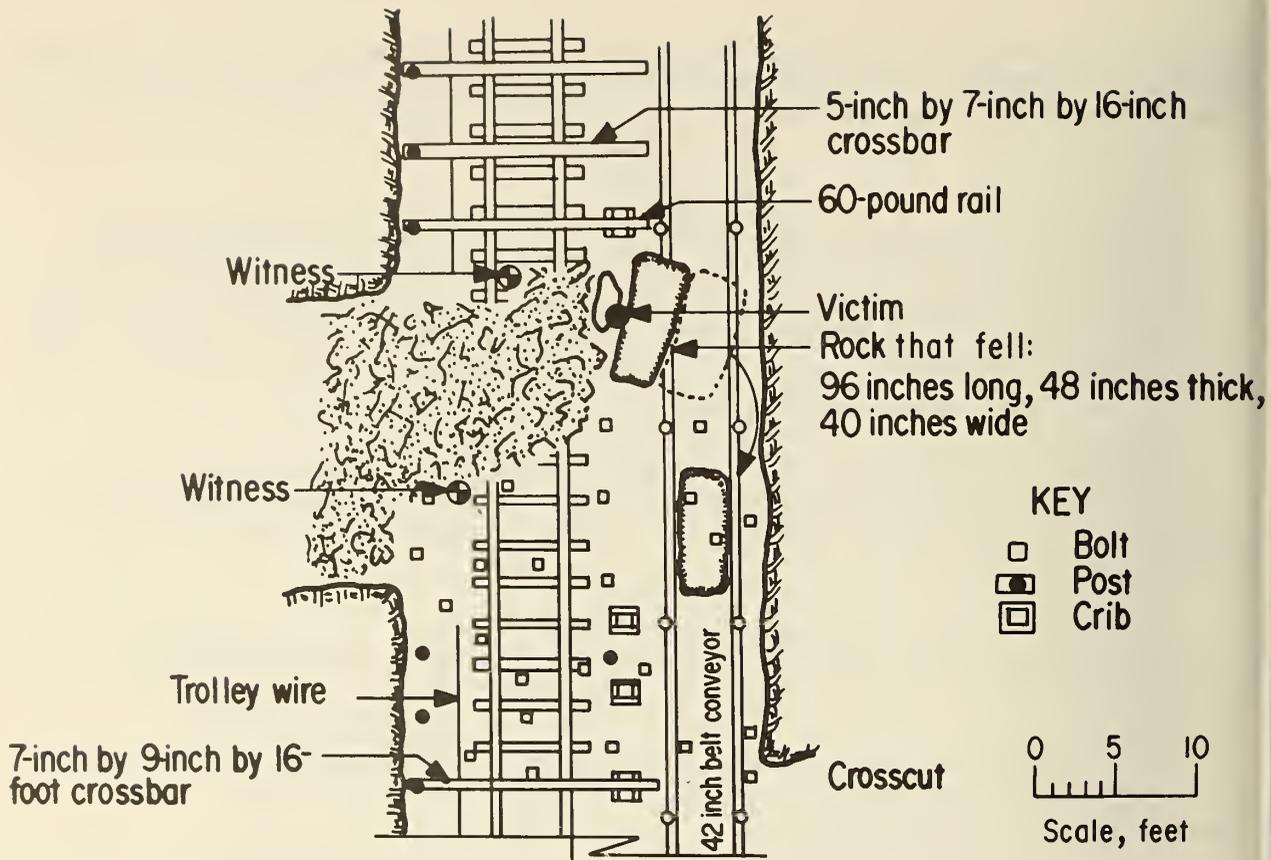
FIGURE A-15. - Accident 16.

After these two falls, the roof of the cavity was about 15 feet above the top of the coalbed. Two miners were hand loading rock from the fall onto the belt conveyor. The victim was assisting the telephone man with the telephone wire that had been broken by the fall. He had just secured a portion of the telephone wire to a roof bolt when a piece of roof rock fell on him. The piece of rock was 8 feet long, 3-1/3 feet wide, and 48 inches thick. There were two roof bolts in this piece of rock which, from all indications, had slipped from their original anchorage plane. The fact that this rock was supported by roof bolts but had broken away from the main roof for a distance of about 2 inches had been previously observed. It was stated that, owing to the vertical distance from the top of the fall to the roof and the nature of the fall, it was not feasible to bolt the roof above before starting cleanup work.

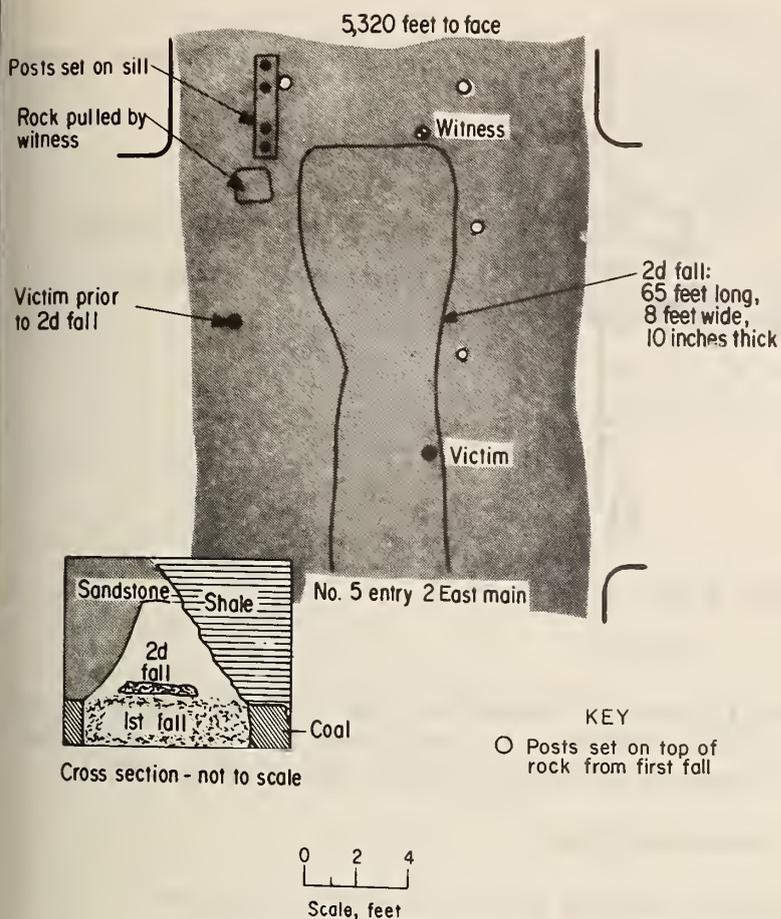
FIGURE A-17. - Accident 18.

The miners had been working several shifts at leveling the fall and trimming the roof. The victim was standing on the left side of the fall under the sandstone roof watching another miner bar down a loose piece of rock near the left rib (fig. A-17). The overhanging sandstone roof was solid. The victim yelled a warning just before the roof fell from the narrow area above the first fall. The fall injured the second miner's foot. The victim was found under the fall near the center of the entry. The rock that was being barred was below and to the left of the secondary fall and had no bearing on the fall. The second fall was 65 feet long, 8 feet wide, and 10 inches thick.

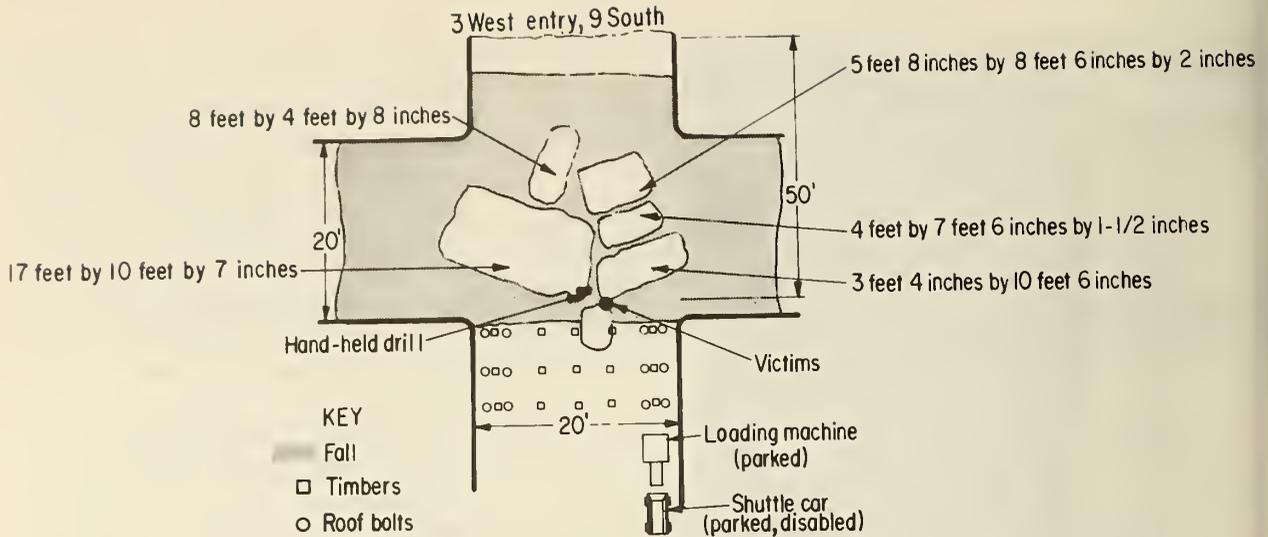
FIGURE A-18. - Accident 19.

The two victims were working by themselves, loading rock and timbering in a section that had been temporarily abandoned for 3 months and was being cleaned up in preparation for reactivating the section (fig. A-18). A fall had previously occurred in the first intersection outby the face, and the victims were drilling blastholes in it with a hand-held drill when they were caught by a second roof fall. The original fall was 60 inches thick and covered the entire intersection, extending toward the face and into each crosscut. The second fall measured 10 feet long, 20 feet wide, and ranged from 2 to 7 inches thick. Roof supports had not been installed in the intersection, and the victims were working beyond the last installed supports.

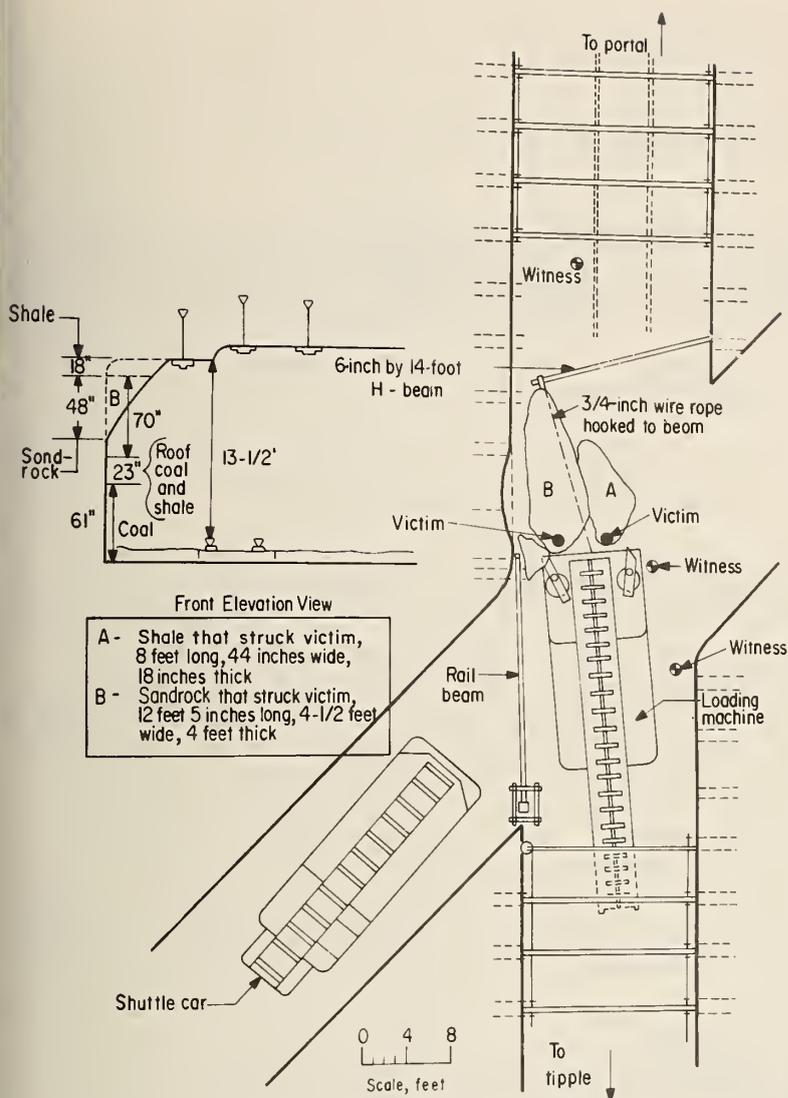
FIGURE A-19. - Accident 20.

Two men, superintendent and master mechanic, were killed by a fall of rib rock. The superintendent was 35 years old and had 13 years of mining experience, 2-1/2 years as superintendent. The mechanic was 46 years old and had 20 years of mining experience, 9 years as master mechanic. The mine was located in the Pittsburgh seam that averages 60 inches thick. Two hundred and eight underground employees produced 5,000 tons per day of coal.

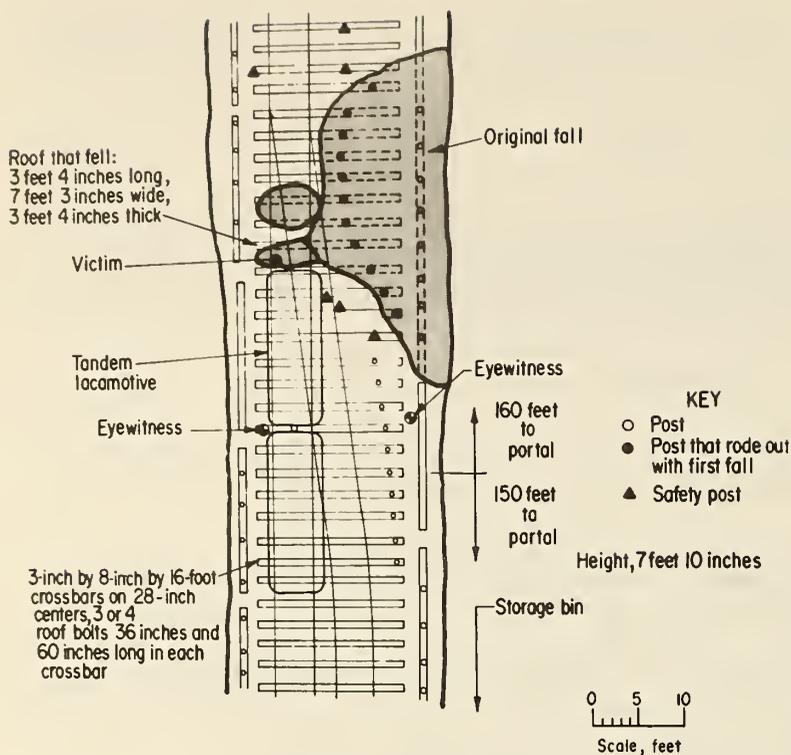
FIGURE A-21. - Accident 22.

A roof fall occurred in the track entry. The fall was 36 feet long, 15 feet wide, and ranged from 3 feet 4 inches to 8 feet thick (fig. A-21). The cleanup crew tested and examined the roof and set six safety posts around the edge of the fall. The victim was fastening a chain onto a crossbar, in preparation for pulling the crossbar from under the fall with a locomotive, when a section of roof fell on him. The second fall was a triangular section of roof adjacent to the original fall. It was 3 feet 4 inches long, 7 feet 3 inches wide, and 3 feet 4 inches thick. Two 36-inch-long roof bolts had been installed in this section of roof.

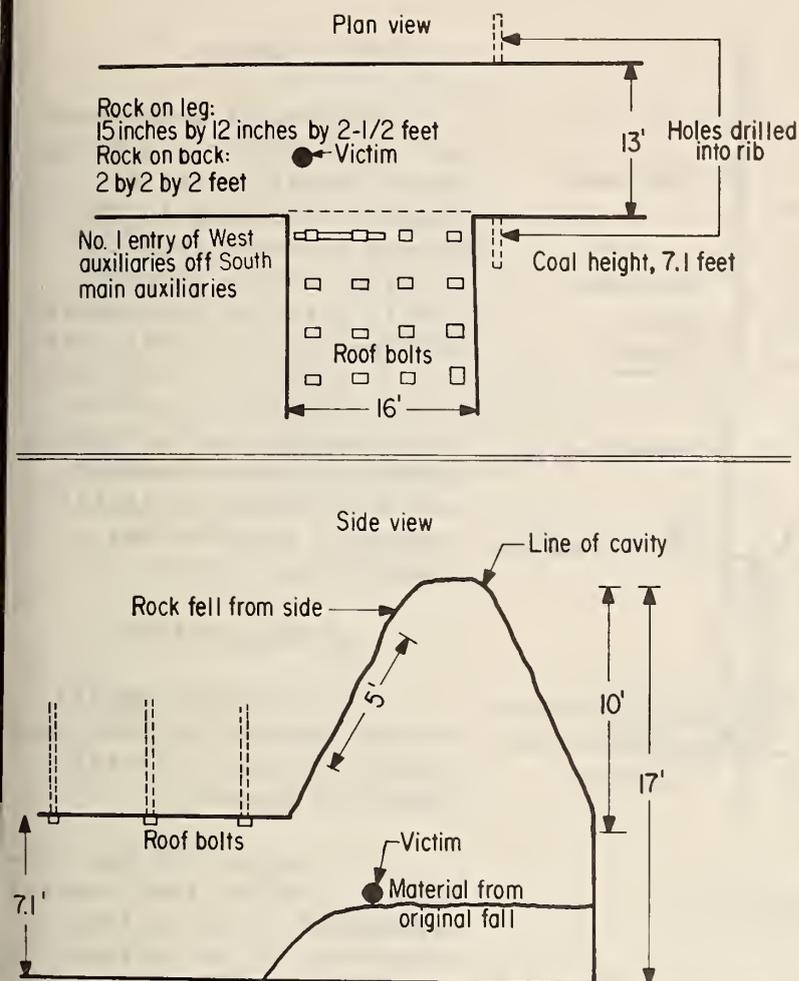
FIGURE A-23. - Accident 24.

The accident occurred because management failed to provide adequate roof controls inasmuch as employees were permitted to work for an extended period of time without benefit of roof supports.

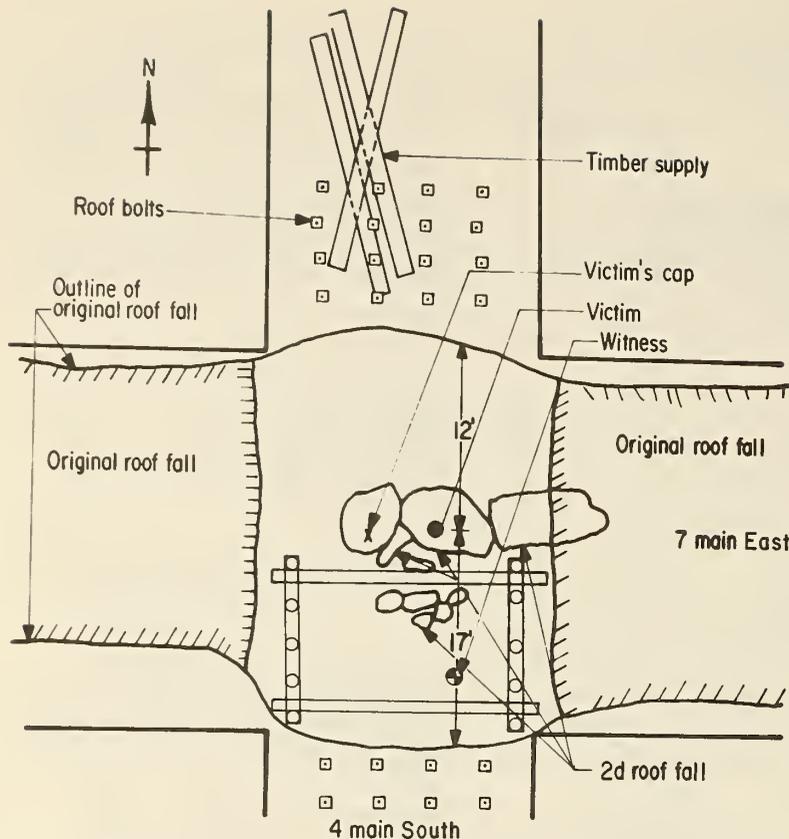
FIGURE A-24. - Accident 25.

A 10-foot-thick roof fall had previously occurred at the juncture of the Nos. 7 East and 4 Main South entries. The fall encompassed an entire intersection, which was 22 feet square, and extended both east and west in the No. 7 Main East entry (fig. A-24). The rock had been loaded out, and one set of posts and crossbars had been installed by the previous shift. Cribs had not yet been installed on top of the crossbars. Upon arriving at the fall area, the victim visually examined the area. He detected loose roof at the inby end and instructed the men to install supports at this location. The victim then turned and walked about 15 feet outby, where he was struck by a piece of falling rock. The second fall was 5-3/4 feet long, 3-1/2 feet wide, and ranged from 1 to 5 inches thick. Temporary supports had not been installed either while loading the rock or timbering the area. The roof cavity had only been examined visually. The supply of timbering materials was on the outby end of the fall and timbering had been started on the inby end, thus requiring the men to walk back and forth under unsupported roof.

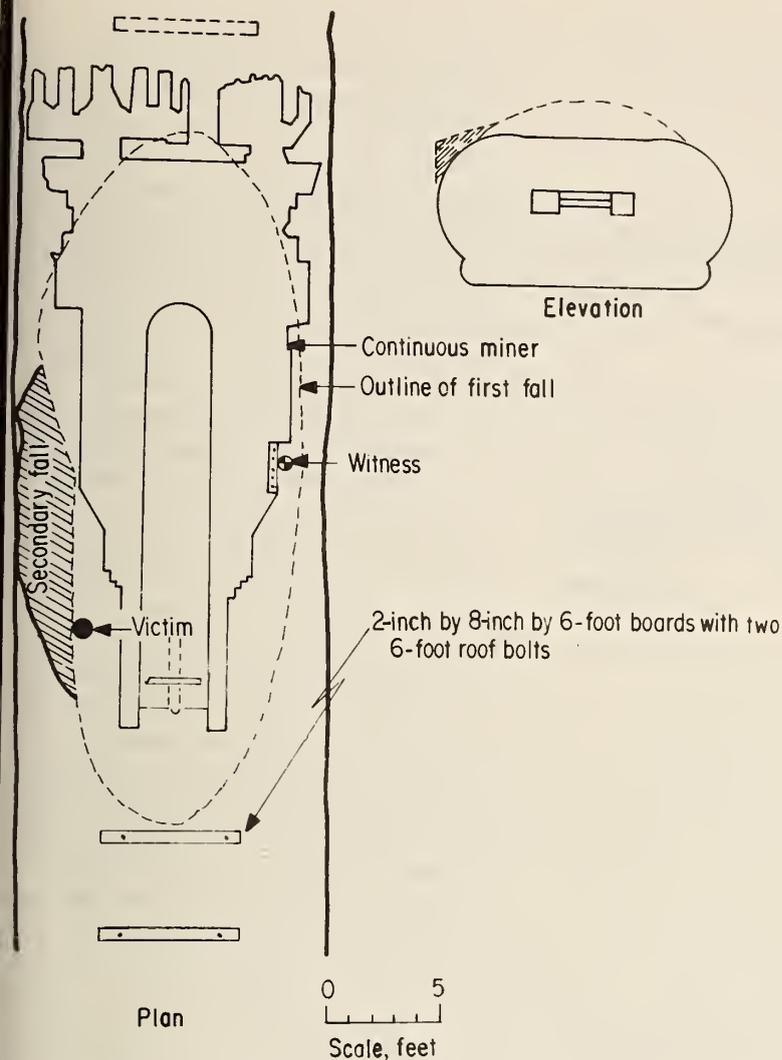
FIGURE A-28. - Accident 29.

A roof fall occurred in the unbolted face area between the day and afternoon shifts (fig. A-28). It measured 30 feet long, 10 feet wide, and 20 inches thick. The continuous miner was used to load the fallen material. The victim, who was performing the duties of continuous-miner operator helper, was standing 3 feet outby the left rear of the machine under an unsupported overhanging arched section of top coal and draw rock. The overhanging material fell on him. The second fall was triangular in cross section, 15 feet long, and ranged from zero to 24 inches thick. The victim was standing 8 feet inby the last permanent support when he was caught by the fall. No temporary supports were set.

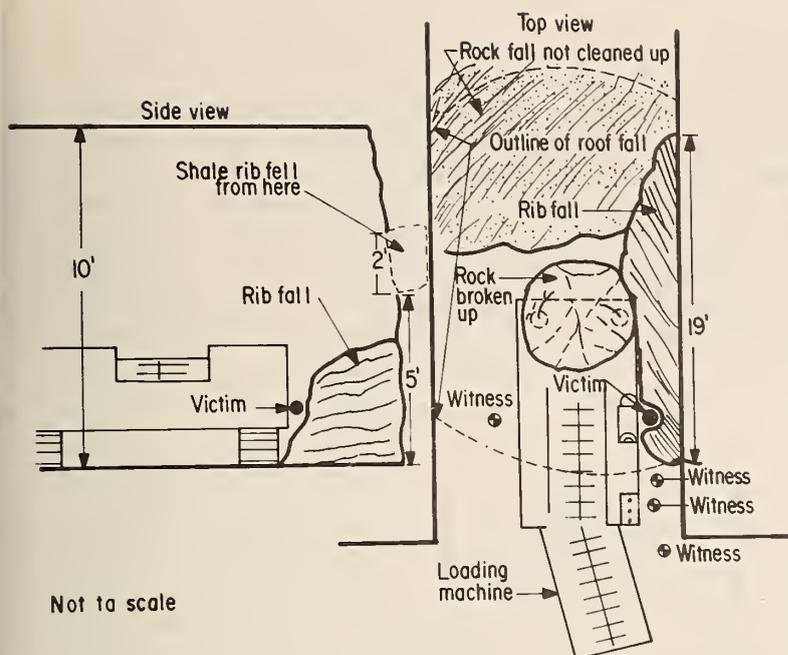
FIGURE A-31. - Accident 32.

A rock fall in the 14-foot-wide No. 4 Main West entry was being cleaned up to reroute the air (fig. A-31). This entry had been driven about 30 years earlier, and it is not known when the fall occurred. The shale roof had fallen exposing the limestone, which was self-supporting. The shale rib, exposed by the fall, had deteriorated considerably owing to years of exposure.

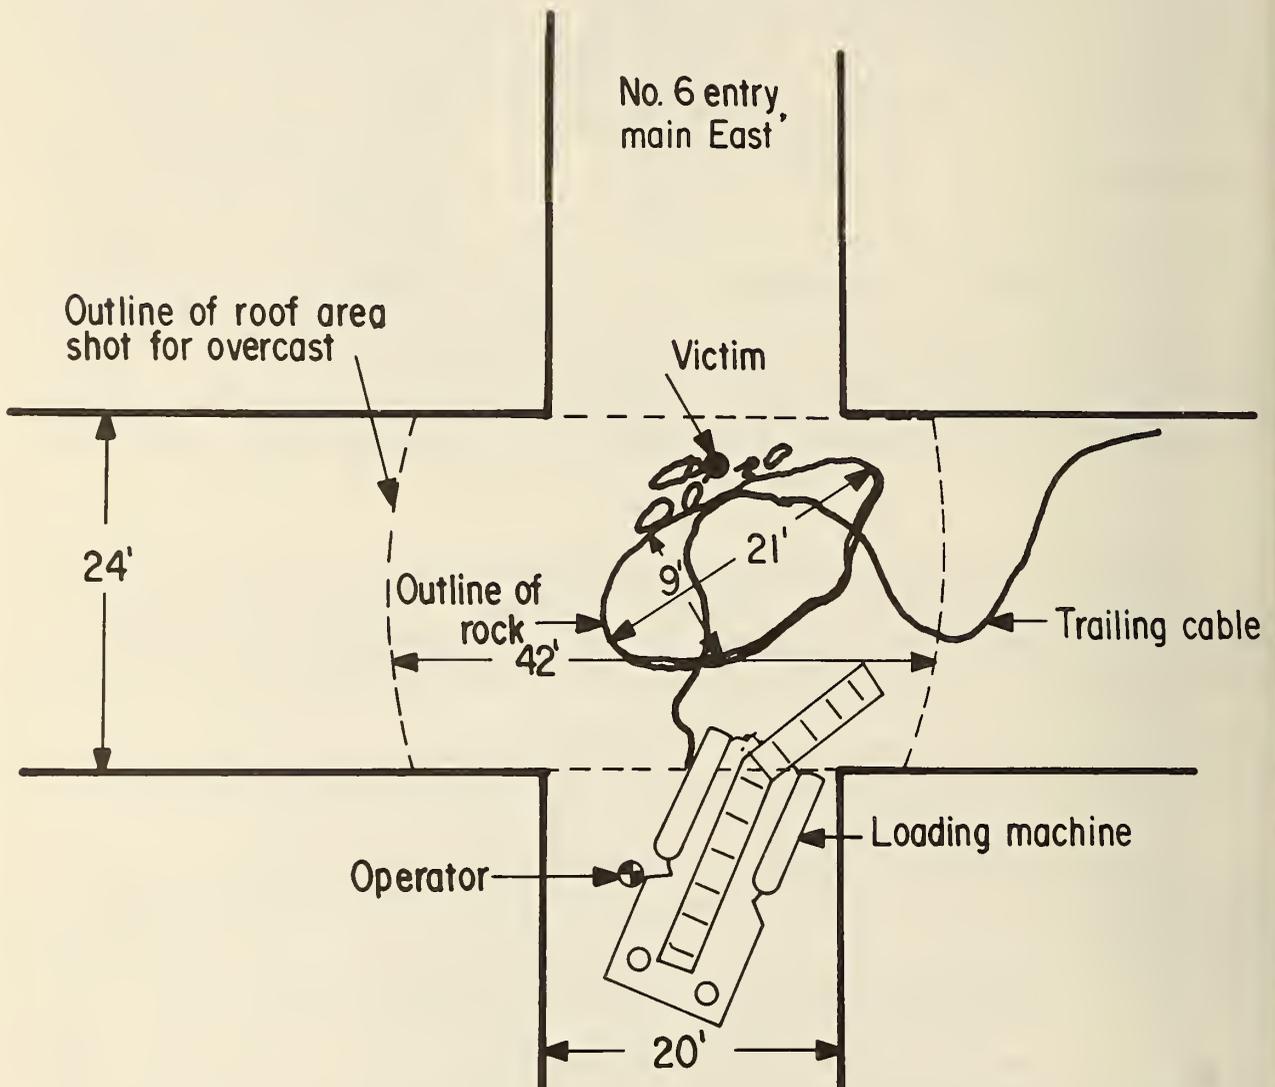
FIGURE A-32. - Accident 33:

A section of roof had been previously blasted for an overcast (fig. A-32). Loading operations were started to clean up the blasted roof rock. The roof was examined periodically by the section foreman and the victim, and loose material was scaled down. The roof was drummy but could not be pulled down. This exposed, unsupported roof was 42 feet long and 24 feet wide. After about 53 shuttle cars of rock had been loaded, the loading-machine operator turned the loader into the No. 6 entry to load some of the remaining rock on the outby side of the blasted area. The victim entered the area, under the loose unsupported roof, to move the loading-machine trailing cable and was hit by a falling rock slab. The victim was struck by the inby edge of the rock that measured 21 feet long, 9 feet wide, and ranged from 4 inches thick to a featheredge.

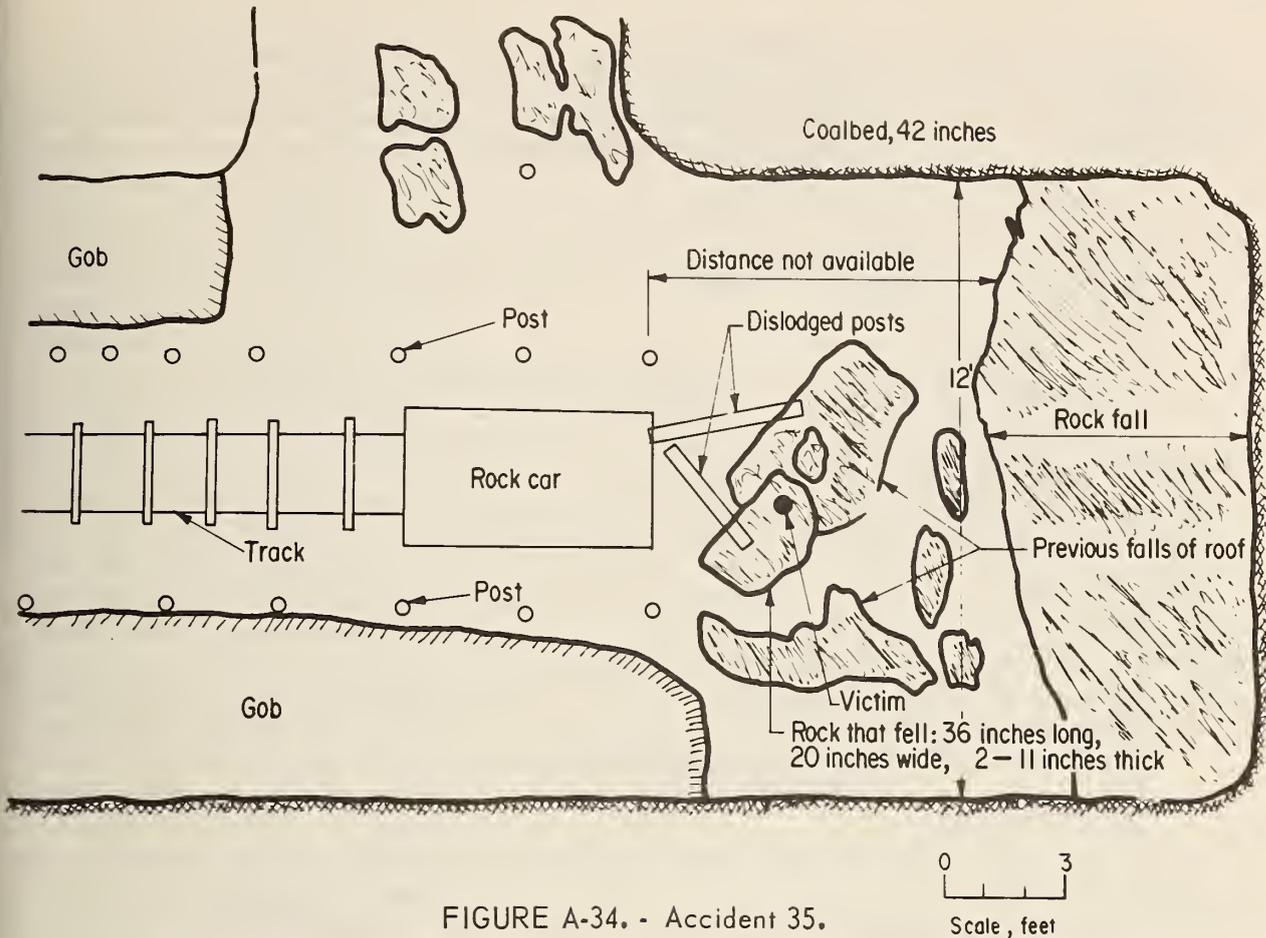
FIGURE A-34. - Accident 35.

The cause of the accident was advancing beyond the protection of artificial roof supports, and the failure to reinstall dislodged safety posts. A

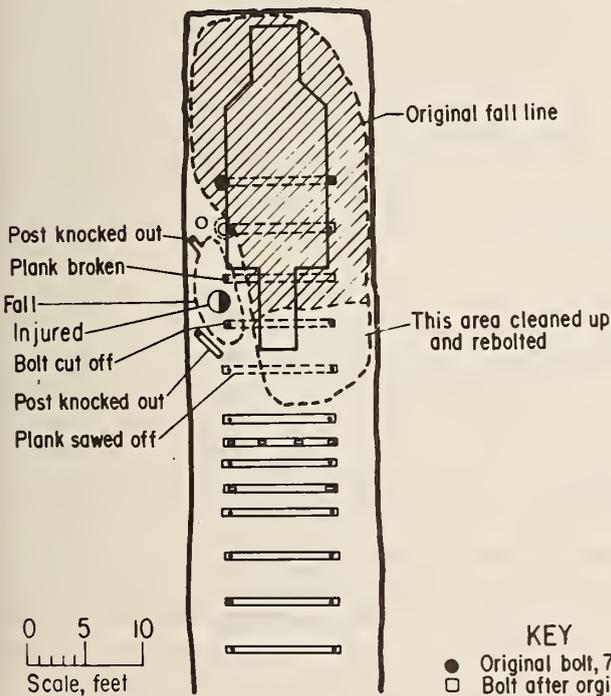
fall that had occurred in the No. 1 entry on the preceding day (fig. A-36). Work progressed without incident for about 3 hours. Six posts had been installed along the left side of the continuous miner, and 14 roof bolts had been installed in the fall area. To facilitate rock loading, three posts along the left rib were dislodged by the loading machine. When the loading machine reached the end of the conveyor boom of the continuous miner, loading of rock ceased. The victim and the loading-machine operator placed a lifting jack under the boom of the continuous miner. The assistant mine foreman was on top of the fall breaking rock with a hammer, and the shuttle car

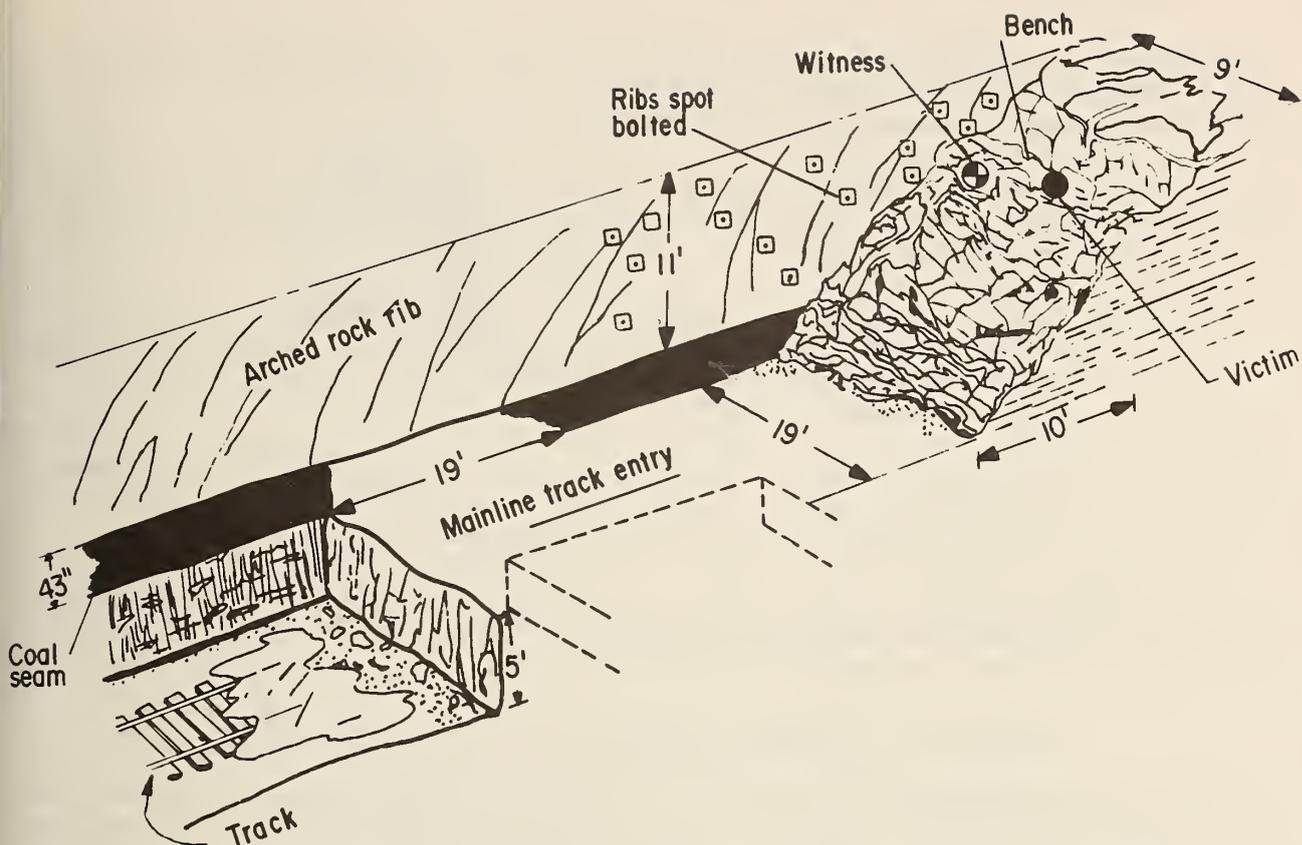
FIGURE A-37. - Accident 38.

The construction crew included a crew loader, the victim, and a second roof bolter. Their duties, as the evening shift crew, were to perform blasting and roof support operations to prepare the fall material for loading on the day shift. Normal operations were started upon arrival in the fall area (fig. A-37). Two blastholes were drilled in the fallen rock material, charged, and fired. After a short wait for smoke clearance, the crew leader returned and examined the work area. He discovered a layer of sandstone rock (the piece that later fell on the victim), and made several unsuccessful attempts to bar it down. He then informed the two bolters that the section of rock would have to be supported and bolted, gave them instructions regarding the work to be performed atop the fall, and left the area to perform other duties. The victim and the second bolter moved the stoper to the bench area and began removing the broken rock to install metal jacks as temporary roof supports. The victim also attempted to bar down the rock slab but was unsuccessful. Thereafter, as the two miners were manually removing the broken rock, the roof fell, without warning, striking the victim.
