Bureau of Mines Information Circular/1976

# Roof-Fall Resupport Accidents, A Study

Information Circular 8723

By Juel H. Stears, John P. Conway, and Robert C. Bates  
Spokane Mining Research Center, Spokane, Wash.

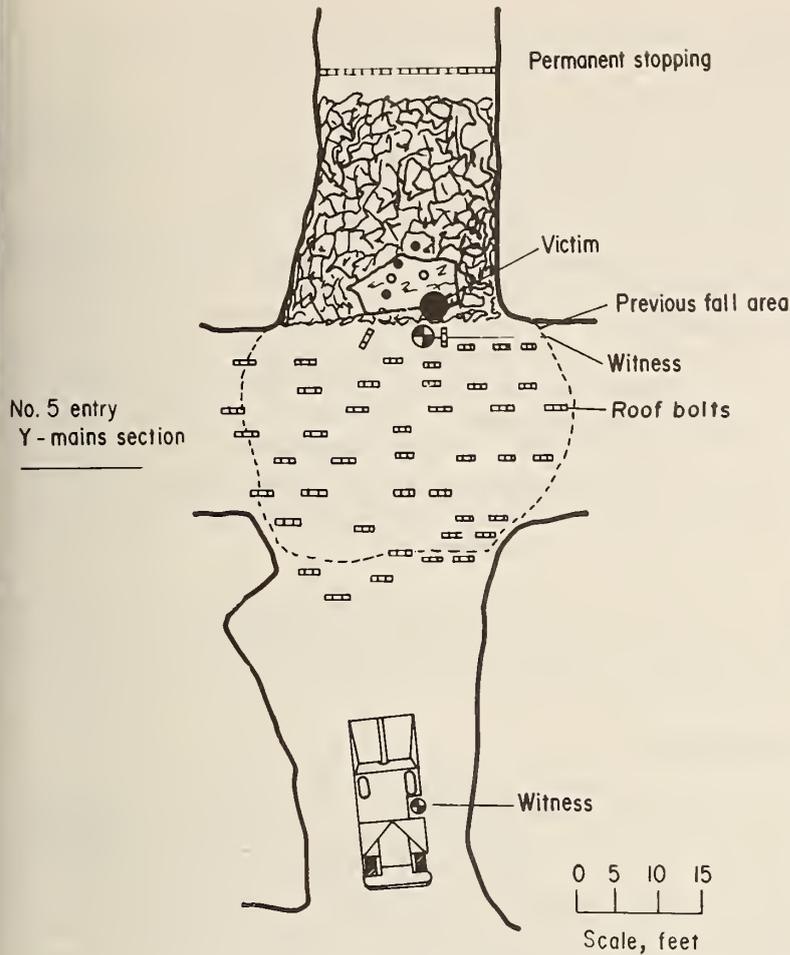
FIGURE A-38: - Accident 39.

Examination of the accident area indicated that the victim was inby permanent roof supports when the accident occurred, and that temporary supports had not been installed. An area about 25 feet long and 15 feet wide had been

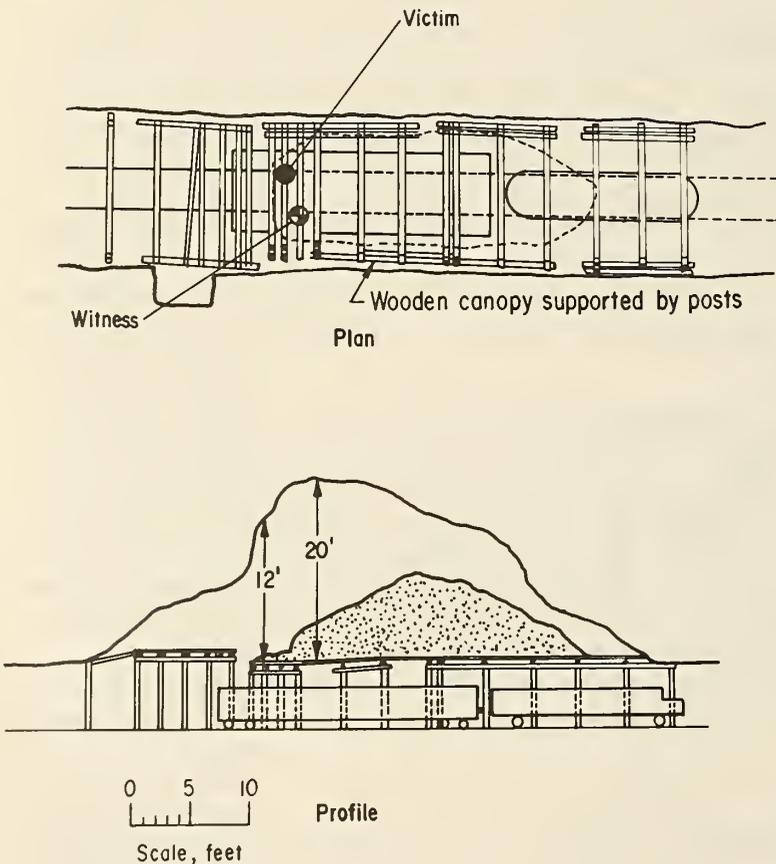
FIGURE A-40. - Accident 41.

A wooden canopy had been erected along the main haulageway for protection of personnel (fig. A-40). The canopy was located in the area of an old roof fall that had been removed before installation of the canopy. Settlement of the support posts, due to the weight of spalling roof material that had accumulated on the canopy, made it necessary to raise the canopy and reset the support posts. The victim and another miner were on top of the canopy removing rock. The foreman had examined the roof area over the canopy and had scaled loose material that he was able to reach with a short bar. Owing to the height of the cavity, most of the area was only examined visually. The victim was pushing loose material through an opening in the top of the canopy into a mine car below when a rock dislodged from the brow and struck him on the head. The rock was approximately 36 inches long, 24 inches wide, and 12 inches thick.

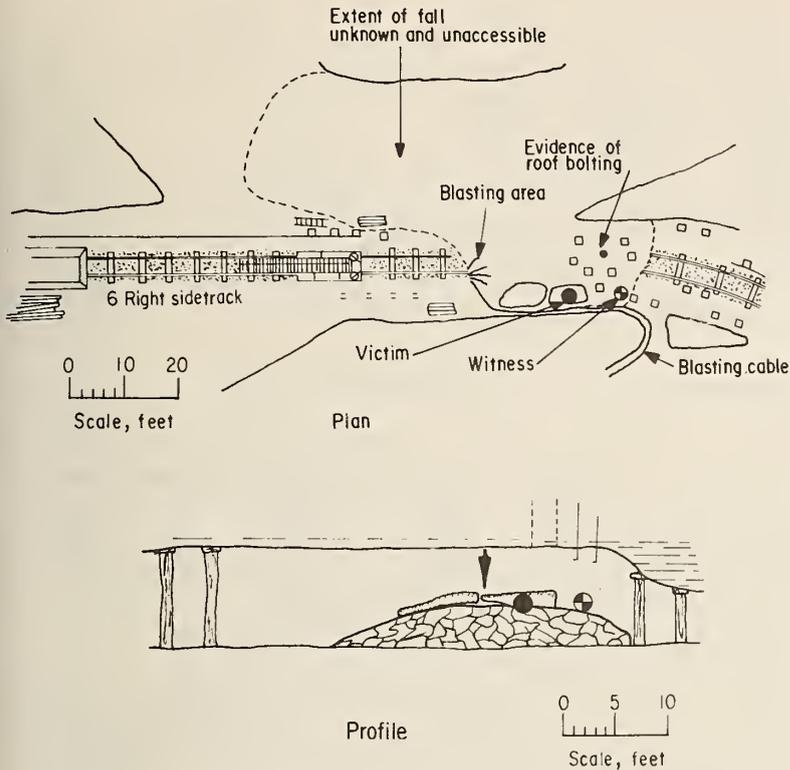
FIGURE A-42. - Accident 43.

The victim and a three-man crew were cleaning up a roof fall on the haulage sidetrack (fig. A-42). The fall had occurred the previous day, shutting down the sidetrack. A loading machine was used to fill a mine car with the fallen roof material. Two of the miners were assigned to transport this material to the surface. The victim and the third miner prepared four shots, all

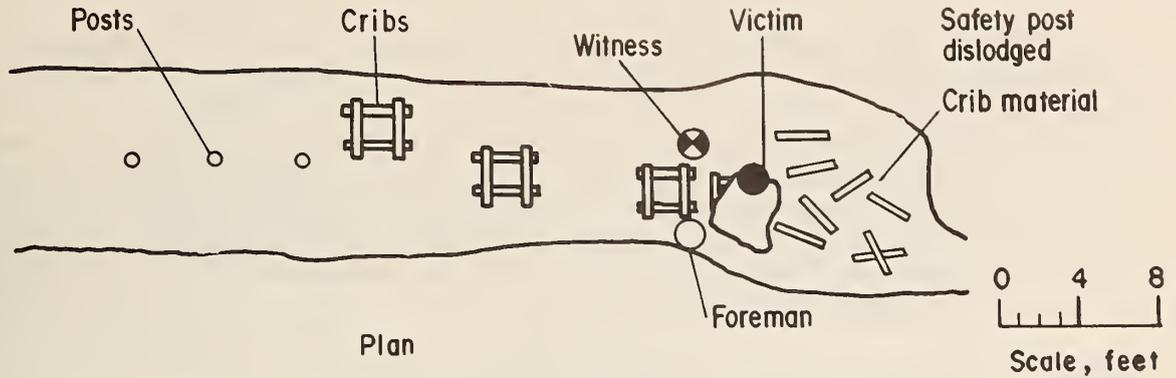
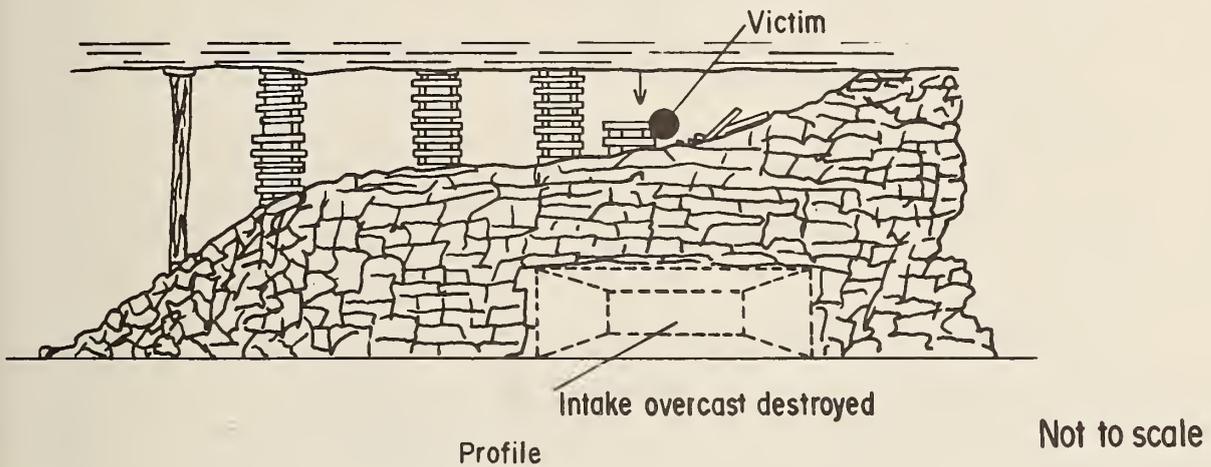
FIGURE A-43. - Accident 44.

1. Management did not incorporate a method of leveling the roof fall that would insure that employees were not exposed to adverse roof conditions.

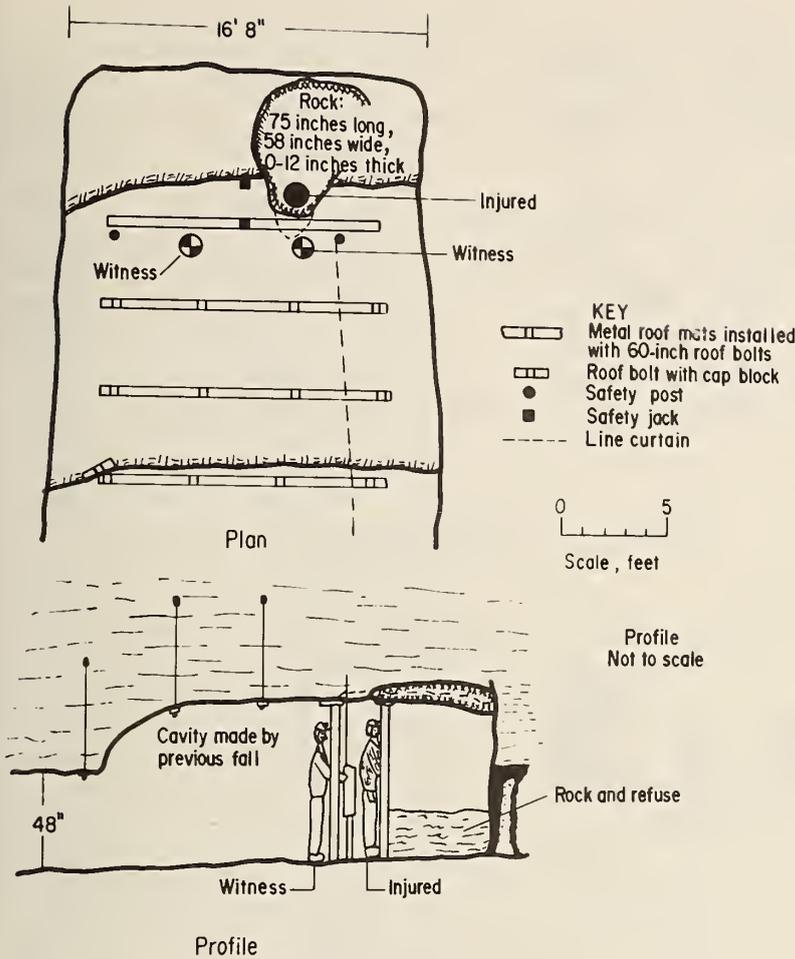
FIGURE A-44. - Accident 45.

The right side of a roof fall in the face of the No. 4 entry was removed with a continuous-mining machine (fig. A-44). The rock on the left side was not loaded because it was sandstone and emitted sparks when struck by the machine bits. Three safety posts that had been dislodged by the miner were reset as the crews left, for a total of five safety posts installed in the place. The two men of the roof-bolting crew observed the roof cavity left by the fallen rock and assumed that the roof was bad. They only examined the roof visually. The victim entered the place as the bolters were starting to set safety posts, commented on the bad roof condition, instructed them to be careful, helped them install six more safety posts, and then left the area. Sometime later, the victim returned to the place as one of the bolters was attempting to free a stuck drill steel. The victim walked around in front of the bolter and asked if the drill steel had been freed. As the bolter answered in the affirmative, the victim turned to walk away when the roof fell on him without any warning. The bolter was knocked down by the fall, which dislodged two safety posts, but was not injured. The victim's injuries included a broken left leg, several broken ribs, and a fractured vertebra. One of the bolters stated that they had not detected the bad roof.

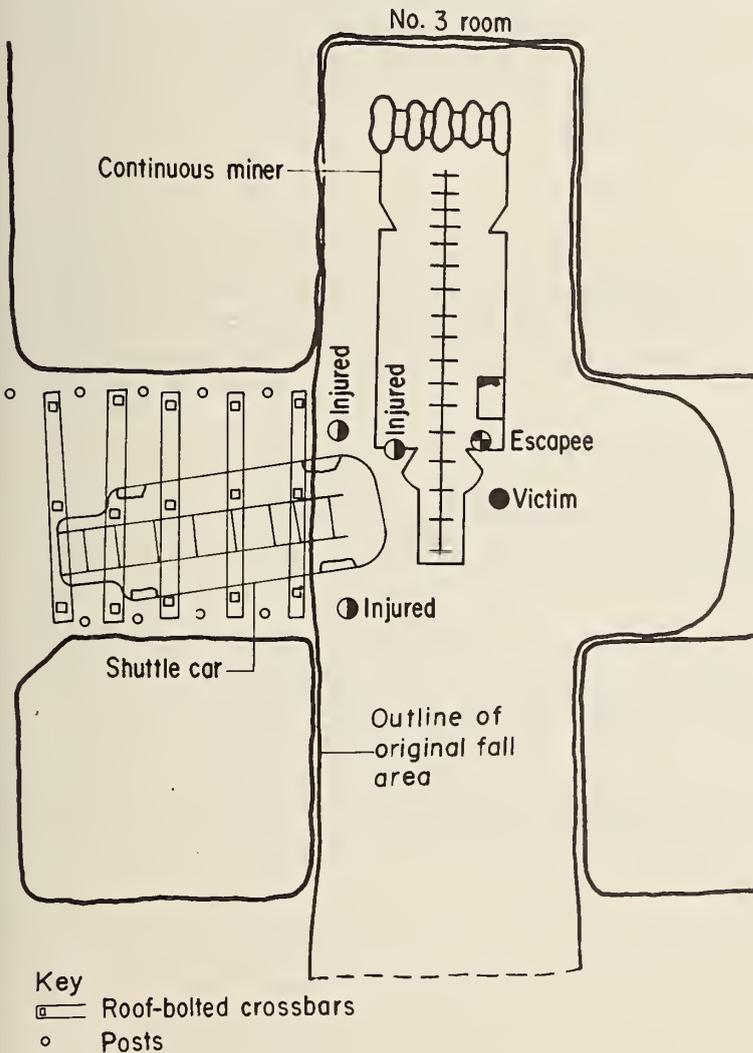
A continuous-mining machine, parked in a face area of an advancing entry, had been covered by a massive roof fall during a change of shift (fig. A-46). Reportedly, the initial fall was 80 feet long, 18 feet wide, and 5 feet high. Management decided to recover the machine through the crosscut; the work had been progressing for two shifts. The recovery work was done by the production crews, by loading rock by hand into a shuttle car. Upon arrival
