INFORMATION CIRCULAR/1994

Longwall Gate Road Stability in Four Deep Western U.S. Coal Mines

**By Lance R. Barron, Matthew J. DeMarco,
and Richard O. Kneisley**

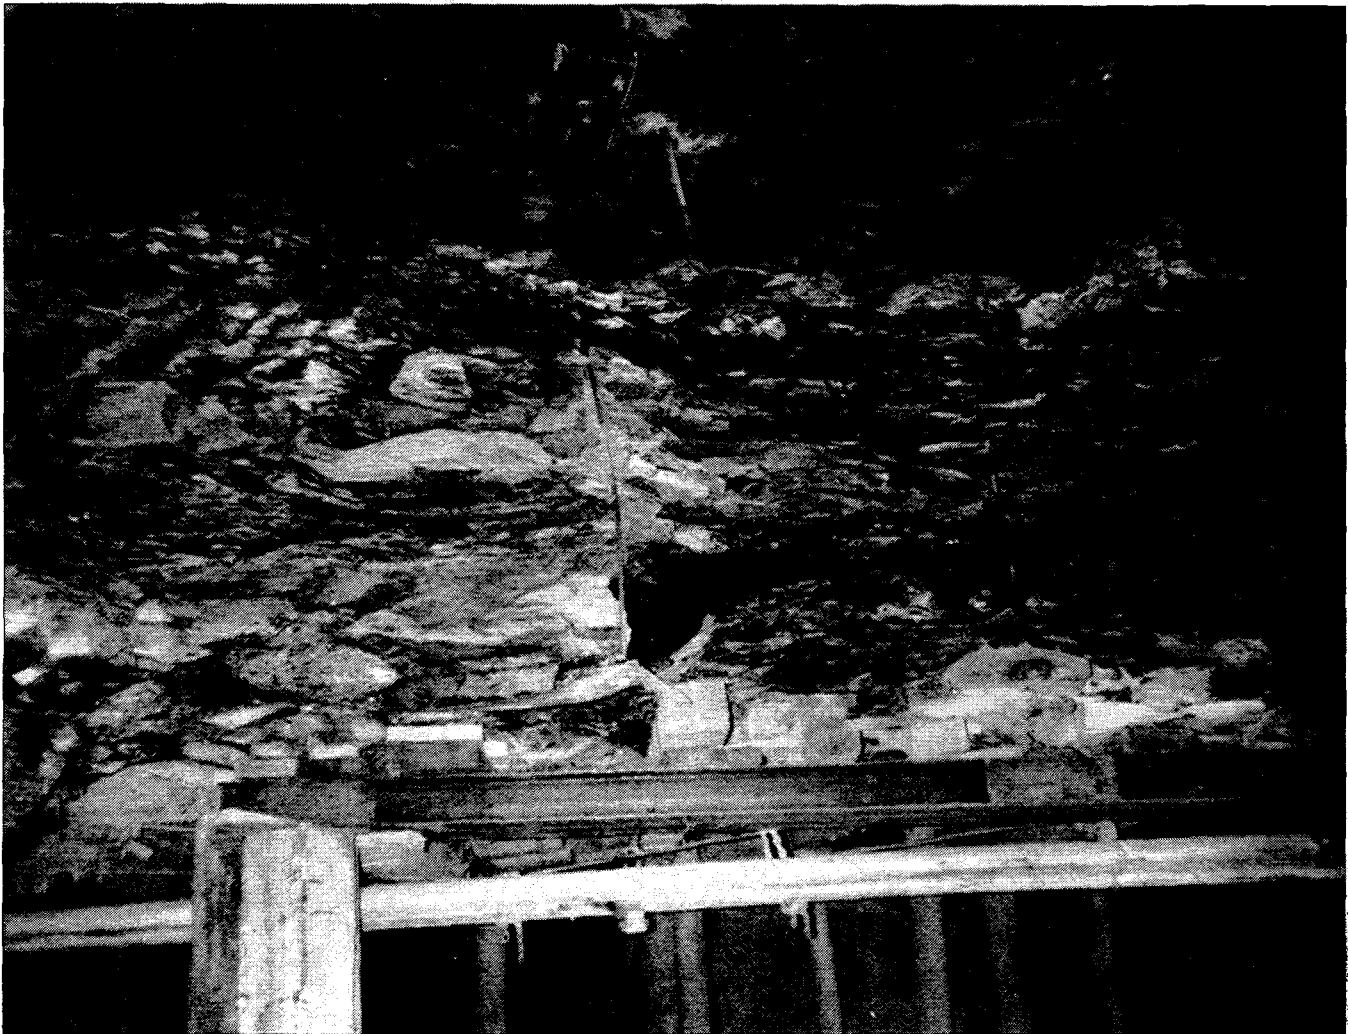
Figure 26

Channel margin roof in Star Point No. 2 Mine. About 2.5 m (8 ft) of interbedded siltstone-mudstone immediate roof has fallen, exposing bottom surface of overlying channel sandstone (dark area surrounding rectangular roof bolt plate).

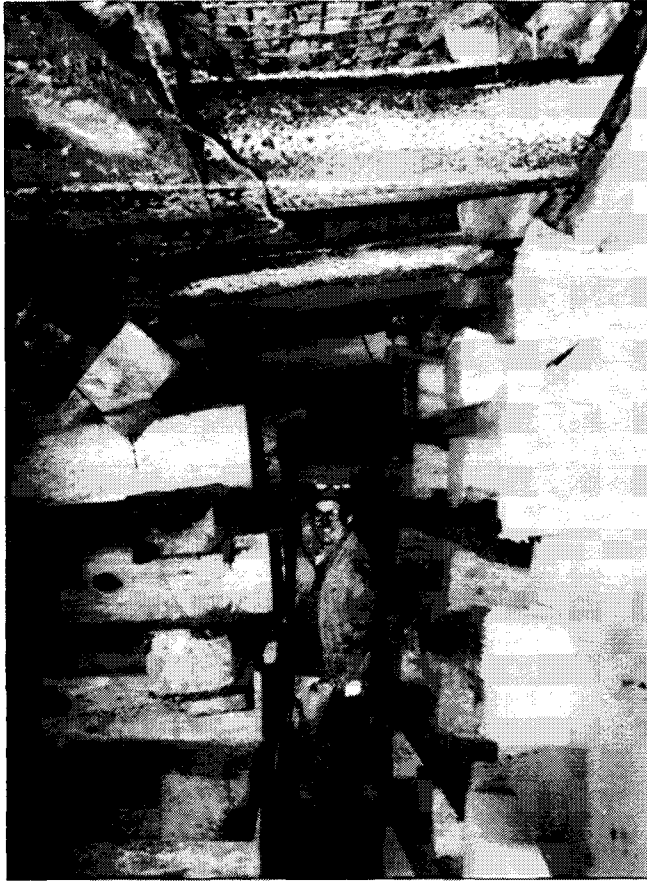
Figure 28

support. Pillars were loaded to their strength, contributing to roof, rib, and floor stability problems. During the retreat of the second (7th Left) and third (6th Left) panels [panel 2 and panel 3 in figure 27], ground conditions deteriorated as load transfer to panel boundaries increased. This increased pillar stresses and resulted in excessive roof, floor, and rib movements. CPMC increased the density of secondary support, adding extra cribs, combination bolts, truss bolts, etc. This helped ground conditions in the second panel, but ground squeeze continued in 6th Left, impacting crib support effectiveness. It became very difficult to maintain an open walkway through the tailgate entry [figure 28].

Sixth Left tailgate escapeway during panel 4 mining. USBM engineer wedged between cribs indicates narrow width of escape walkway.

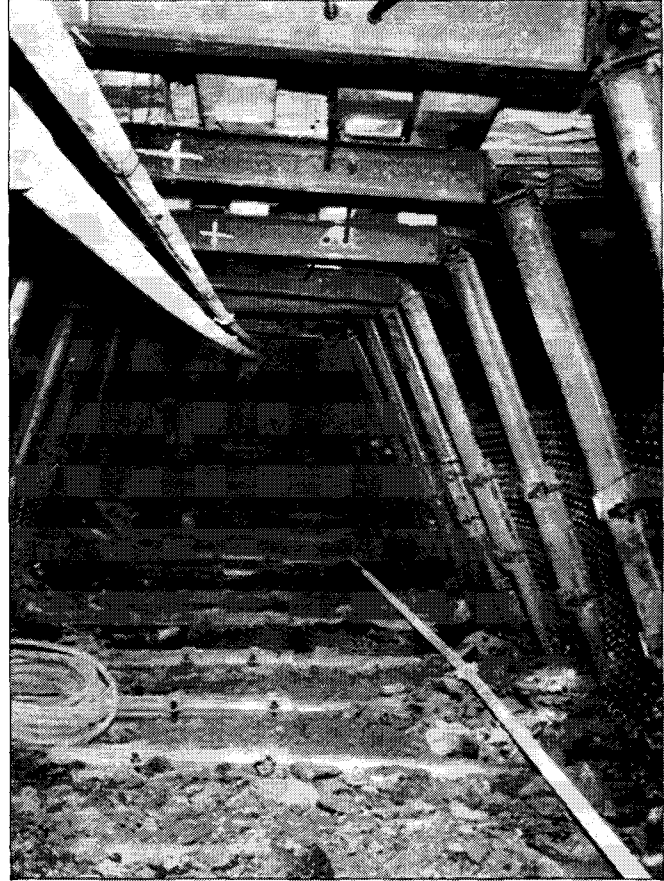
Figure 29

Yieldable steel sets in 5th Left gate road. In subsequent gate roads, this expensive secondary support system was abandoned in favor of conventional wooden cribbing.

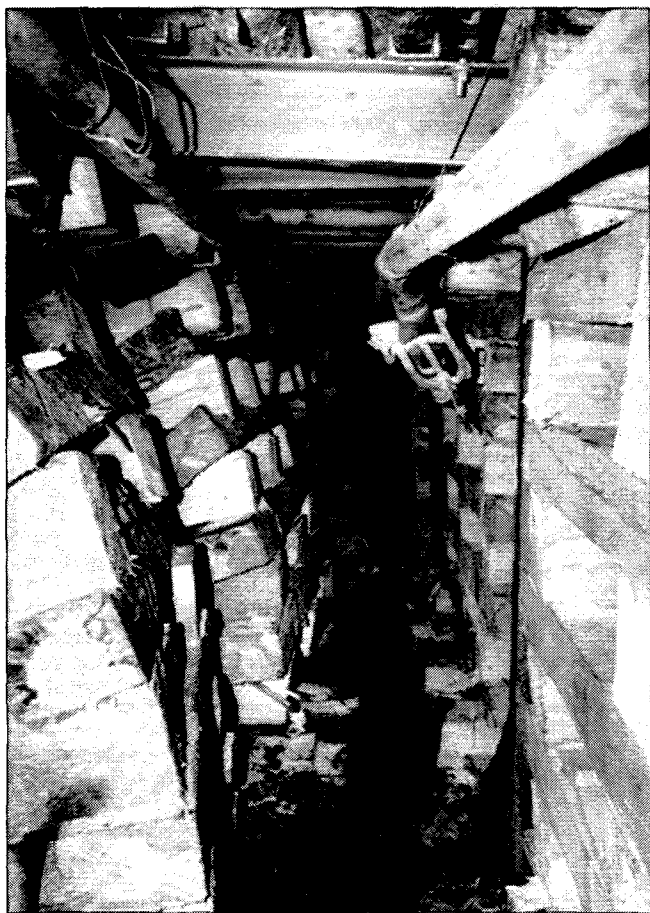
Figure 38

Sixth Left tailgate entry during panel 4 mining. In addition to extensive cribbing, which has crushed and rolled out at chain pillar side of the entry, steel I-beams and wood lagging have been used to support deteriorating roof.

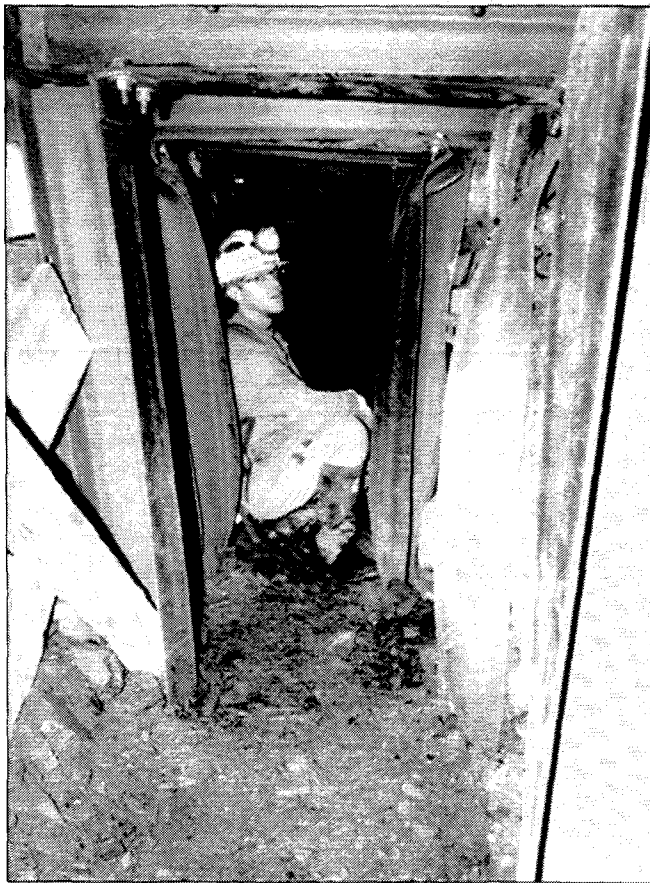
Figure 39

"Door-frame" steel sets in 6th Left tailgate entry. Despite structural rigidity of I-beams used to construct sets, excessive loads imposed by panel 4 extraction have buckled and twisted uprights. Height of tailgate walkway, about 1.5 m (5 ft), is indicated by USBM engineer; original mining height at development was approximately 2.1 m (7 ft).

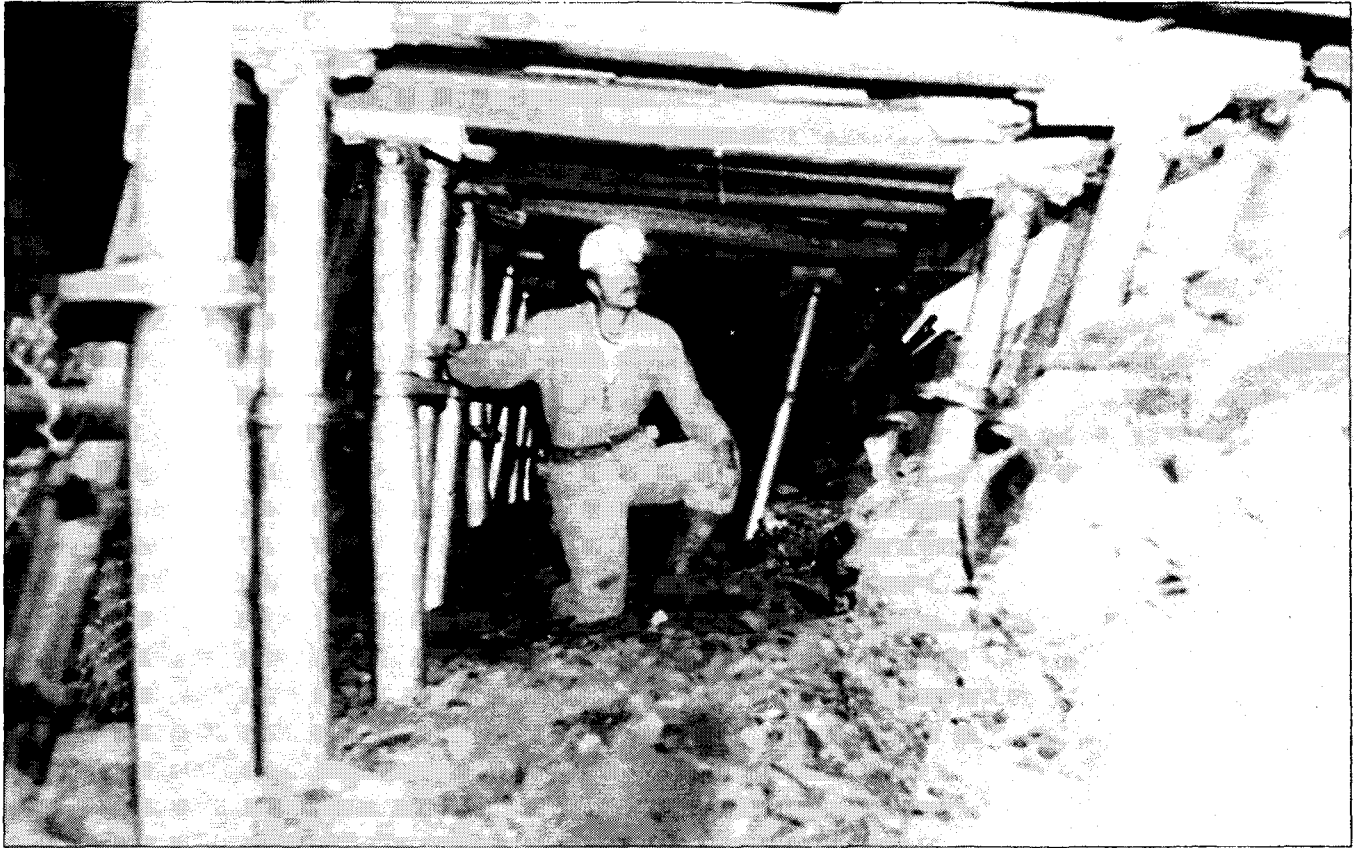
Figure 40

Fifth Left tailgate entry during panel 5 mining. Hydraulic supports have been used to reinforce yieldable steel sets against front abutment loading from nearby approaching face; wire mesh was utilized to prevent infilling of escape walkway by loose material from rib sloughage and minor roof falls.

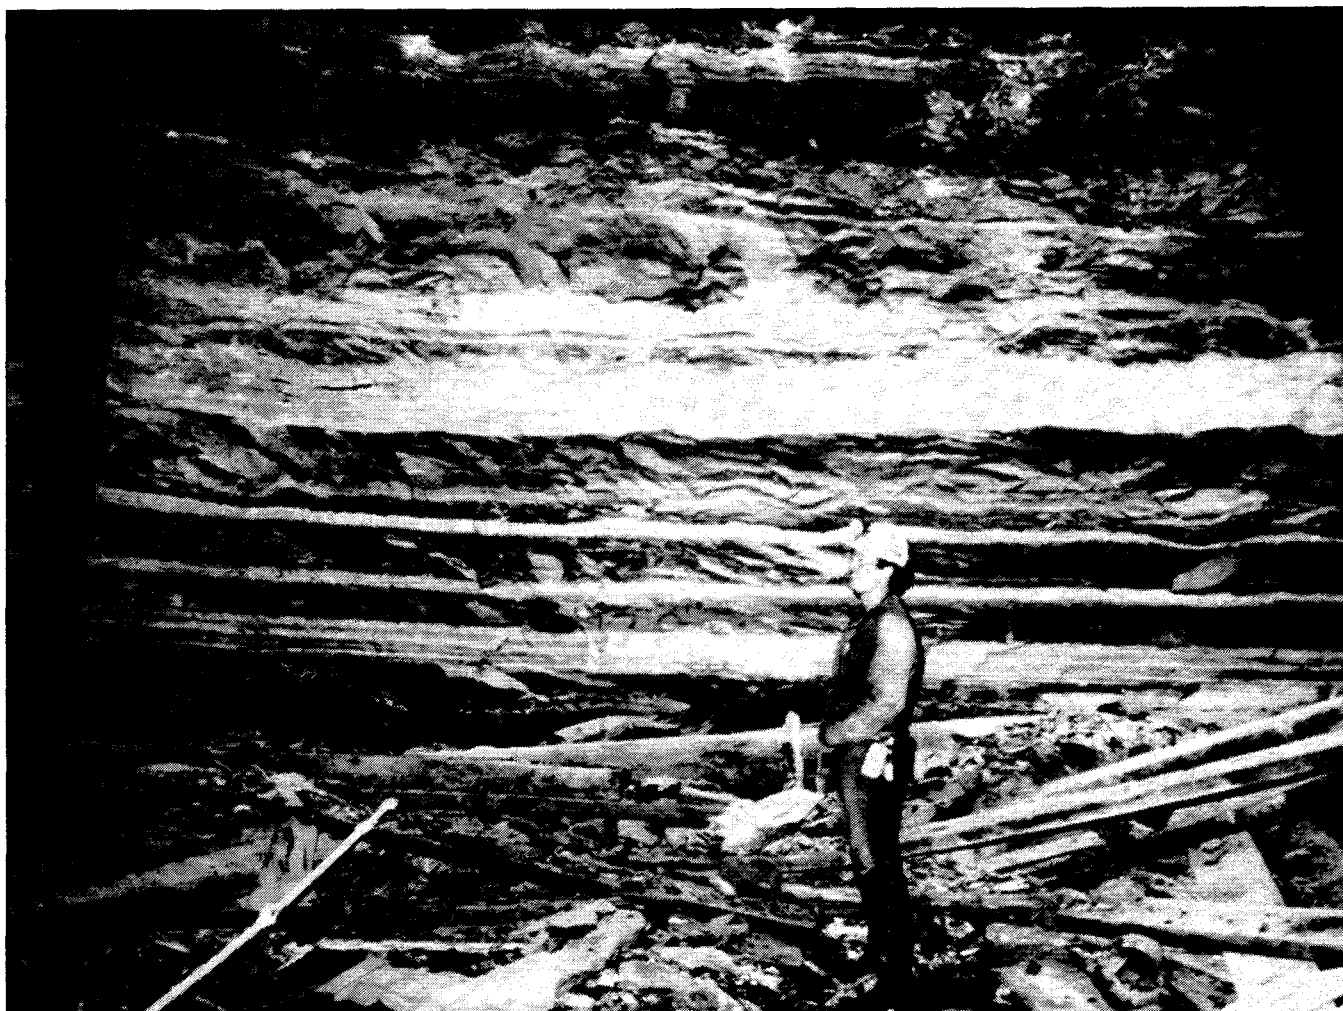
Figure 47

Castle Gate No. 3 Mine roof strata exposed at shaft station in north side of mine. Large slabs of thinly bedded sandstone, siltstone, and mudstone separate along bedding planes, leading to roof falls.

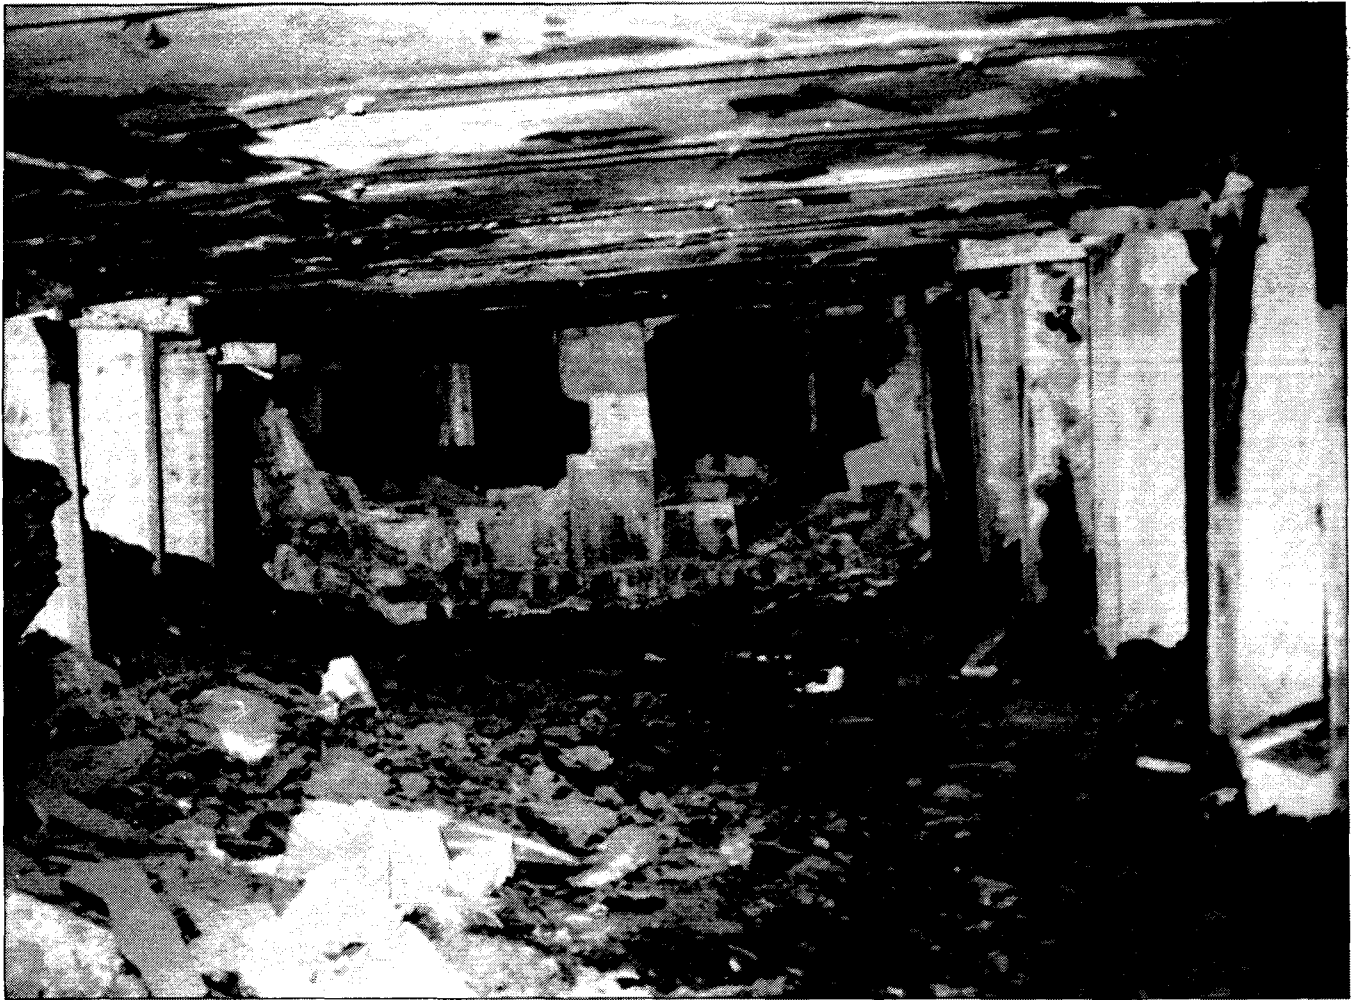
Figure 51

Aftermath of tailgate pillar bump in 8th East gate road. The bump, which occurred outby approaching 9th East panel face, partially filled crosscut with coal thrown from pillars at either side and destroyed solid concrete block stopping.

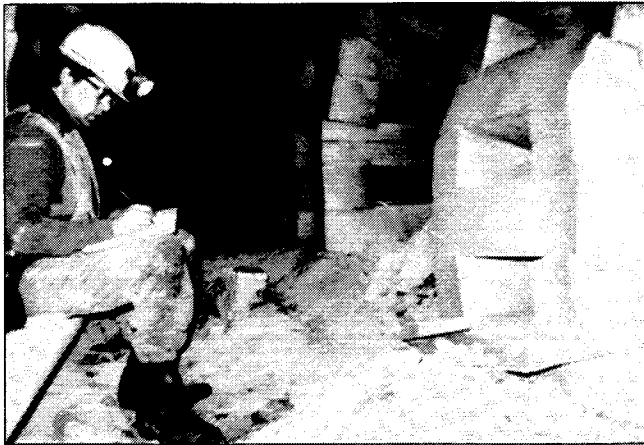
Figure 62

Floor heave and rolled-out cribs in Sunnyside No. 1 Mine gate road. Loads transferred to floor by oversized chain pillar (to right of photograph) have caused basal siltstone (immediate floor) to separate from underlying rigid sandstone and move laterally toward location of USBM engineer, shifting lower portion of cribs. Floor heave at base of cribs probably resulted from separated siltstone strata overriding intact floor beneath engineer's feet.

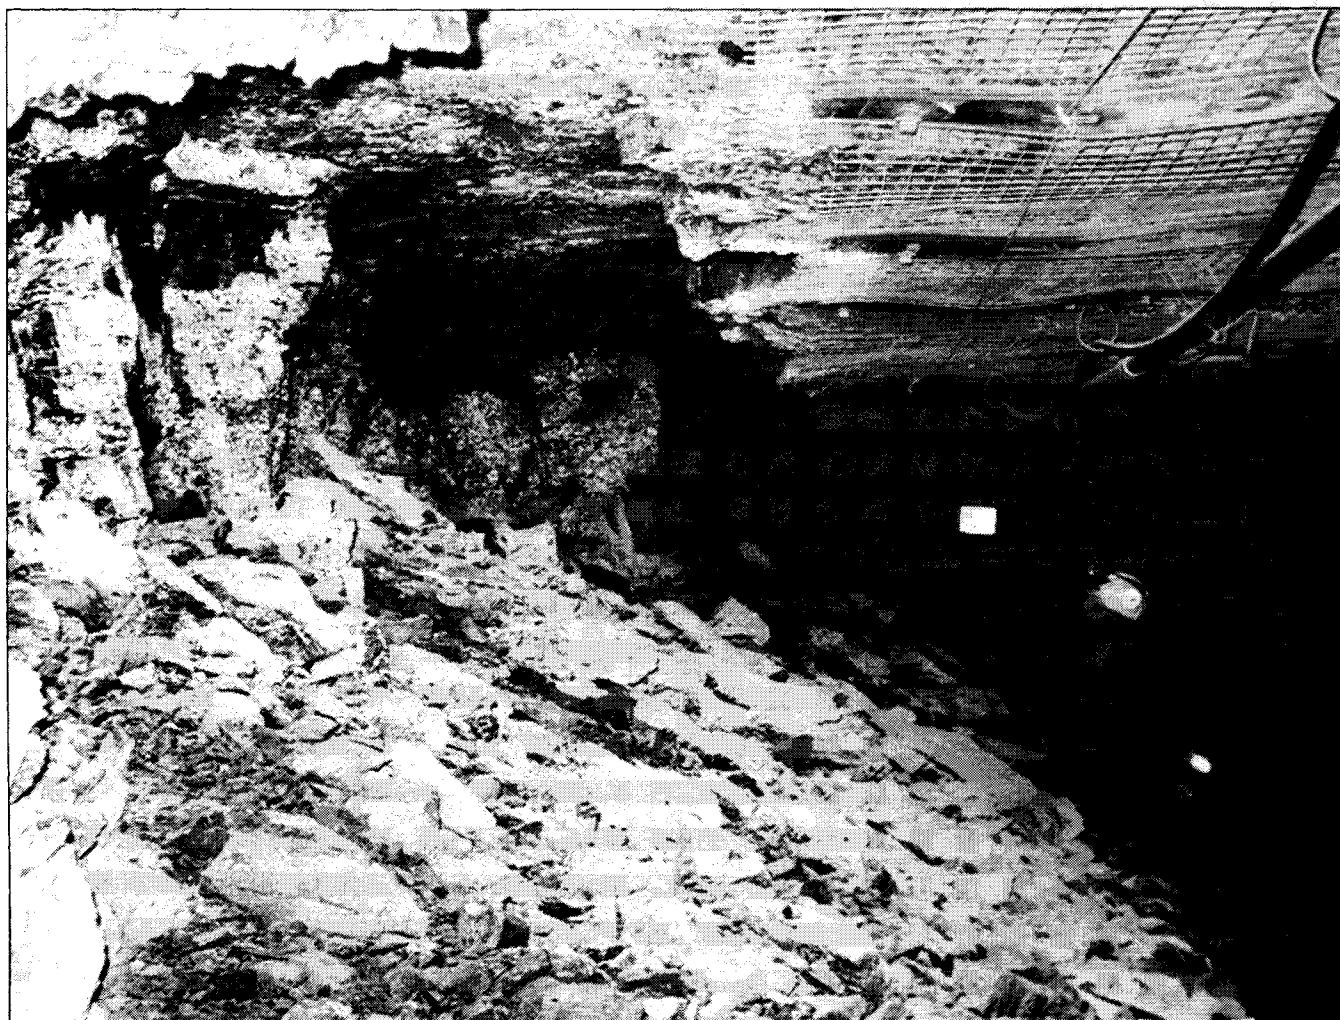
Figure 63

Sloughed rib in Sunnyside No. 1 Mine gate road. Original rib line is seen at roof brow to left of wire mesh. Upper portion of composite seam has fractured and fallen away from roof, covering relatively intact lower part of seam with loose coal.

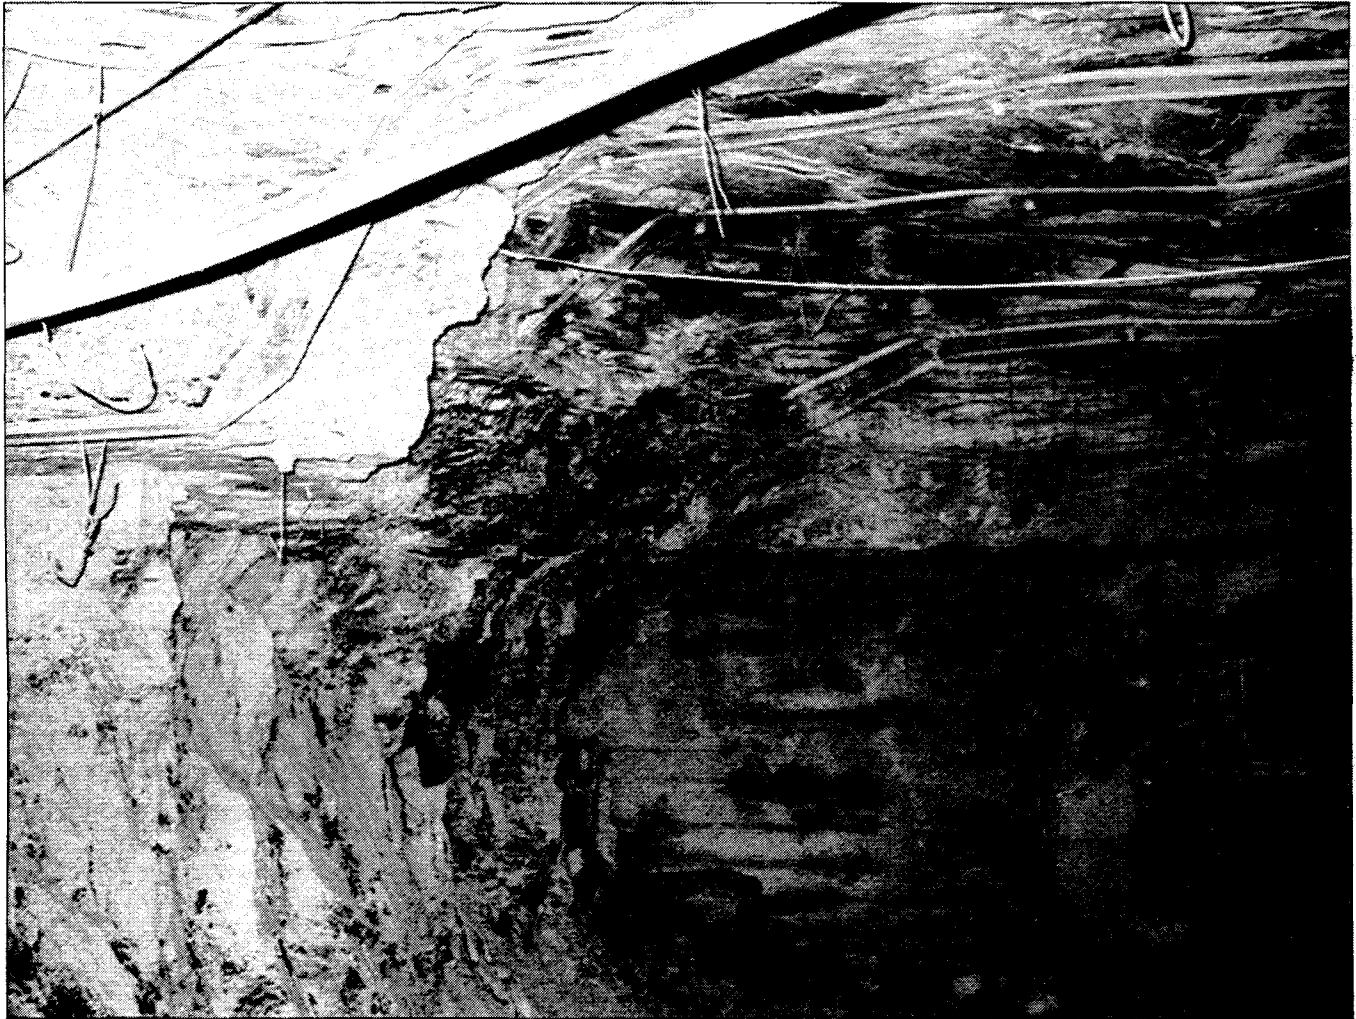
Figure 65

Domed roof fall area in Sunnyside No. 1 Mine near gate road study area. Besides poor roof conditions, horizontal stresses often contribute to occurrence of domed falls.

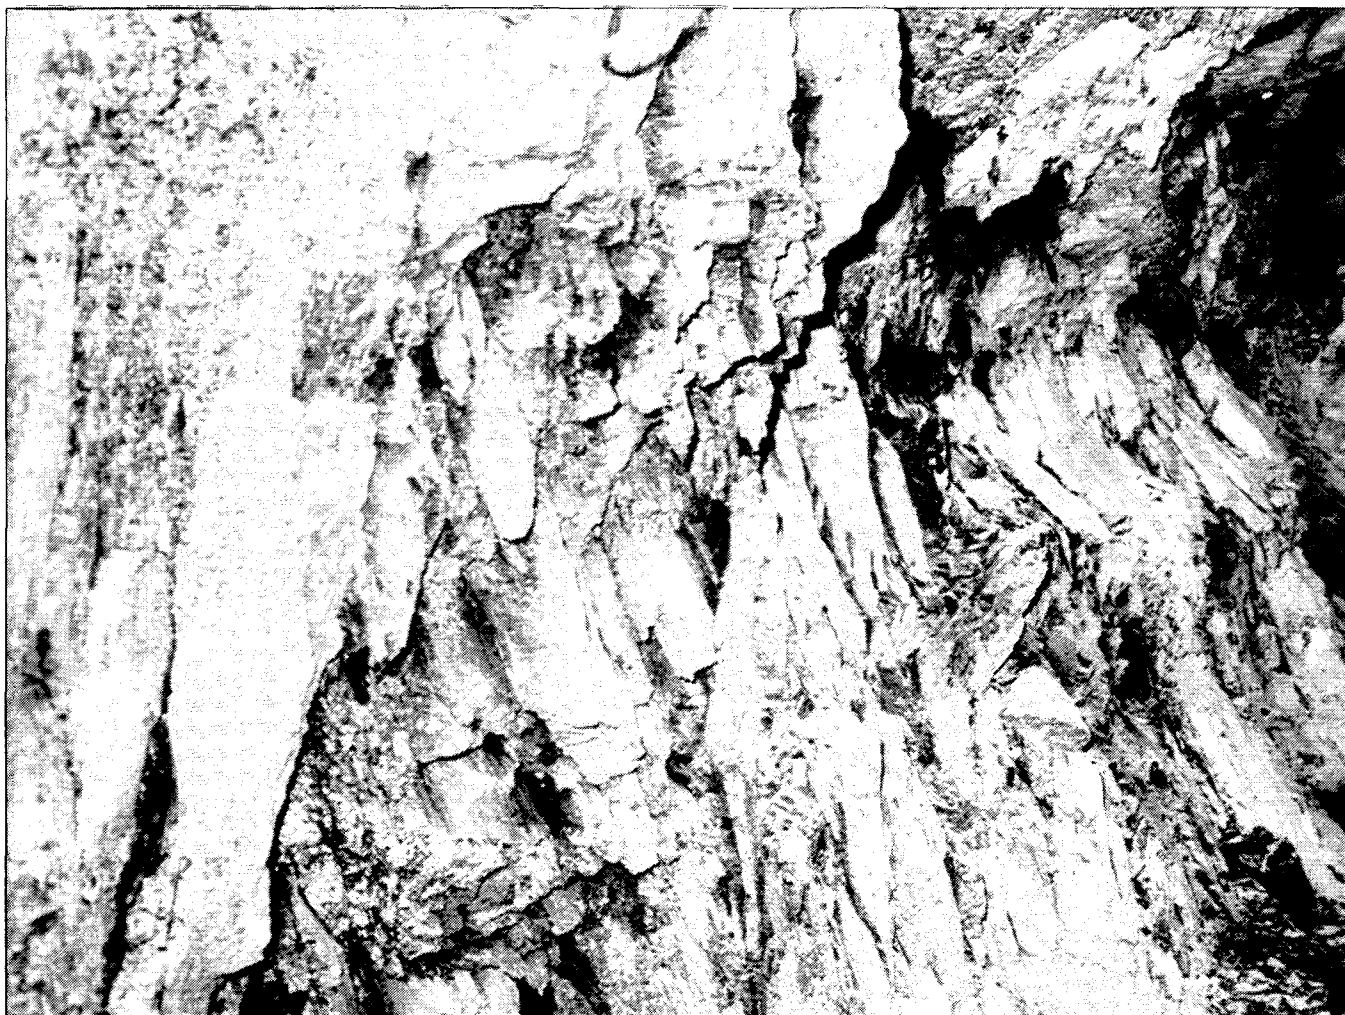
Figure 69

*Yielded gate road panel rib in northeast part of Sunnyside No. 1 Mine.*

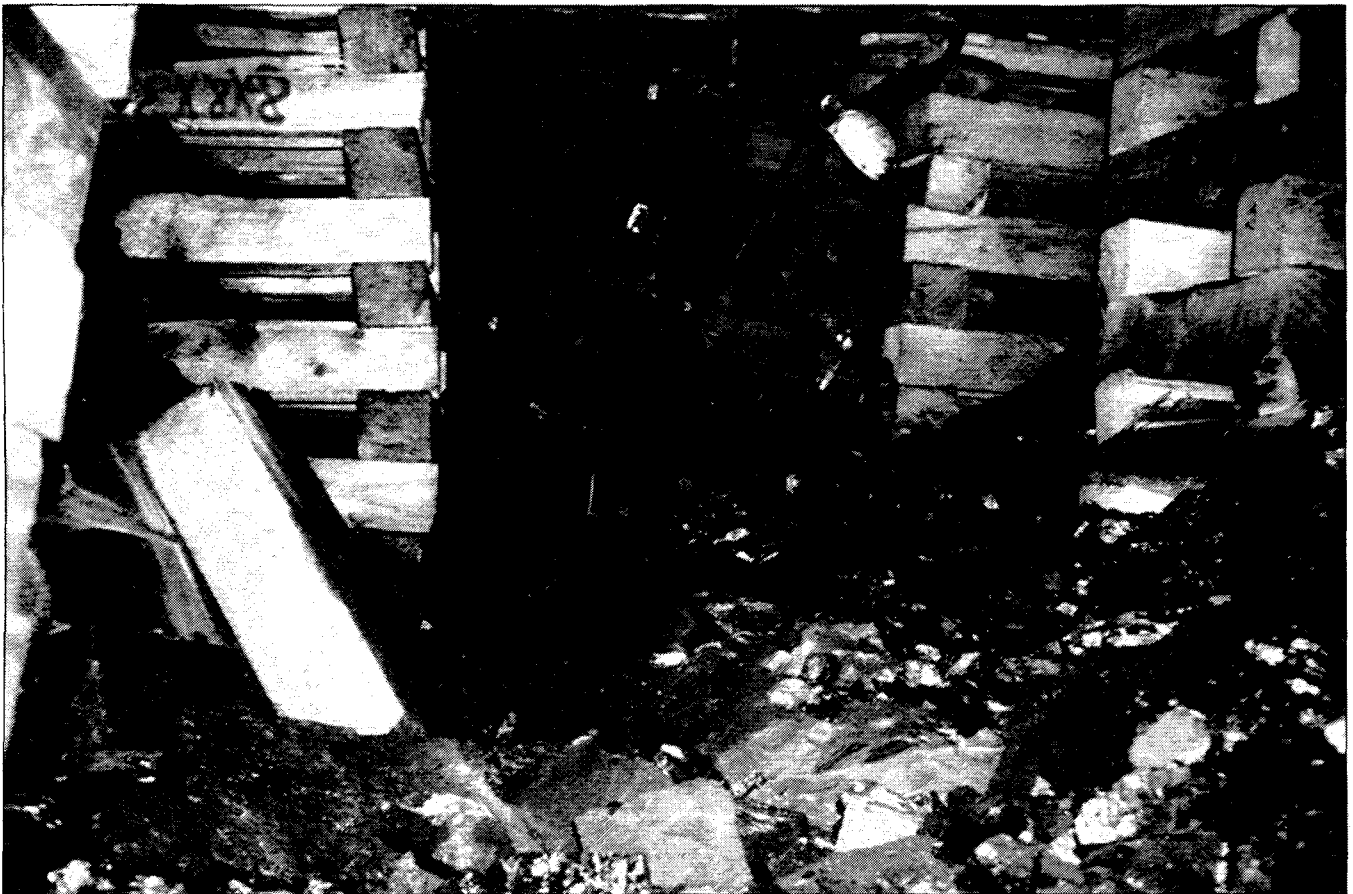
Figure 72

Aftermath of gate road chain pillar bump in northeast part of Sunnyside No. 1 Mine. Crosscut has been mostly filled with loose coal thrown from pillars during bump. Pillars were oversized at 16.8 m (55 ft) wide owing to headgate entry misalignment.
