A Minerals Research contract report
December 1981

AN APPLICATION OF THE DEDICATED WIRE TECHNIQUE TO IMPROVE COAL MINE TROLLEY CARRIER PHONE COMMUNICATIONS

Bureau of Mines Open File Report 203-82

Contract J0308036
Arthur D. Little, Inc.

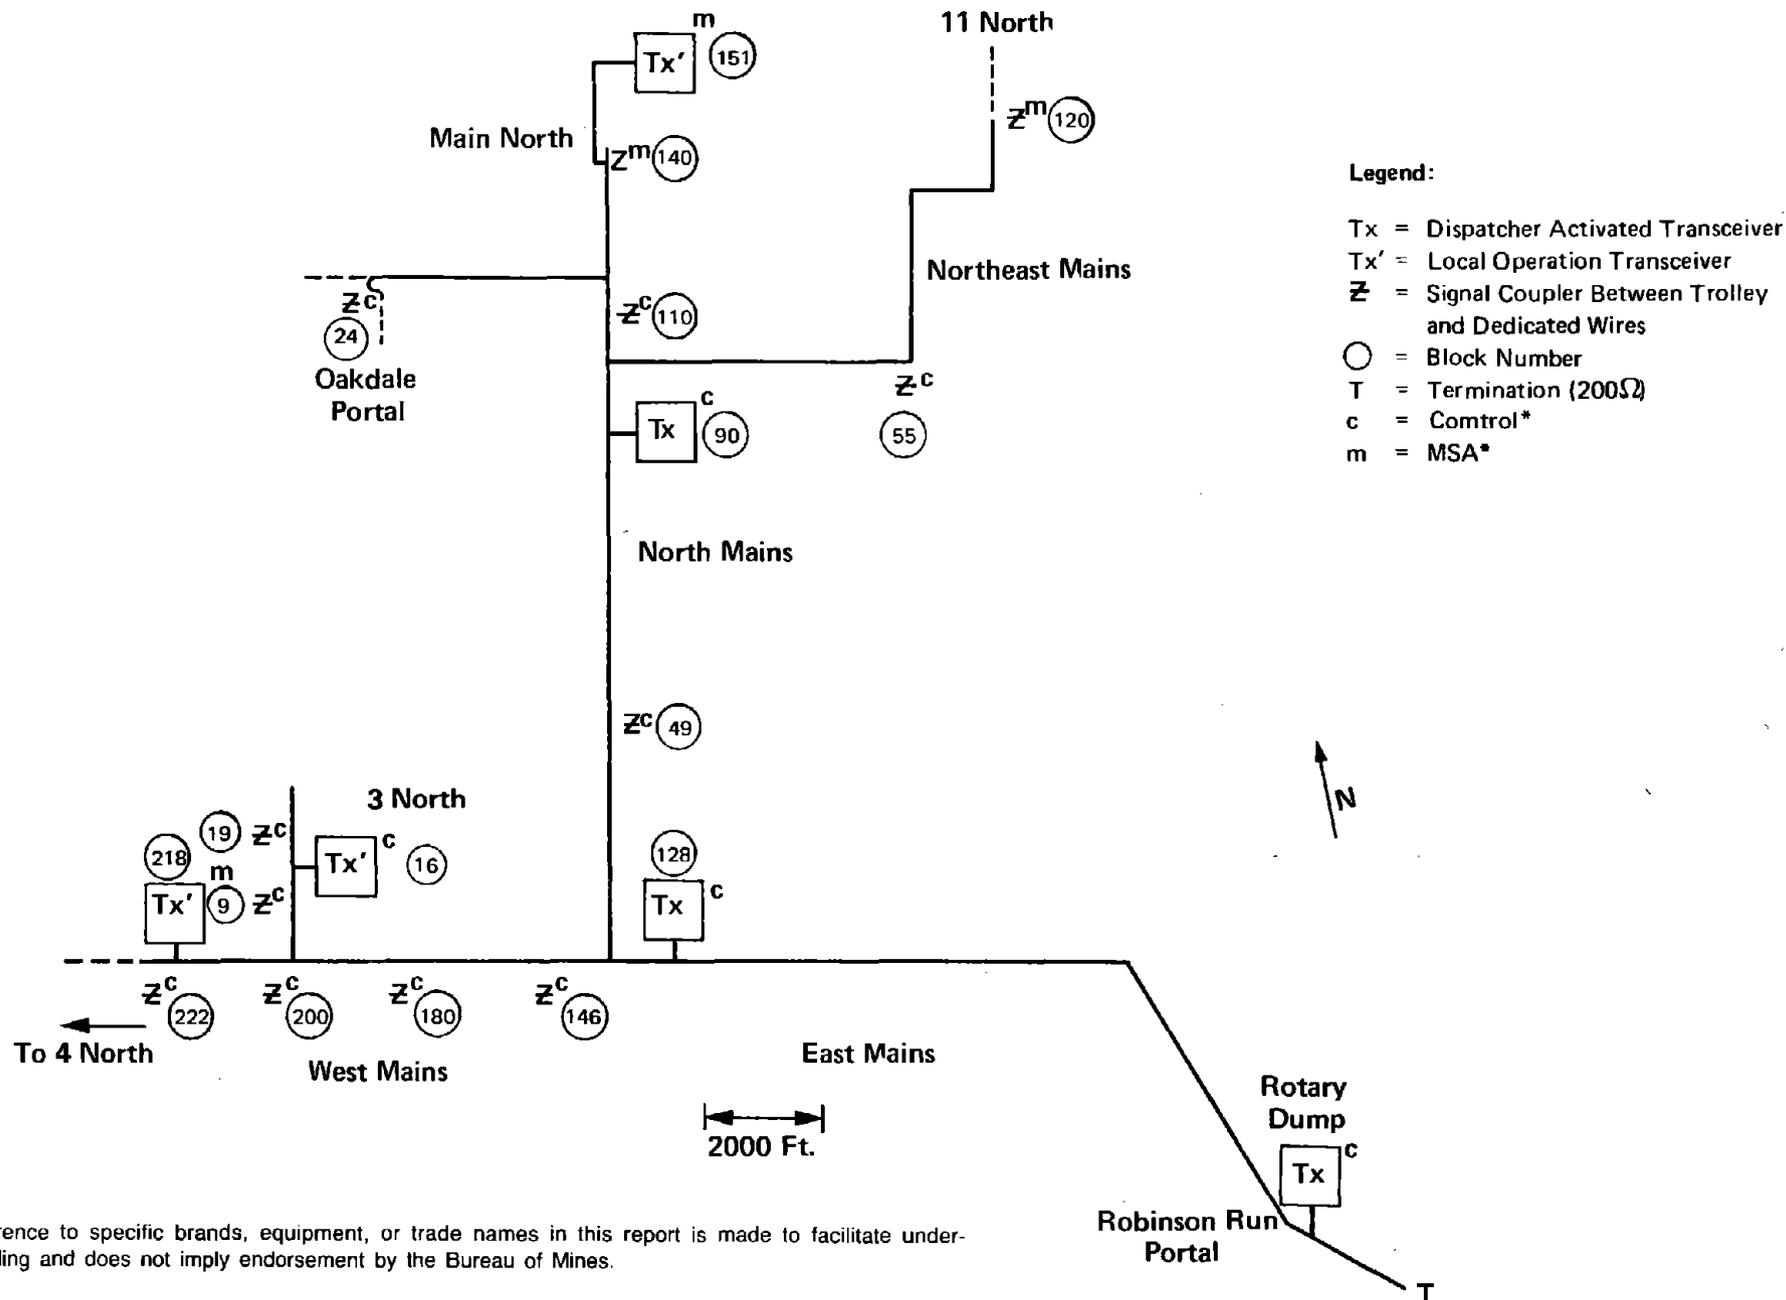
FIGURE 4 SIMPLIFIED SCALE MAP OF ORIGINAL DEDICATED WIRE INSTALLATION ALONG ROBINSON RUN MINE RAIL HAULAGE NETWORK

- The mine management had already installed an auxiliary dedicated wire along most of the mine's rail haulage network, but its performance improvement capabilities had not been achieved. Its capabilities had not been achieved because the signal transmission characteristics of the dedicated wire transmission line were unpredictable and unstable. This condition was caused by the absence of matched line terminations and matched power splitters, and the presence of numerous trolley wire-to-dedicated wire signal couplers. Therefore, substantial improvement in performance could be expected by optimizing the existing dedicated wire installation.

coupler terminating the end of the dedicated wire, and the apparently large current drains from the dedicated wire caused by two other signal couplers interconnecting the trolley wire and dedicated wire along the West Mains.

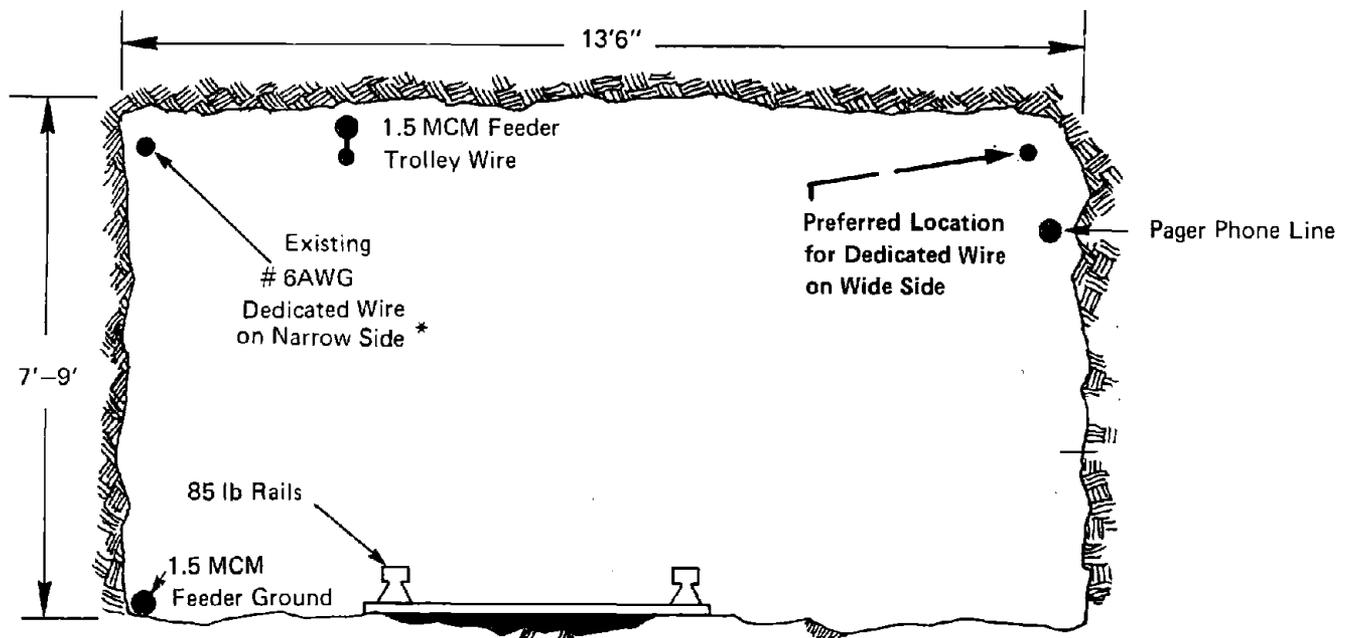
FIGURE 9 APPROXIMATE CROSS-SECTION OF MAIN HAULAGEWAY LAYOUT (ALL DIMENSIONS NOMINAL, SIGNIFICANT VARIATIONS IN DIMENSIONS AND DISPOSITION OF CONDUCTORS, INCLUDING POWER CABLES AND WATER PIPES NOT SHOWN, OCCUR WITH DISTANCE)

We found the dedicated wire installed on the rib located on the trolley wire (narrow) side of the tunnel in most of this mine. This accounts for the mine's use of the large No. 6 AWG wire size along most of the haulage network to prevent wire breakage when trolley poles become disengaged from the trolley wire and flap against the coal. Wide side installations of No. 12 wire were found primarily along sections of the Northeast Mains in this mine.

Notwithstanding the dedicated wire installations found at this mine, we do not recommend narrow side installations. Wide side installation of the dedicated wire is greatly preferred because it results in better performance and greater electrical safety, and it allows the use of more economical smaller gauge wire such as No. 12 AWG. Therefore, we recommend that all dedicated wires be installed, like the pager phone lines, on the wide side of track haulageway tunnels, as described in the U.S. Code of Federal Regulations, Title 30, Chapter 1, Part 75, paragraph 75.516-2.

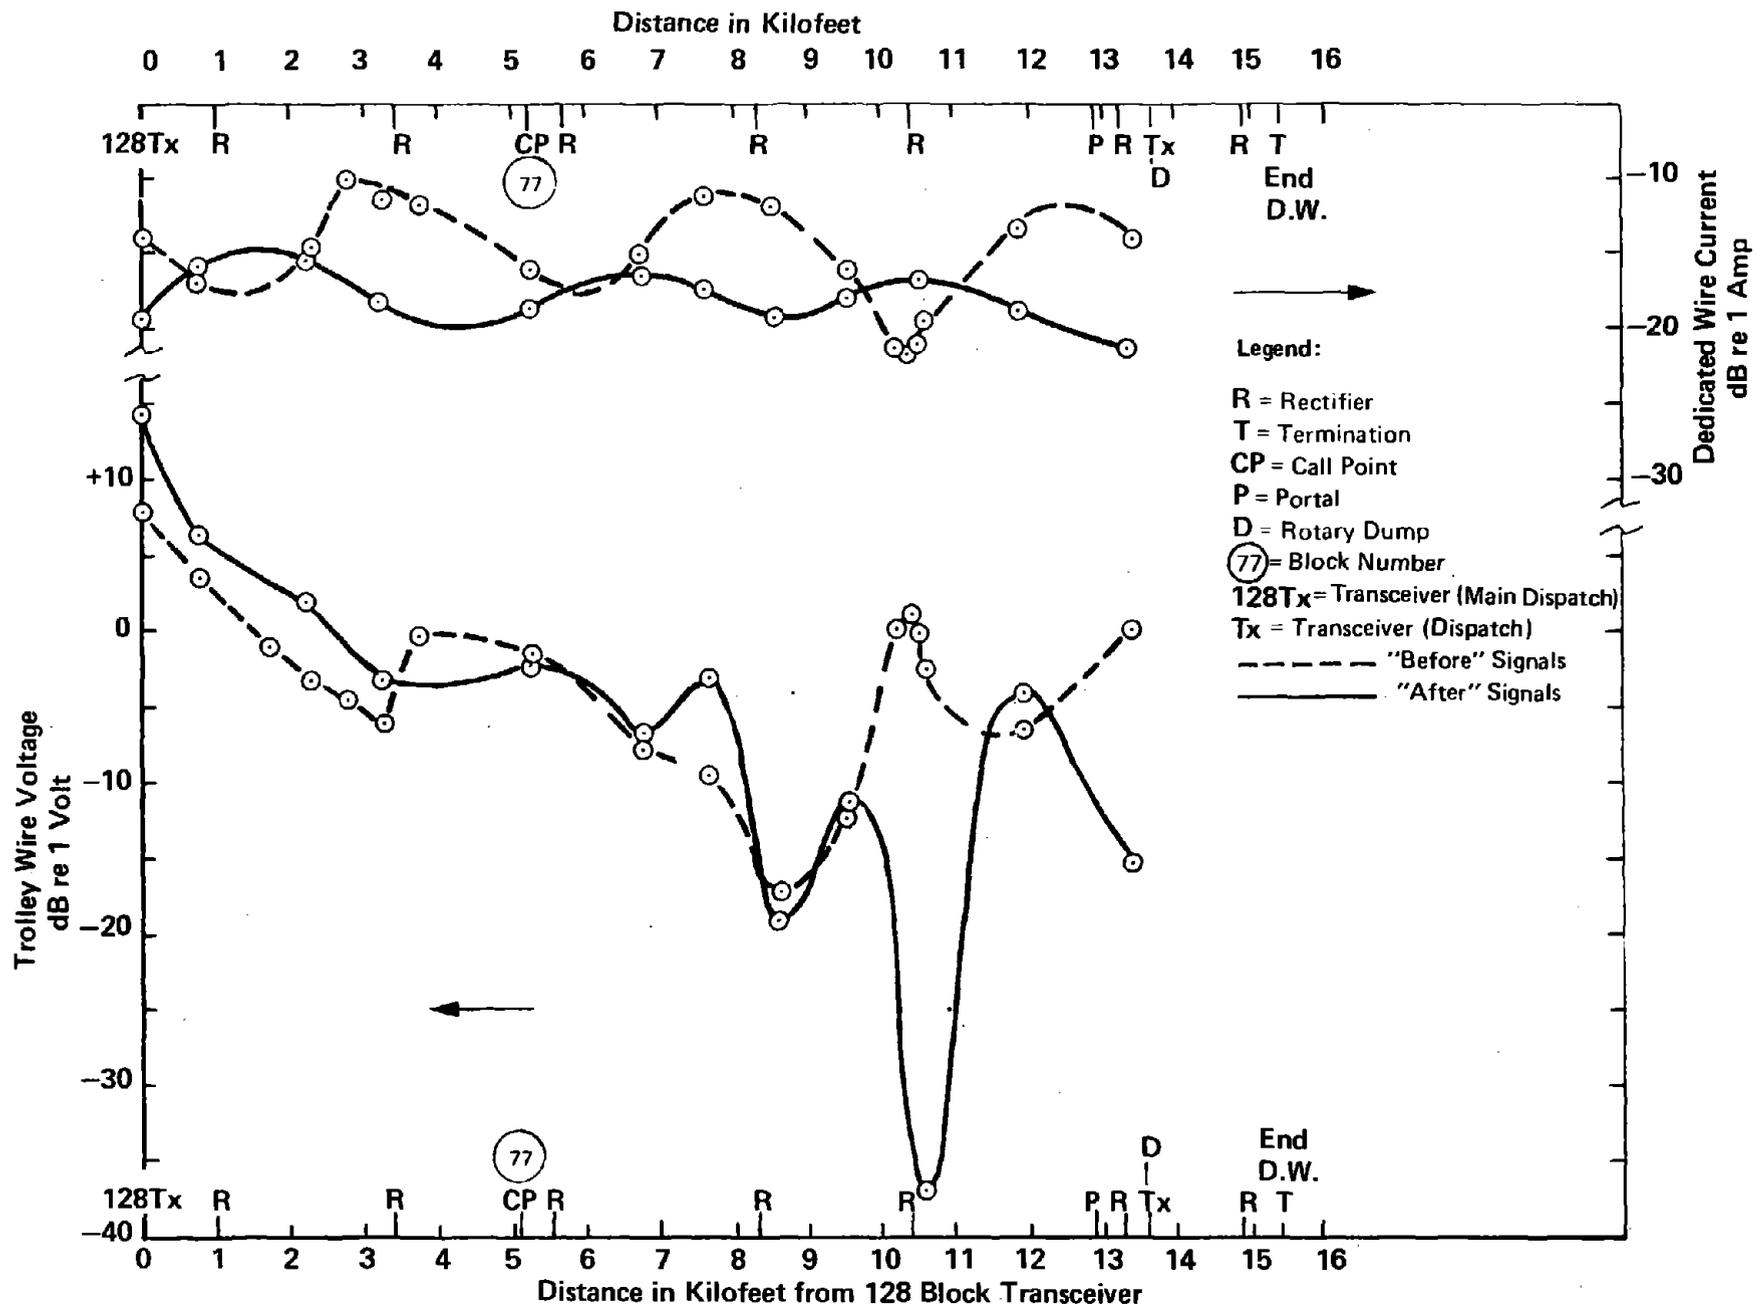
FIGURE 16 COMPARISON OF "BEFORE" AND "AFTER" CARRIER PHONE SIGNALS FOR EAST MAINS, 128 BLOCK TRANSCEIVER TO OUTSIDE ROTARY DUMP

The East Mains segment of dedicated wire (shown in Figures 4 and 11) required the least modification, and as a result demonstrated the least change in performance. "Before" and "after" plots of dedicated-wire current and the associated trolley wire voltage are shown in Figure 16. These plots reveal highly satisfactory performance. At all locations, the trolley wire voltage levels were well above -40 to -50 dB relative to 1 volt (10 to 3 millivolts), the marginal performance range where intelligibility deteriorates significantly into the background noise at this mine. Most importantly, a very strong voltage level of about 800 millivolts (-2 dBV) was recorded at the principal East Mains call point at block 77.

As previously indicated, the dedicated wire, as found, had already been terminated with a matched 200-ohm resistive termination about 2000 feet beyond the outside rotary dump. The standing wave depicted in the "before" dedicated-wire current plot was caused by the unexpectedly low input impedance of the rotary dump carrier phone transceiver when operating in the standby (receive) mode. Substitution of a modified transceiver board supplied by Comtrol* cured this problem. The residual "after" standing wave was caused by the mechanisms discussed in the previous section of this chapter, and by the change in line characteristic impedance produced by the absence of tunnel boundaries beyond the mine portal.

The plots also reveal a drop of about 15 dB in voltage level at the rotary dump in the rail yard outside the Robinson Run portal. We believe this drop resulted from the removal of the transceiver's impedance mismatch to the dedicated wire at the rotary dump. We have observed in this plot, and the others, that impedance mismatches and discontinuities such as terminations and splits along the dedicated wire, are usually accompanied by increases in the trolley wire voltage in the vicinity of these locations. We do not fully understand the reasons for this apparent increase in coupling to the trolley wire/rail line at such locations. However, the effect should be useful in practice as a means of selectively improving or extending performance near the end-points of the dedicated wire. For example, voltage levels at the rotary dump, and other locations in the outside rail yard, could be increased closer to the "before" levels by moving the outside termination closer to the rotary dump location. We believe this could be accomplished without losing the ability to communicate satisfactorily along the car storage track beyond the dump. Consequently, we recommend that the termination be so moved by the mine, and the expected performance verified.

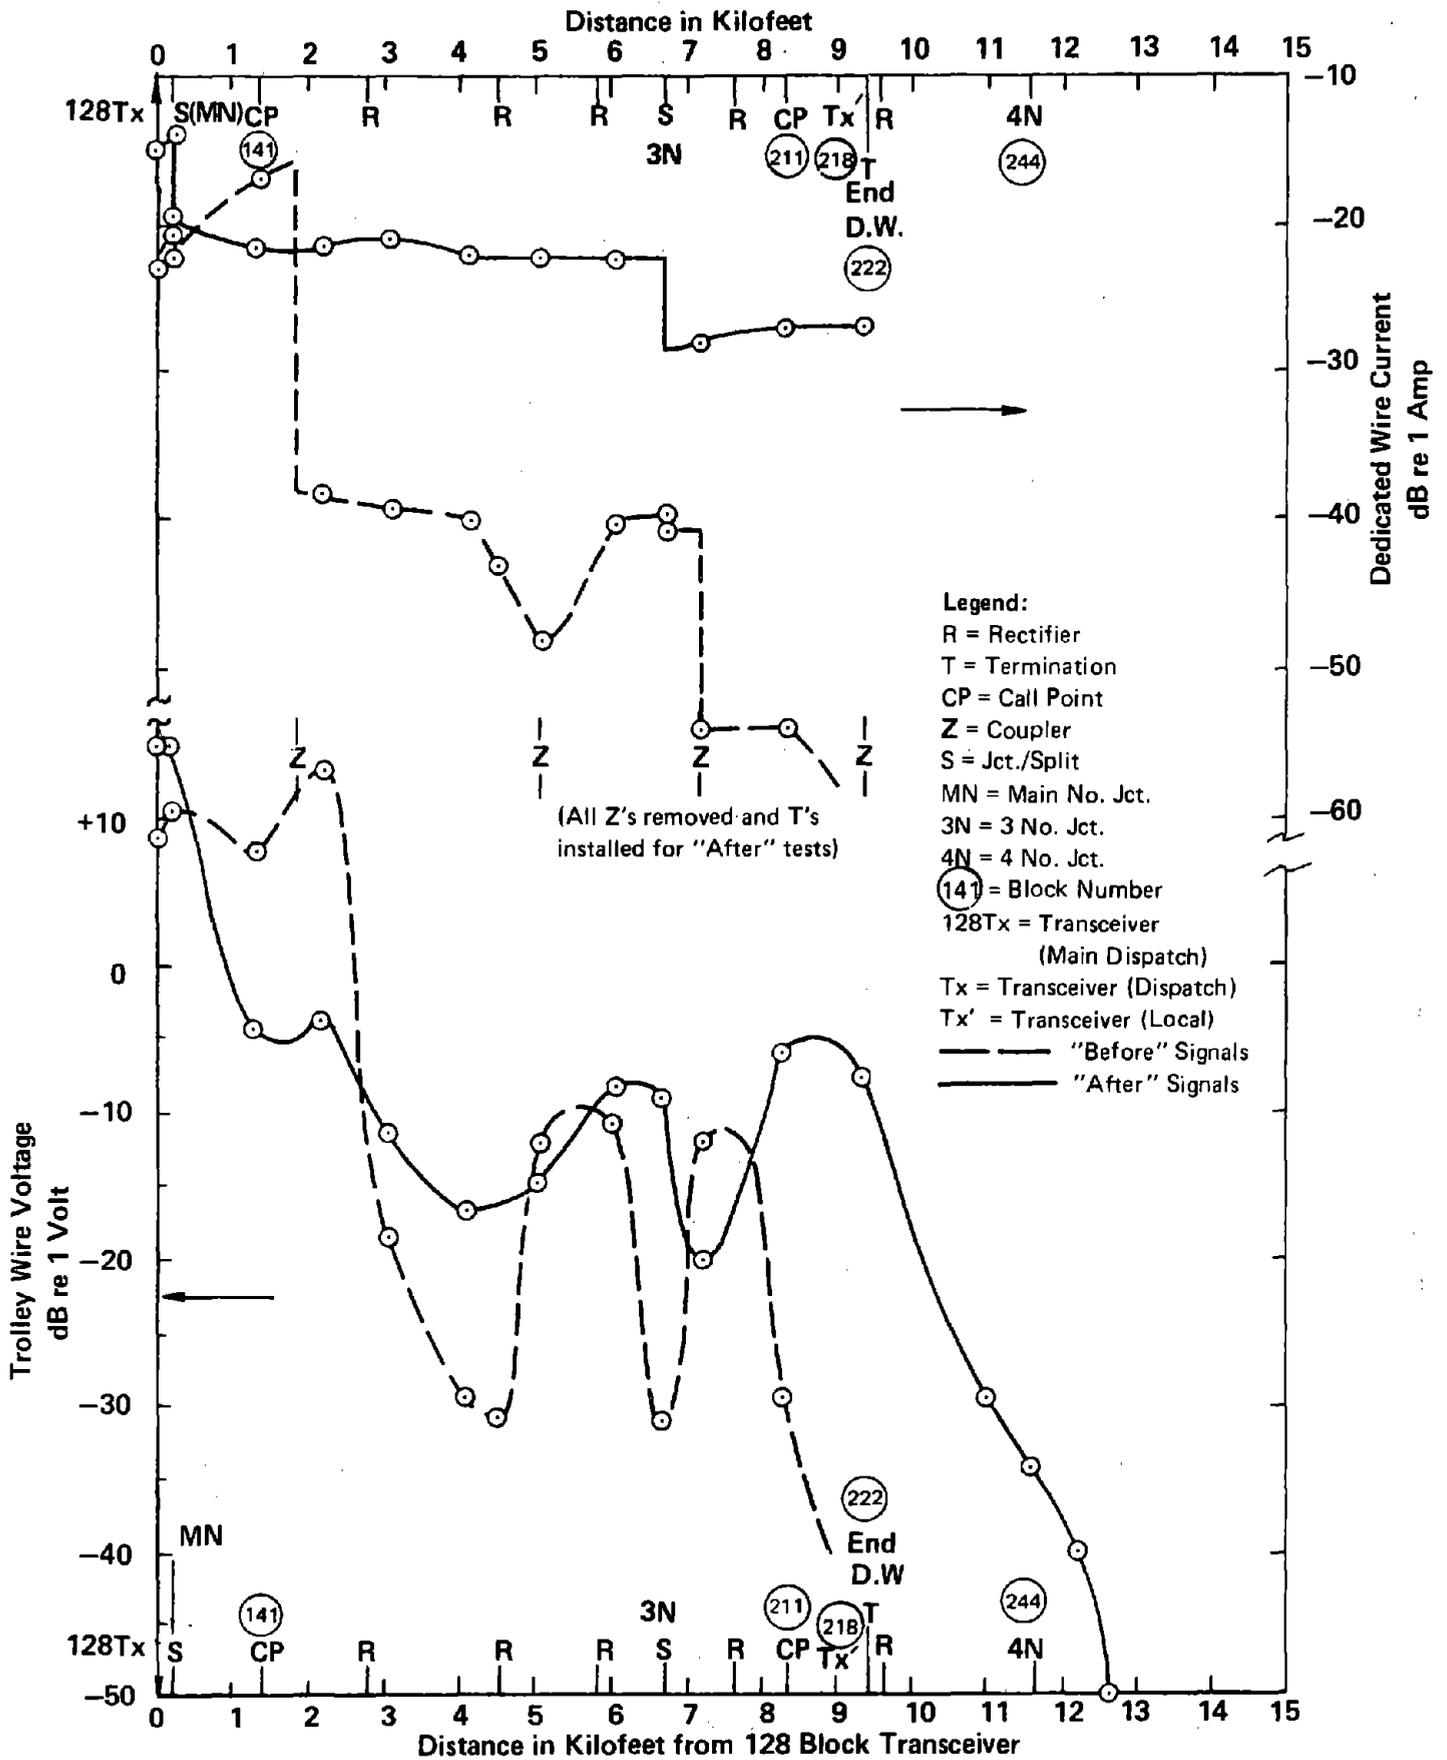
FIGURE 17 COMPARISON OF "BEFORE" AND "AFTER" CARRIER PHONE SIGNALS FOR WEST MAINS, 128 BLOCK TRANSCEIVER TO 4 NORTH

Examination of the "before" current plot reveals significant reductions in the dedicated-wire current caused by the signal couplers shown in the figure as Z's; that is, the hardwired couplers along this section of haulageway were transferring large fractions of the dedicated-wire current to the trolley wire. These couplers were used by the mine to compensate for the severe signal attenuating characteristics of the power rectifiers connected across the trolley wire/rail. Since rectifiers quickly attenuate transferred carrier phone signals too, this method provides only local improvements in trolley wire voltage. Therefore, many such couplers may be required along heavily loaded sections of track to obtain perhaps only marginally acceptable performance. These couplers do not represent the most desirable or practical solution for a number of reasons:

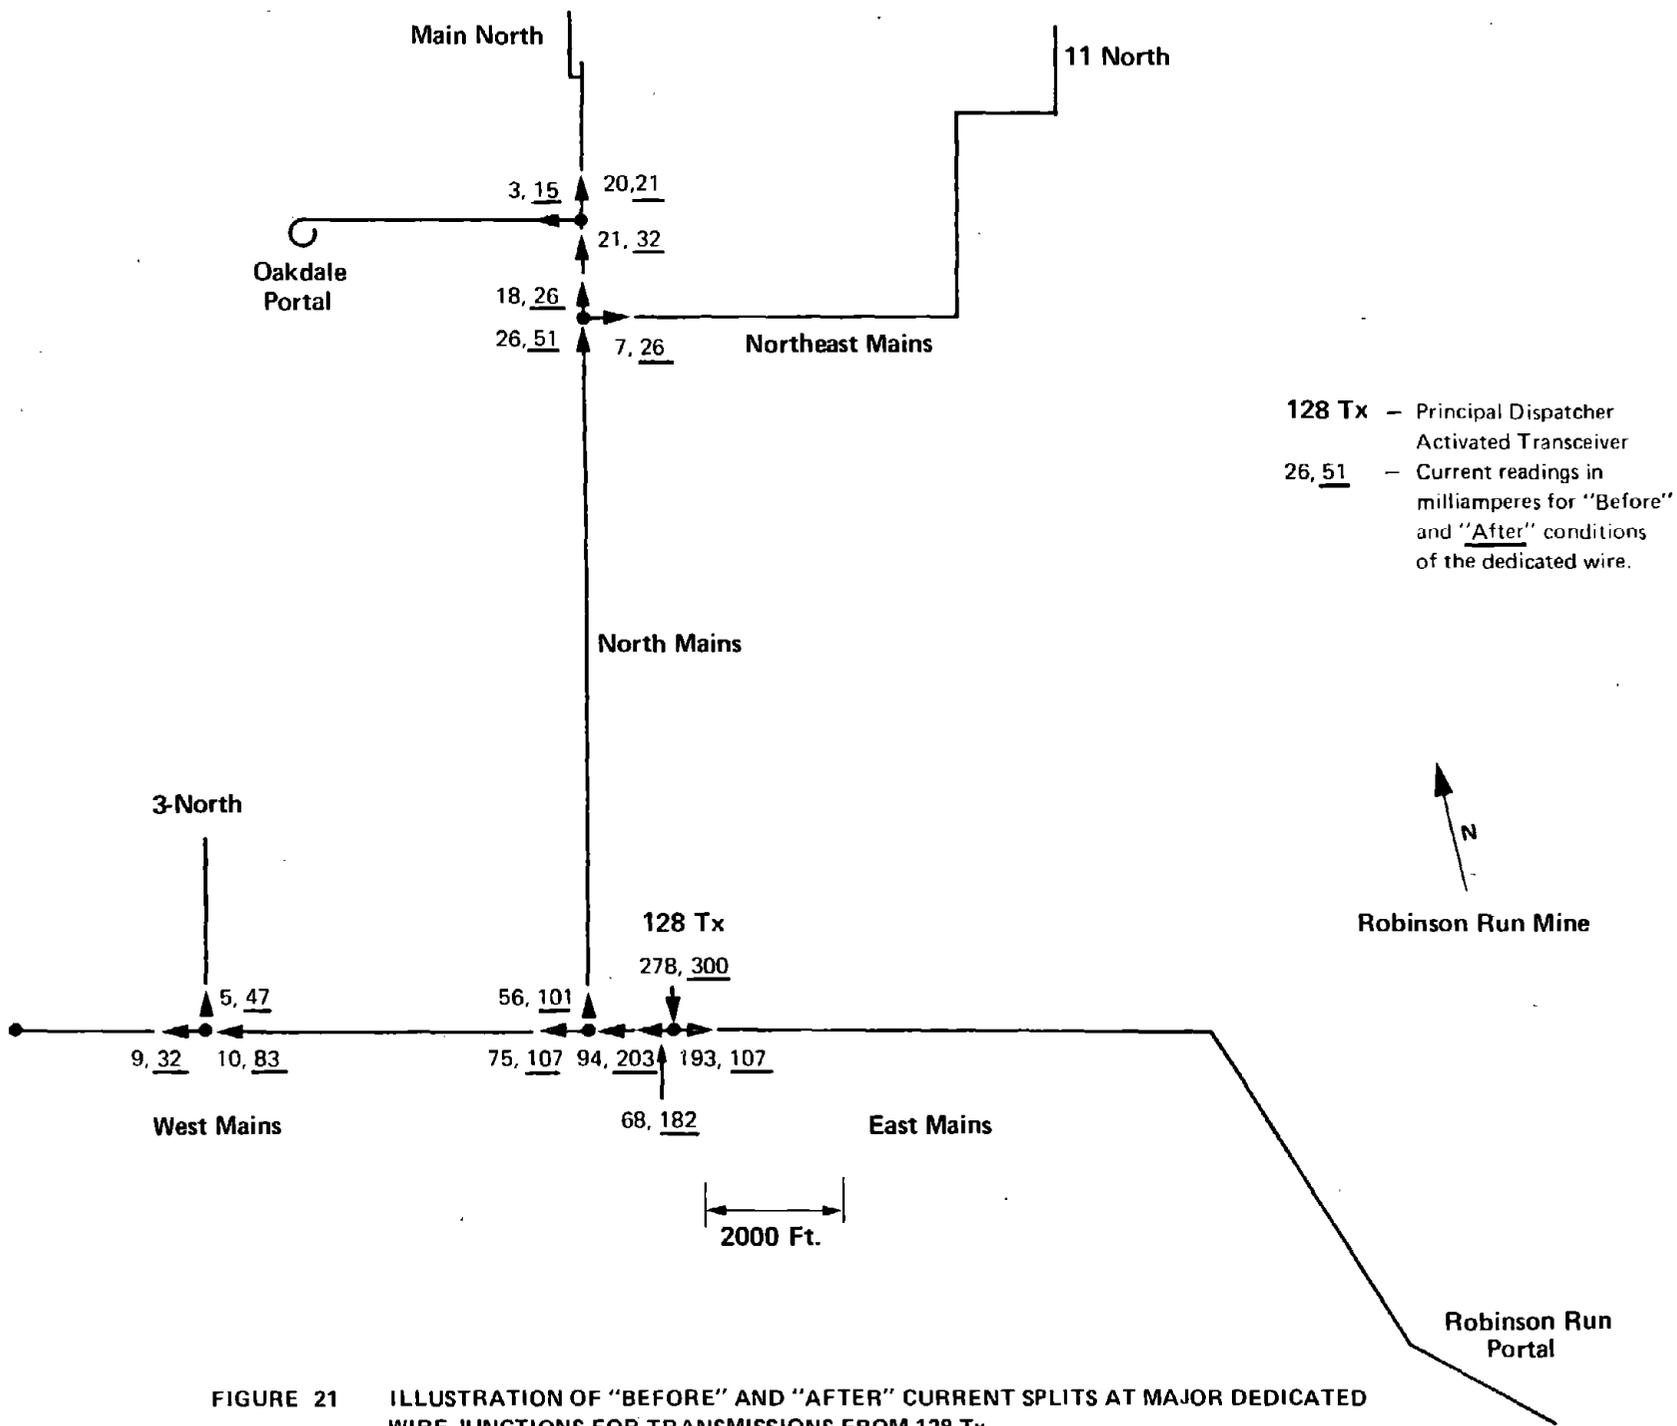
FIGURE 21 ILLUSTRATION OF "BEFORE" AND "AFTER" CURRENT SPLITS AT MAJOR DEDICATED WIRE JUNCTIONS FOR TRANSMISSIONS FROM 128 Tx

Table 1 and Figure 21 clearly demonstrate both the higher current levels and the nearly equal splitting of the incoming currents that occur with the matched signal splitters working into lines with matched terminations. The results also indicate that, in each case, the arithmetic sum of the output currents does not exactly equal the input current, but that, in fact, the sum in most cases is larger than the input current. This can occur when the two output currents do not have the same phase. This unequal phase condition is usually more pronounced for unoptimized dedicated-wire configurations without matched splits and terminations to control the line impedances, such as the "before" installation at Robinson Run. For "optimized" configurations, the output discrepancies are still present, but smaller, because the terminations are "matched" only in an "average" sense for practical dedicated-wire installations. When the sum of the measured values of the two output currents is less than that of the input current, the cause is probably related to instrumentation or reading errors.
