**EVALUATION OF MILL TAILINGS DISPOSAL
PRACTICES AND POTENTIAL DAM STABILITY
PROBLEMS IN
SOUTHWESTERN UNITED STATES**

**RECONNAISSANCE
REPORT**

**UNITED STATES
DEPARTMENT OF THE INTERIOR
BUREAU OF MINES
WASHINGTON, D.C.**

Bureau of Mines Open File Report 50(5)-75

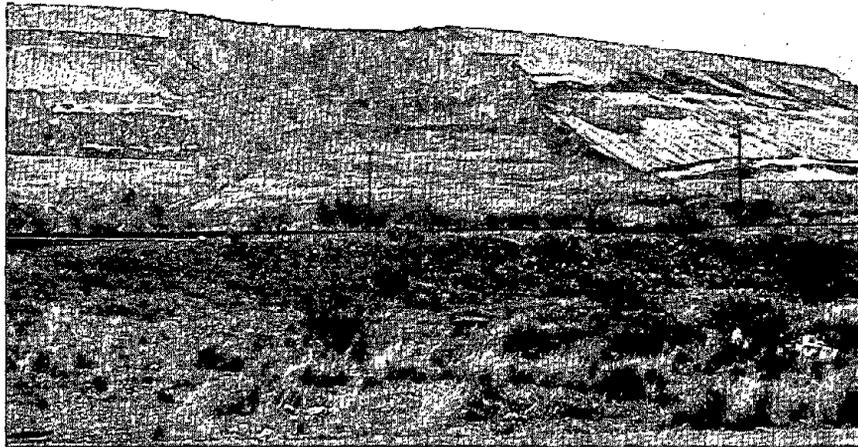
The failures apparently consisted initially of rotational landslides. The failure of last December was apparently followed by a partial liquefaction of the upper 20 to 30 feet of unconsolidated tailings located behind the failed portion. The February failure was not accompanied by liquefaction of tailings (Photoplate 1-B). In the December 2 failure, tailings covered the railroad tracks located near the northern toe of the structure (Photoplate 2-A); fortunately, however, there were no human casualties. Smaller slides and incipient failures could be observed on the ground between both failures. Our aerial inspection also disclosed an unstable area along the western edge of the deposit (Photoplate 2-B), which was discussed with Kennecott personnel.

PHOTO A. FAILURE OF HAYDEN DEPOSIT

A soils sampling and investigation program was begun in the failure areas with the result that new dike construction was set inside the original at considerable distance, thus in effect, flattening the impoundment dike slopes. As the sluffed material has dried out, it is being returned to the original structure and the slope faces dressed up.

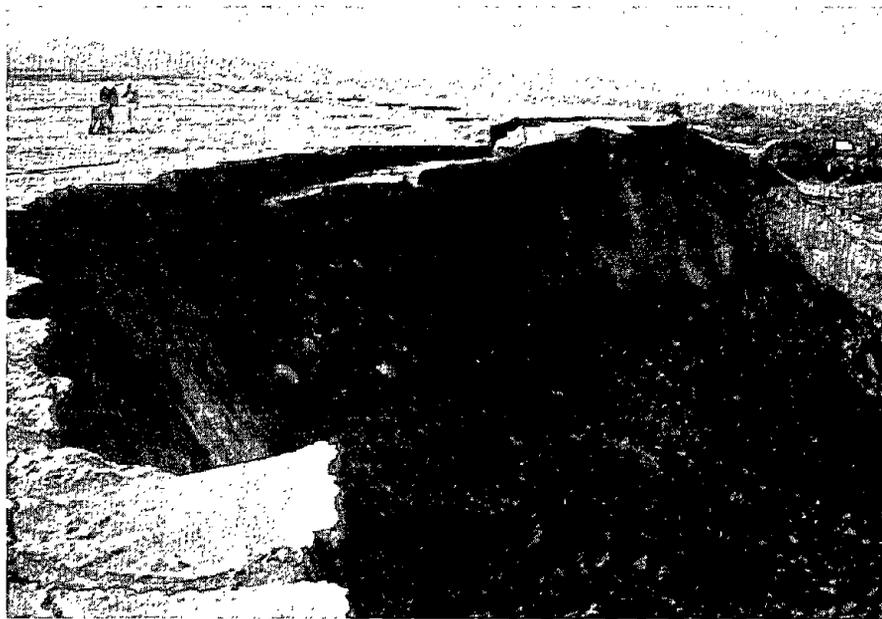
was from 30 to 50 feet deep and extended about 200 feet into the reservoir. A similar but smaller failure occurred the day before our visit, on February 3, 1973, about 1,000 feet east of the previous one. This failure left a gap about 500 feet wide, 20 to 40 feet deep, which extended about 150 feet into the reservoir (Photoplate 1-A). Water was seeping out of the failed portions and active piping could be observed at several points near the contact of the sandy and silty tailings.

PHOTO B. HEADSCARP OF HAYDEN FAILURE

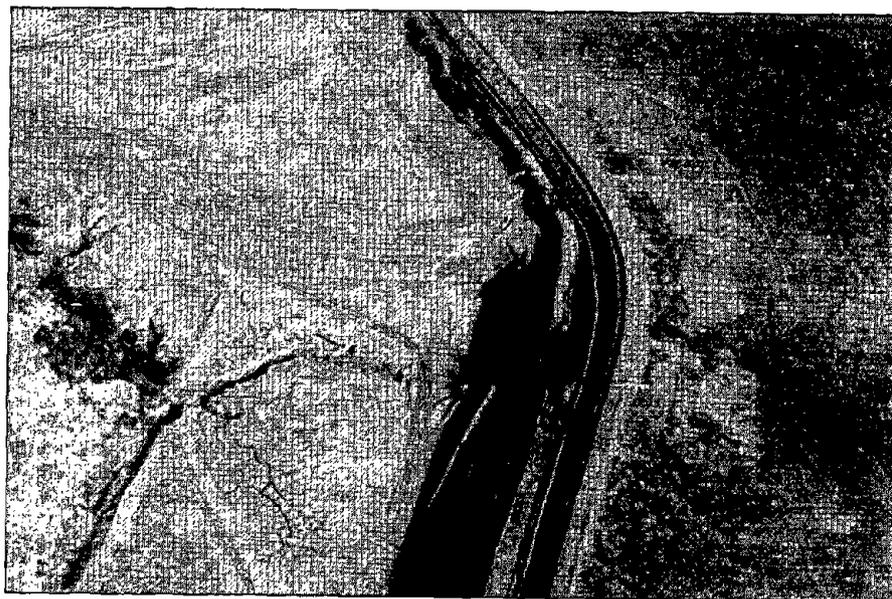
PHOTO B. INCIPIENT FAILURE AT HAYDEN DEPOSIT.

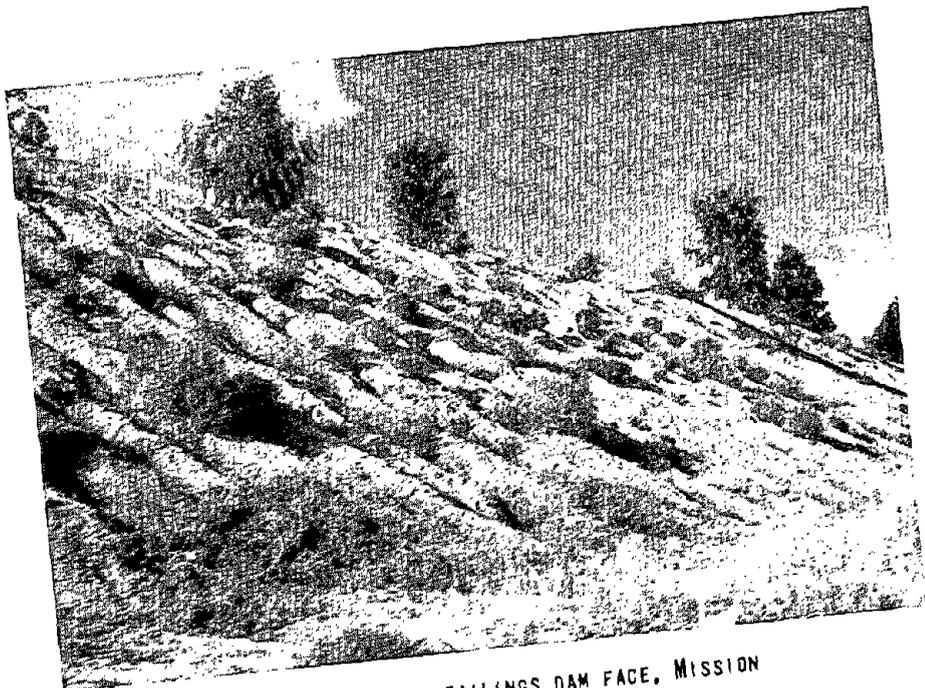
The faces of the tailings dams are being covered with planted native grass and eucalyptus trees as part of a beautification plan (Photoplate 4-B). Native grasses and eucalyptus trees are able to obtain enough water from normal rainfall and nutrients from the tailings material and the alluvial soil used to cover the tailings dam faces. Irrigation is being planned to maintain this vegetation cover during periods of drought.

PHOTO B. PLANTED TAILINGS DAM FACE, MISSION

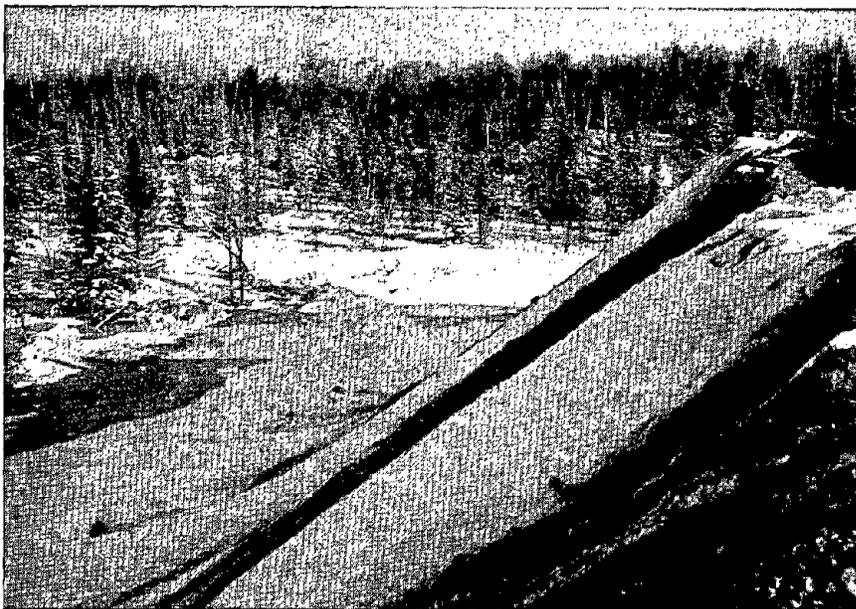
One feature observed during our visit was the sloughing of the toe of the dike being constructed. This was apparently due to water moving through the embankment and producing a piping effect at the toe of the embankment. However, no slope failures have been observed as a consequence of this, according to the mine representatives.

PHOTO B. TAILINGS DAM OUTER SLOPE RESTING AT NATURAL ANGLE OF REPOSE, GROVELAND MINE.

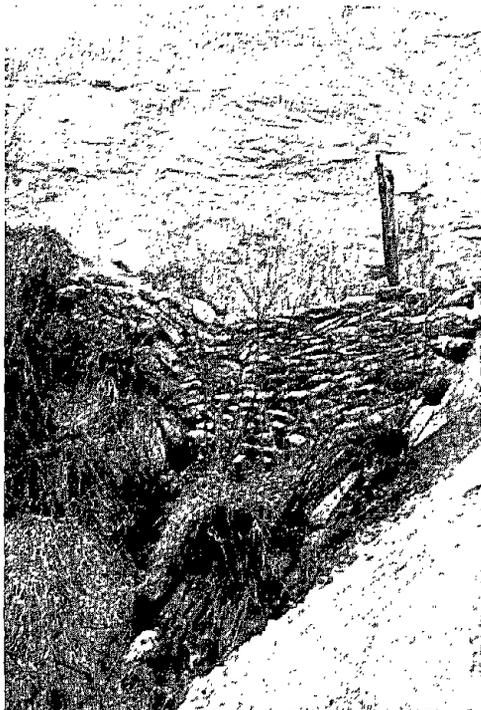
PHOTO C. REPAIR AND PROTECTION FOR SEEPAGE, NEW MARKET UNIT.

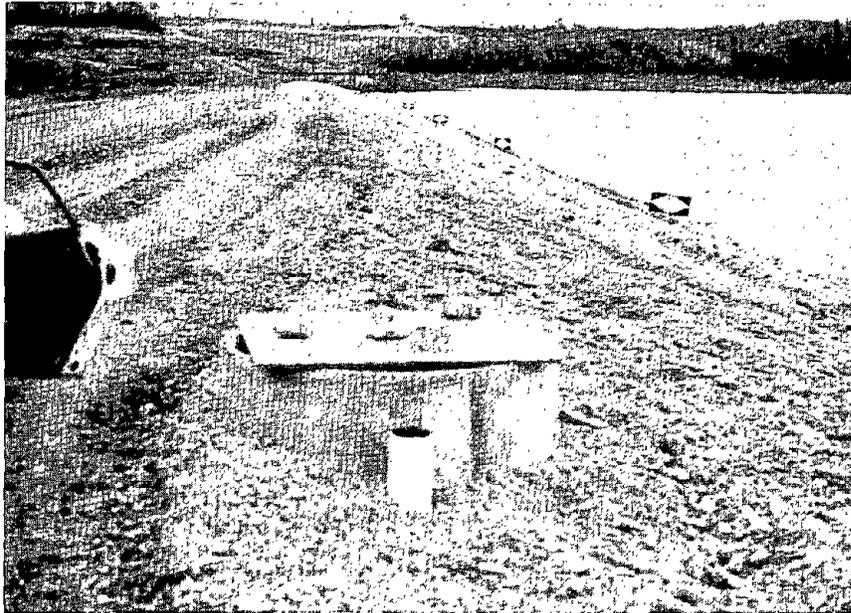
Seepage that developed on the face of the dam while the reservoir was being filled with mill slimes was eliminated by sealing the upstream slope of the embankment with consolidated slimes. The clayey slimes deposited in the reservoir and consolidated to a slurry containing 20 to 25 percent solids were pumped out and placed on the interior face of the dam. This procedure stopped the seepage and no problems have been experienced since.

PHOTO A. INSTRUMENTATION HOUSING, MONSANTO'S ROLLED EARTH FILL DAM, COLUMBIA

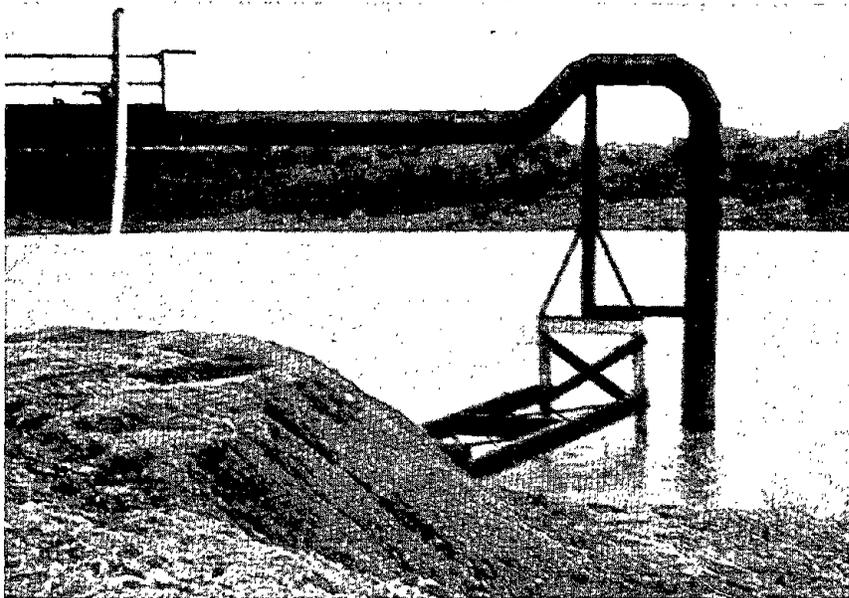
PHOTO B. SIPHON FOR DEWATERING RESERVOIR, COLUMBIA
