**ANALYSIS OF
COAL REFUSE DAM FAILURE**

**MIDDLE FORK BUFFALO CREEK
SAUNDERS, WEST VIRGINIA**

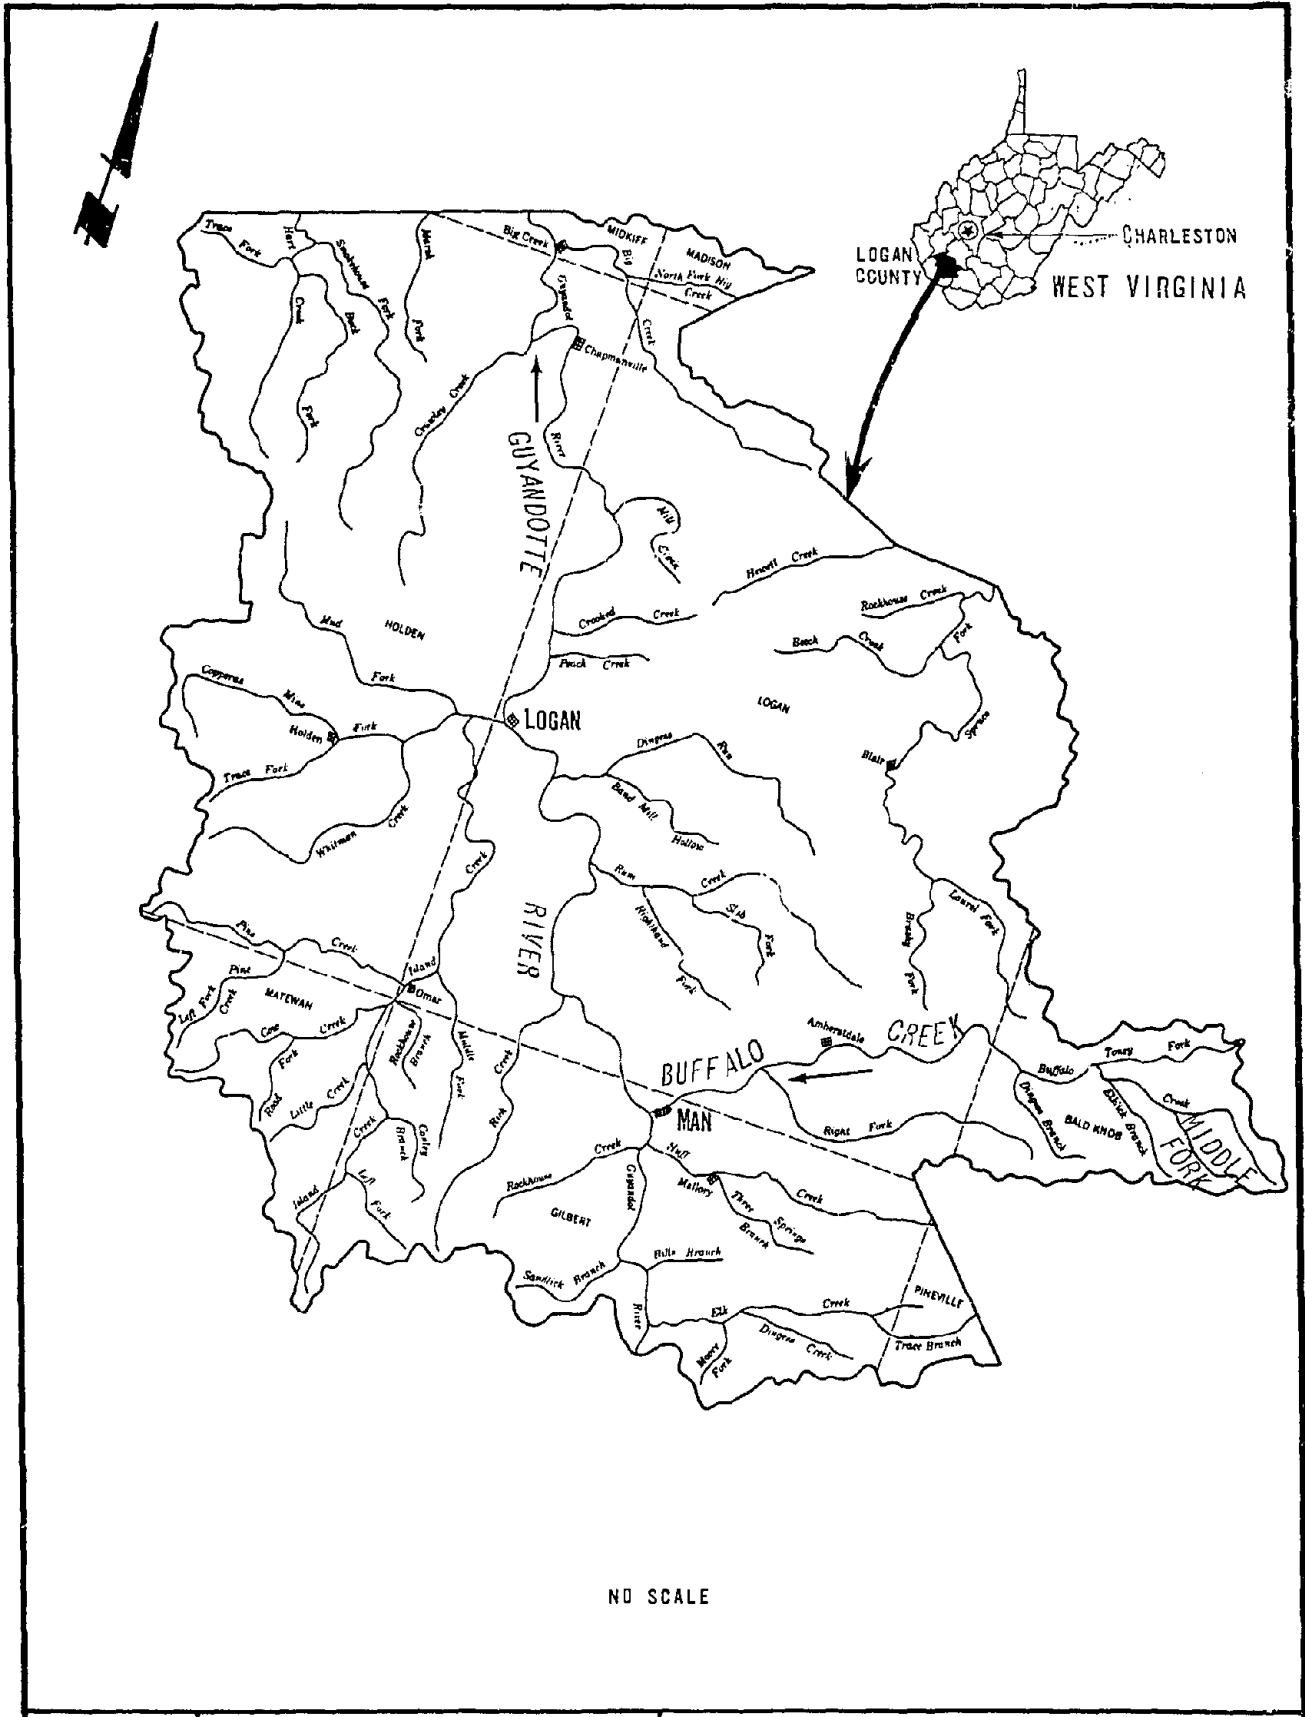
The topography of southwestern West Virginia, and the Buffalo Creek area, is characterized by rugged hills. The action of numerous small streams has completely dissected the Appalachian Plateau and created a region of high ridges and sharp, V-shaped valleys. The heavily forested valley walls generally slope at about 2.0 H to 1.0 V; a dense growth of bushes and small trees comprises most of the ground cover. The surrounding hills attain a maximum elevation of 2,850 feet above sea

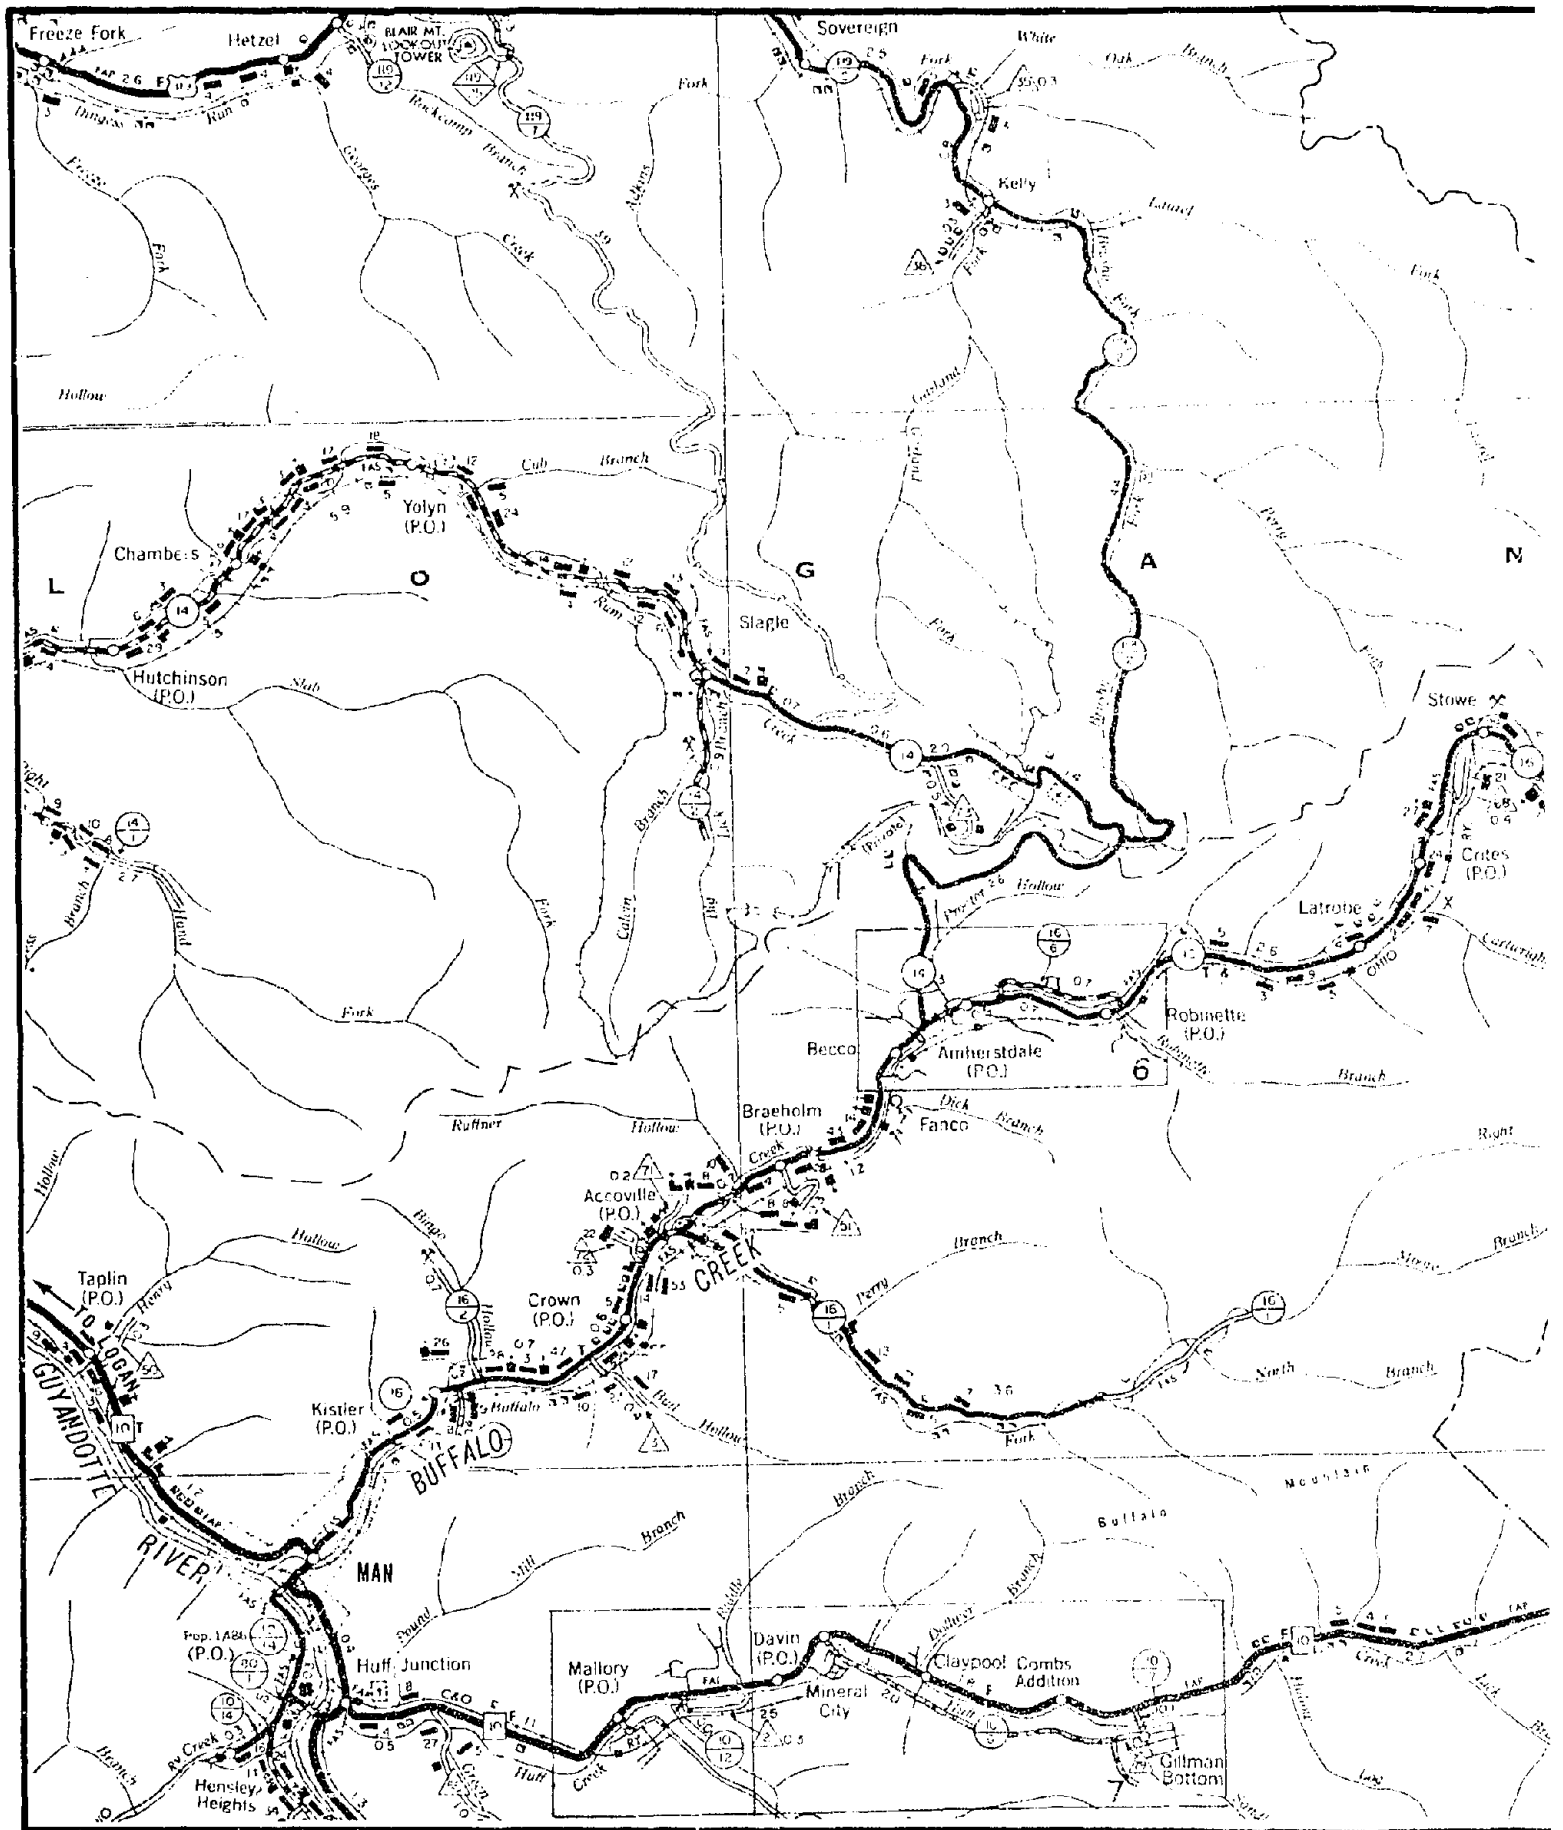
W. A. WAHLER & ASSOCIATES	COAL REFUSE DAM FAILURE SAUNDERS, WEST VIRGINIA		LOGAN COUNTY MAP	
	PROJECT NO. 0700	DATE NOVEMBER 1972	DRAWING NO. 111-1	
PALO ALTO • NEWPORT BEACH • CALIF.

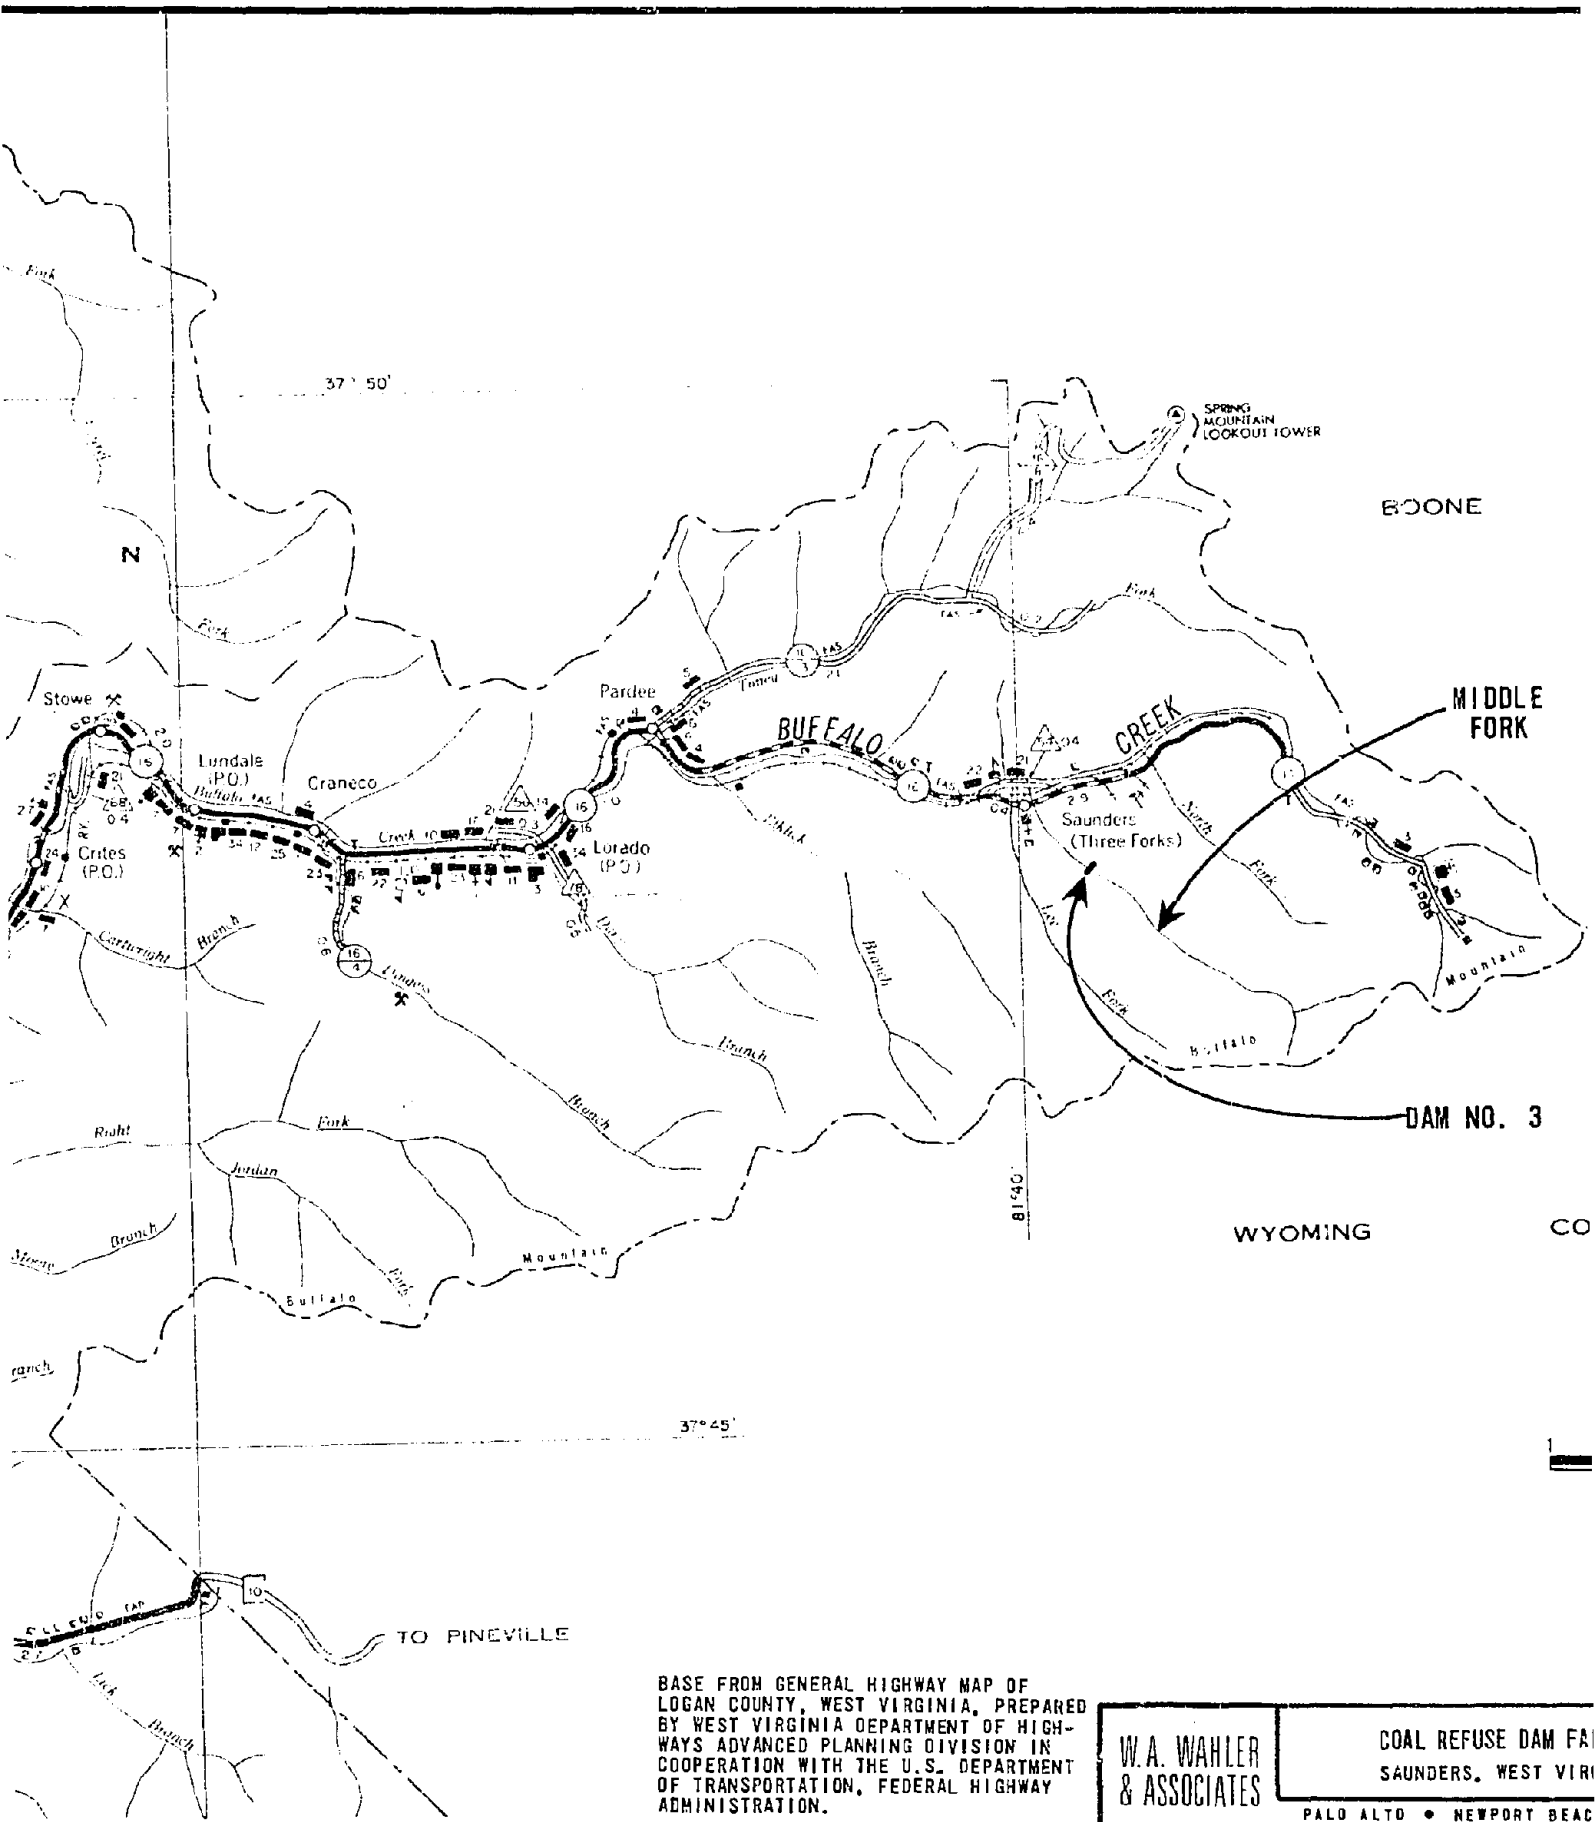
BASE FROM GENERAL HIGHWAY MAP OF LOGAN COUNTY, WEST VIRGINIA, PREPARED BY WEST VIRGINIA DEPARTMENT OF HIGHWAYS ADVANCED PLANNING DIVISION IN COOPERATION WITH THE U. S. DEPARTMENT OF TRANSPORTATION, FEDERAL HIGHWAY ADMINISTRATION.

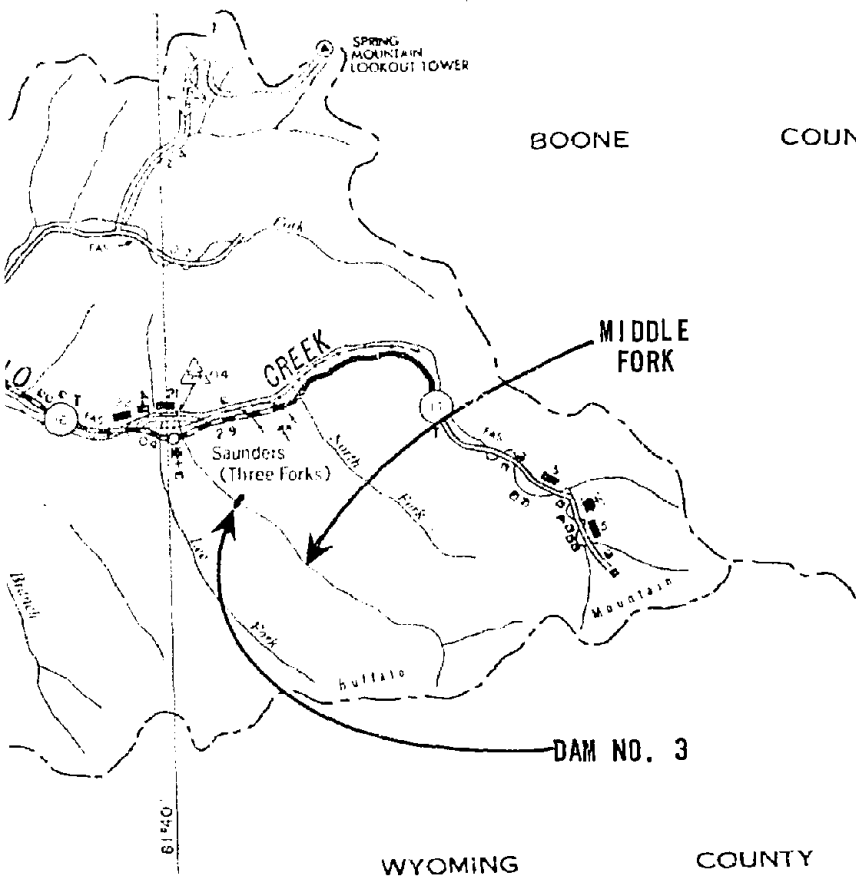
HIGHWAY MAP OF
 VIRGINIA, PREPARED
 DEPARTMENT OF HIGH-
 WING DIVISION IN
 IE U.S. DEPARTMENT
 FEDERAL HIGHWAY

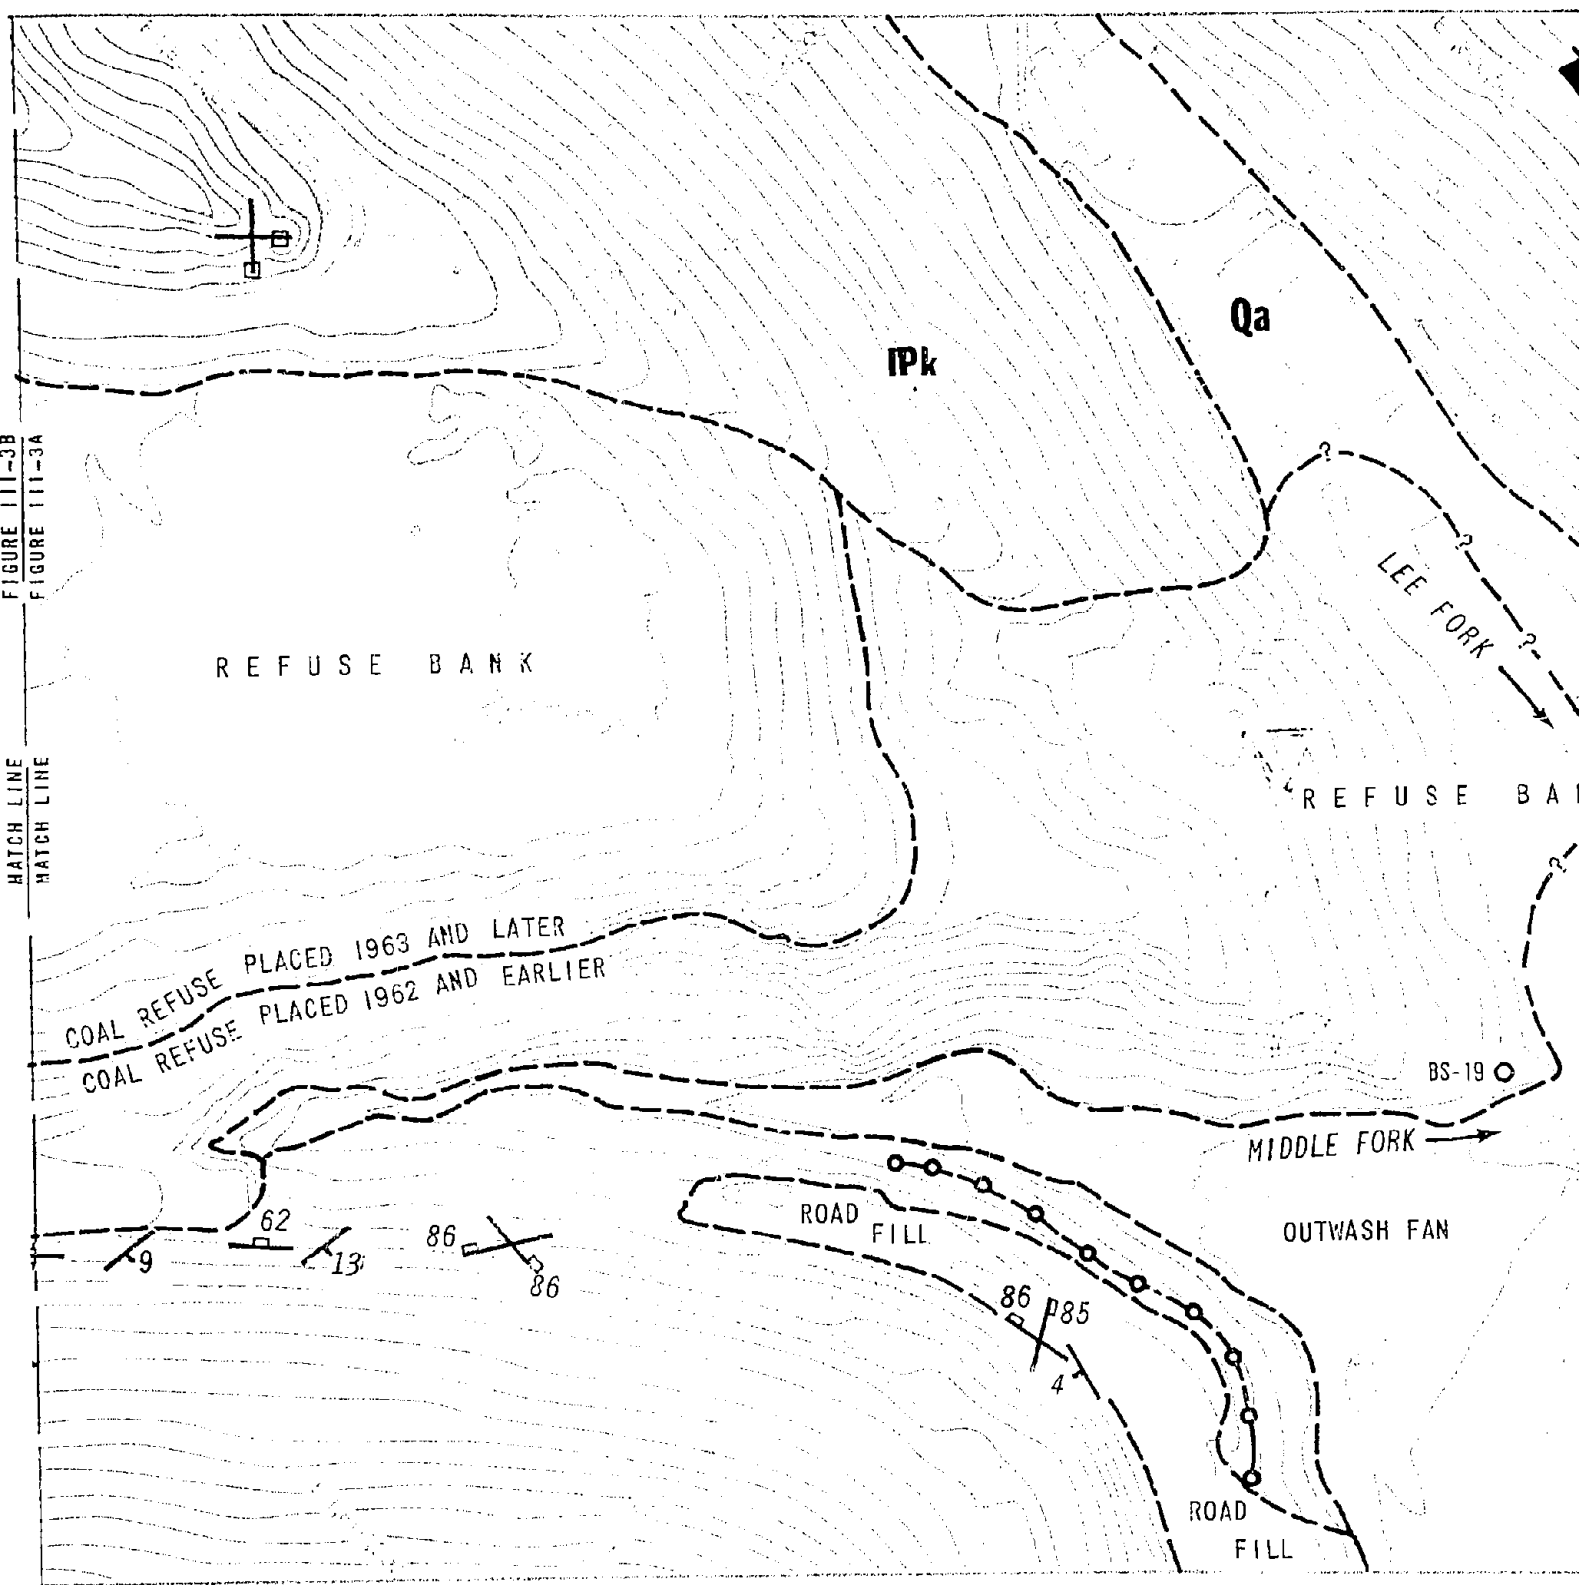
- NOTES: (1) GEOLOGIC MAPPING BASED ON TOPOGRAPHY AS OF APRIL 9, 1972. (5) FOR PRE-FAILURE TOPOGRAFI
- (2) SELECTED EXPLORATION FEATURES ONLY ARE SHOWN. FOR DETAILED GEOLOGY AND EXPLORATION OF DAM NO. 1 TO DAM NO. 3 AREA SEE FIGURE VI-20. (4) FIELD DENSITY, CONE PENI TESTS ARE SHOWN ONLY ON FIGURE VI-20.

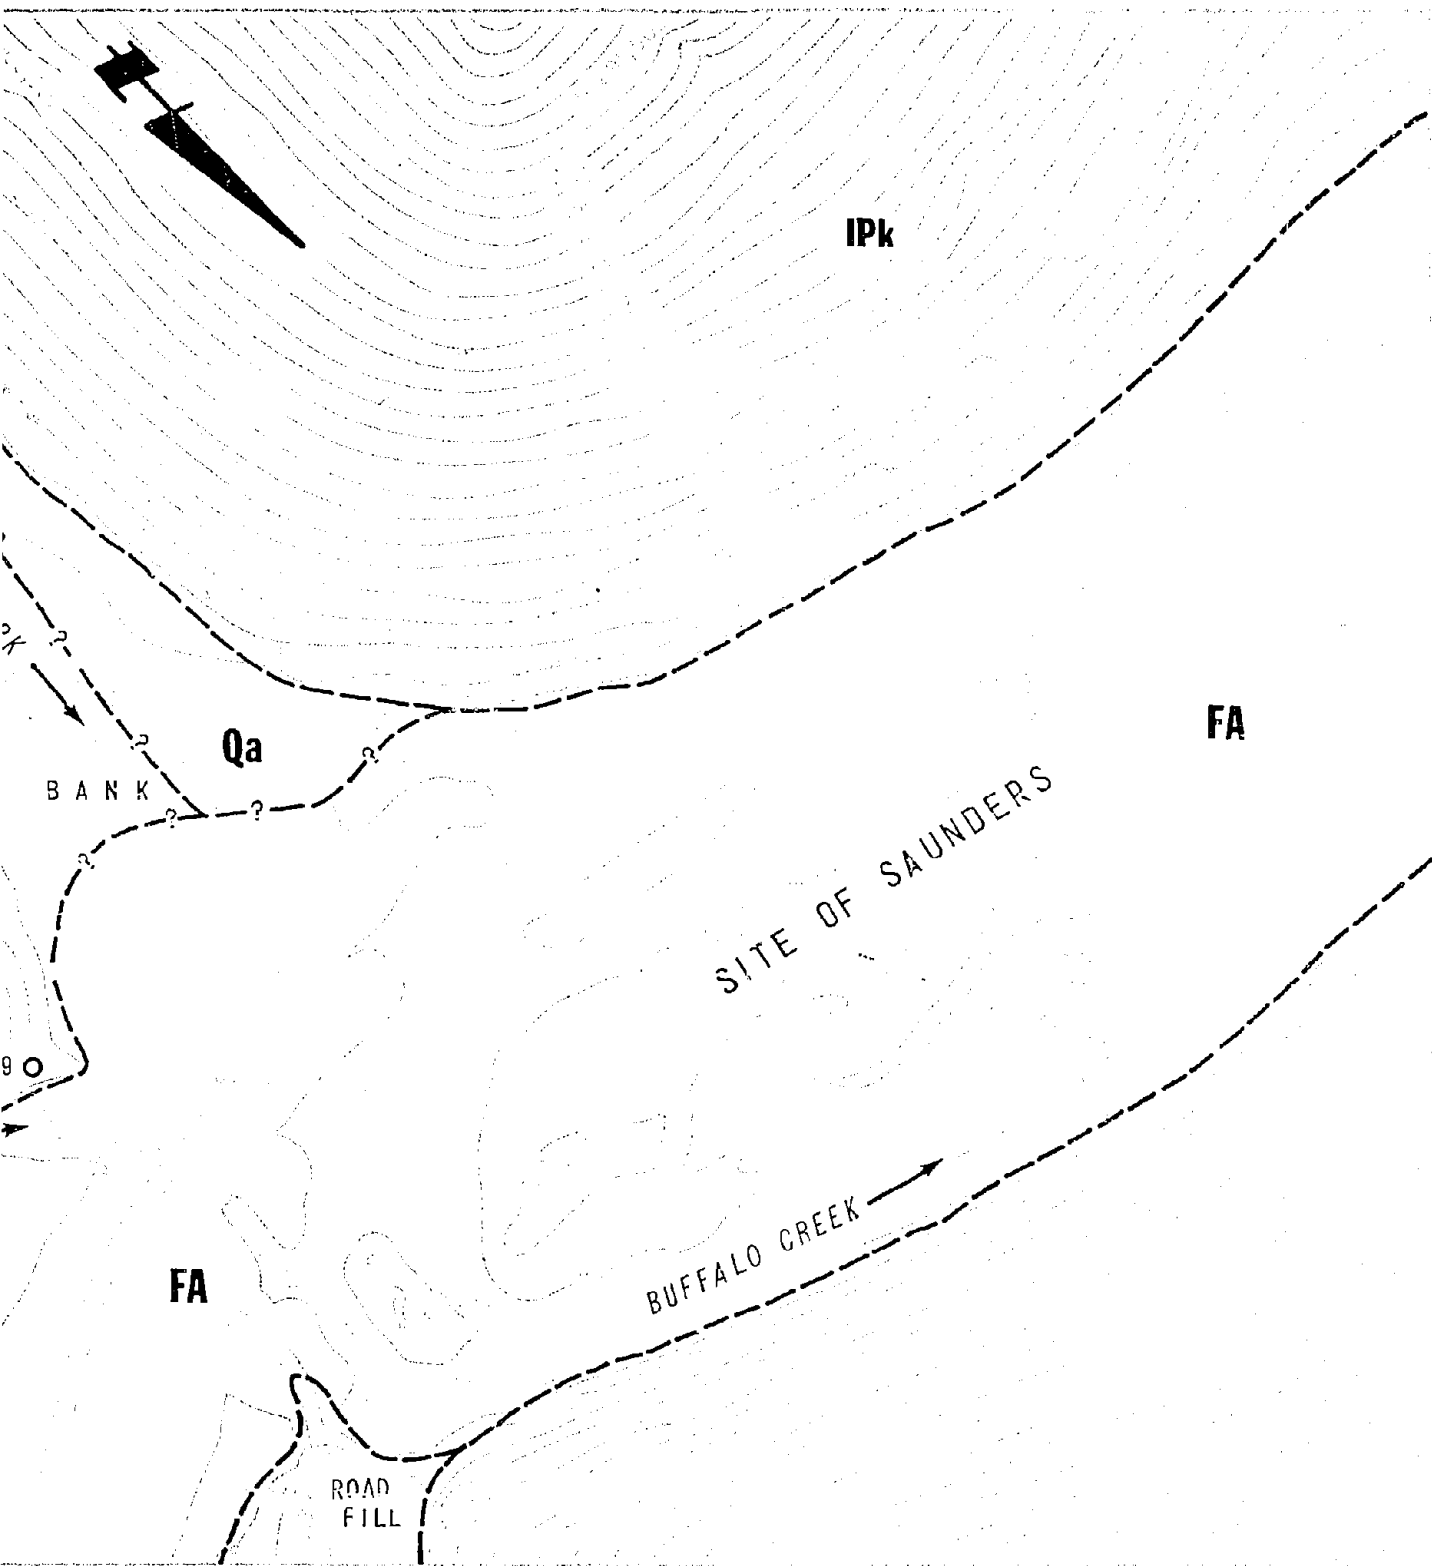
TOPOGRAPHY SEE FIGURE V-16.

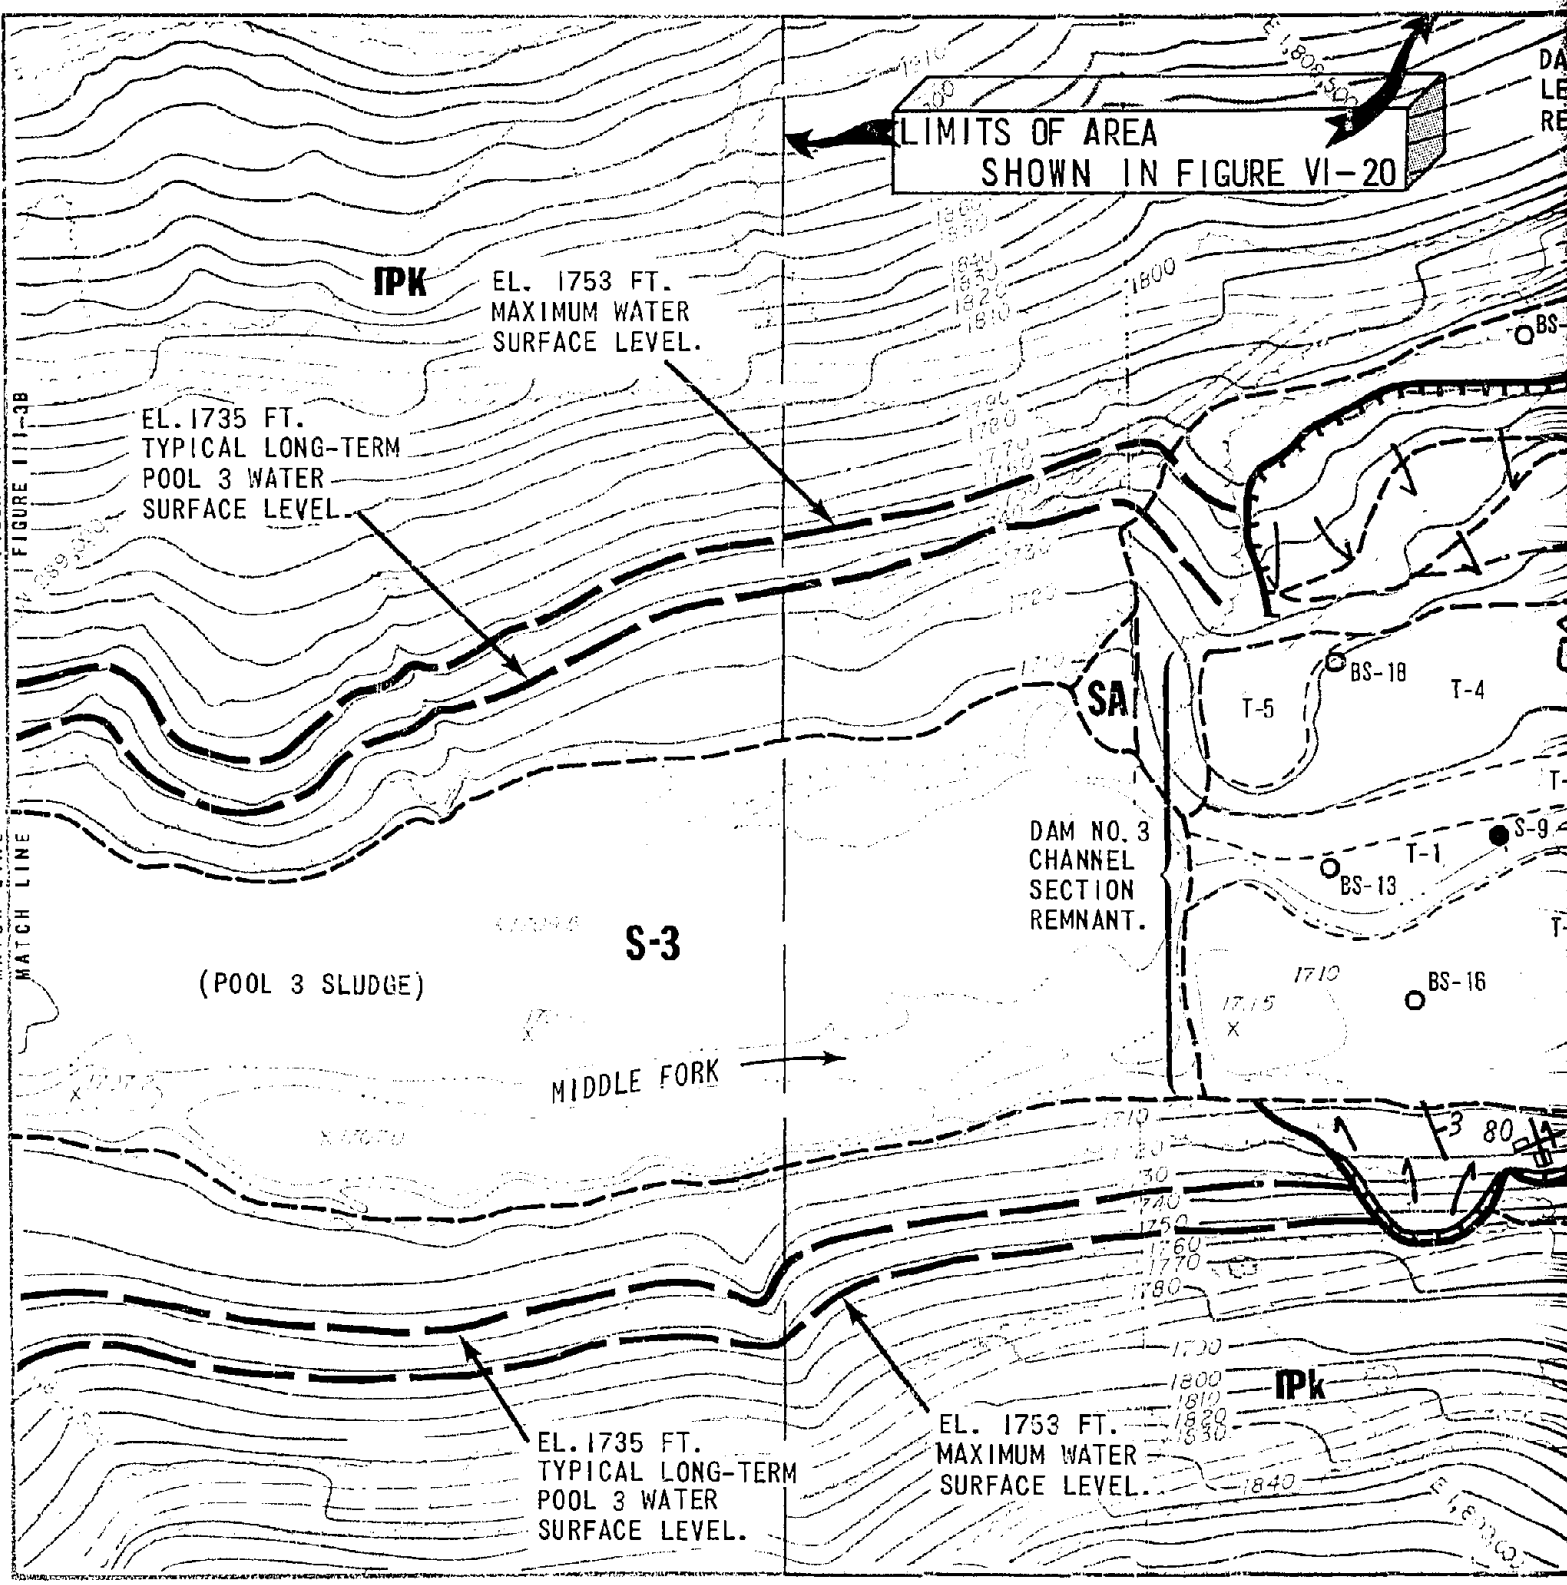
BASE MAP BY MICHAEL BAKER, JR., INC.,
COMPILED FROM AERIAL PHOTOS FLOWN ON
4/9/72.

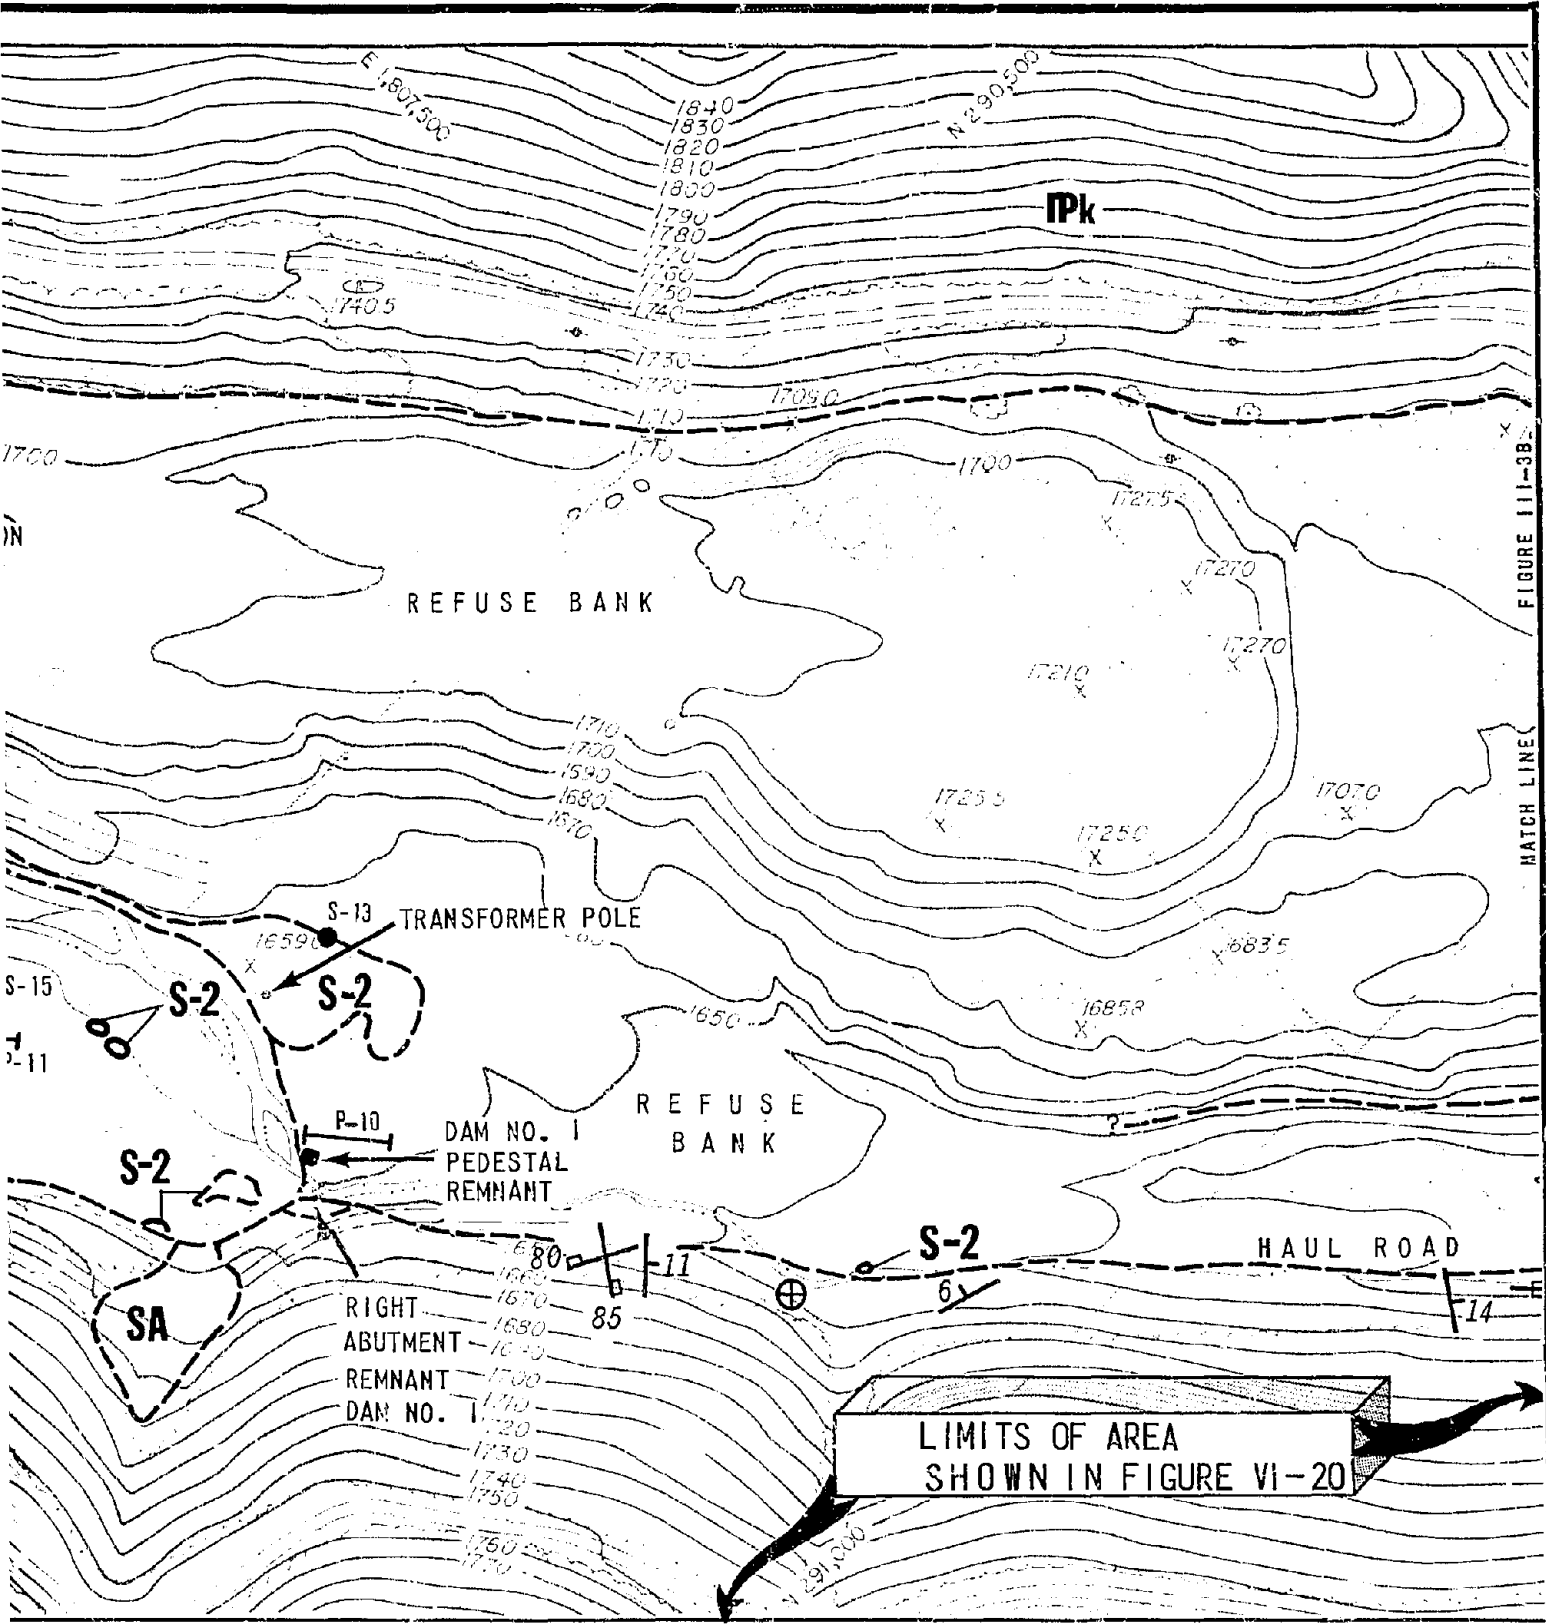
FIGURE III-38
 FIGURE III-3A
 MATCH LINE
 MATCH LINE

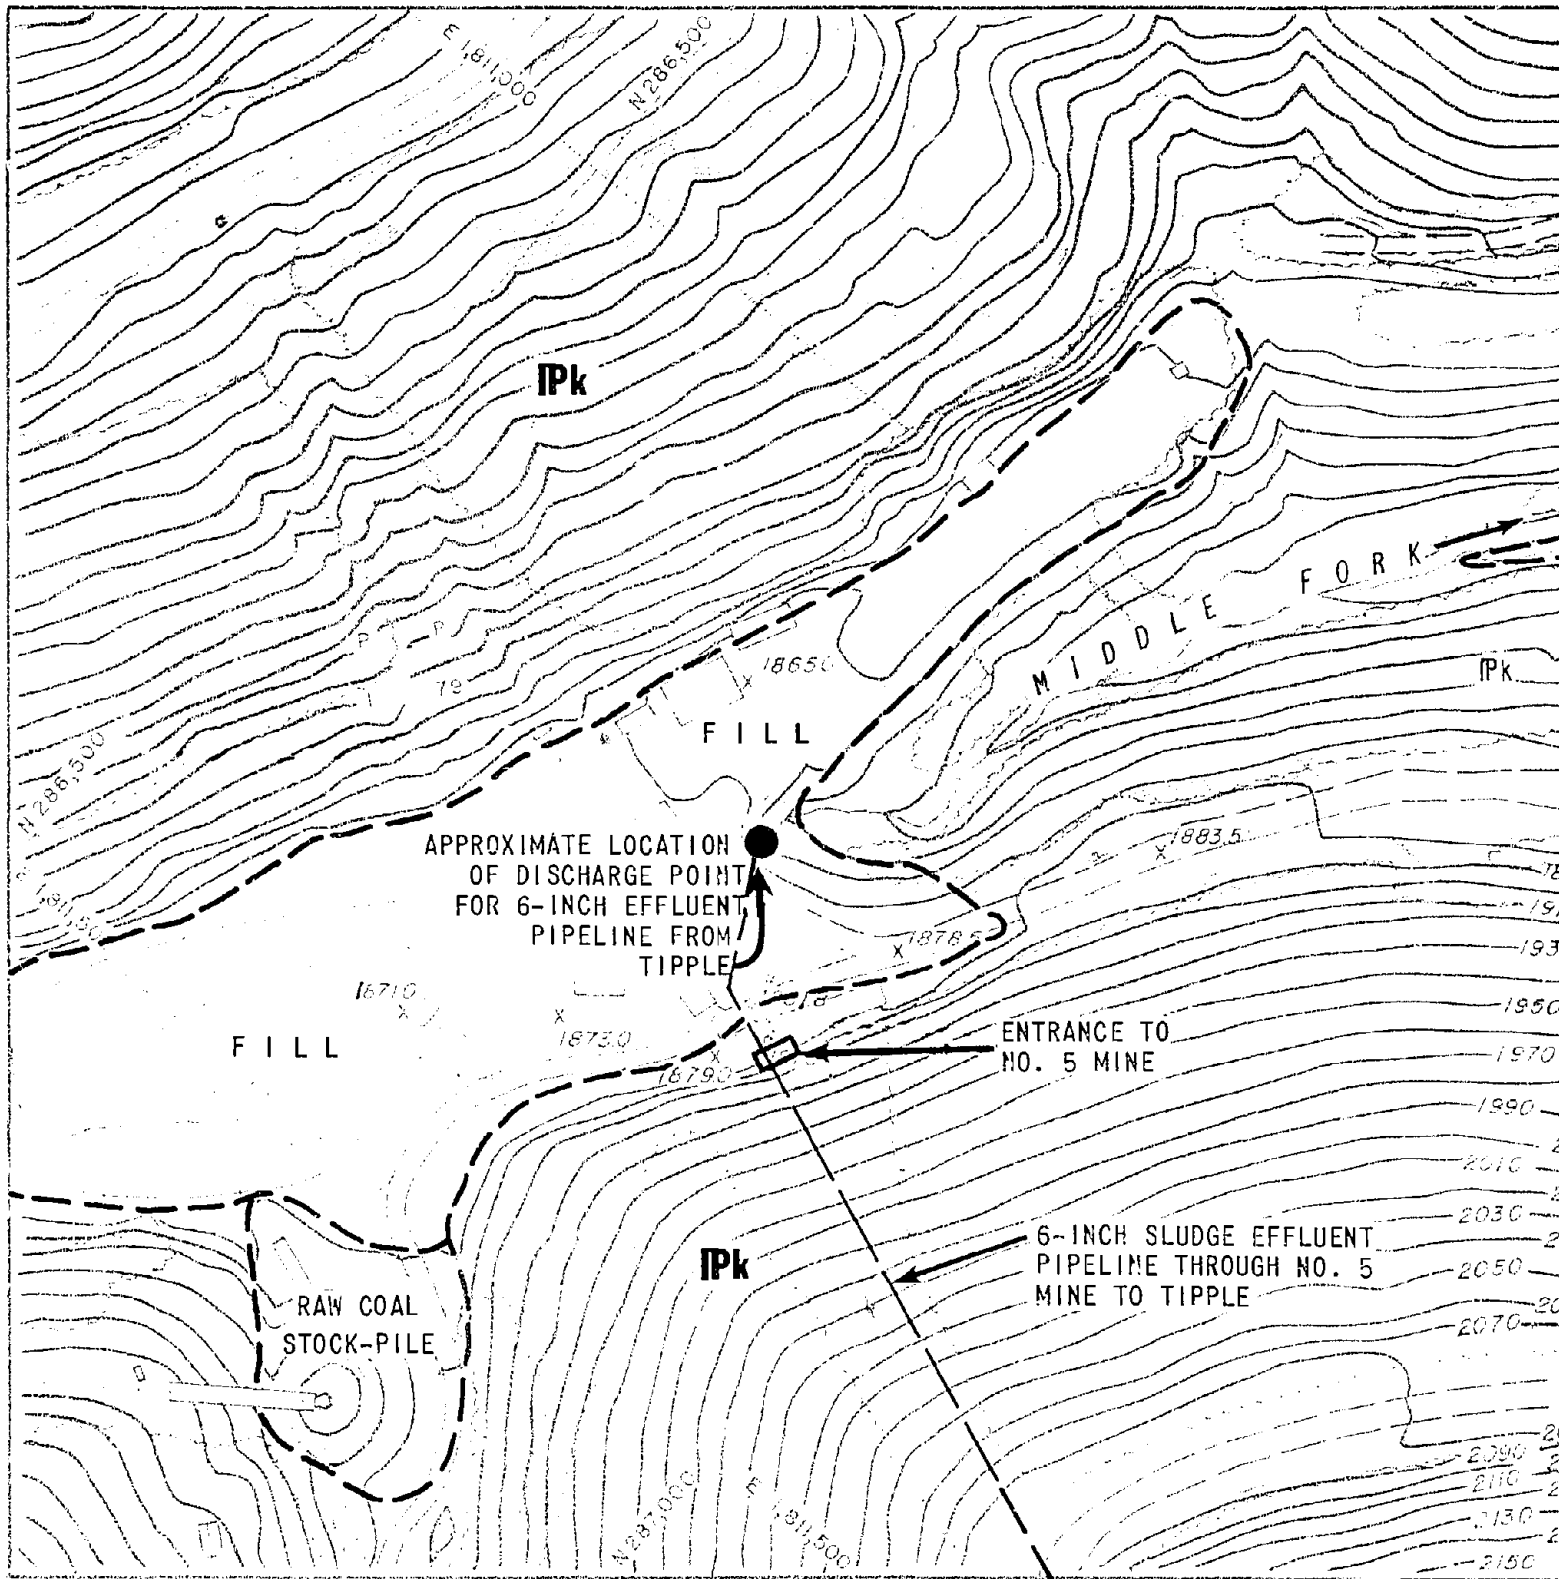
BASE MAP BY MICHAEL BAKER, JR., INC.,
 COMPILED FROM AERIAL PHOTOS FLOWN ON
 4/9/72.
