**ANALYSIS OF
COAL REFUSE DAM FAILURE**

**MIDDLE FORK BUFFALO CREEK
SAUNDERS, WEST VIRGINIA**

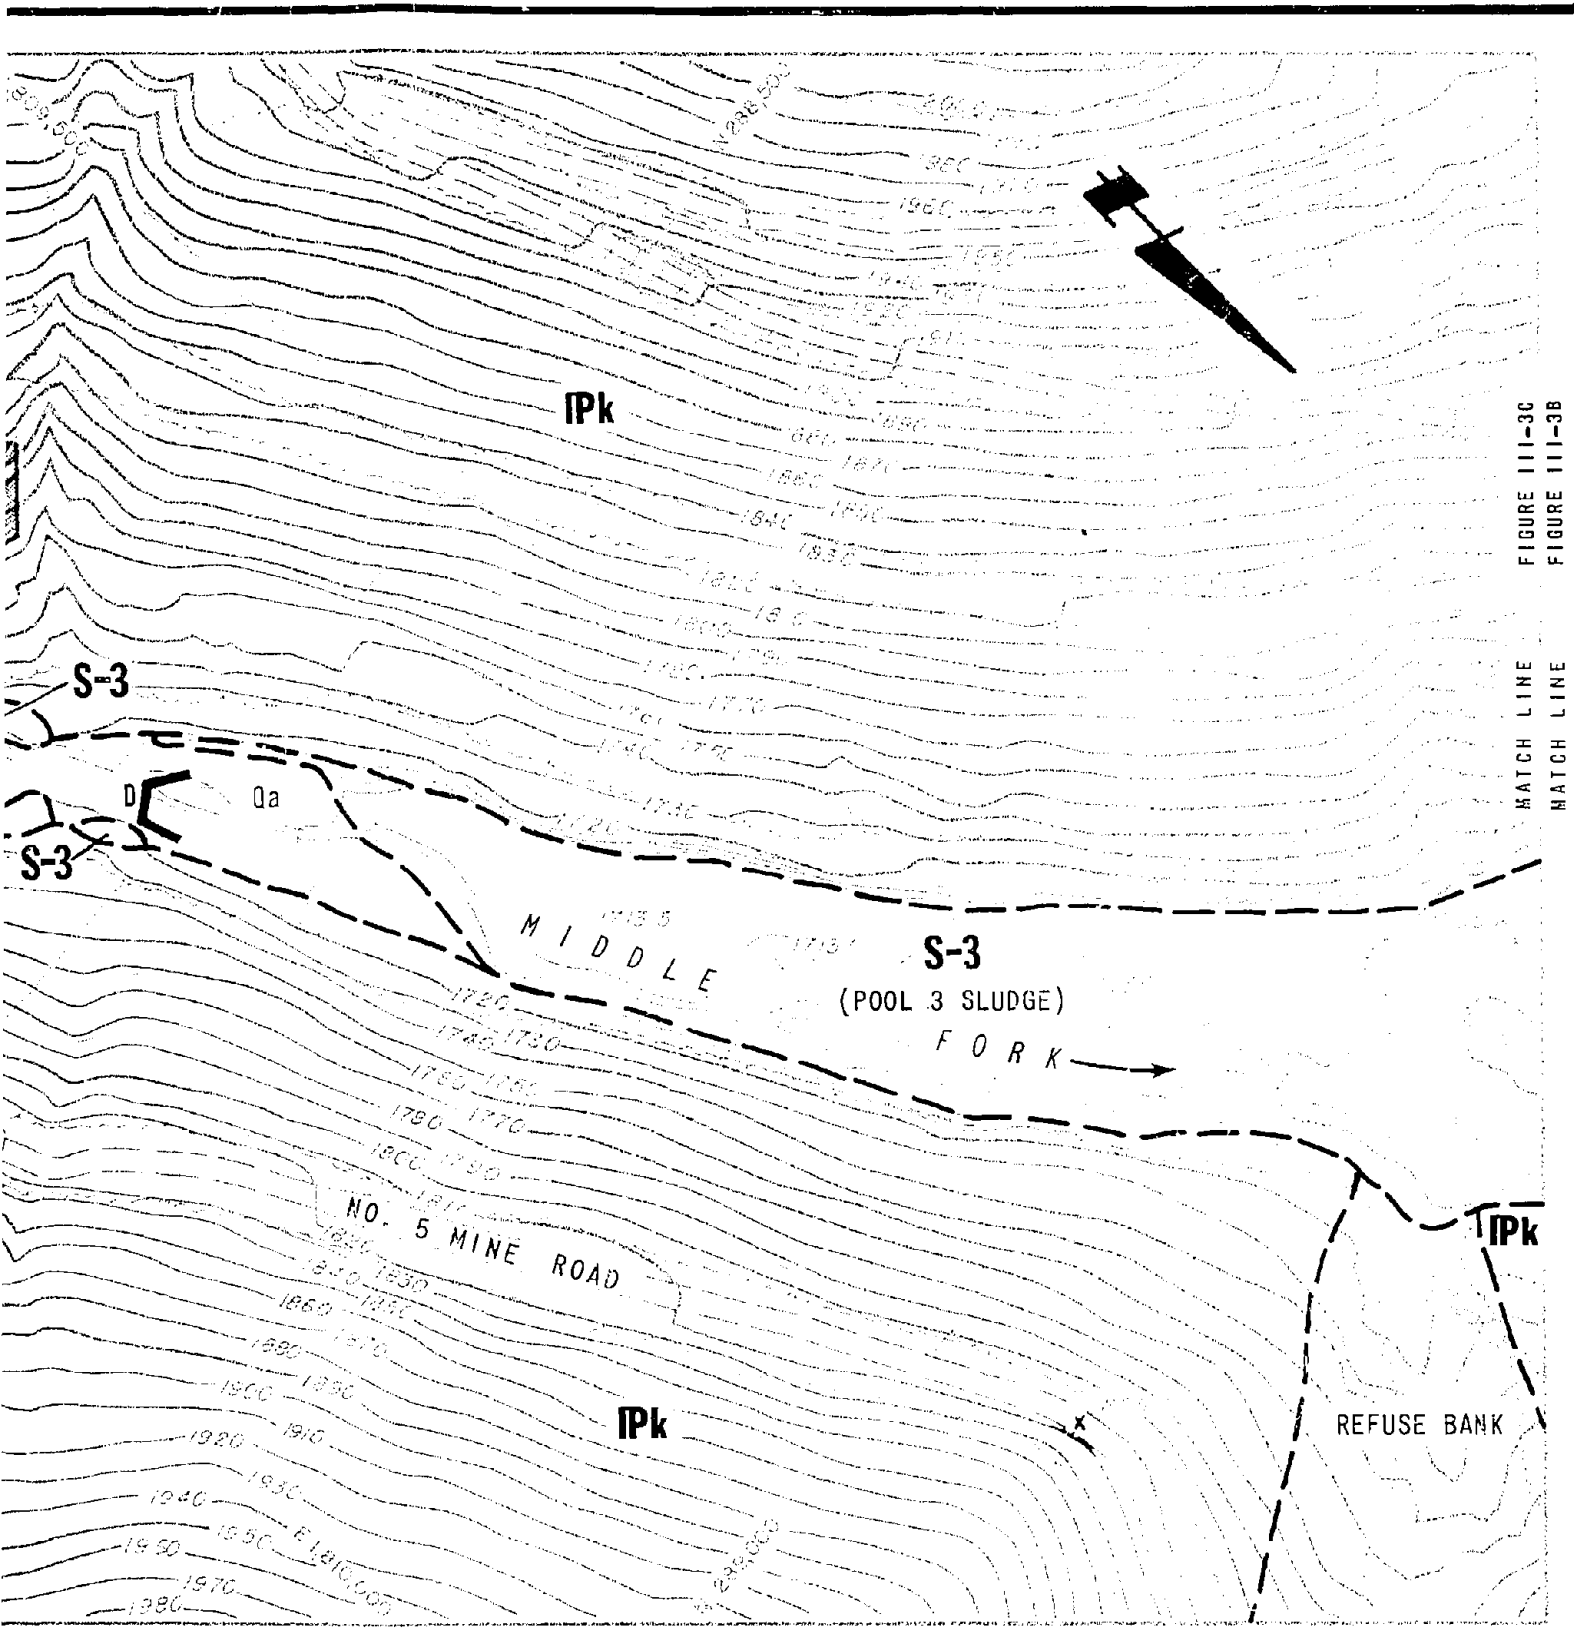
W. A. WAHLER & ASSOCIATES	COAL REFUSE DAM FAILURE SAUNDERS, WEST VIRGINIA	GENERALIZED GEOLOGIC AND EXPLORATION MAP MIDDLE FORK VALLEY		
		PROJECT NO	DATE	FIGURE NO
		0700	NOVEMBER 1972	111-3C

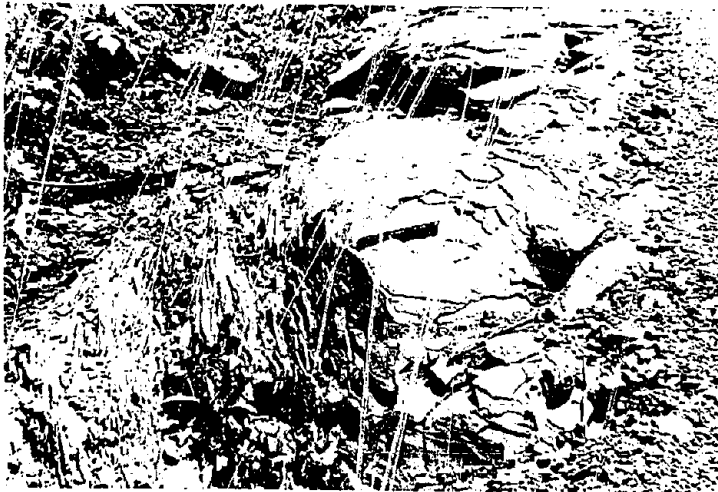
PHOTO B. SHALE ALONG NO. 5 MINE ROAD ABOVE POOL 2. THE FOLDING RULE LIES ON A BEDDING PLANE. LEFT OF THE RULE IS AN AREA OF VERY CLOSELY SPACED NEAR-VERTICAL JOINTS.

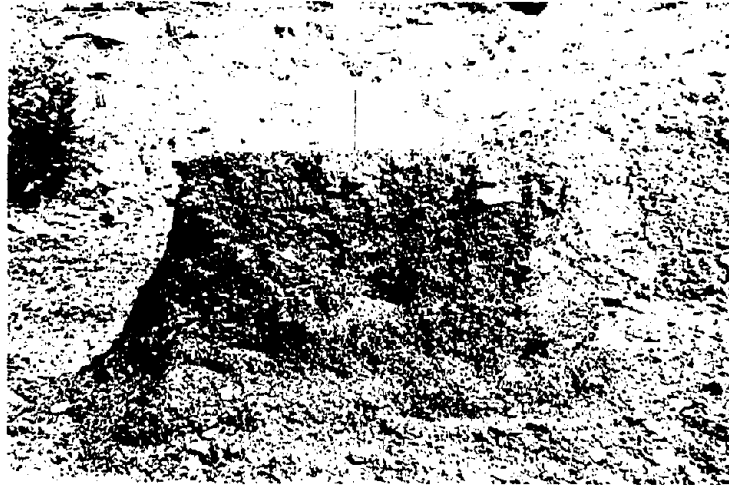
PHOTO A. DAM NO. 1 PEDESTAL REMNANT, SIDE VIEW
NOTE DIP OF GRAVEL FROM UPPER RIGHT TO LOWER
LEFT STAKE ON TOP IS TWO FEET HIGH.

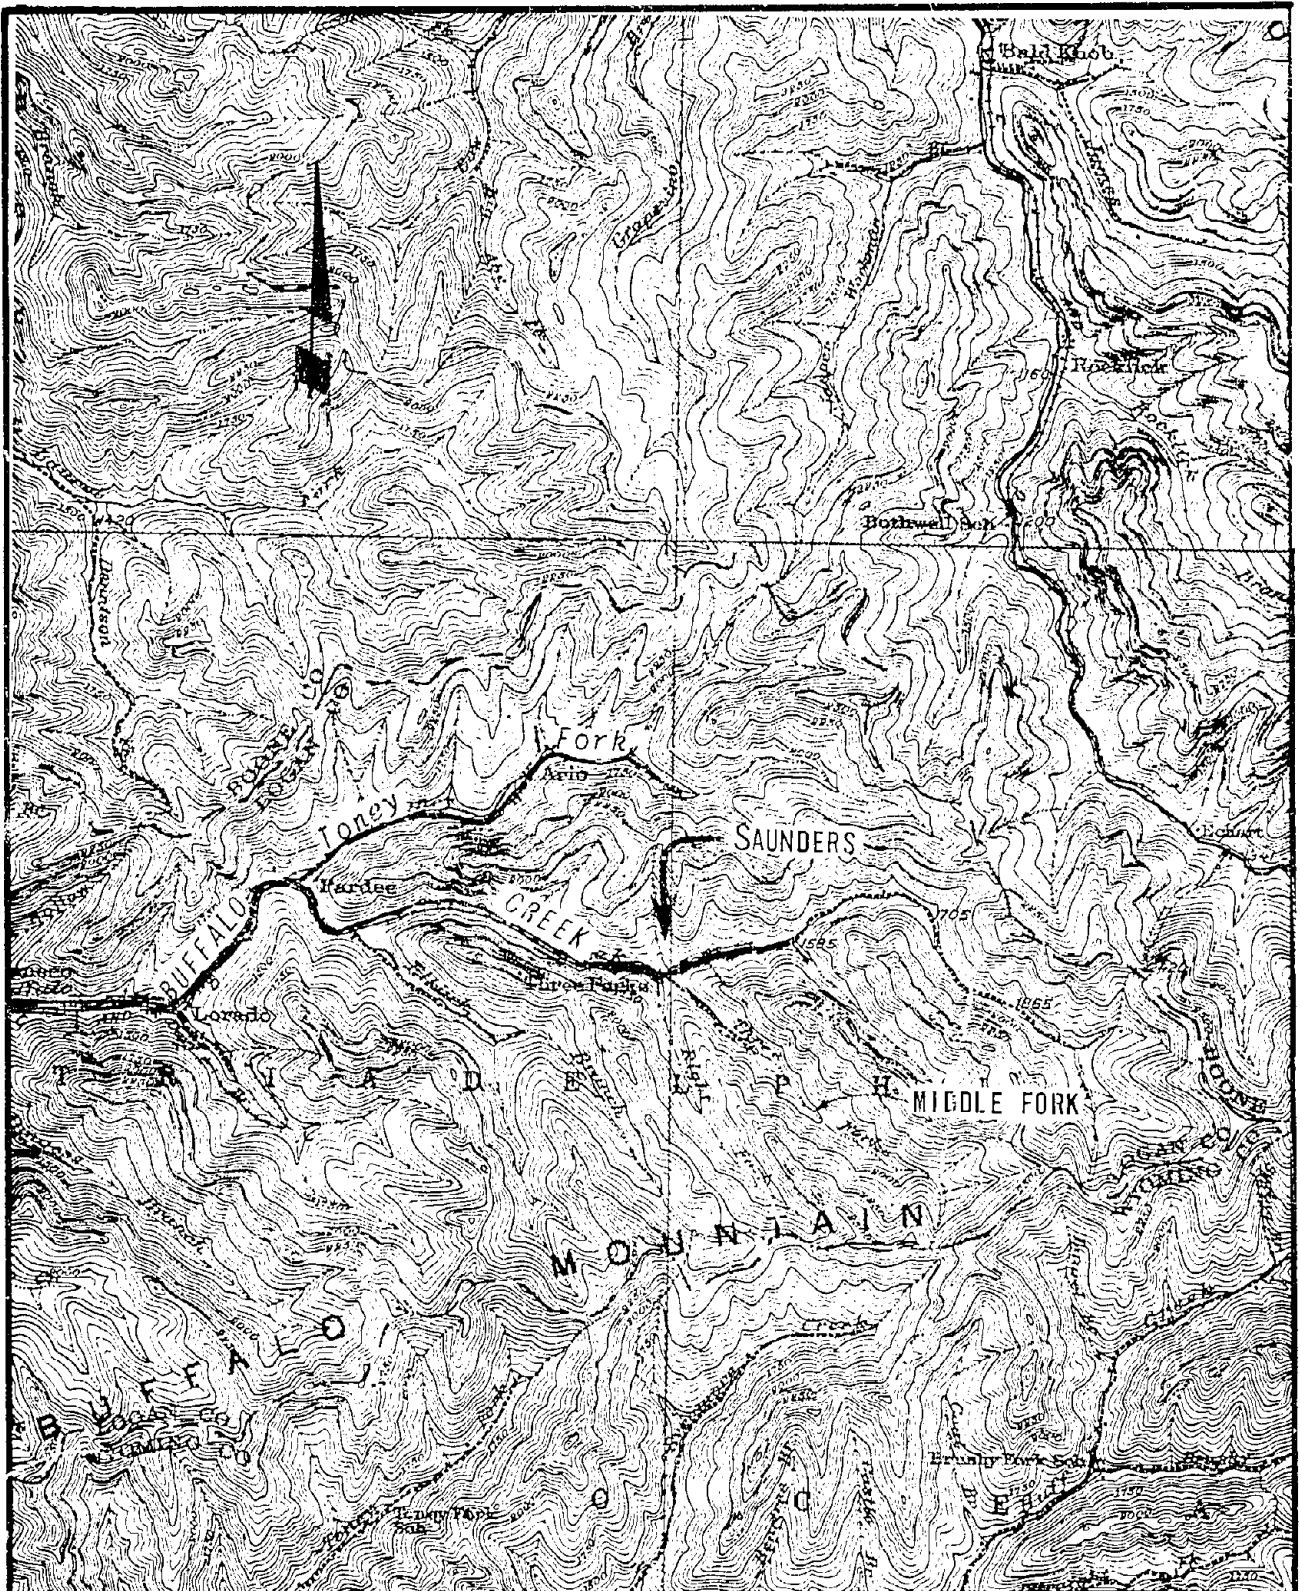
NOTE. MAP PUBLISHED IN 1914, LATEST REVISION 1928

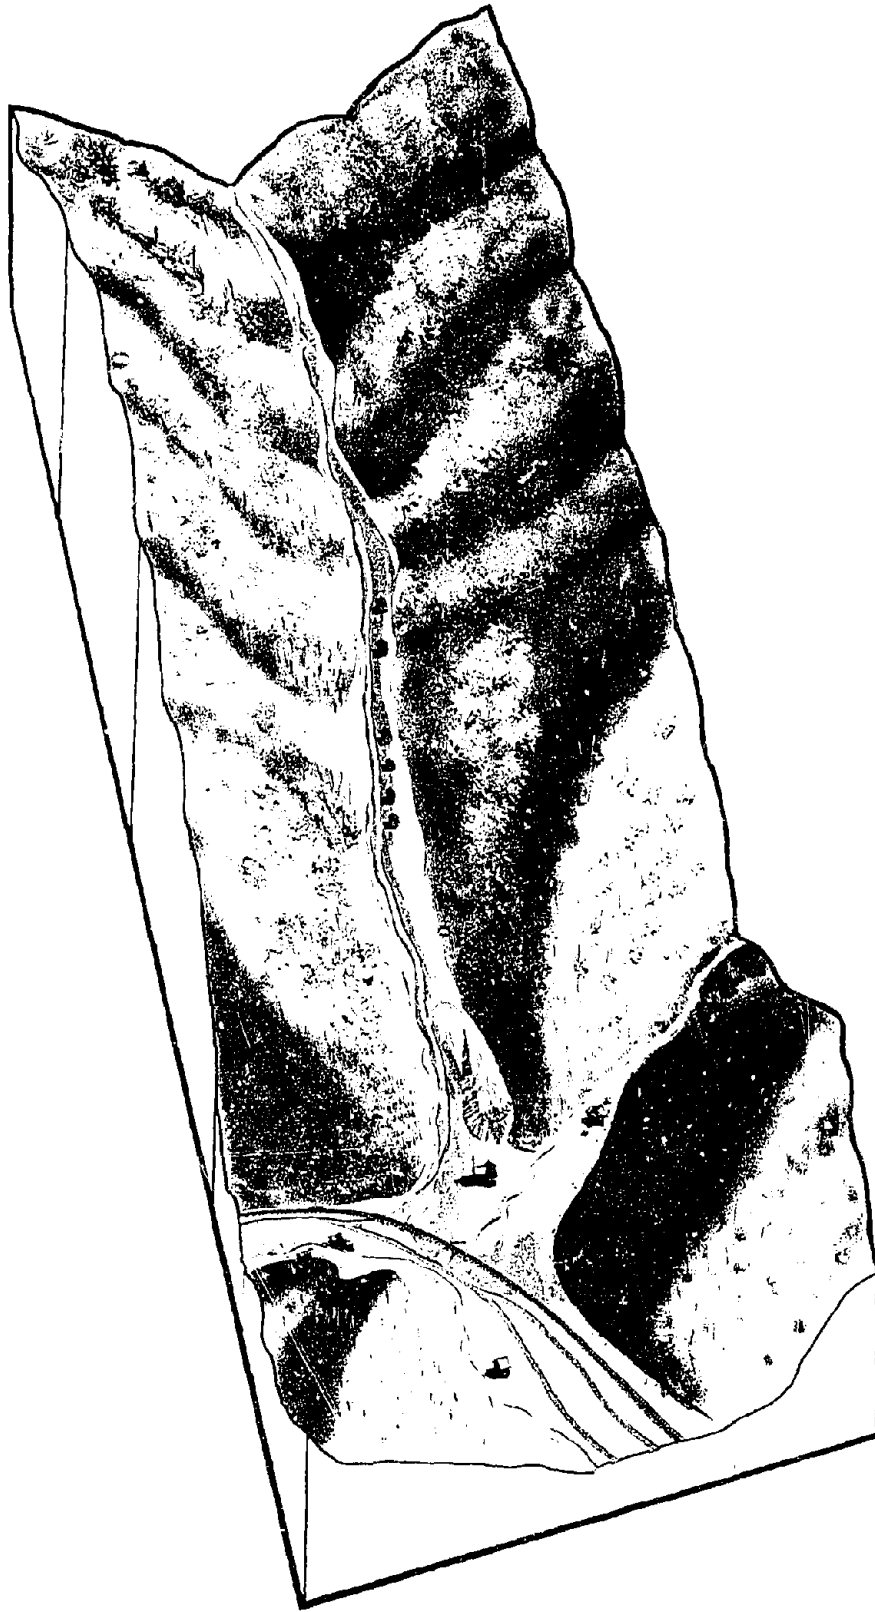
MIDDLE FORK VALLEY IN LATE 1947. THE REFUSE BANK HAS BEEN STARTED AT THE MOUTH OF THE VALLEY.

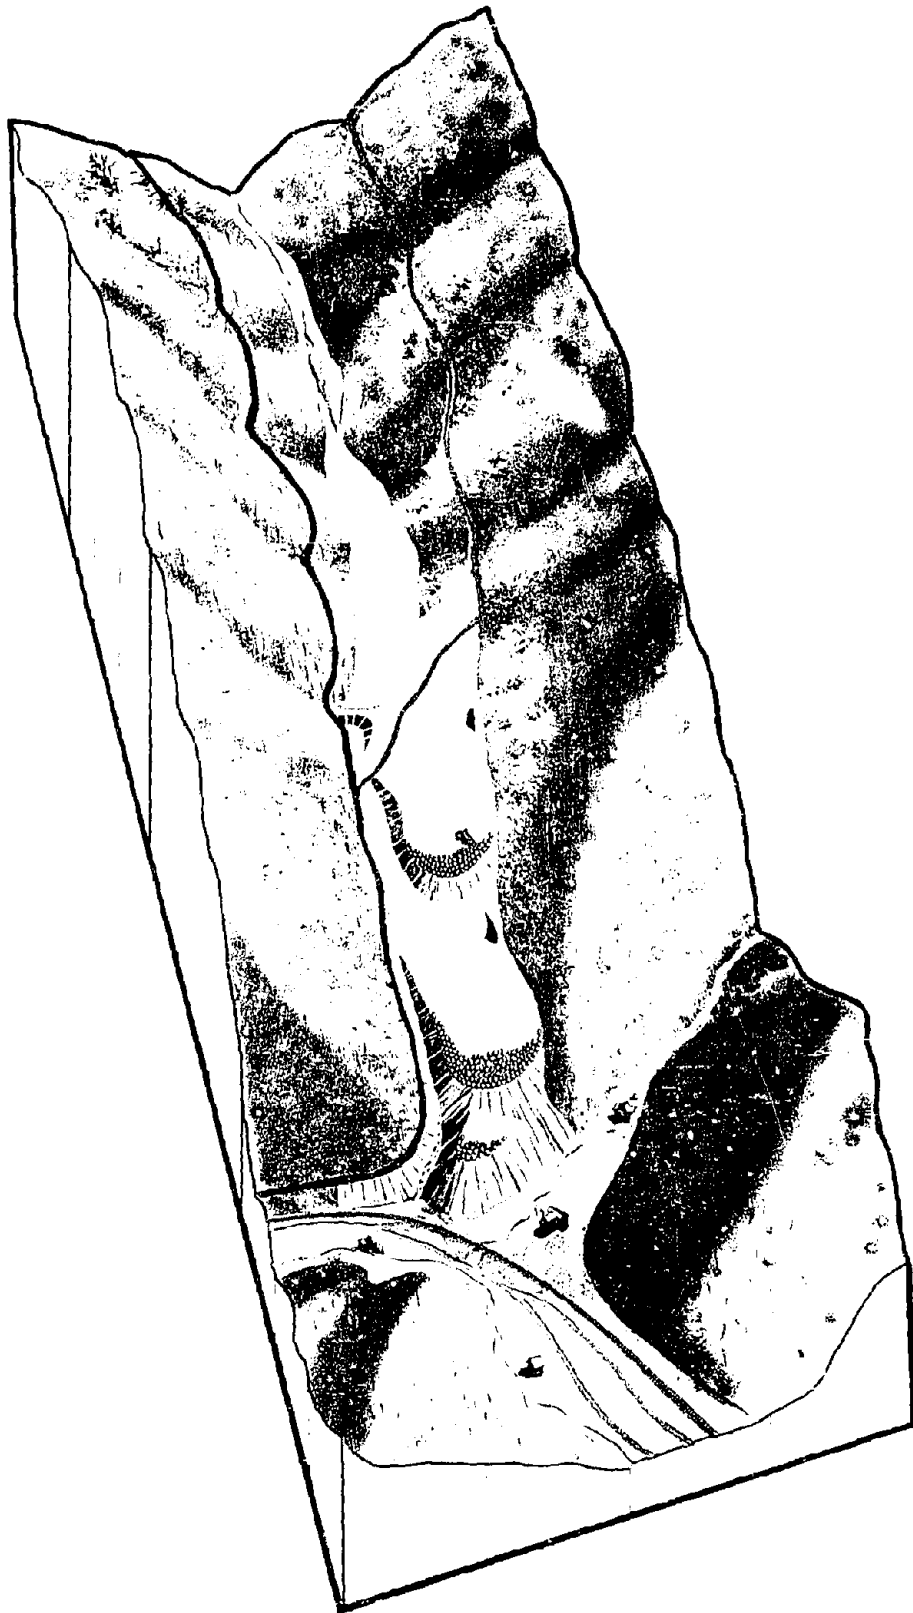
MIDDLE FORK VALLEY ON NOVEMBER 28, 1962. DAM NO. 1 AND THE REFUSE BANK ARE BOTH HIGHER AND HAVE PROGRESSED UPSTREAM. SKETCH BASED ON AERIAL PHOTOGRAPHS.

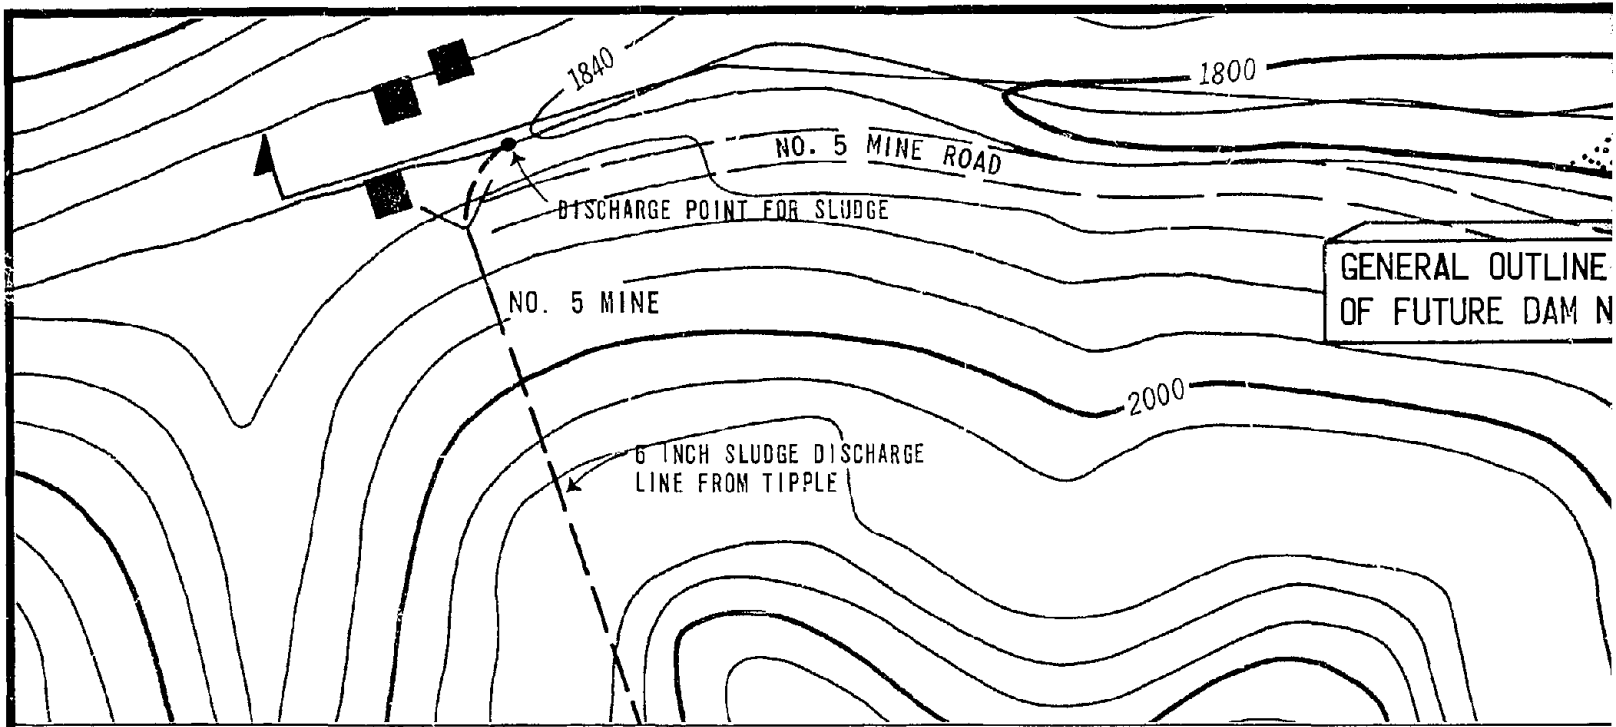
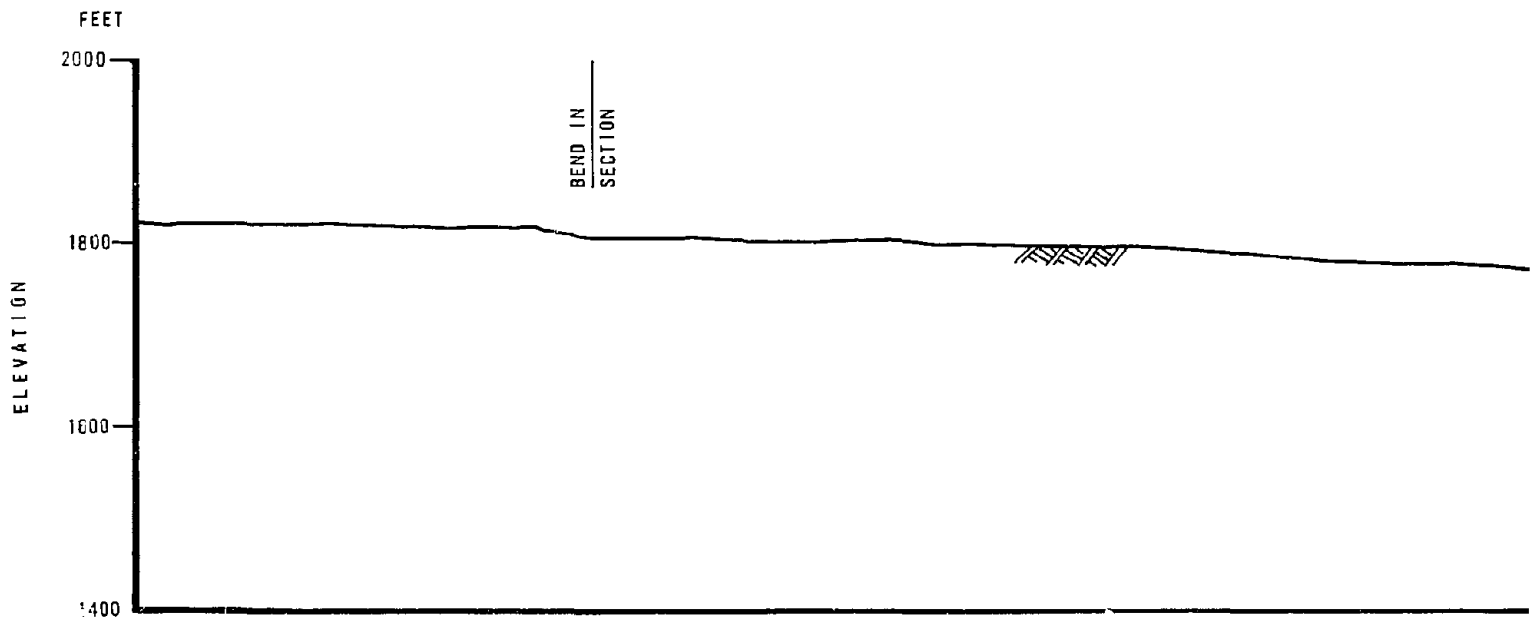
Figures V-10A, B, and C, based on portions of the 1968 Lorado (7.5 minute) quadrangle, show the configuration of the refuse bank, Dam No. 1, Dam No. 2 and their respective pools as of 1968. The locations of the Buffalo Mining Company tipple (preparation plant), the No. 5 Mine, and the discharge point for preparation plant waste water are also indicated.

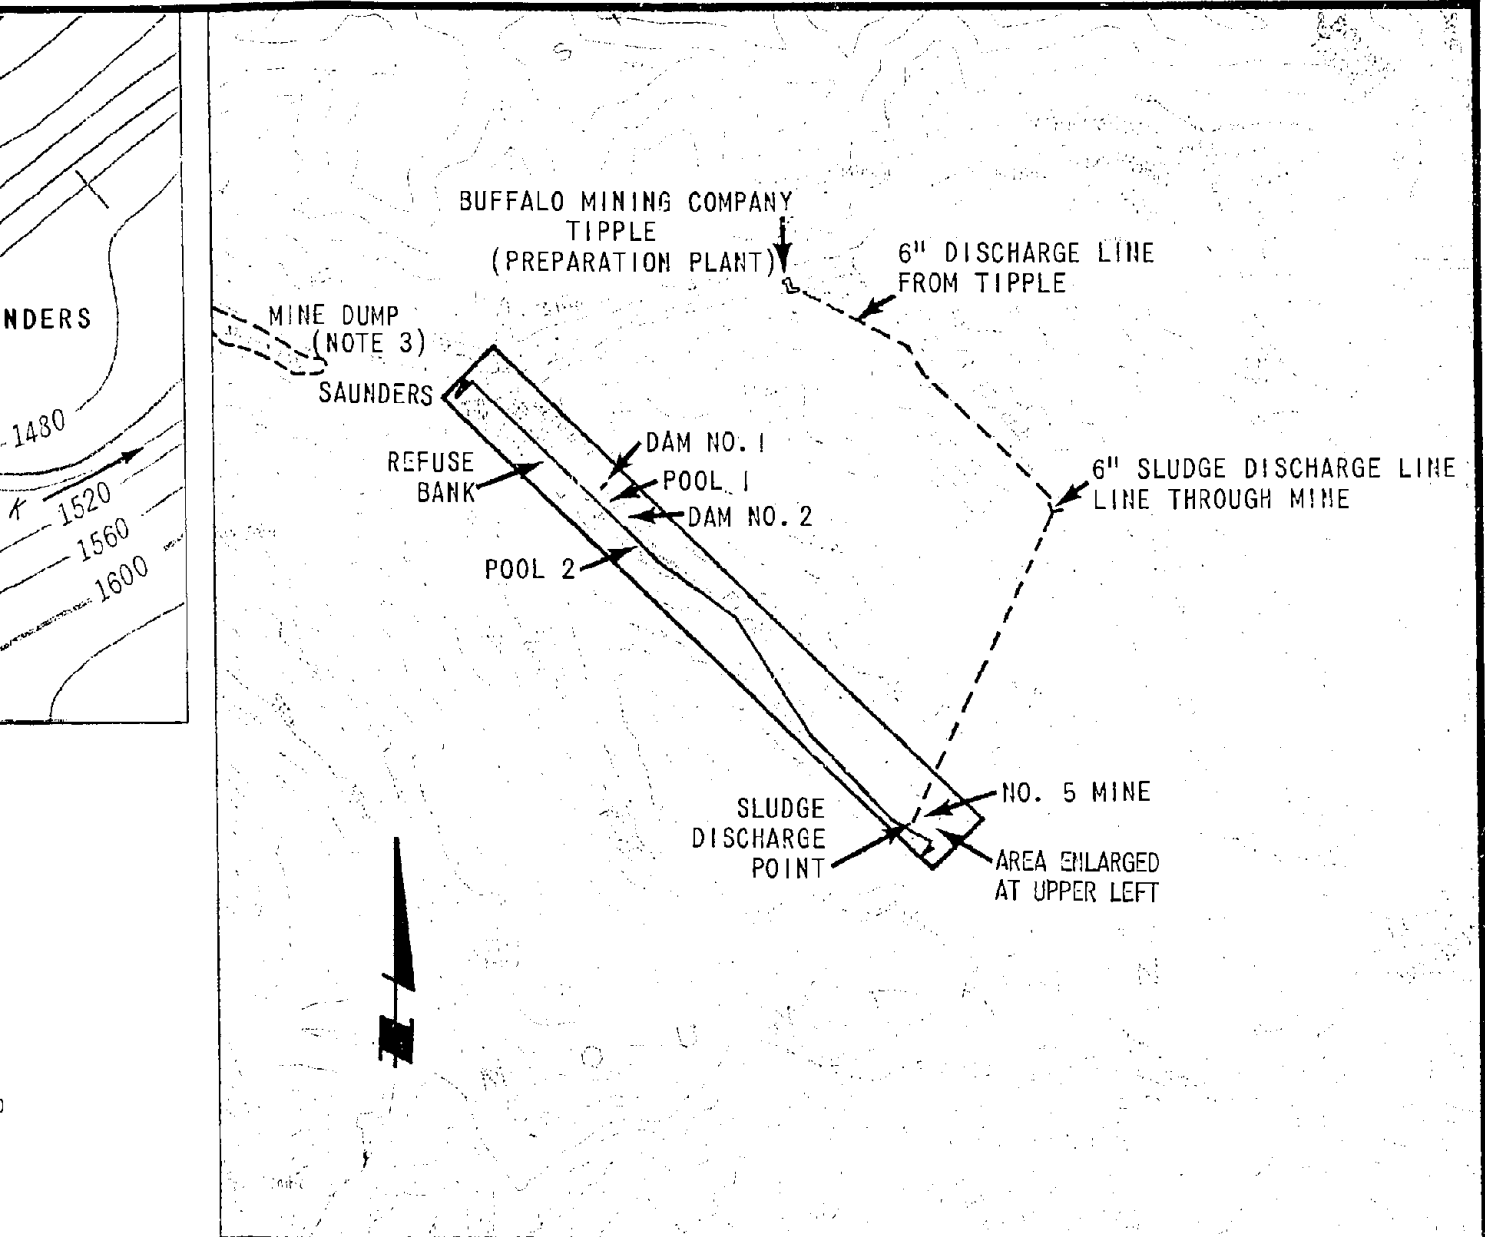
<p>W.A. WAHLER & ASSOCIATES</p>	<p>COAL REFUSE DAM FAILURE SAUNDERS, WEST VIRGINIA</p>
<p>PALO ALTO • NEWPORT BEACH • CALIF.</p>

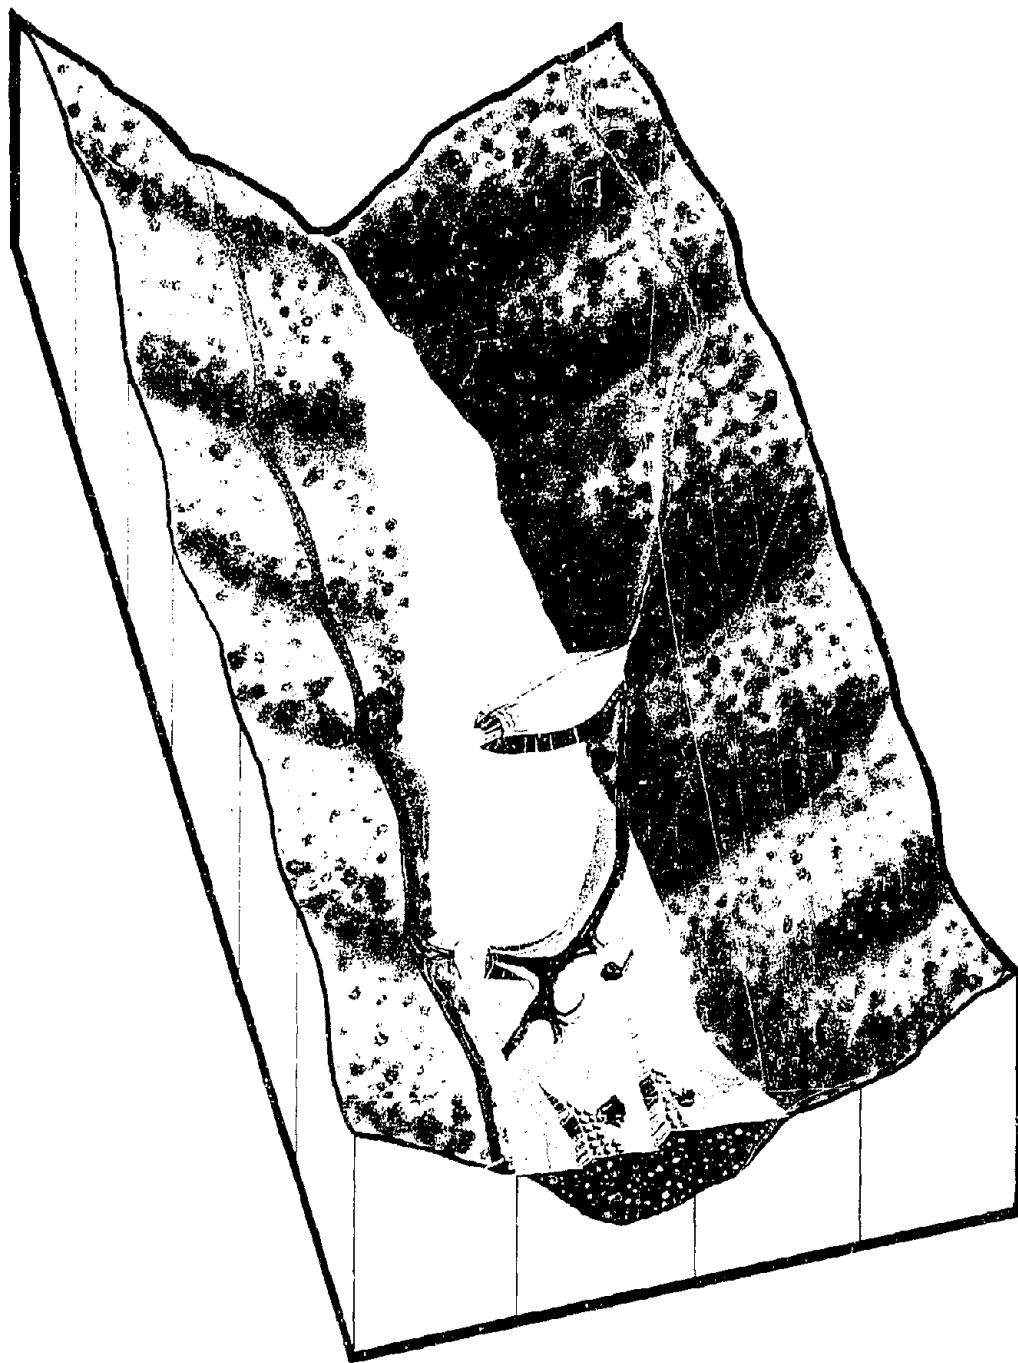
MIDDLE FORK VALLEY, MARCH 1967, LOOKING UPSTREAM. DAM NO. 1 HAS FAILED BY OVERTOPPING. DAM NO. 2 SUFFERS EROSION AND SLUMPING THROUGH INCOMPLETE AT THIS TIME.

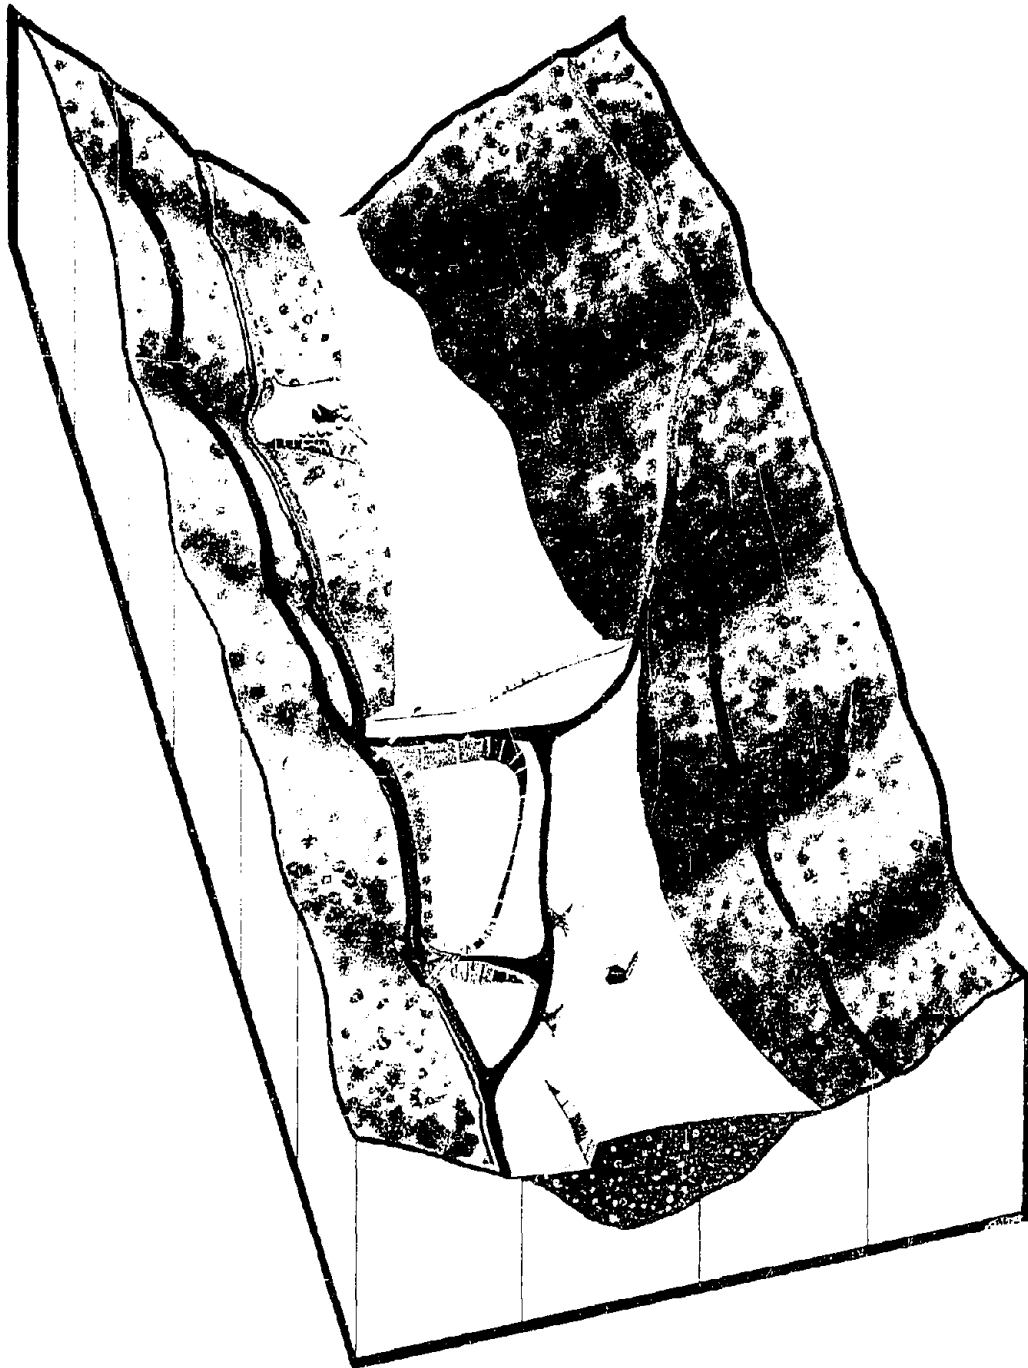
MIDDLE FORK VALLEY IN MID-1969, LOOKING UPSTREAM
A PLATFORM OF COAL WASTE AT ITS RIGHT ABUTMENT.
MAXIMUM EXTENT AND COVERS ONE-HALF OF POOL 1.

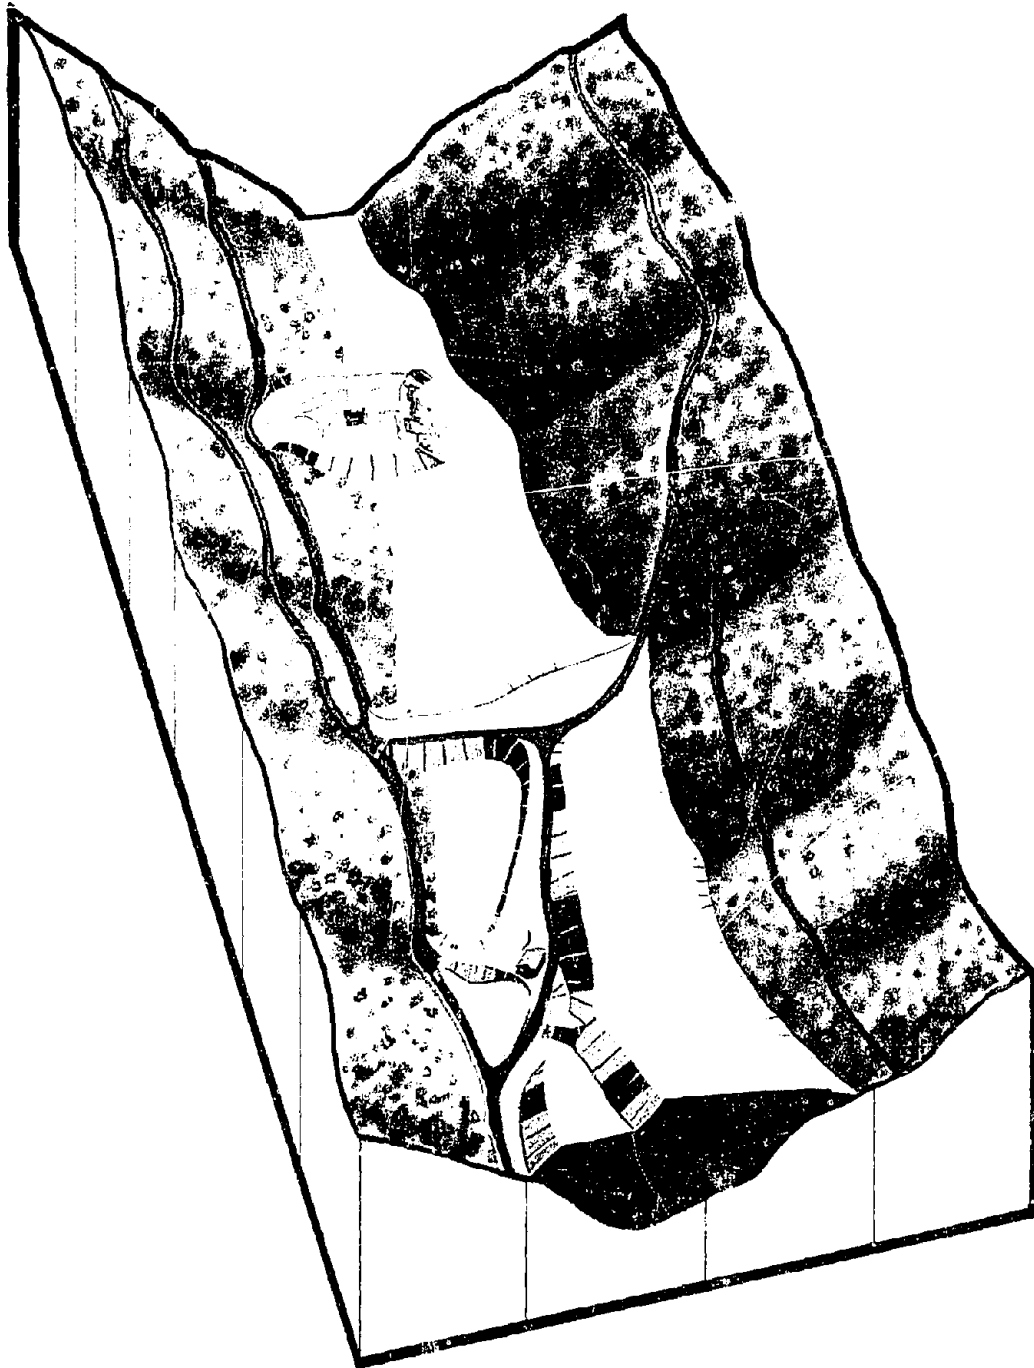
MIDDLE FORK VALLEY, FEBRUARY 1969, LOOKING UPSTREAM. THE ADVANCING FACE OF THE DAM NO. 3 EMBANKMENT HAS FAILED.

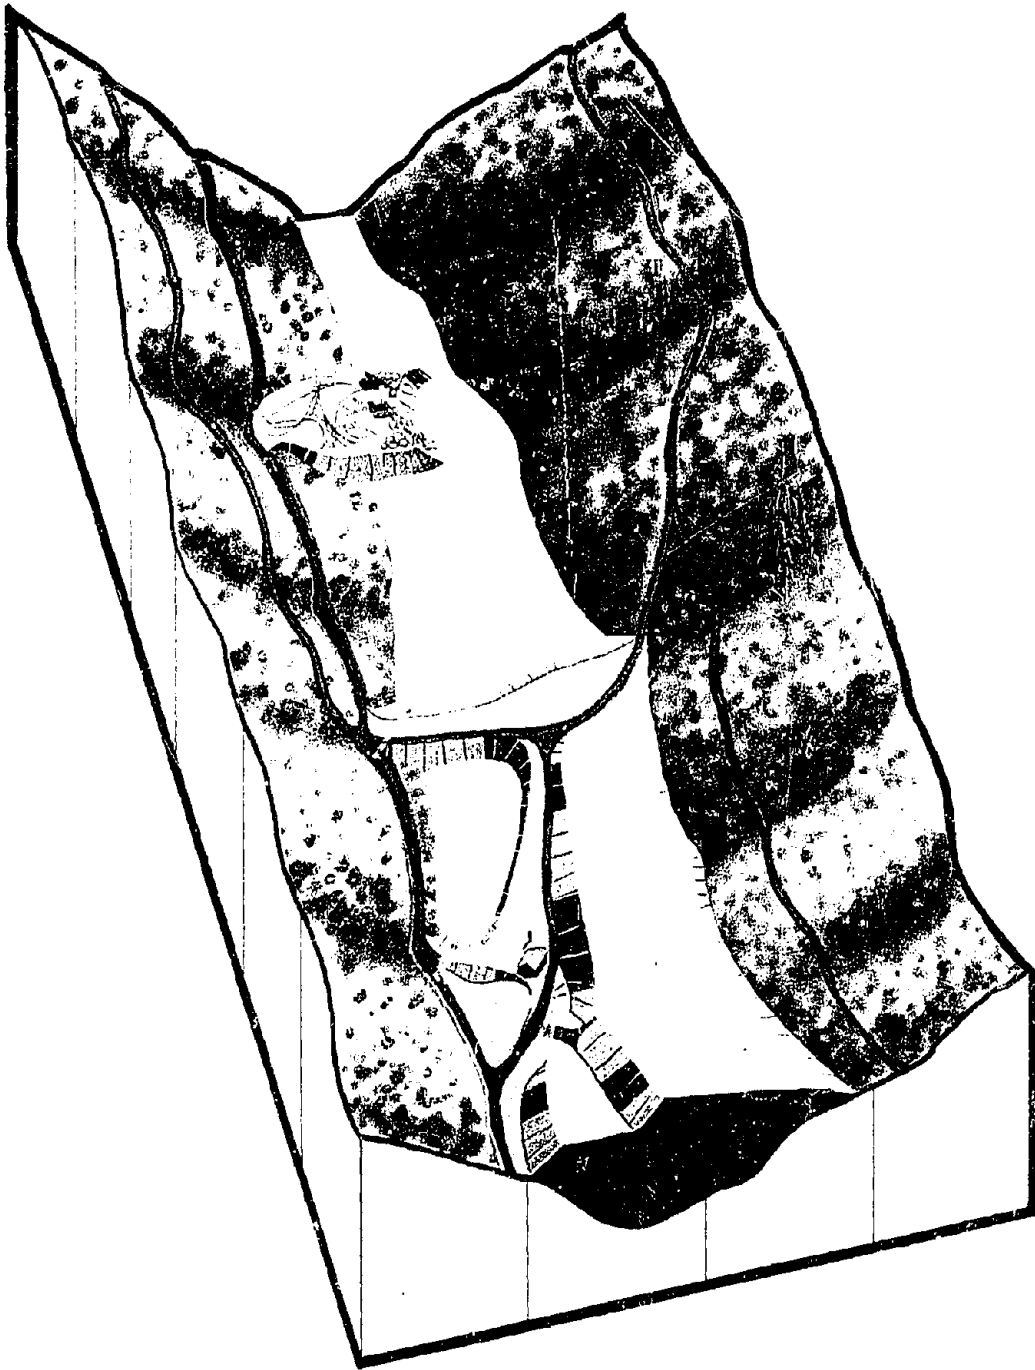
MIDDLE FORK VALLEY IN SPRING 1969, LOOKING UPSTREAM. THE FAILURE OF THE EMBANKMENT IS REPAIRED BY CONTINUING TO DUMP INTO THE SLUMPED AREA.

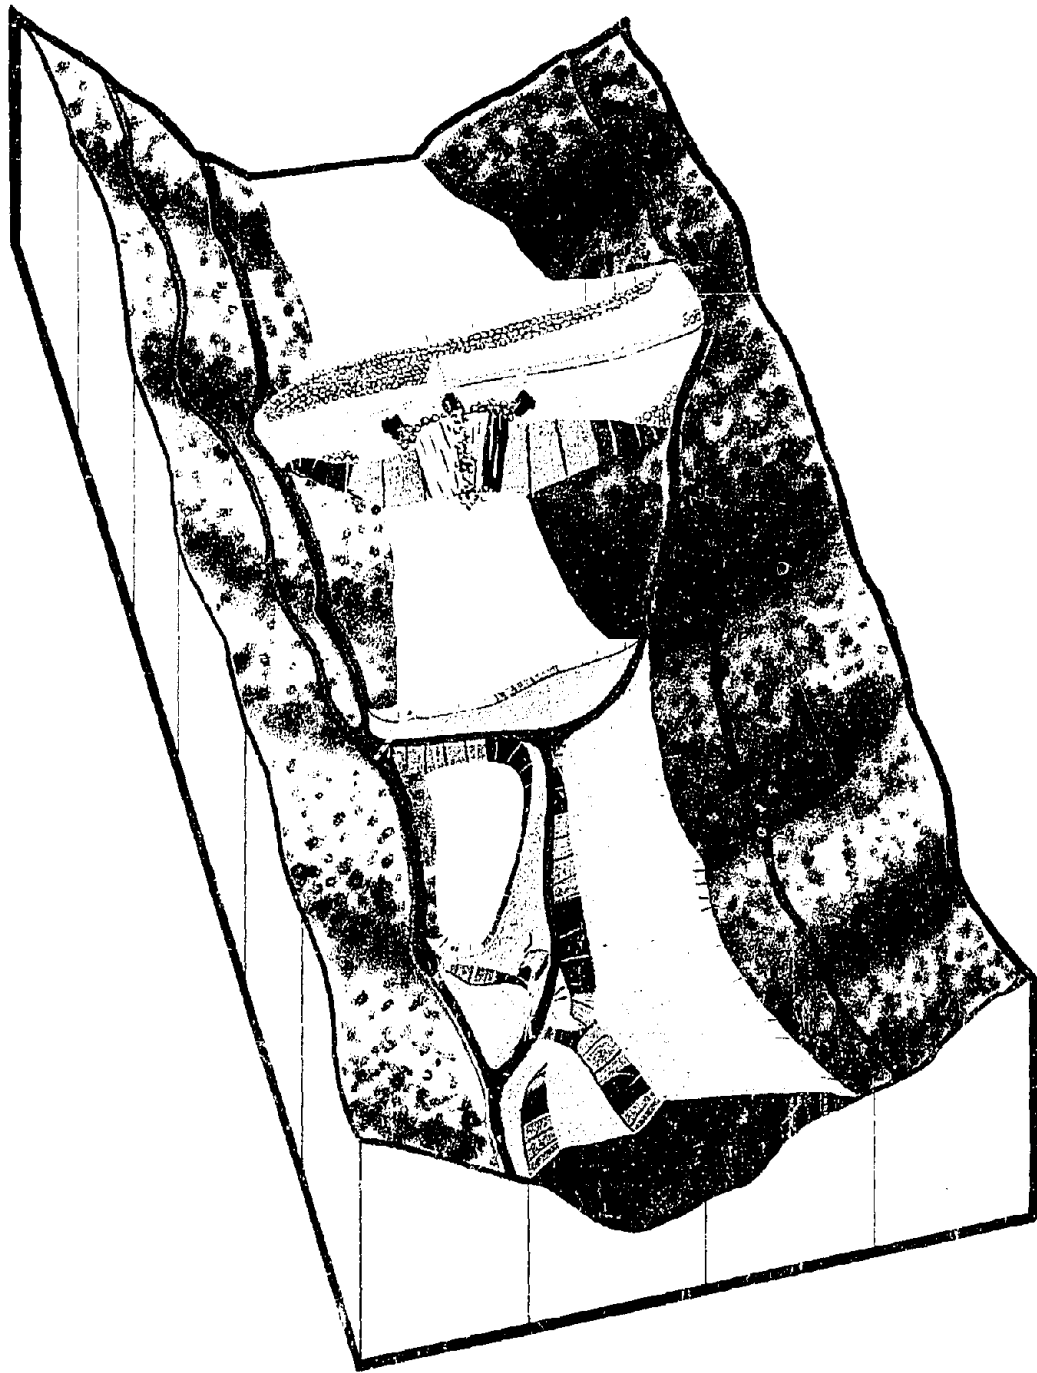
MIDDLE FORK VALLEY IN MARCH 1971, LOOKING UPSTREAM. THE FAILURE OF DAM NO. 3 IS REPAIRED BY FILLING IN THE SLUMPED AREA.

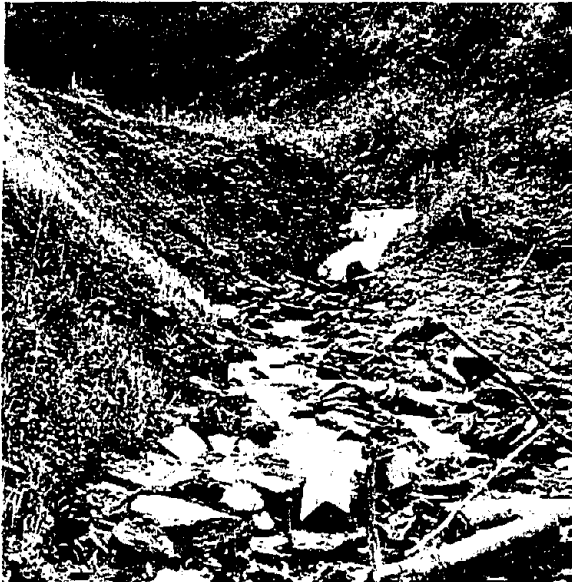
PHOTO A. DAM NO. 4, DOWNSTREAM FACE.
SPILLWAY IS IN BEDROCK.

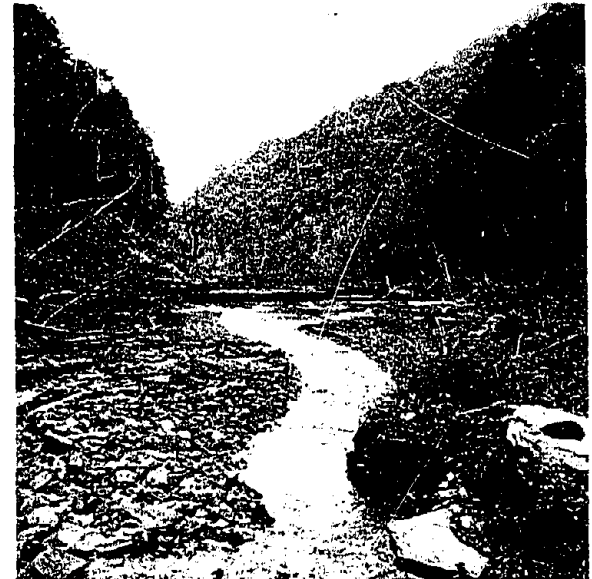
PHOTO D. UPPER END OF POOL 3, LOOKING
DOWNSTREAM. THE BASES OF THE LOWER-
MOST LIVE TREES ARE AT ELEVATION 1735;
THE SLUDGE IN THE MIDDLEGROUND IS AT
ELEVATION 1714.

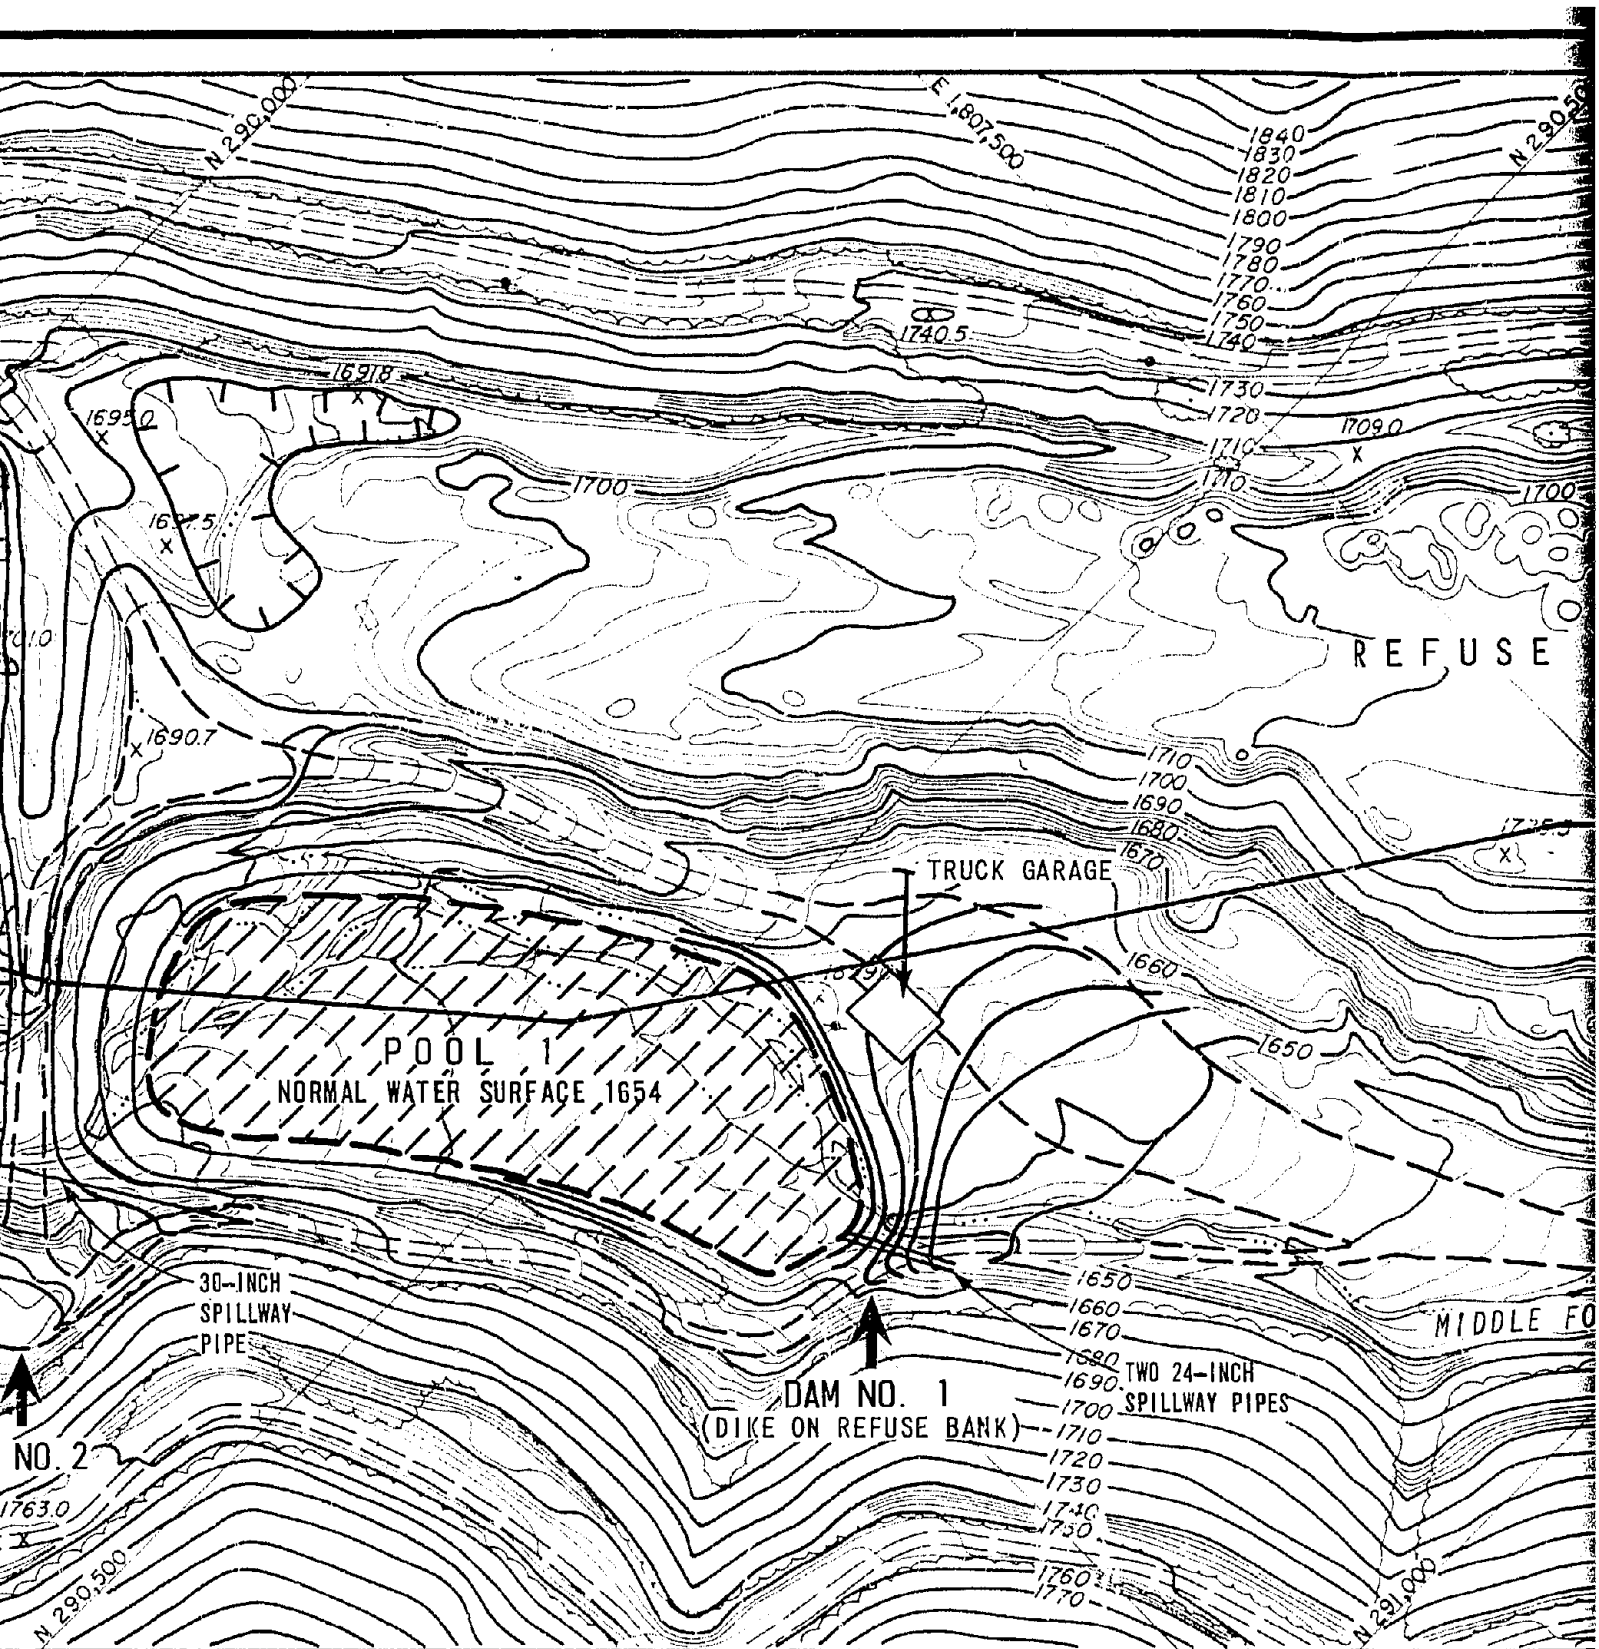
CONSTRUCTED PREFAILURE CONTOURS SHOWN IN HEAVY LINES, POST-FAILURE CONTOURS ARE LIGHT LINES.
