**ANALYSIS OF
COAL REFUSE DAM FAILURE**

**MIDDLE FORK BUFFALO CREEK
SAUNDERS, WEST VIRGINIA**

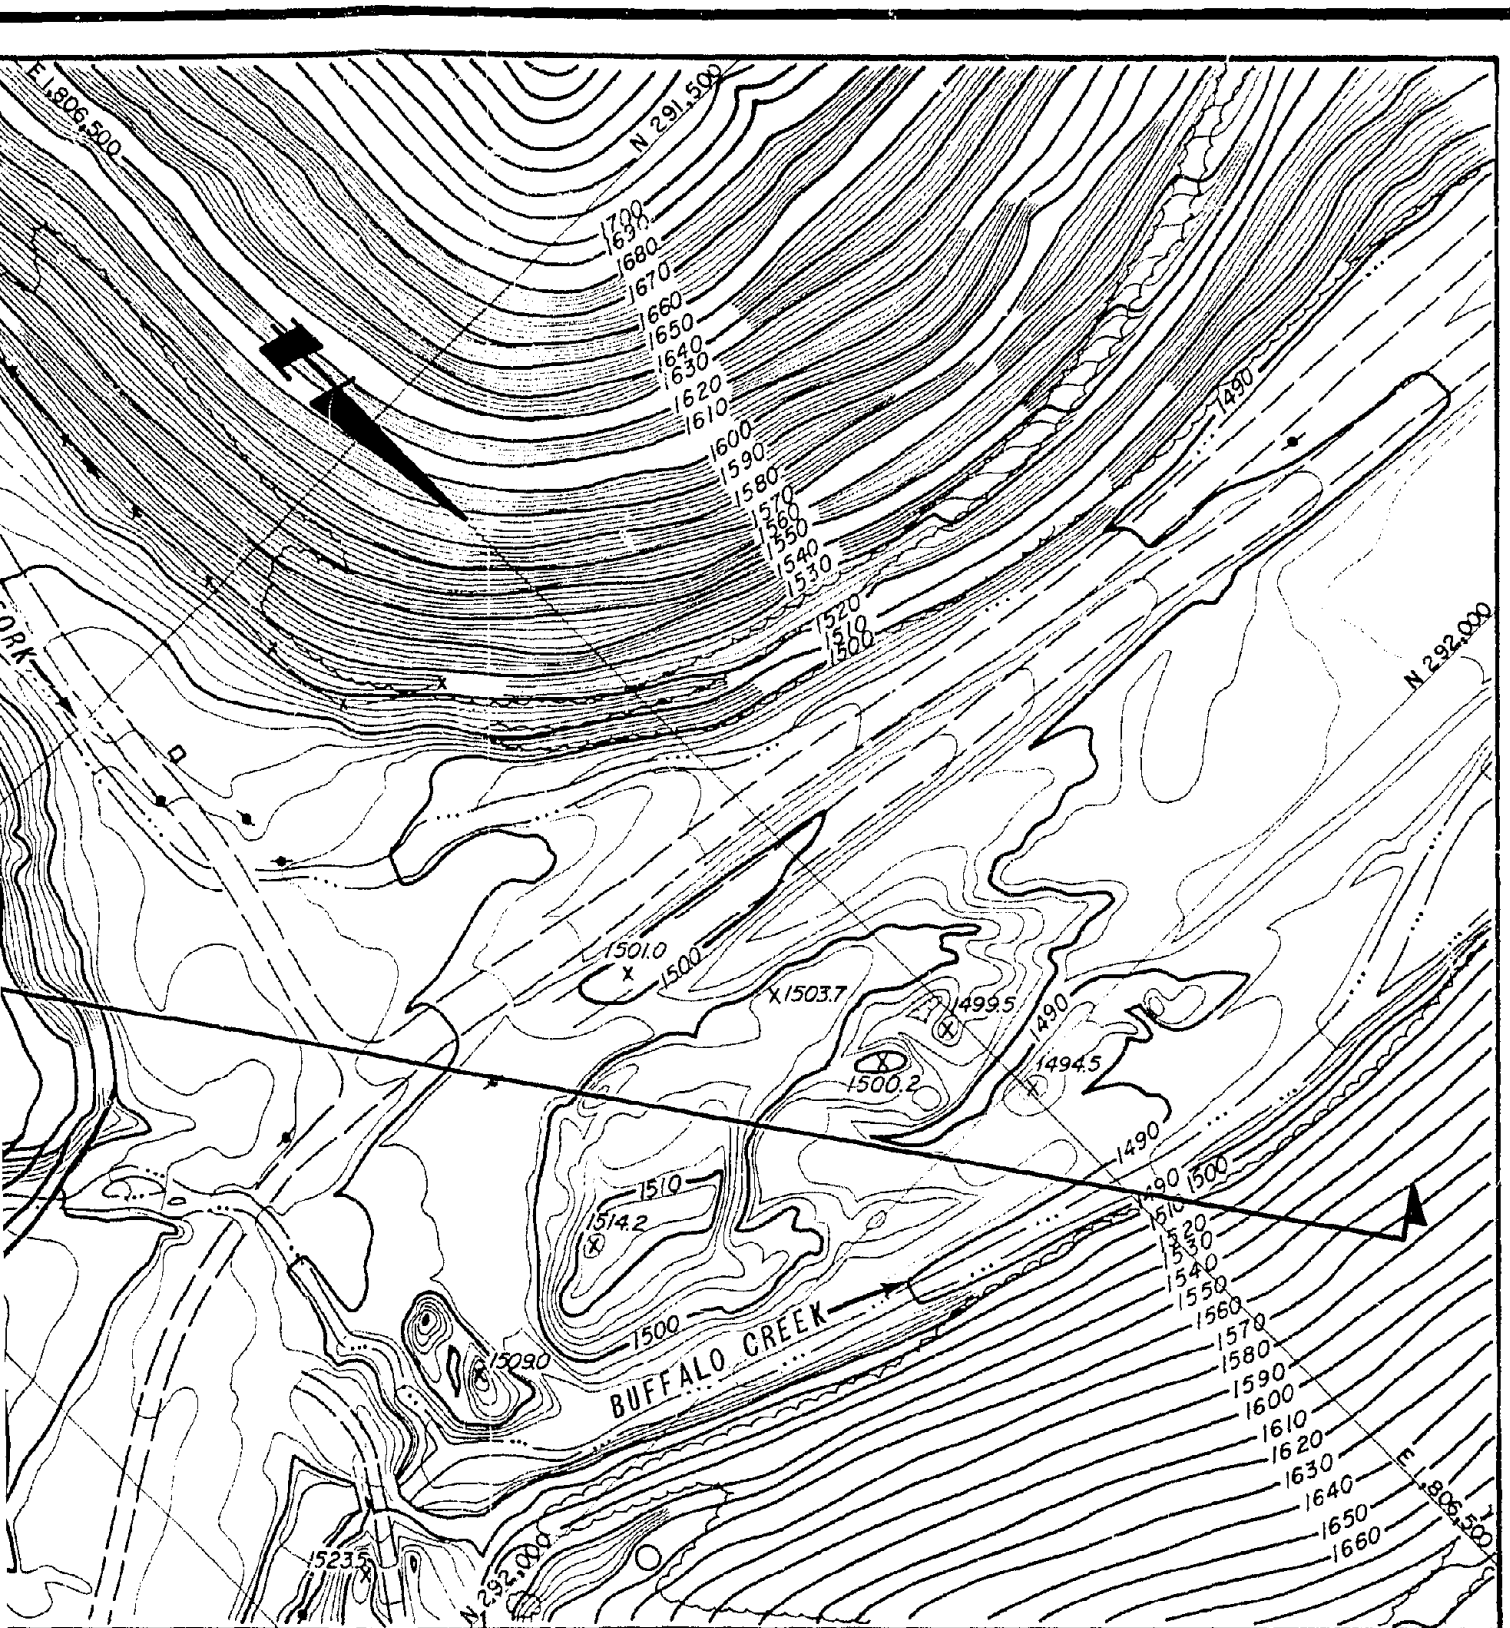
W.A. WAHLER & ASSOCIATES	COAL REFUSE DAM FAILURE SAUNDERS, WEST VIRGINIA		GENERALIZED PREFAILURE TOPOGRAPHY MIDDLE FORK VALLEY, EARLY 1972	
	PALO ALTO • NEWPORT BEACH • CALIF.	PROJECT NO 0700	DATE NOVEMBER 1972	FIGURE NO. V-16

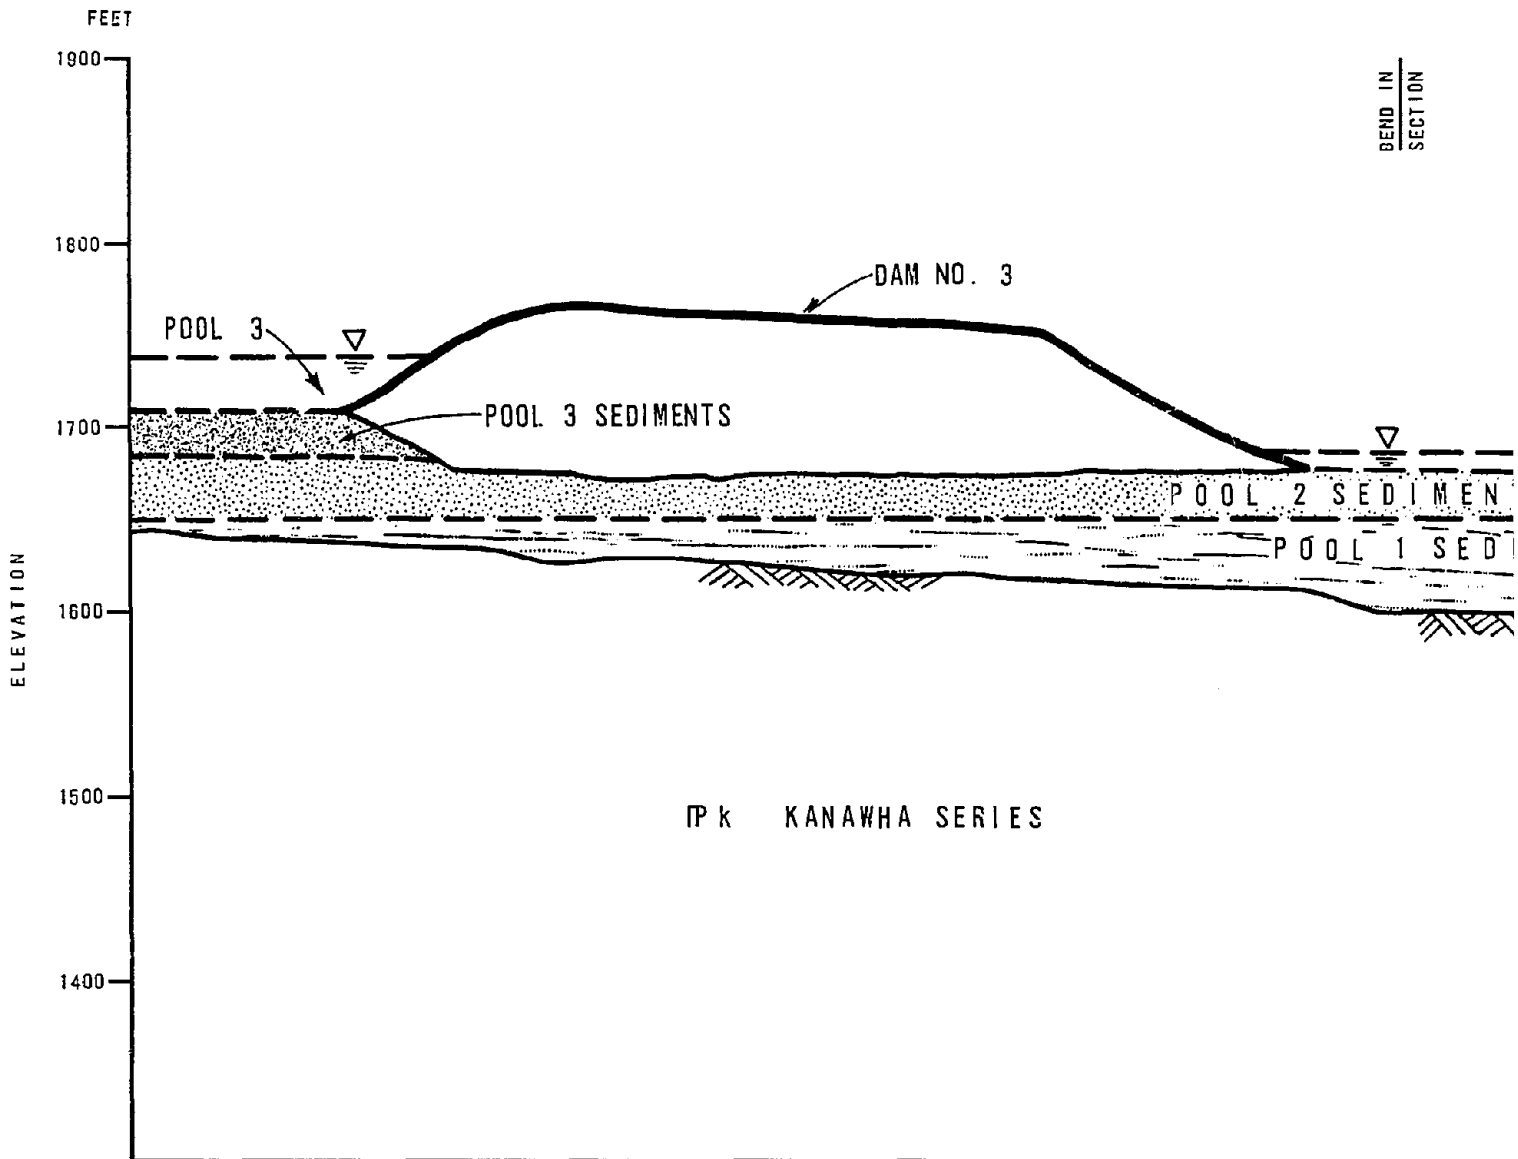
NOTES: (1) PATTERNS USED FOR THE SLUDGE OF POOLS 1, 2, AND 3 ARE FOR DELINEATION ONLY AND ARE NOT MEANT TO SUGGEST TEXTURE OR COMPOSITION.
 (2) FOR LOCATION OF SECTION SEE FIGURE NO. V-16.

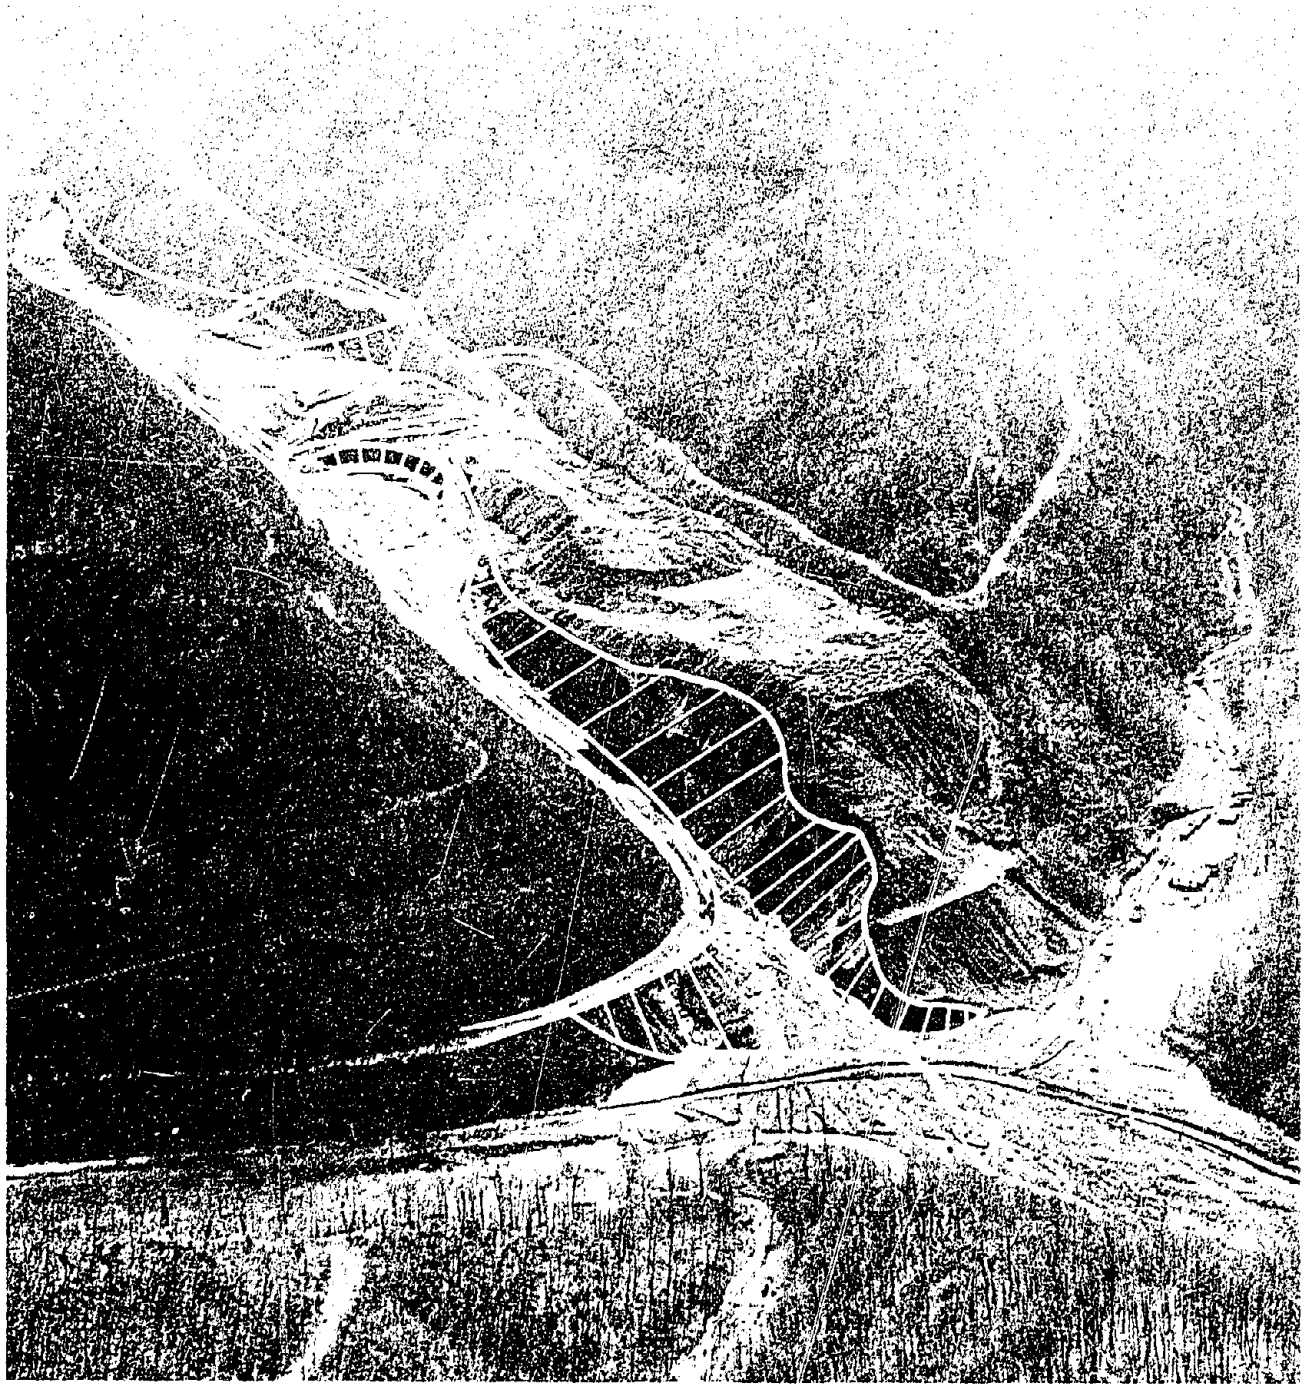
AERIAL VIEW OF MIDDLE FORK VALLEY, FEBRUARY 28, 1972, LOOKING UPSTREAM. THE PREFAILURE CONFIGURATION OF REFUSE BANK AND DAMS 1, 2, AND 3, HAS BEEN ADDED. PHOTO COURTESY, WEST VIRGINIA DEPARTMENT OF HIGHWAYS.

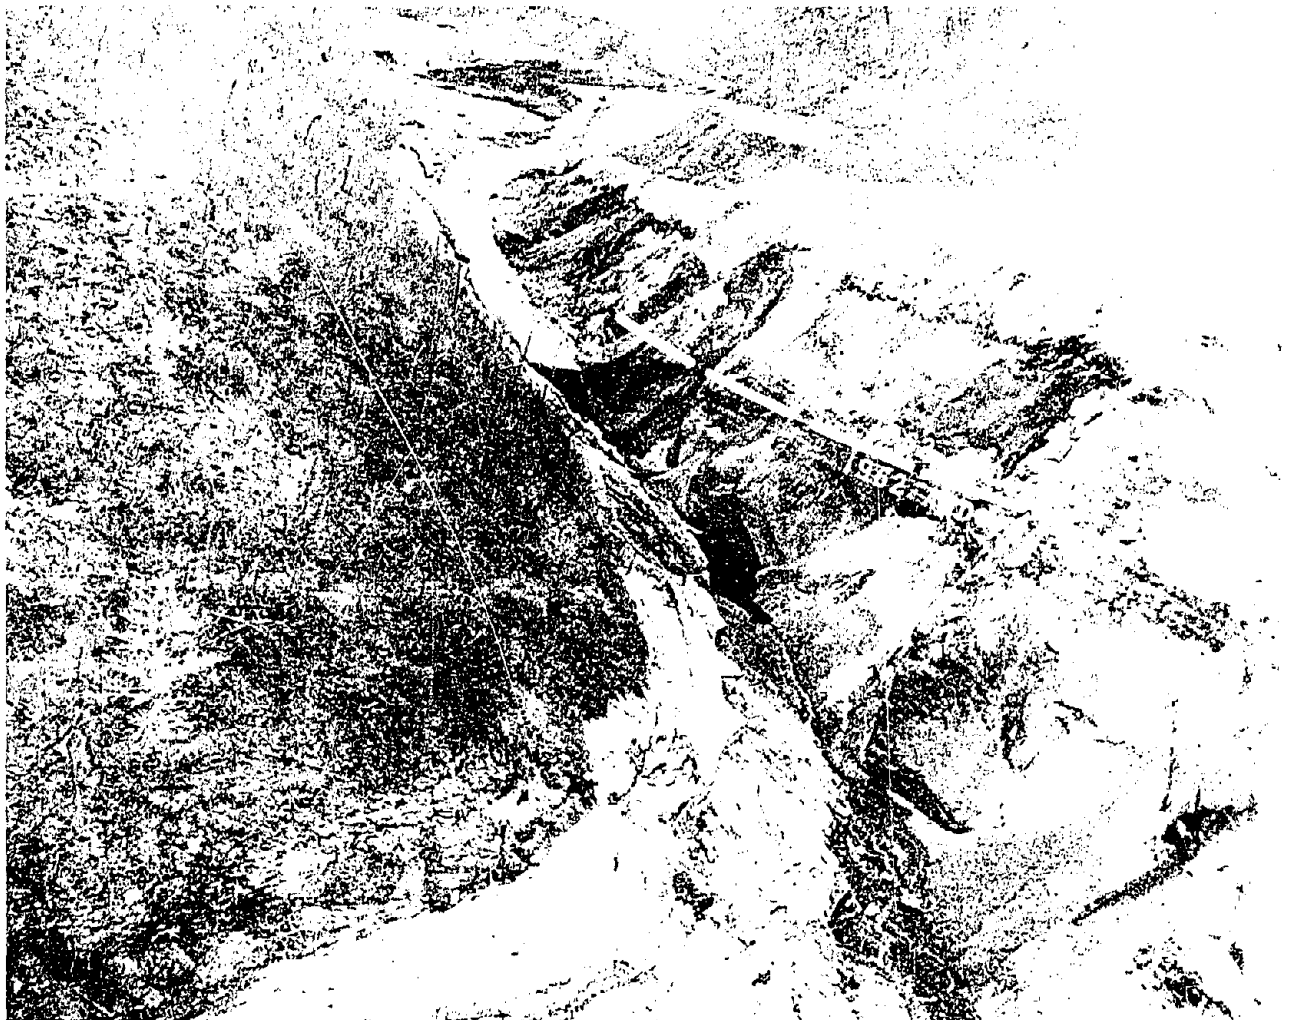
AERIAL VIEW, MARCH 15, 1972, OF THE NOTCH CUT IN THE REFUSE BANK BY THE FLOODWATERS
DASHED LINE IS APPROXIMATE BOUNDARY BETWEEN REFUSE PLACED IN THE YEARS SHOWN

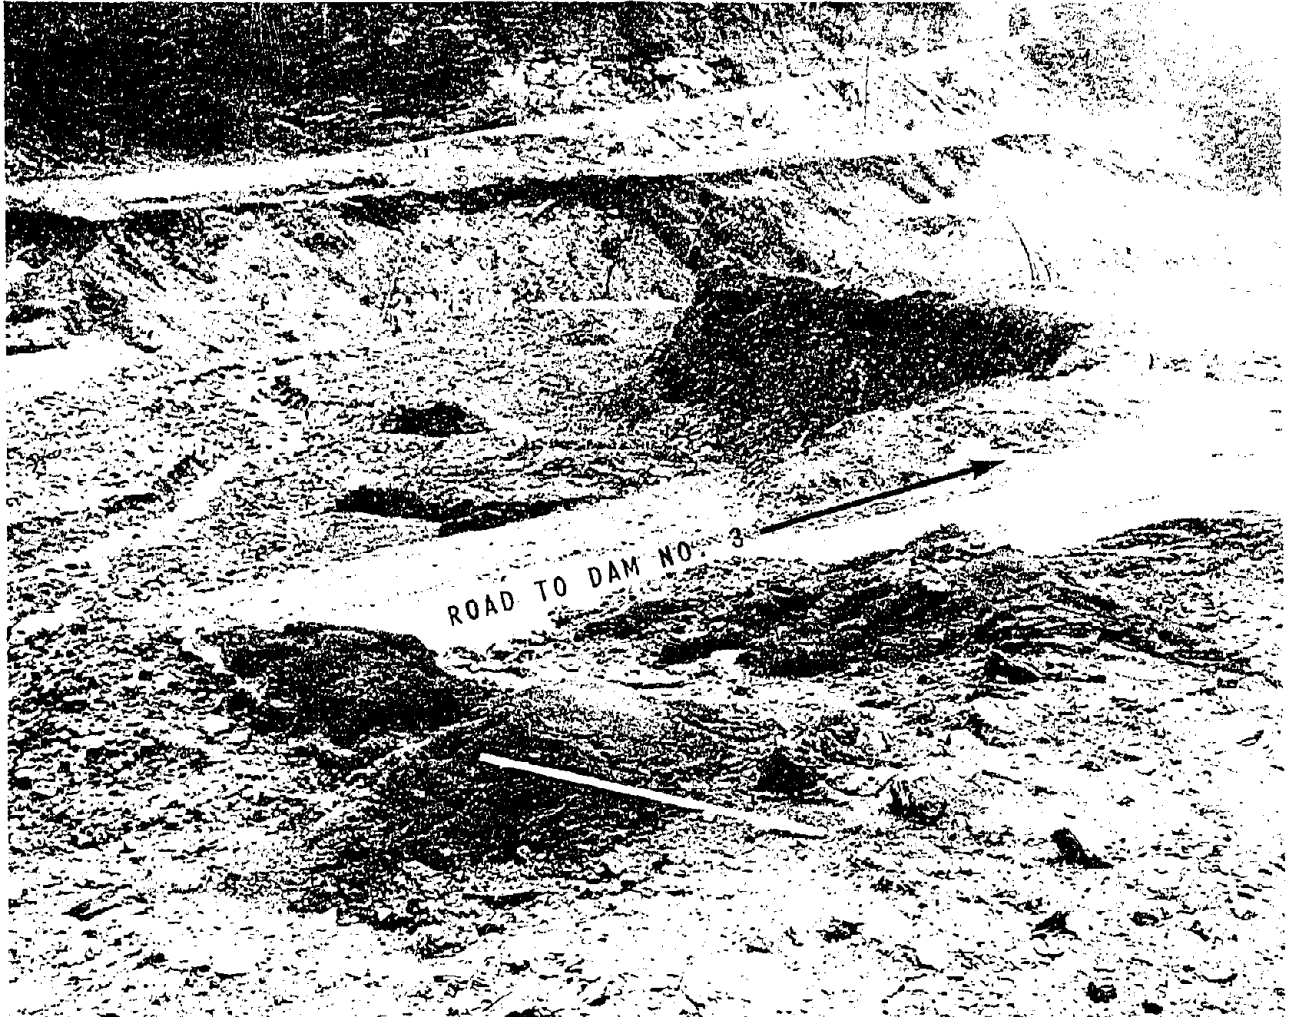
PATCHES OF POOL 2 SLUDGE AT APPROXIMATE ELEVATION 1702 ON REFUSE BANK (SEE ALSO FIGURE VI-4).

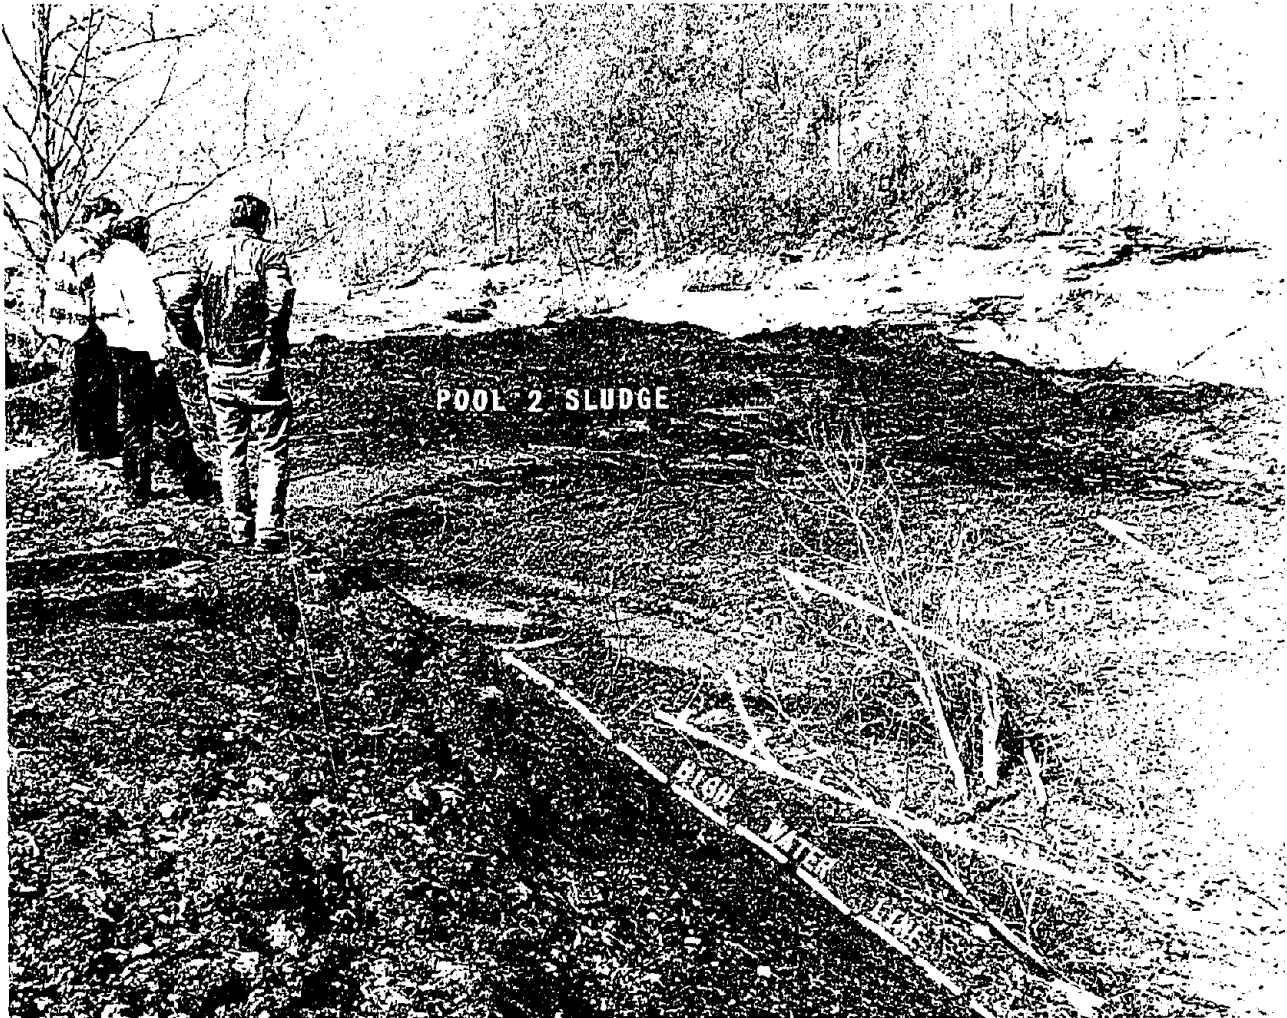
POOL 2 SLUDGE (DARK AREA IN MIDDLEGROUND) AND TRANSLATED DAM NO. 3 EMBANKMENT GRAVELS AT RIGHT, BELOW SLOPE. VIEW FROM ROAD ABOVE POOL 2 AT LEFT SIDE OF VALLEY. THE HIGH WATER LINE IS SHOWN HERE AT APPROXIMATE ELEVATION 1712. SYMBOLS SHOW LOCATIONS OF SECONDARY LANDSLIDE CRACKS IN TRANSLATED DAM NO. 3 EMBANKMENT GRAVEL. THE MAIN SLIDE MASS MOVED DOWNSTREAM (DIAGONALLY TO THE UPPER LEFT IN THE PHOTO), PUSHING THE DARK POOL 2 SLUDGE IN FRONT OF IT. HIGHER PORTIONS OF THE TRANSLATED EMBANKMENT ON THE LEFT SIDE OF POOL 2, JUST BELOW THE HIGH WATER LINE IN THE PHOTO, THEN SLID TOWARDS THE CENTER OF MIDDLE FORK VALLEY. FIGURES VI-9 THROUGH VI-14 WERE TAKEN IN THE POOL 2 SLUDGE OR "ROILED AREA", SHOWN ABOVE. FOR ANOTHER VIEW OF THE HIGH WATER LINE SHOWN HERE, SEE FIGURE VI-25A.

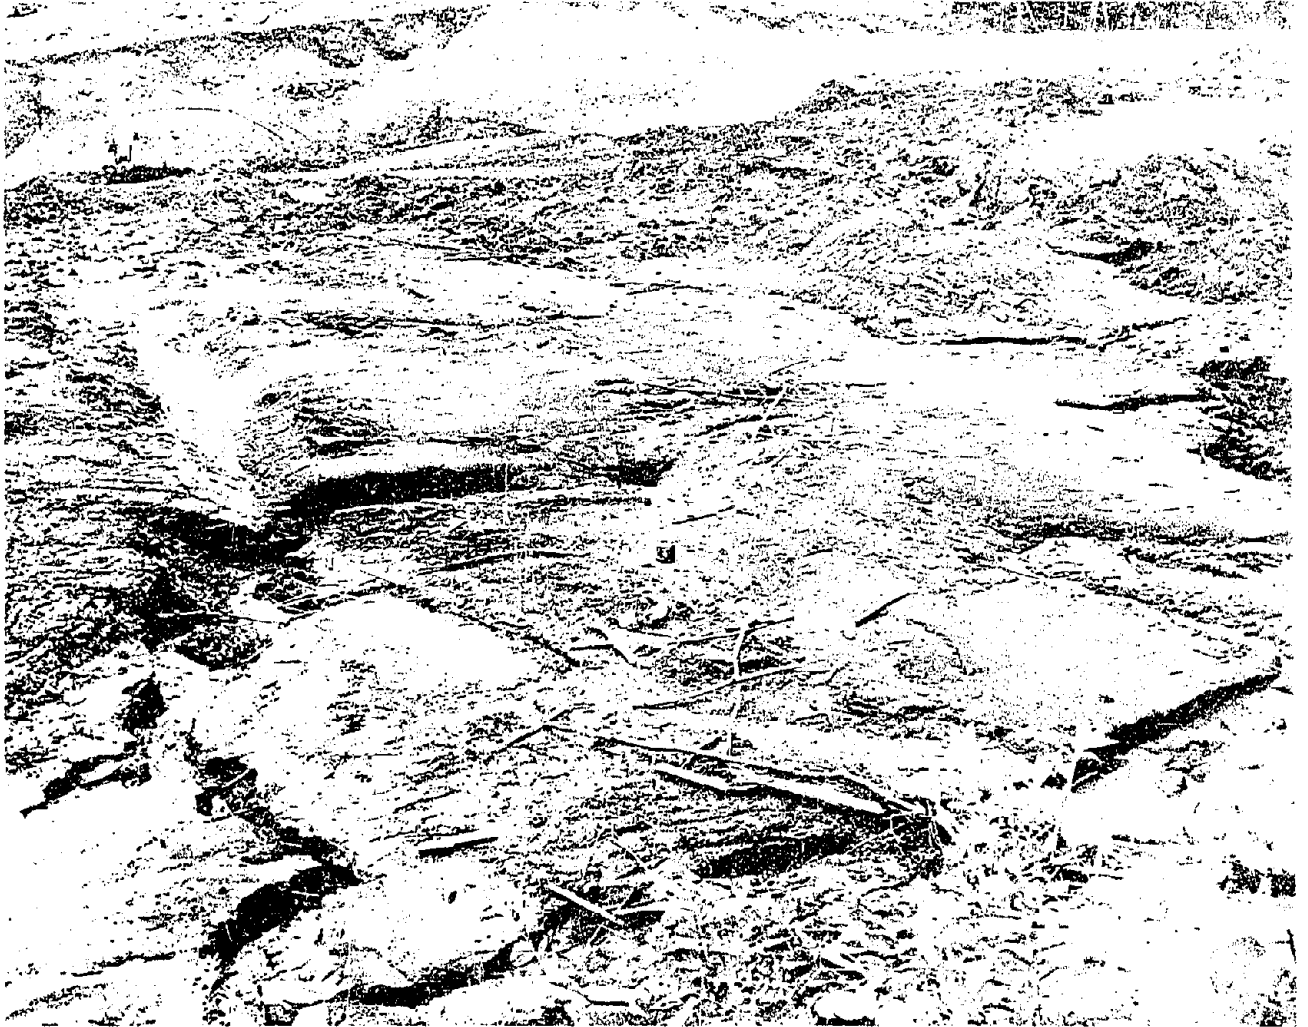
PORTION OF THE "ROLLED AREA" OF TRANSLATED POOL 2 SLUDGE. THE SMOOTH, FLAT AREA IS ONE OF THE MAJOR BLOCKS OF SLUDGE THAT WERE MOVED AS UNITS DURING THE FAILURE.

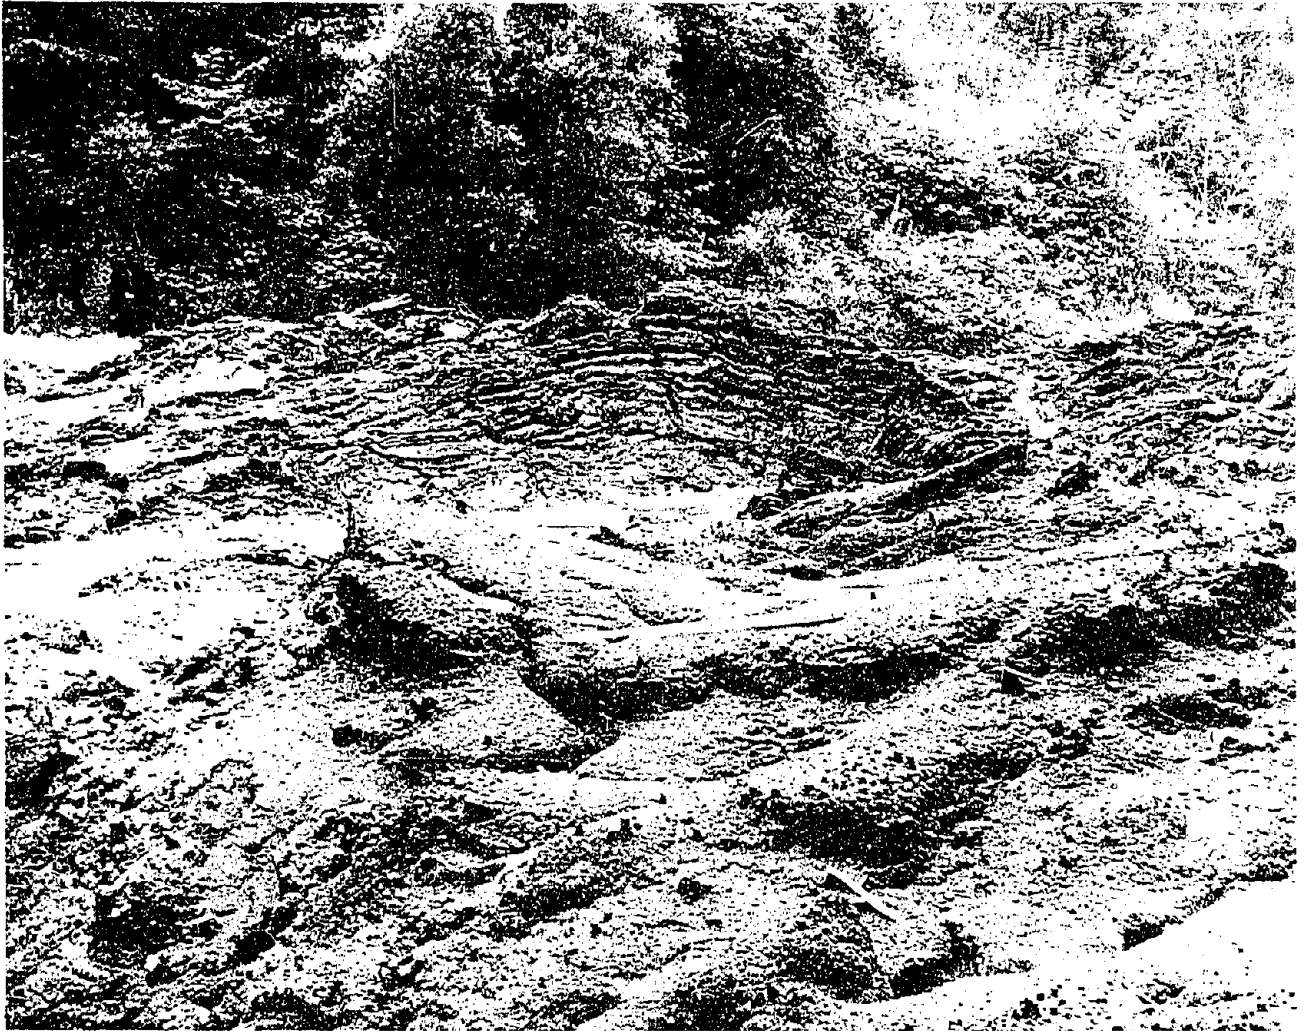
GENTLE FOLDS IN THE "ROILED AREA" OF POOL 2 SLUDGE. DETAILS OF THE BEDDING ARE WELL PRESERVED IN THE ANTICLINE IN THE BACKGROUND.

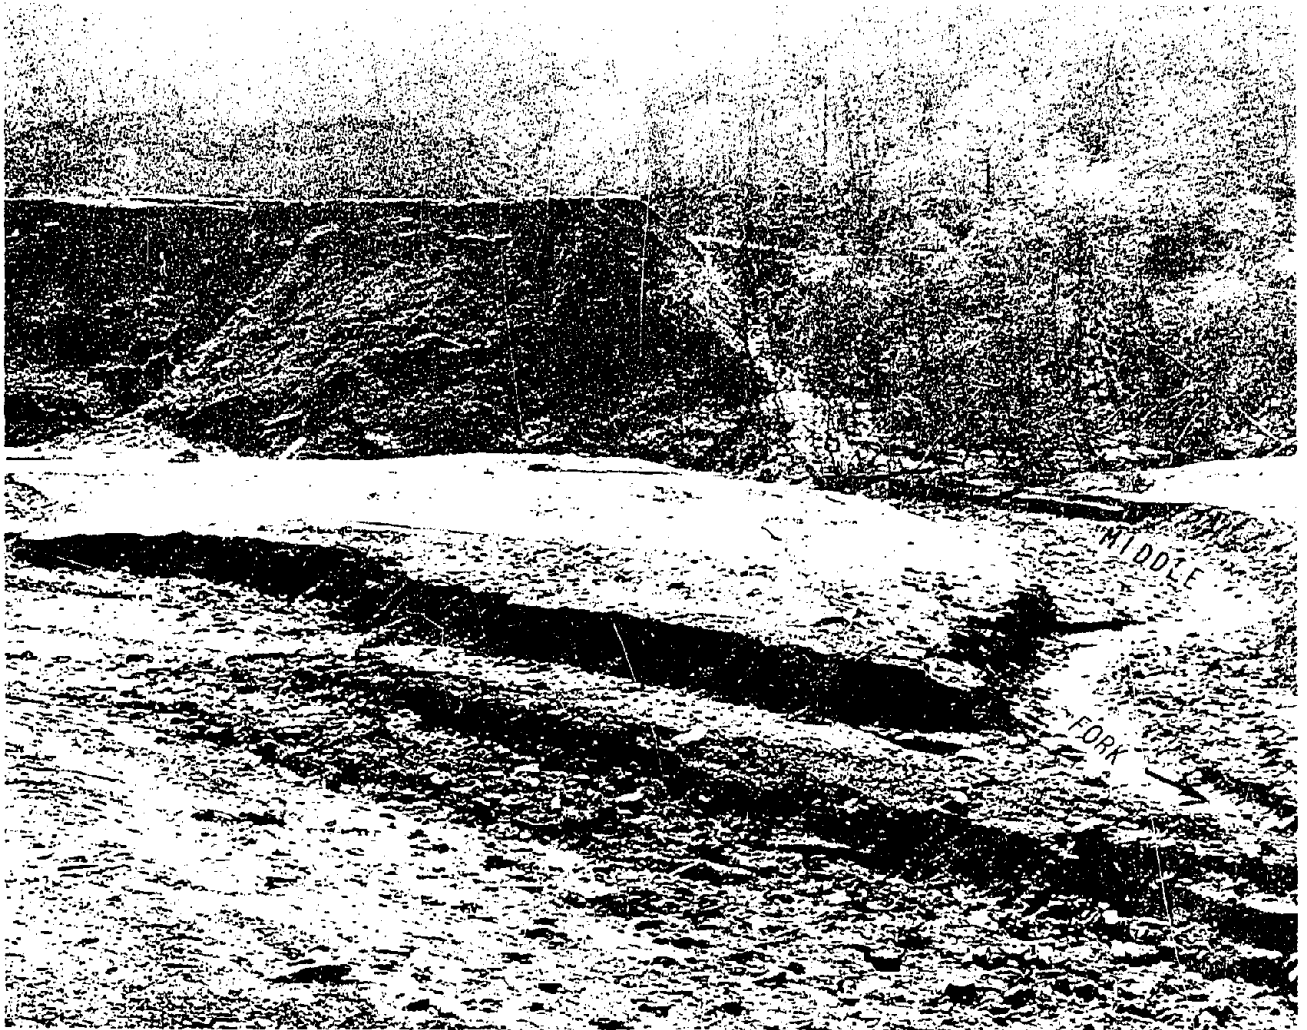
DOWNSTREAM PORTION OF LEFT ABUTMENT REMNANT OF DAM NO. 3, FEBRUARY 29, 1972. THE LOW, SCoured MOUND IN THE CENTER EXTENDED TO THE RIGHT DURING THE FIRST STAGES OF THE FAILURE. IN THE FINAL EMPTYING OF POOL 3, THE MOUND WAS DISECTED BY MIDDLE FORK AS SEEN HERE.

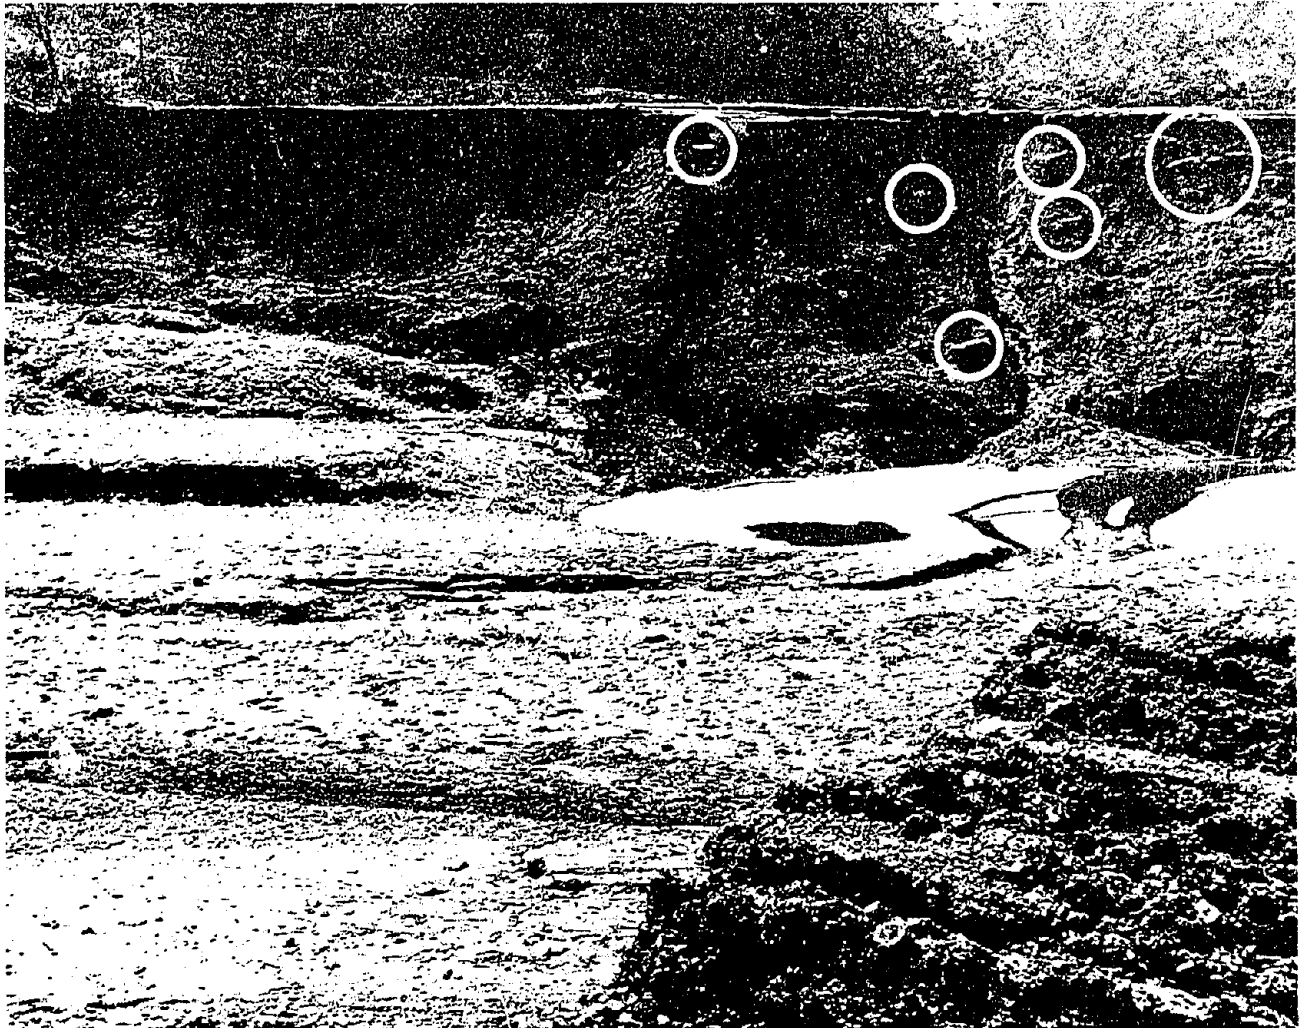
CENTRAL AND UPSTREAM PORTIONS OF THE LEFT ABUTMENT REMNANT OF DAM NO. 3, FEBRUARY 29, 1972.
NOTE THE CONTRAST BETWEEN THE LIGHT, RELATIVELY SAND-FREE STREAM TERRACES AND THE DARK
EMBANKMENT MATERIAL. PORTIONS OF THE SURFACE OF DAM NO. 3 WHICH HAVE SLID TOWARD THE
VIEWER ARE READILY IDENTIFIABLE BY THE HIGHLIGHTS ON THEM (CIRCLED). THE LARGE CIRCULAR
FEATURE AT THE BASE OF THE ABUTMENT REMNANT (RIGHT CENTER) CONTAINED SINKHOLE-LIKE
CAVITIES, ONE TO FOUR FEET IN DIAMETER, SINCE FILLED IN

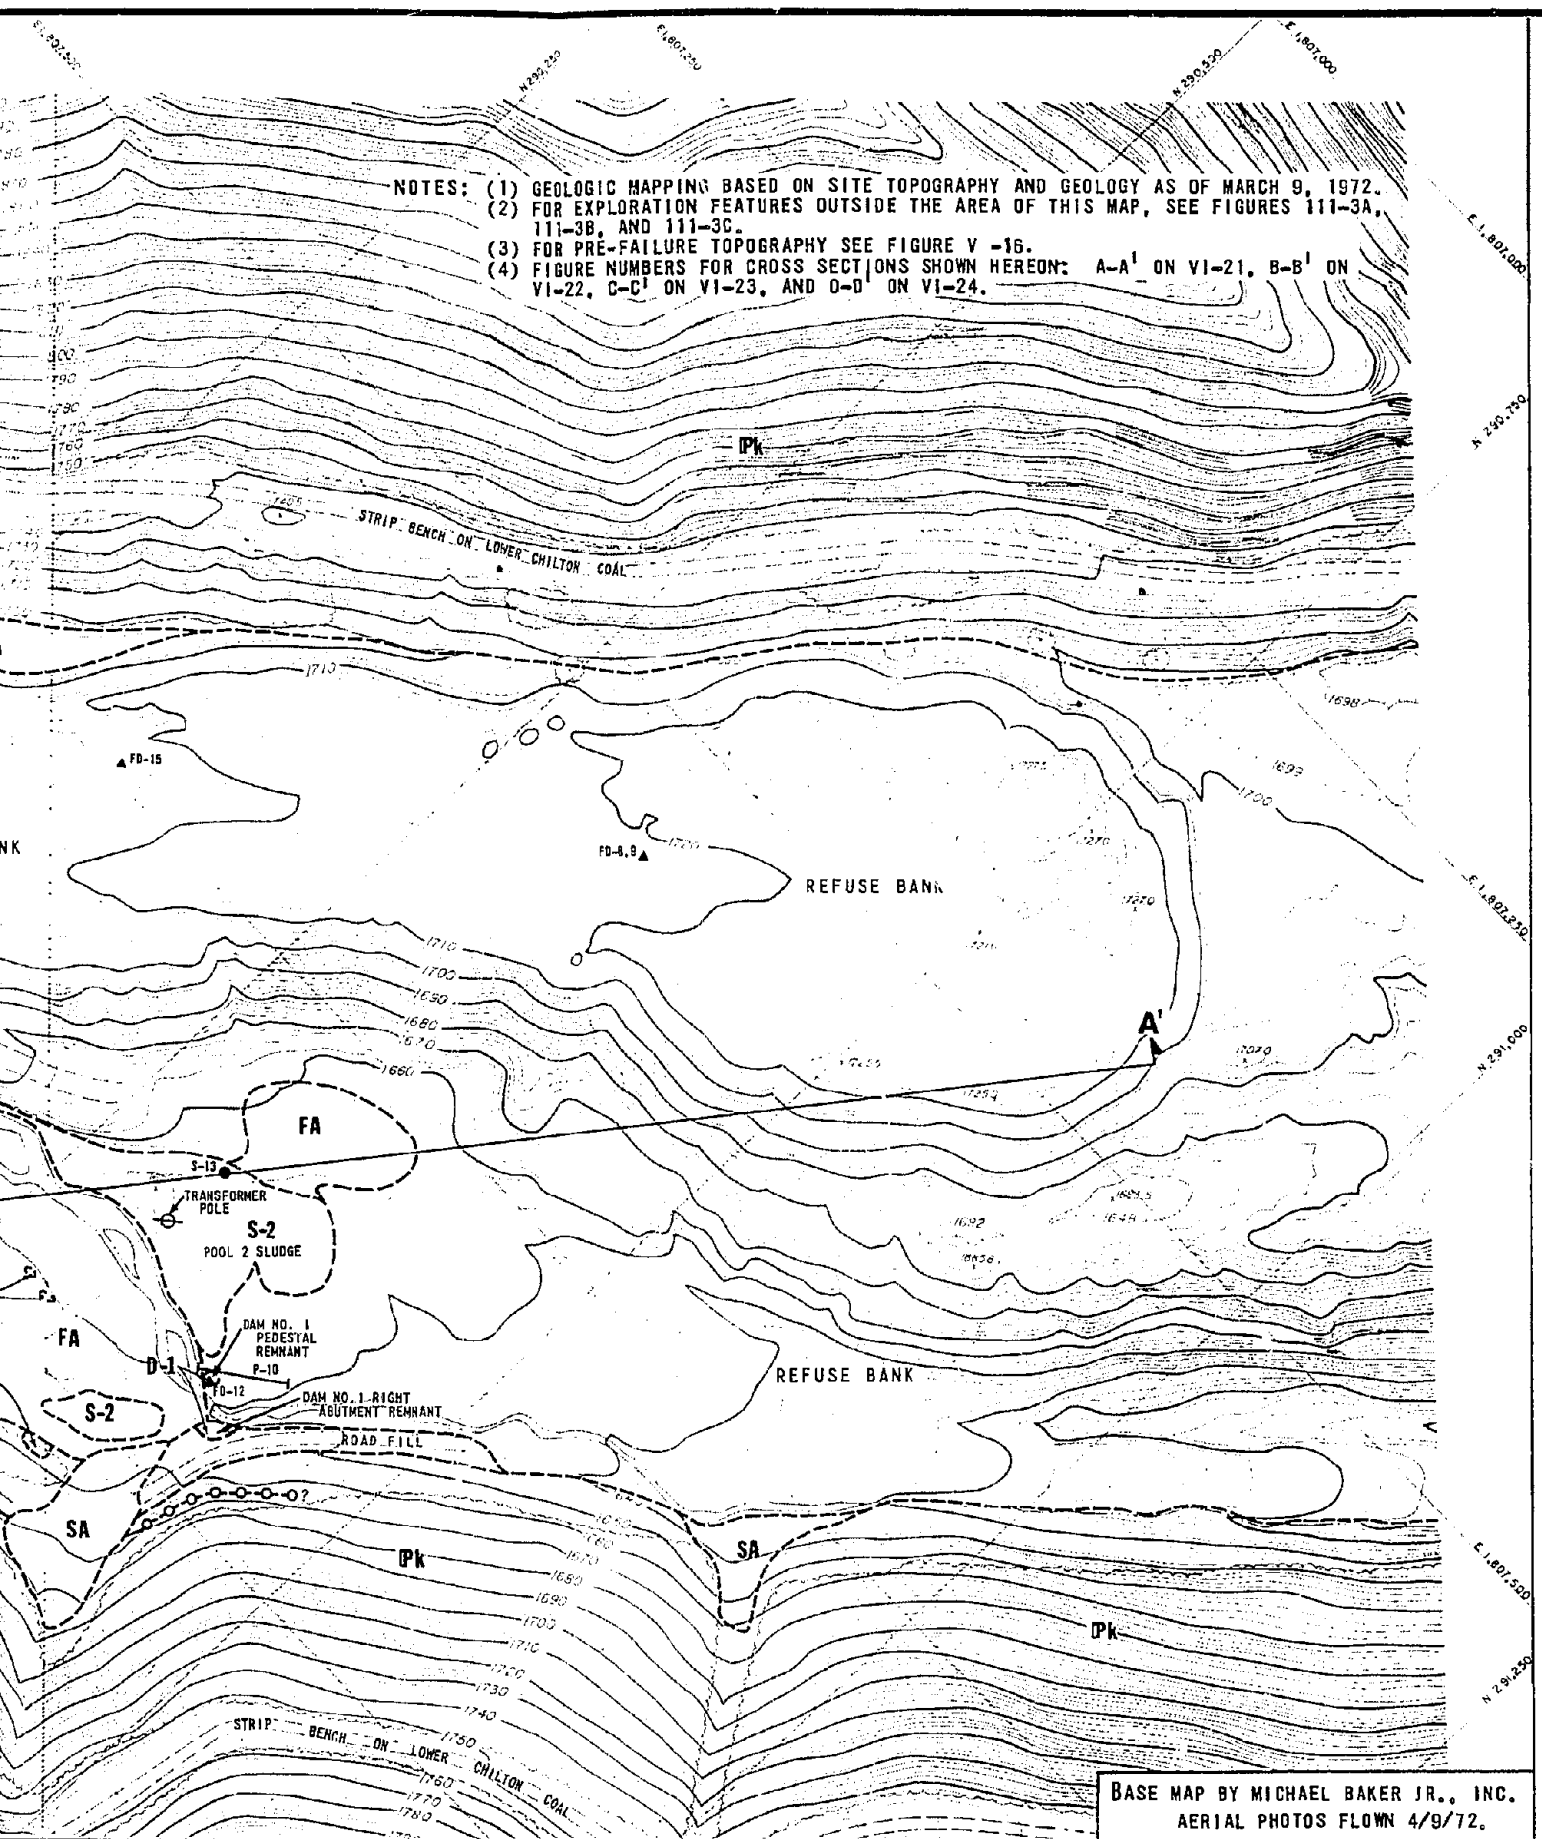
BASE MAP BY MICHAEL BAKER JR., INC.
 AERIAL PHOTOS FLOWN 4/9/72.

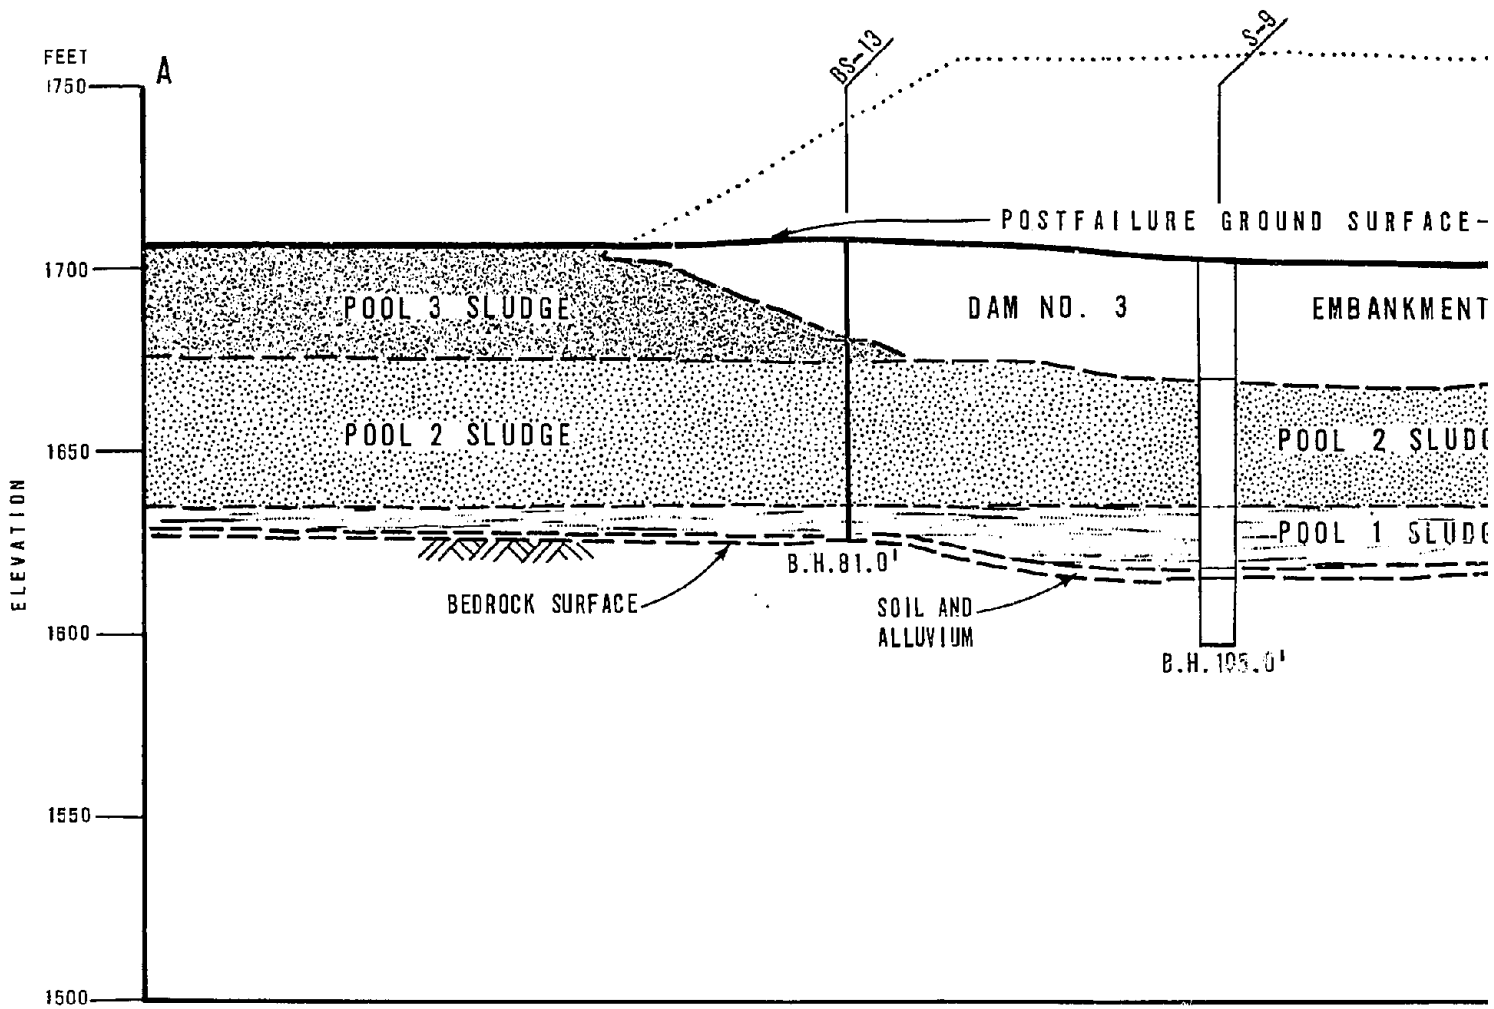
- NOTES: (1) FOR LOCATION OF SECTION SEE FIGURE VI-20.
 (2) FOR PREFAILURE SECTION, SEE FIGURE V-17.
 (3) PATTERNS USED FOR THE SLUDGE OF POOLS 1, 2, AND 3 ARE FOR DELINEATION ONLY AND ARE NOT MEANT TO SUGGEST TEXTURE OR COMPOSITION.

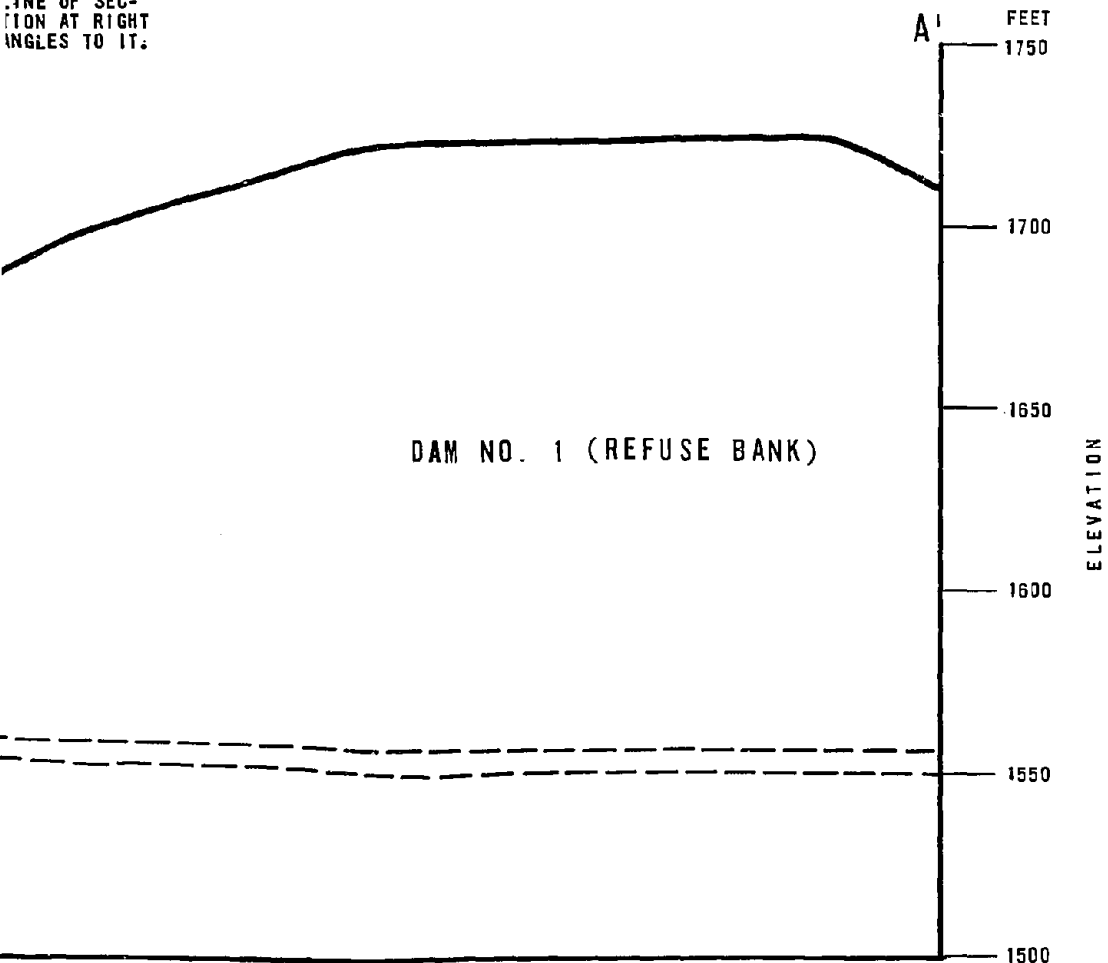
DAM NO. 1 (REFUSE BANK)

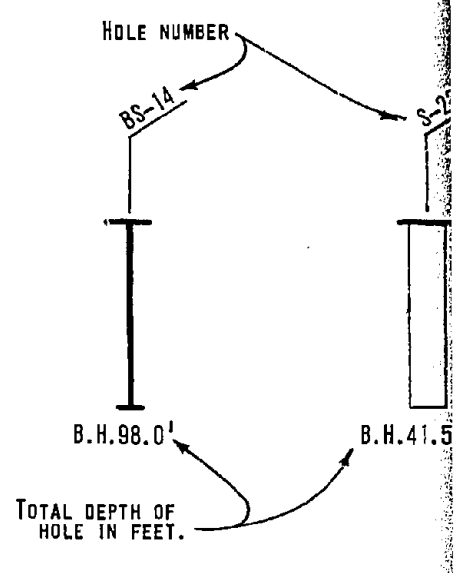
- NOTES: (1) FOR LOCATION OF SECTION,
 (2) FOR DRILL HOLE LOGS SEE
 (3) PATTERNS USED FOR THE SLI
 2 ARE FOR DELINEATION ON
 TO SUGGEST TEXTURE OR COI
