**ANALYSIS OF
COAL REFUSE DAM FAILURE**

**MIDDLE FORK BUFFALO CREEK
SAUNDERS, WEST VIRGINIA**

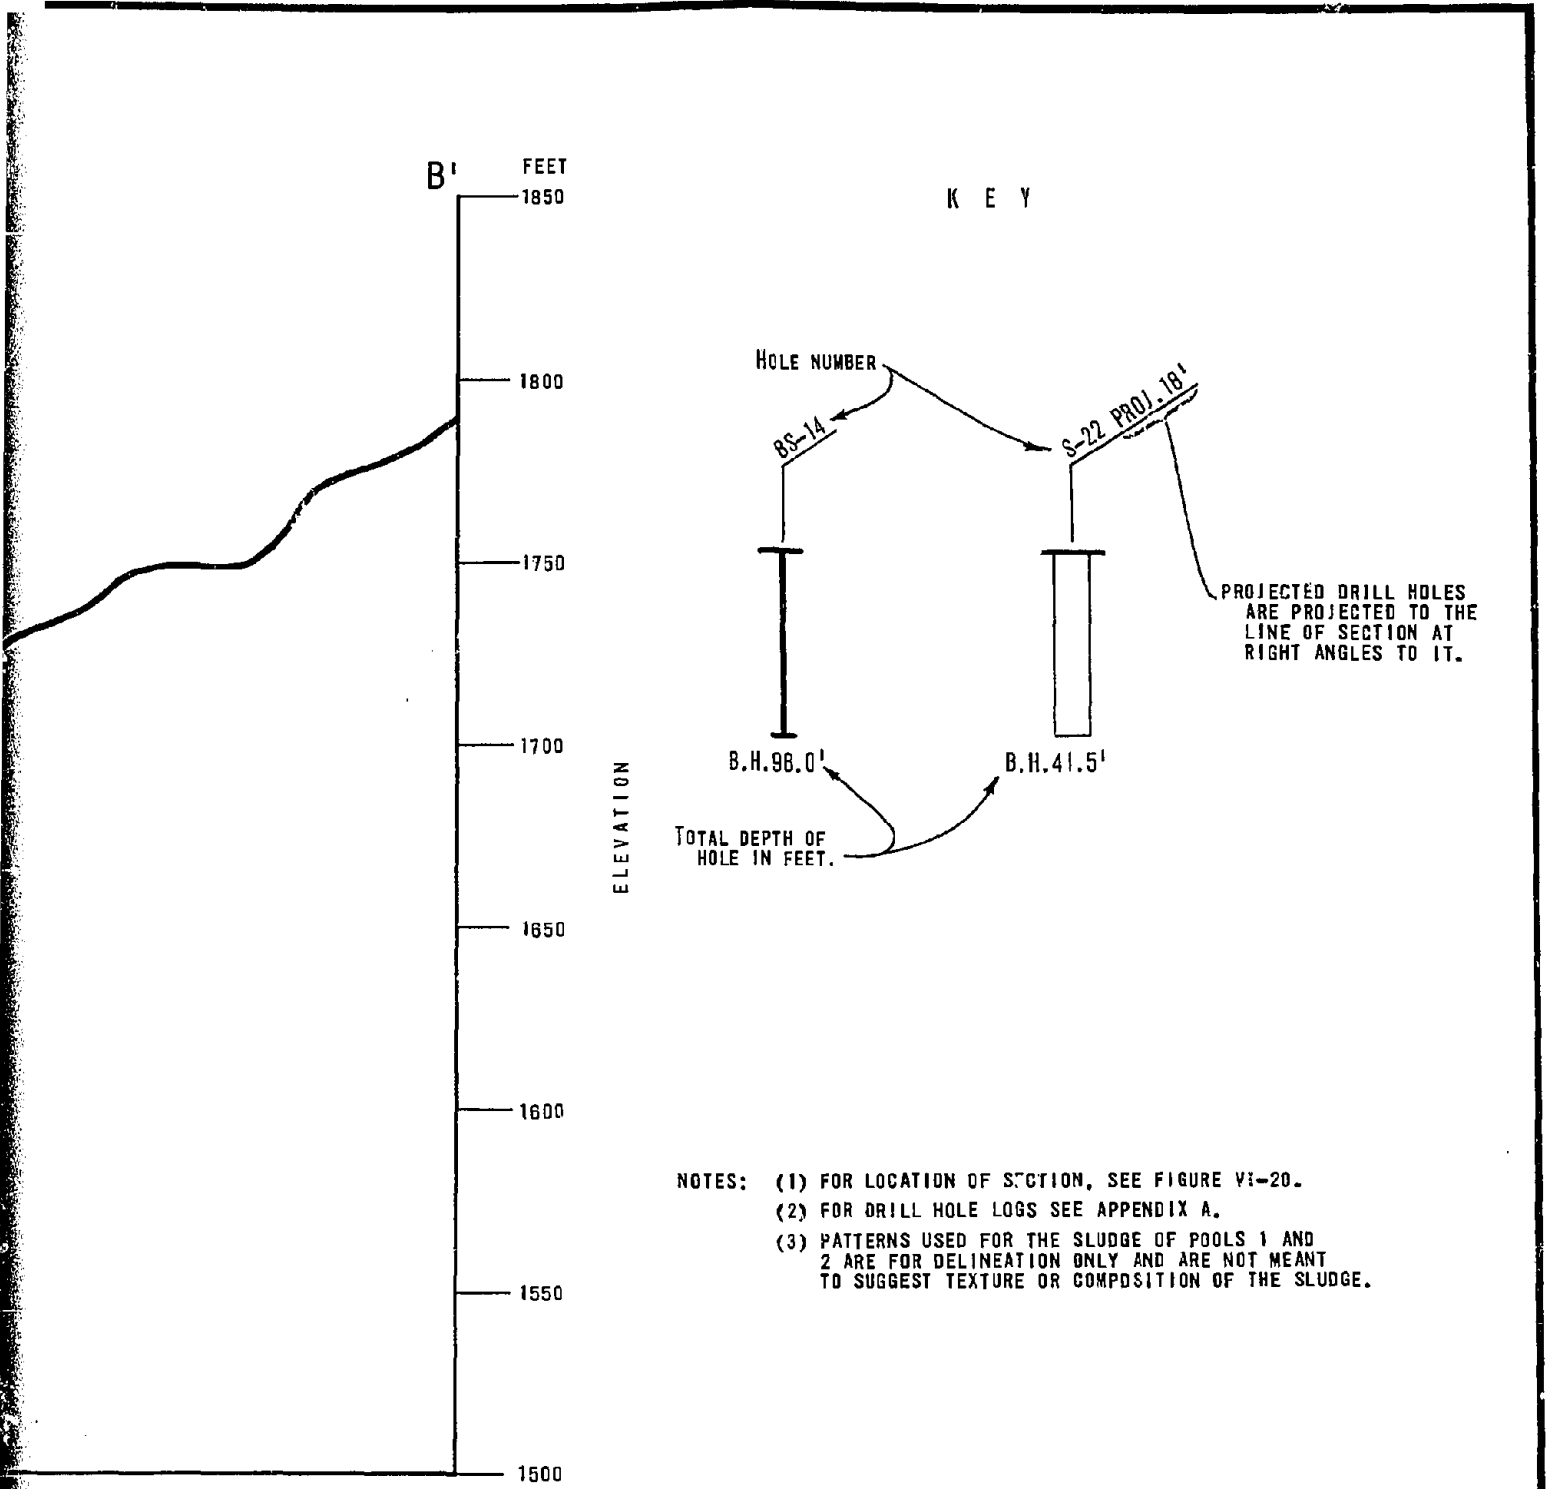
W. A. WAHLER & ASSOCIATES	COAL REFUSE DAM FAILURE SAUNDERS, WEST VIRGINIA PALO ALTO • NEWPORT BEACH • CALIF.	GEOLOGIC CROSS SECTION B-B' (POSTFAILURE)		
		PROJECT NO. 0700	DATE NOVEMBER 1972	FIGURE NO. VI-22

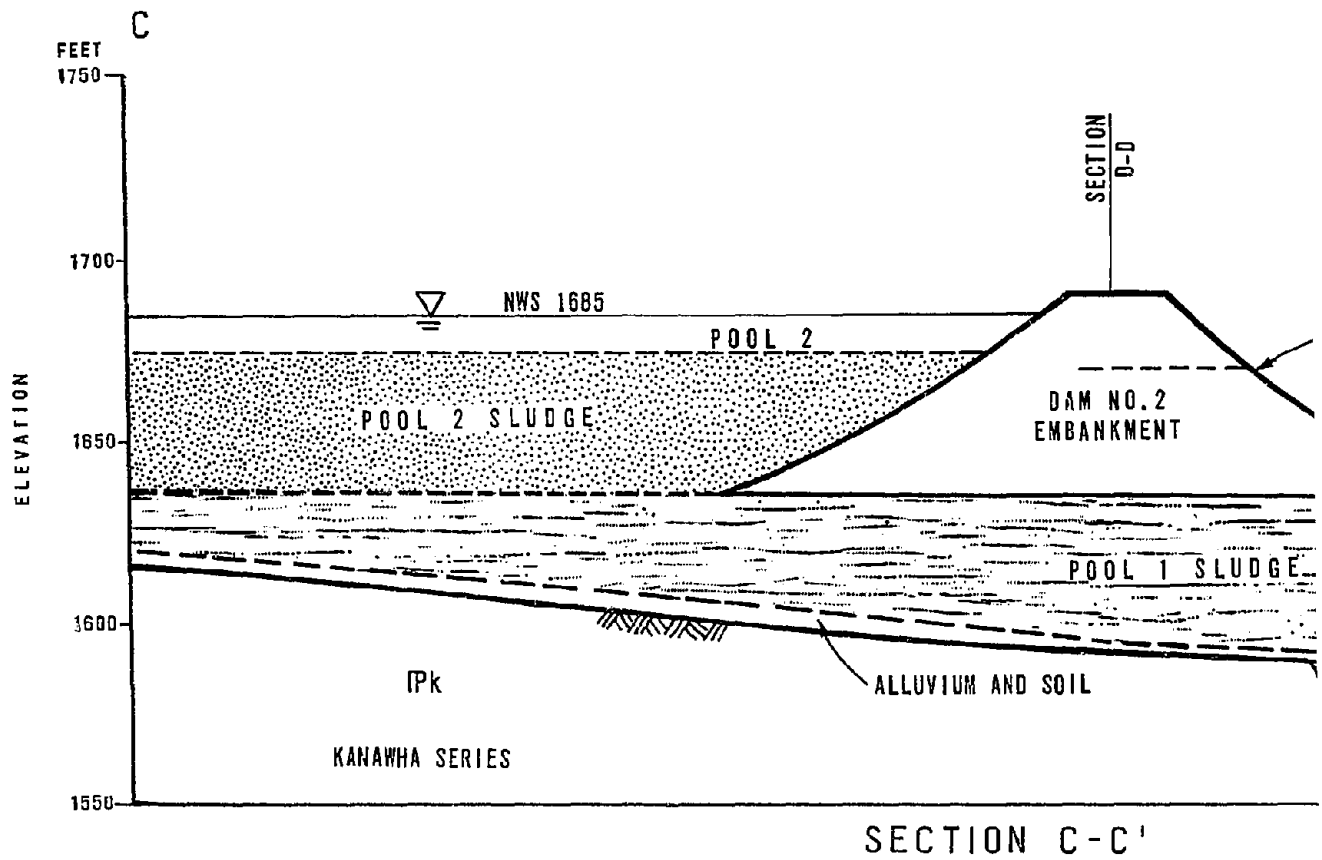
- NOTES: (1) FOR POSTFAILURE VIEW SEE CORRESPONDING PORTION OF SECTION A-A' (FIGURE VI-21).
 (2) FOR LOCATION OF SECTION SEE FIGURE VI-20.
 (3) PATTERNS USED FOR THE SLUDGE OF POOLS 1 AND 2 ARE FOR DELINEATION ONLY AND ARE NOT MEANT TO SUGGEST TEXTURE OR COMPOSITION.

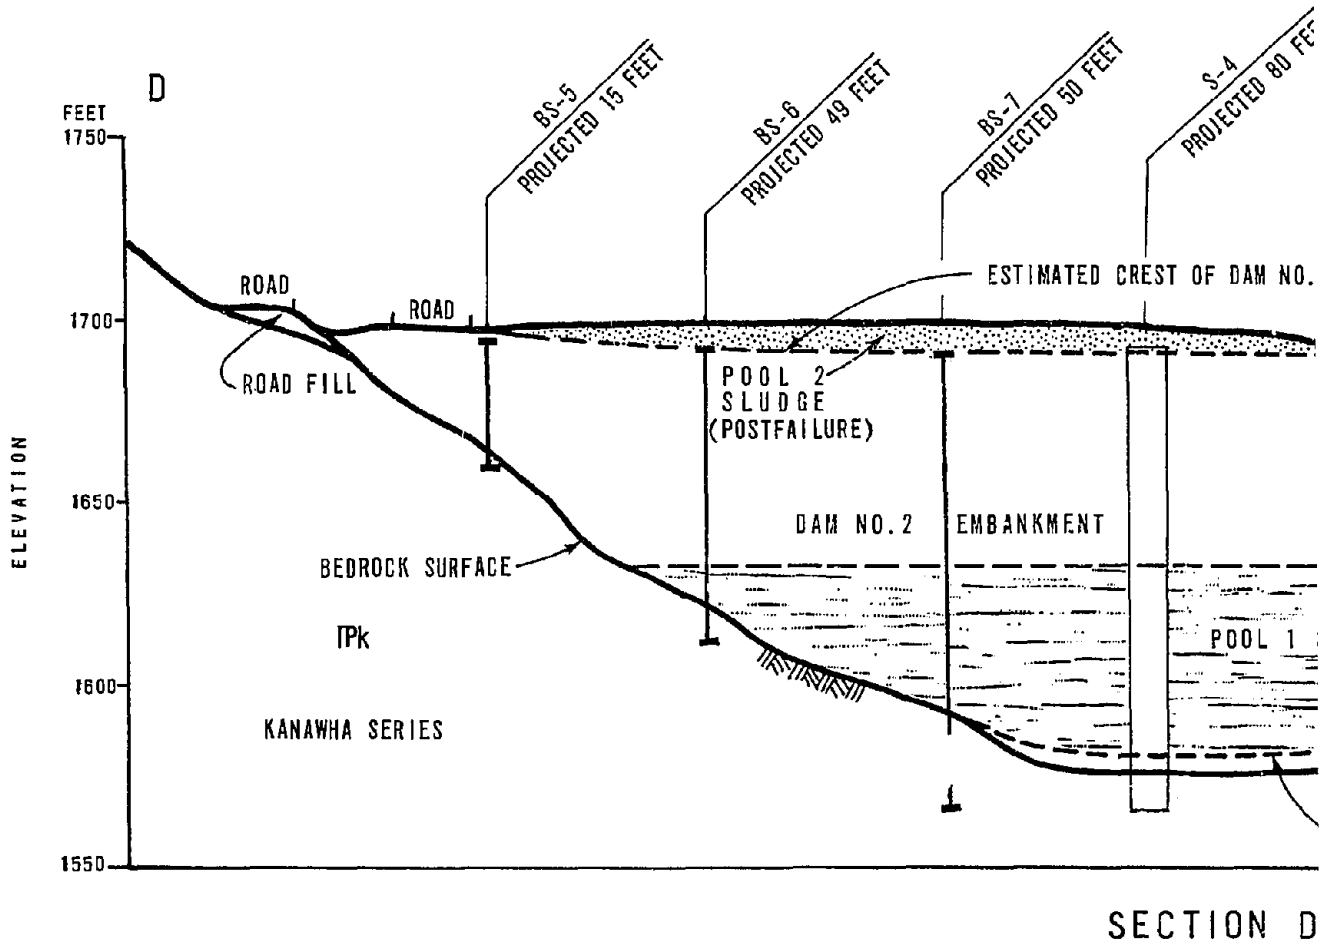
- NOTES: (1) PROJECTED DRILL HOLES ARE PROJECTED TO THE LINE OF SECTION AT RIGHT ANGLES TO IT.
- (2) FOR LOCATION OF SECTION SEE FIGURE VI-20.
- (3) PATTERNS USED FOR THE SLUDGE OF POOLS 1 AND 2 ARE FOR DELINEATION ONLY AND ARE NOT MEANT TO SUGGEST TEXTURE OR COMPOSITION.

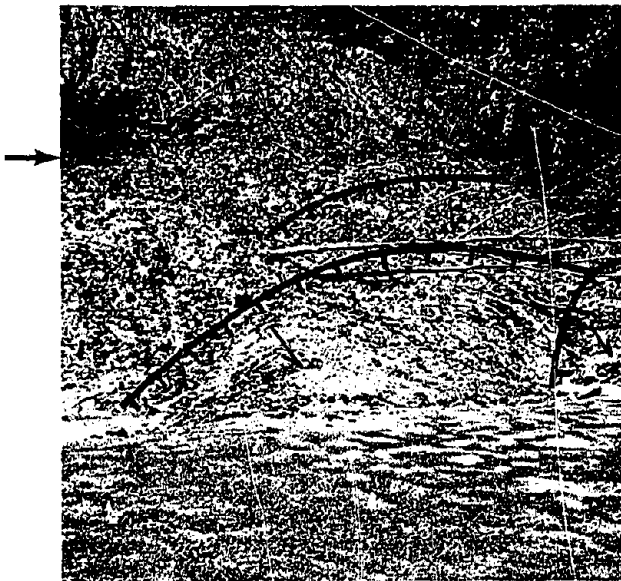
PHOTO A. SECONDARY SLIDES DEVELOPED ALONG LEFT SIDE OF POOL 2 IN TRANSLATED DAM NO. 3 EMBANKMENT. ARROW INDICATES HIGH-WATER LINE OF FLOOD WATER AT ABOUT ELEVATION 1711-1712. FIGURE VI-8 WAS TAKEN FROM THE TOP OF THE SLOPE JUST OUT OF VIEW AT THE UPPER LEFT.

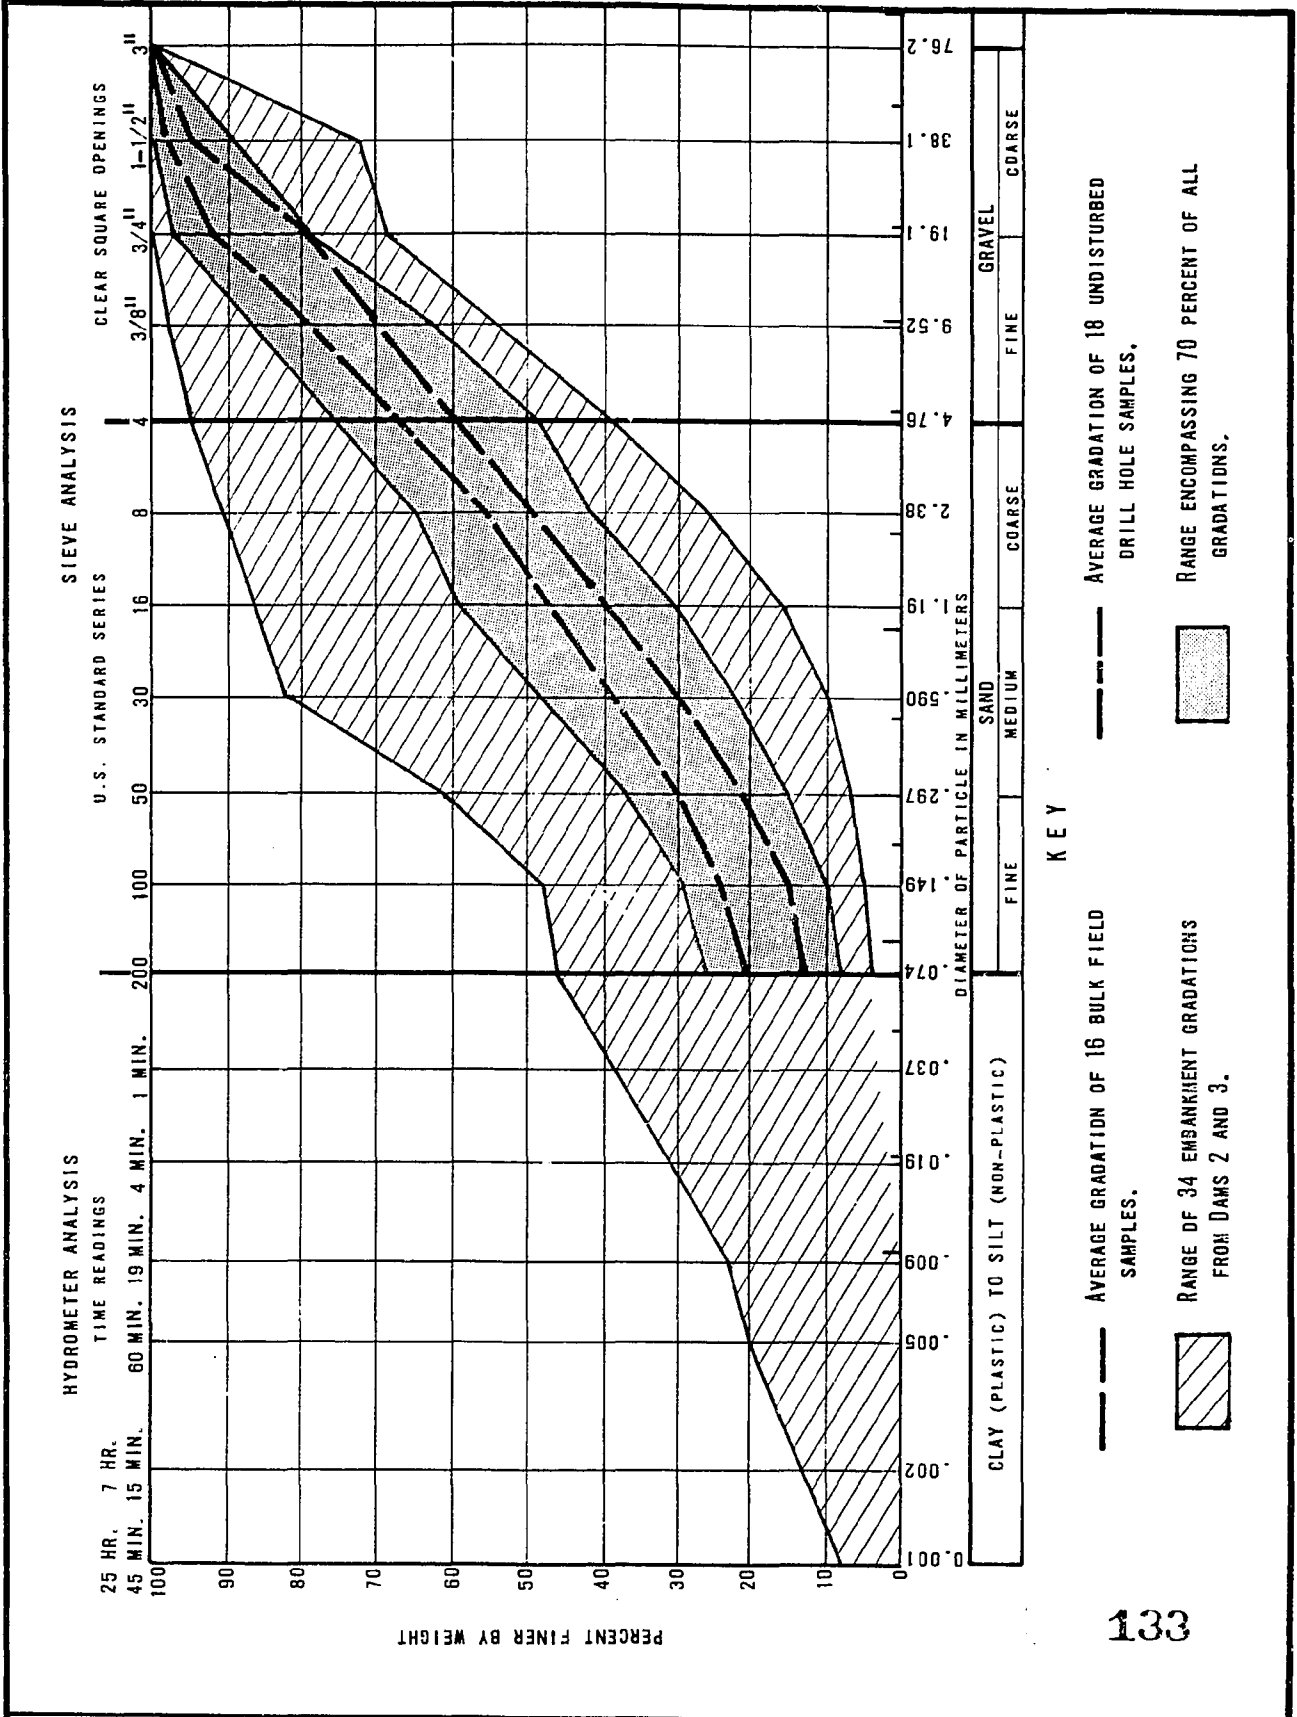
The average gradation characteristics of the embankment materials for Dams 2 and 3 were determined from a total of 34 gradation tests, of which 18 were performed on undisturbed tube samples, and 16 were performed on disturbed samples such as those obtained from field density tests. The results of the gradation tests are presented on Figure VII-1 in the form of the total range of all tests and the average gradation as determined from undisturbed and disturbed samples. As noted on Figure VII-1, the average gradations for the coarse-grained coal waste embankment material, as determined by the two sampling methods, are remarkably similar.

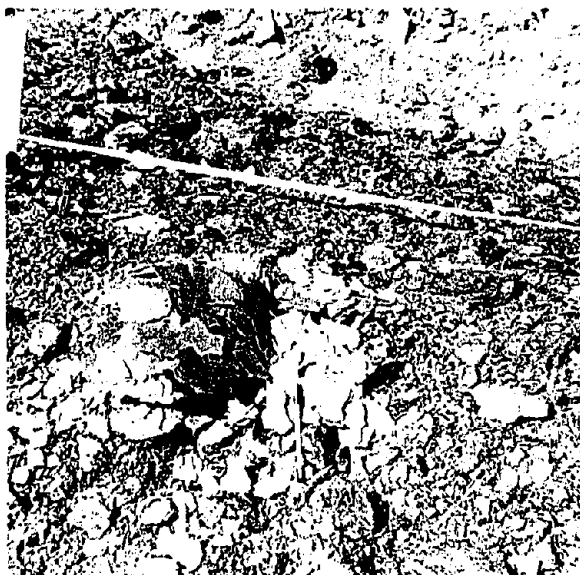
PHOTO A. SLAKING SHALE ON LEFT ABUTMENT REMNANT OF DAM NO. 3. A RARE MODE OF SLAKING ON THE SITE, THE SHALE HERE SLAKES INTO BRITTLE PIECES ABOUT 1/16 INCH THICK. FOR SCALE, PEN IS 6 INCHES LONG.

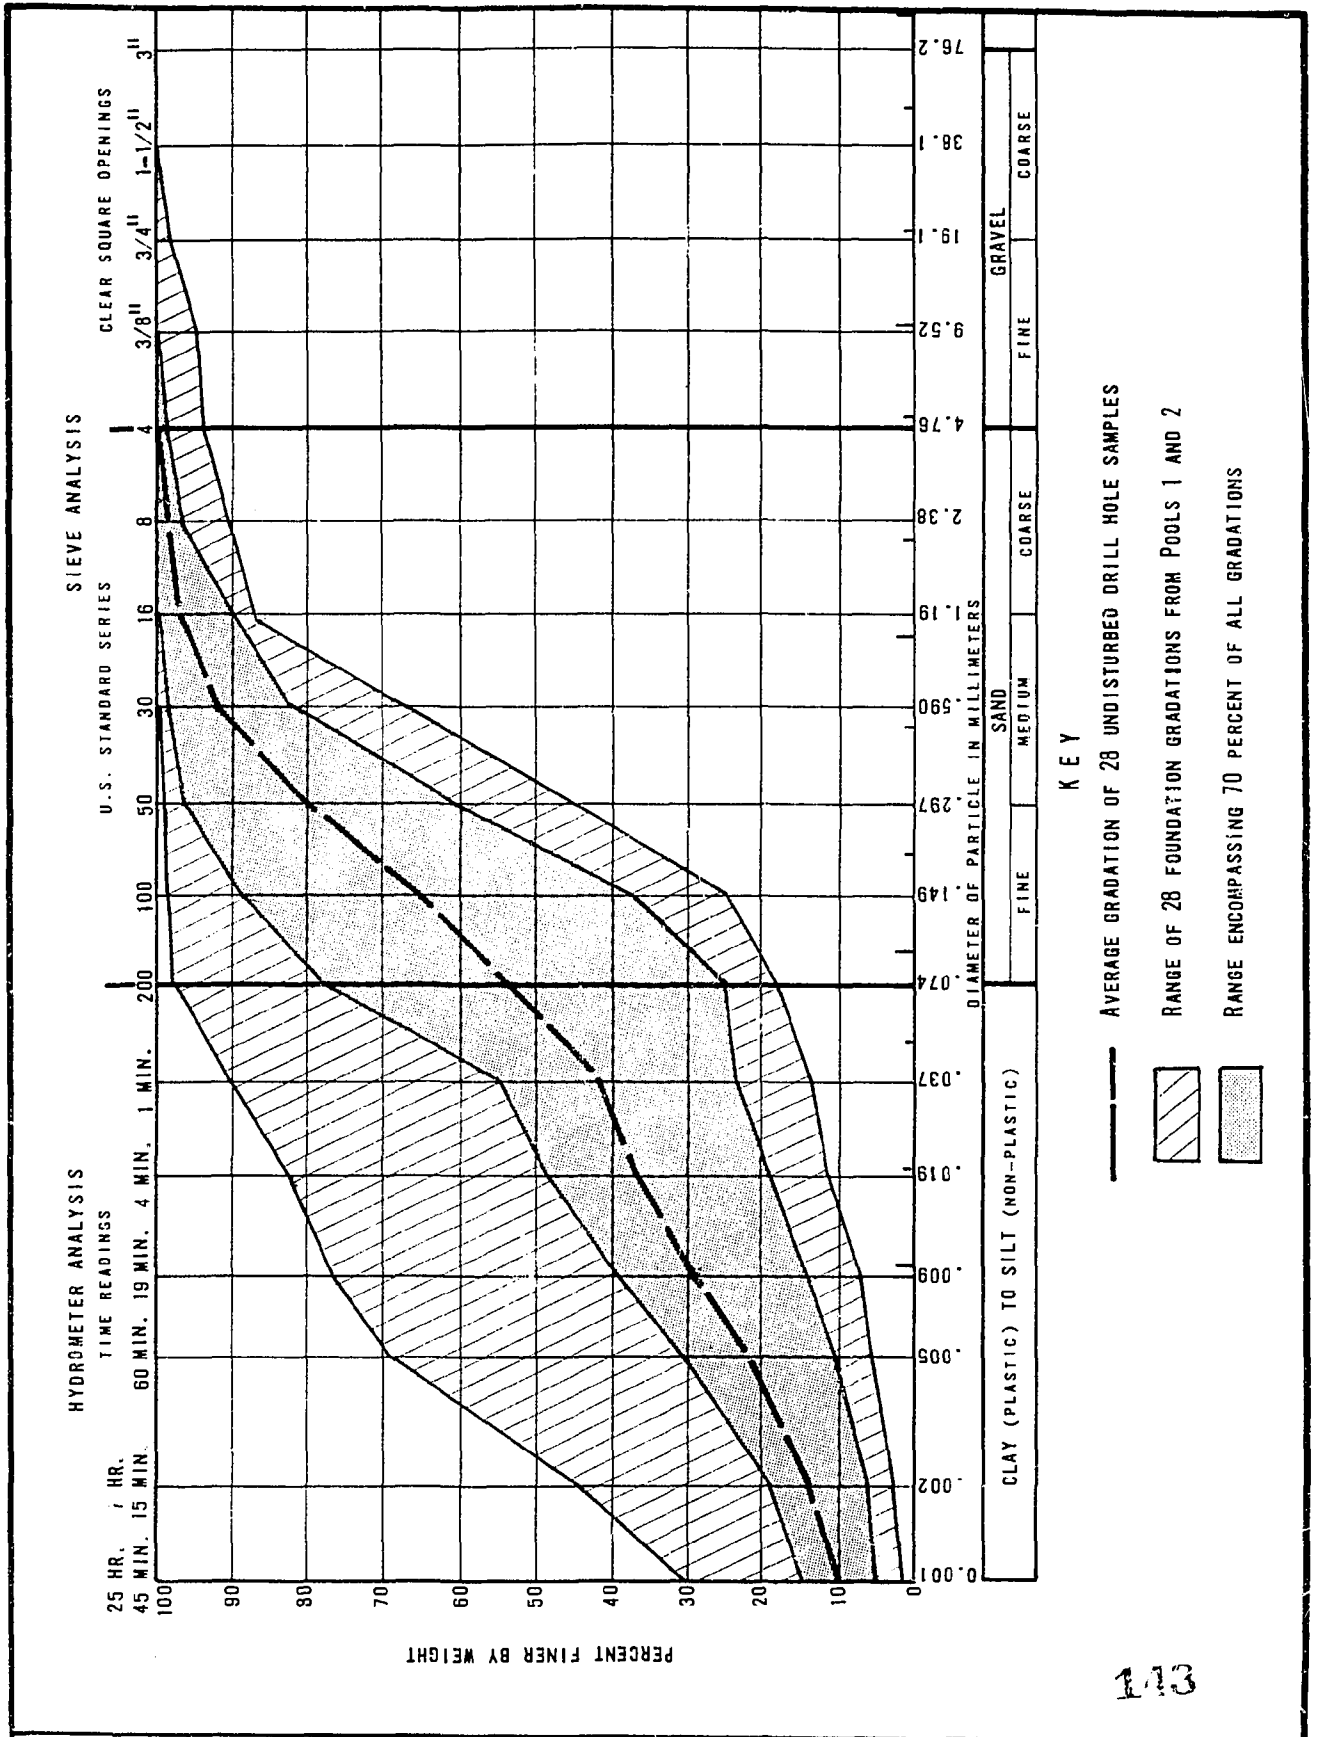
The maximum dry density for a representative sample of the foundation sludge material was determined to be only 57 pounds per cubic foot.

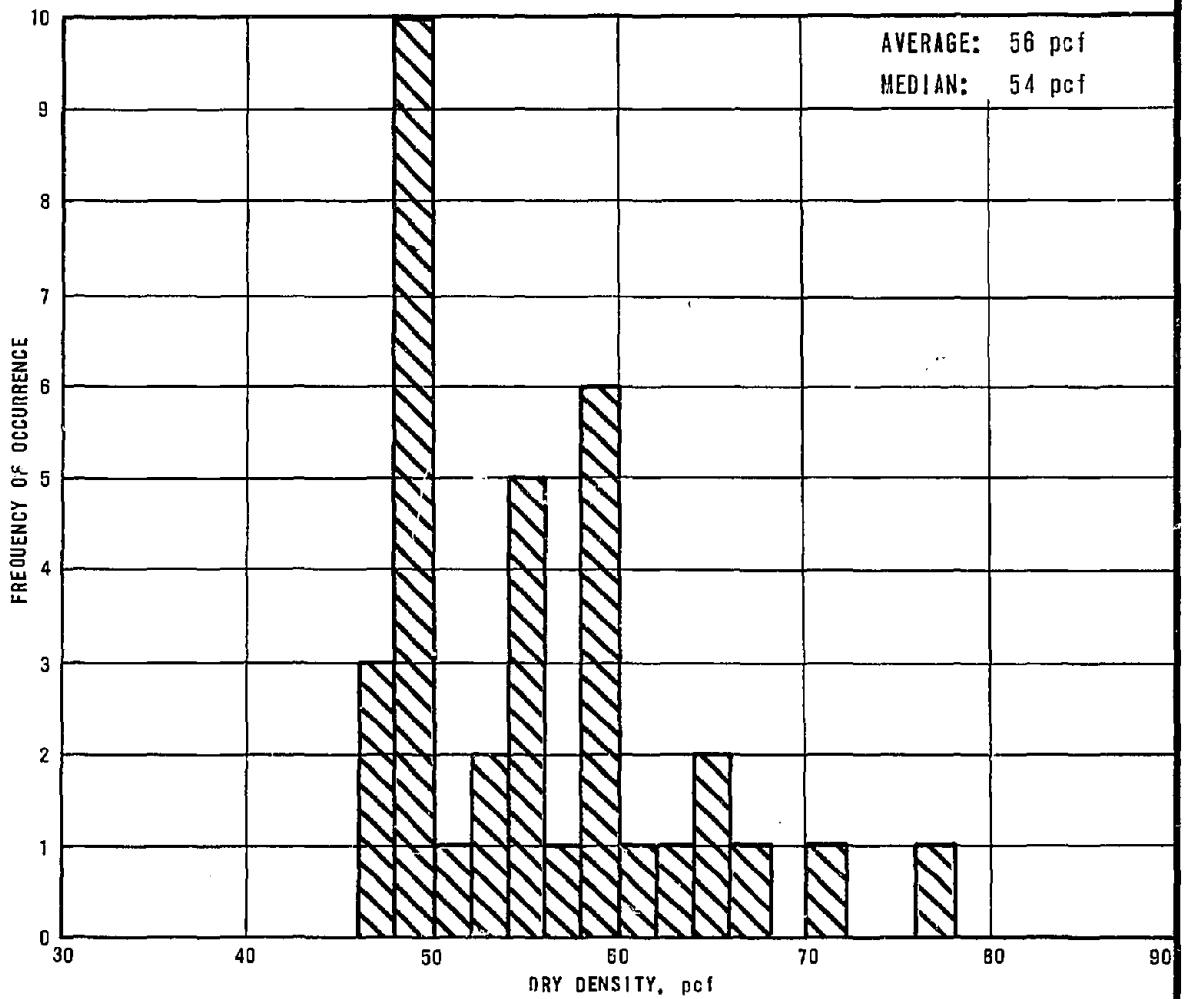
- NOTES: (1) THE DATA SHOWN HEREON, WHICH IS PRESENTED IN ITS ORIGINAL FORM IN TABLES A-2 AND B-1, REPRESENT DRY DENSITIES OF SELECTED FOUNDATION MATERIALS AS DETERMINED FROM BOTH IN-PLACE FIELD DENSITIES AND UNDISTURBED DRILL HOLE SAMPLES.
- (2) A STATISTICAL EVALUATION OF THESE DATA WAS NOT PERFORMED BECAUSE THE SAMPLE SELECTION PROCESS COULD PRECLUDE A RANDOM VARIATION OF SAMPLED DATA.
- (3) NOT INCLUDED IN THE FREQUENCY DISTRIBUTION ARE TEST RESULTS REPRESENTING DISTURBED, TRANSLATED OR MIXED MATERIALS.

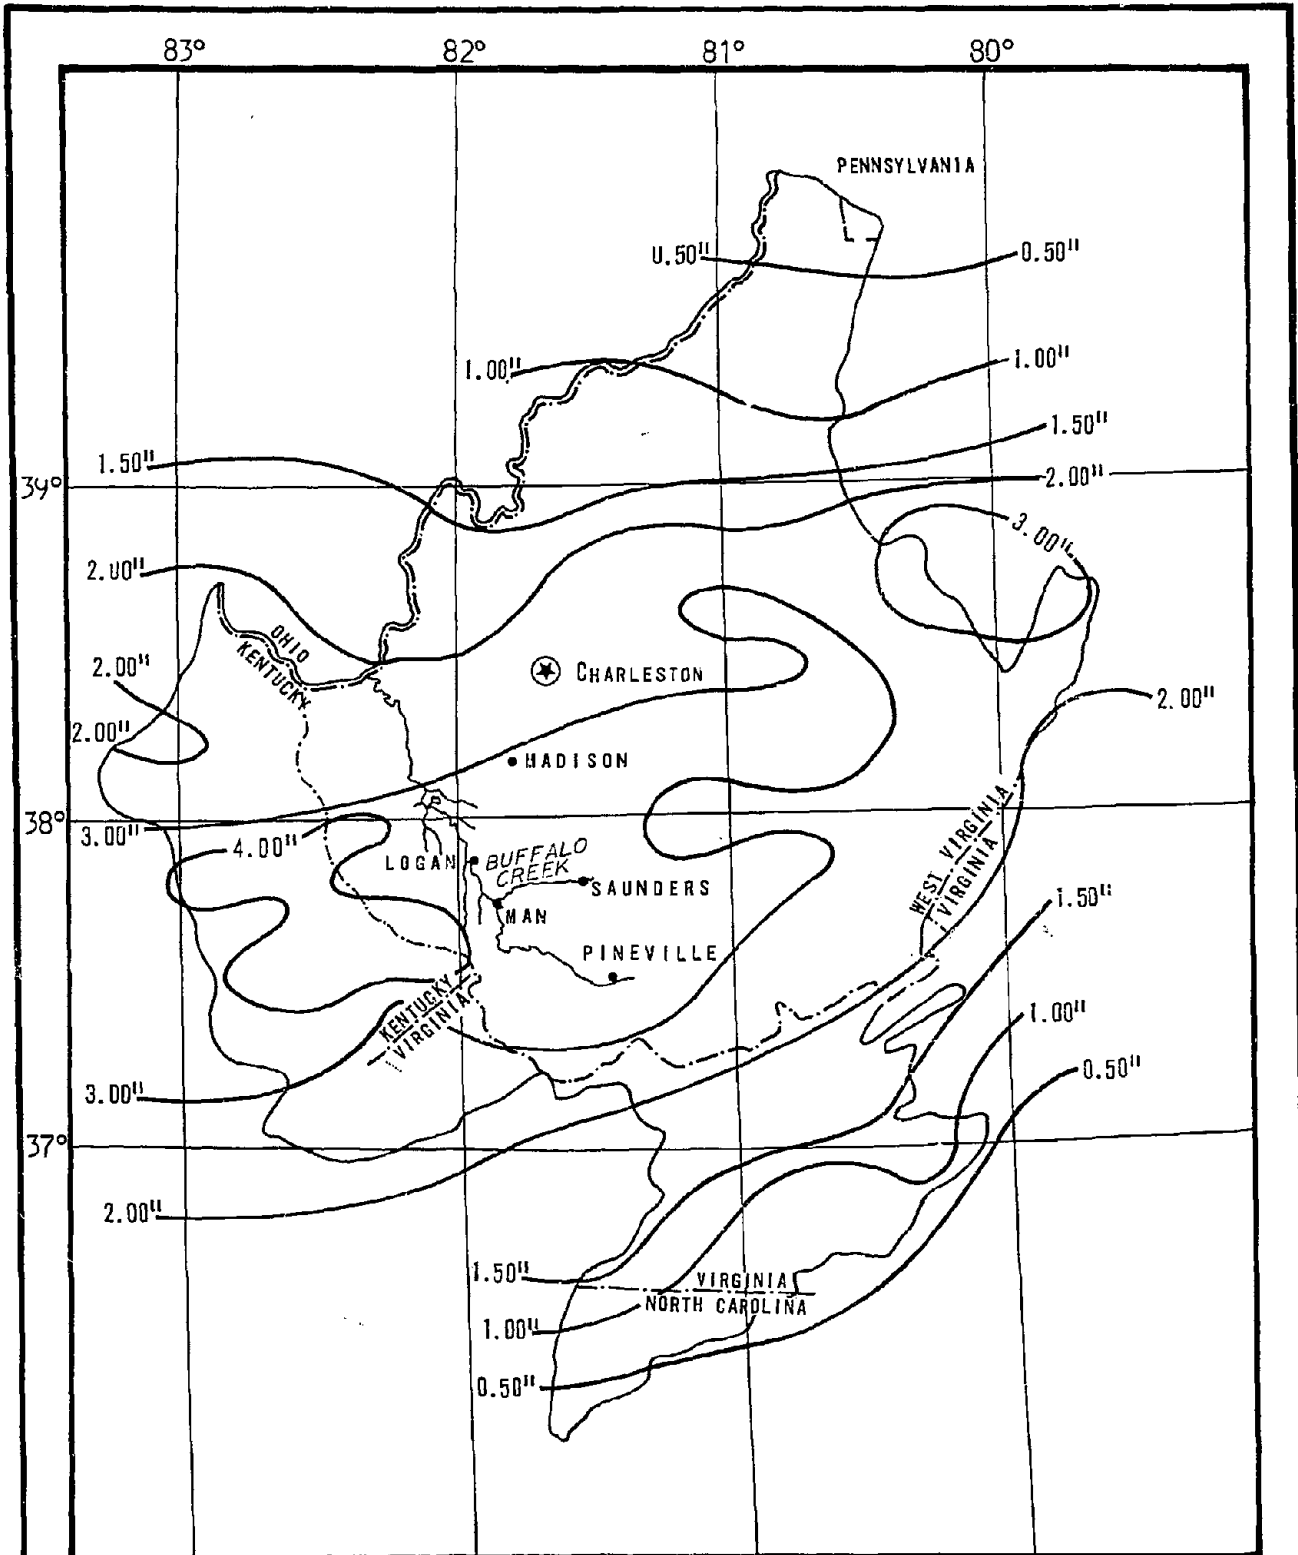
INFORMATION FROM NATIONAL WEATHER SERVICE DATA.

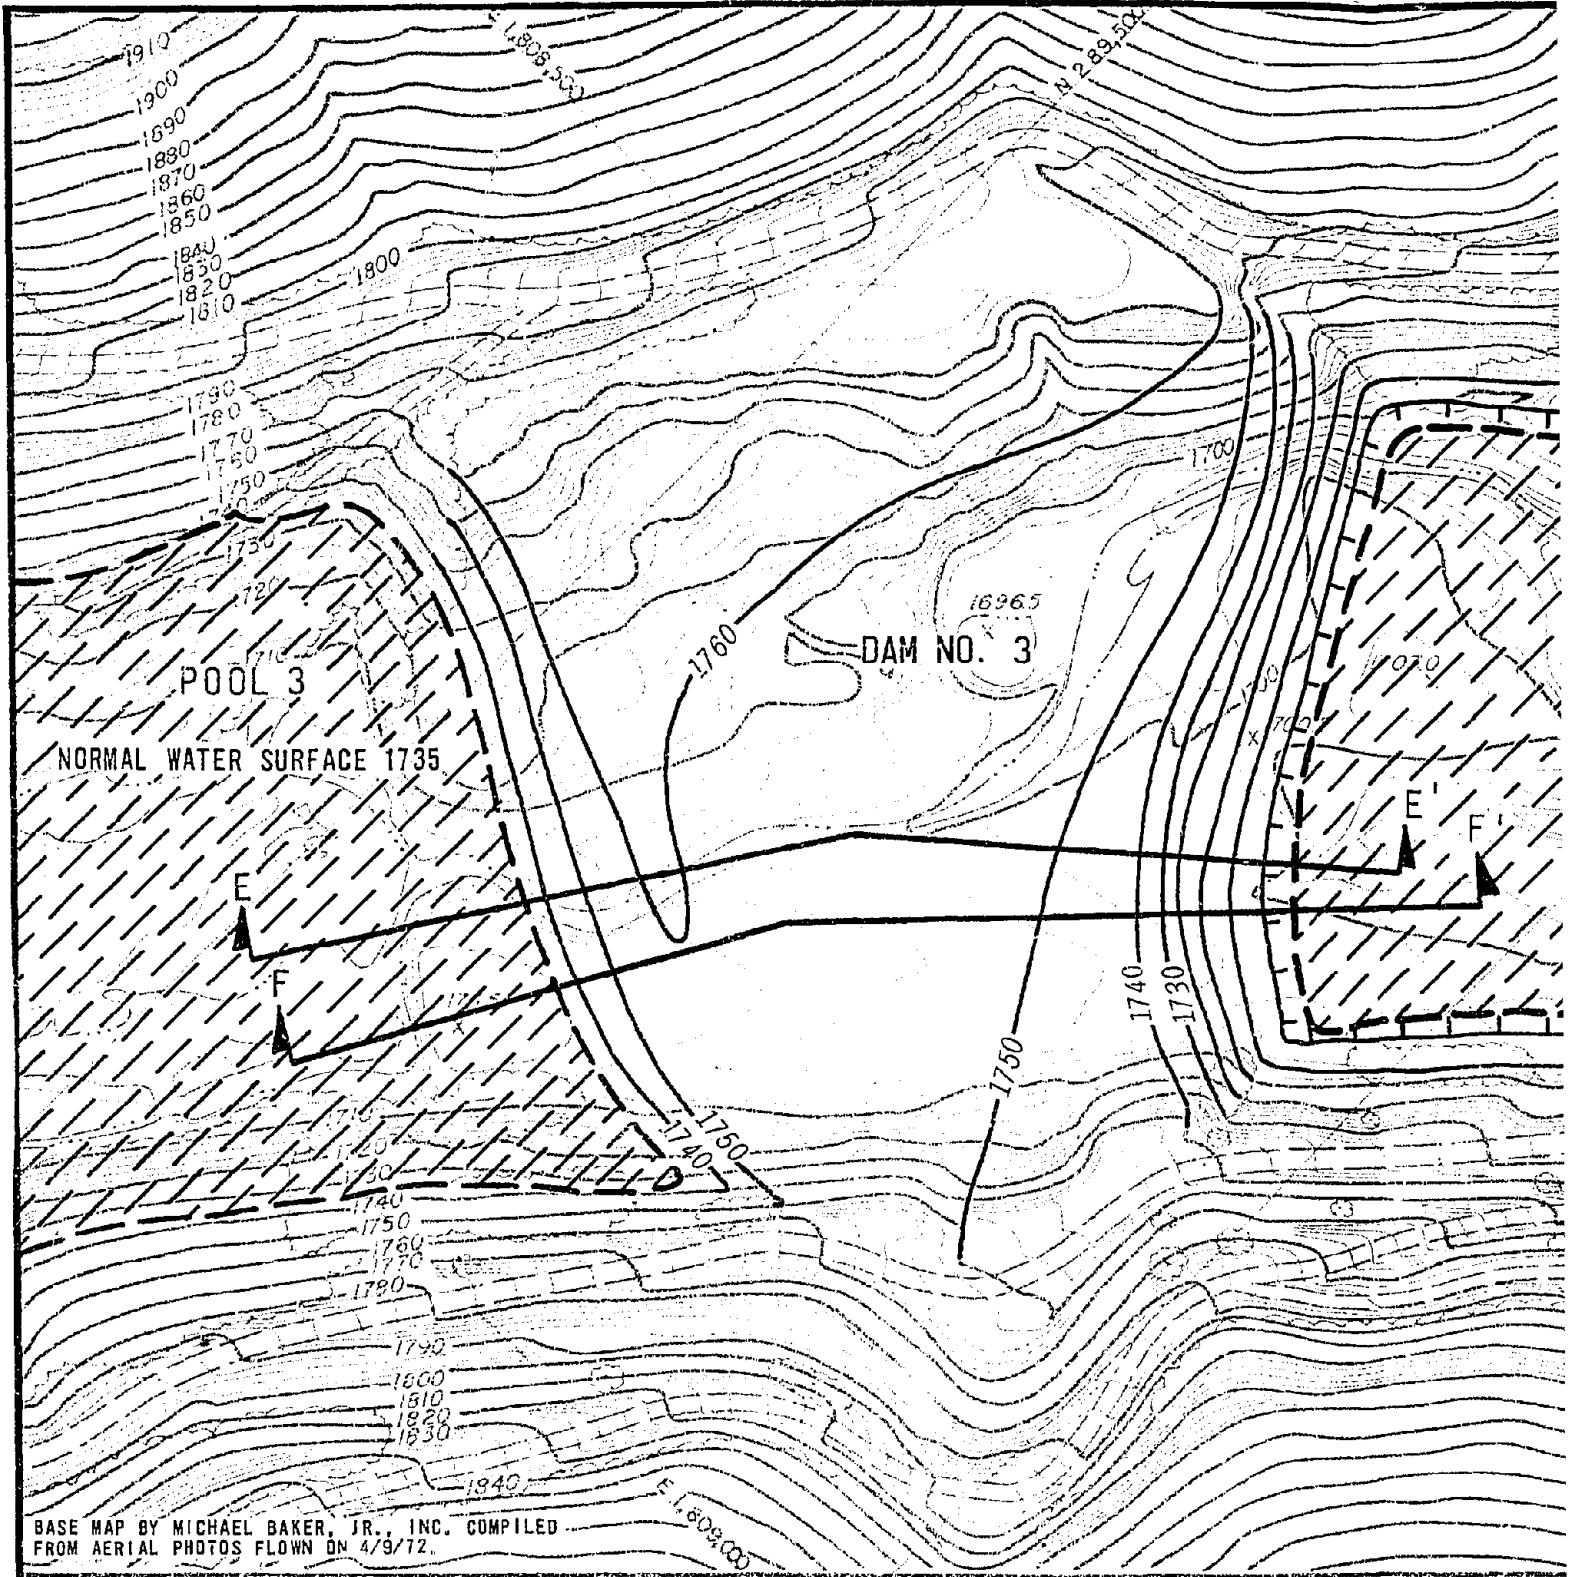
- NOTES: (1) PREFAILURE TOPOGRAPHY CONSISTS OF 10' CONTOURS AND SELECTED 2' CONTOURS IN THE DAM NO. 2 AREA.
- (2) RECONSTRUCTED PREFAILURE TOPOGRAPHY IS BASED ON POSTFAILURE TOPOGRAPHIC CONFIGURATION AND OTHER AVAILABLE DATA. SEE FIGURE V-16.
- (3) SEE FIGURE VII-12 FOR SECTION E-E'.
- (4) SEE FIGURE VII-13 FOR SECTION F-F'.

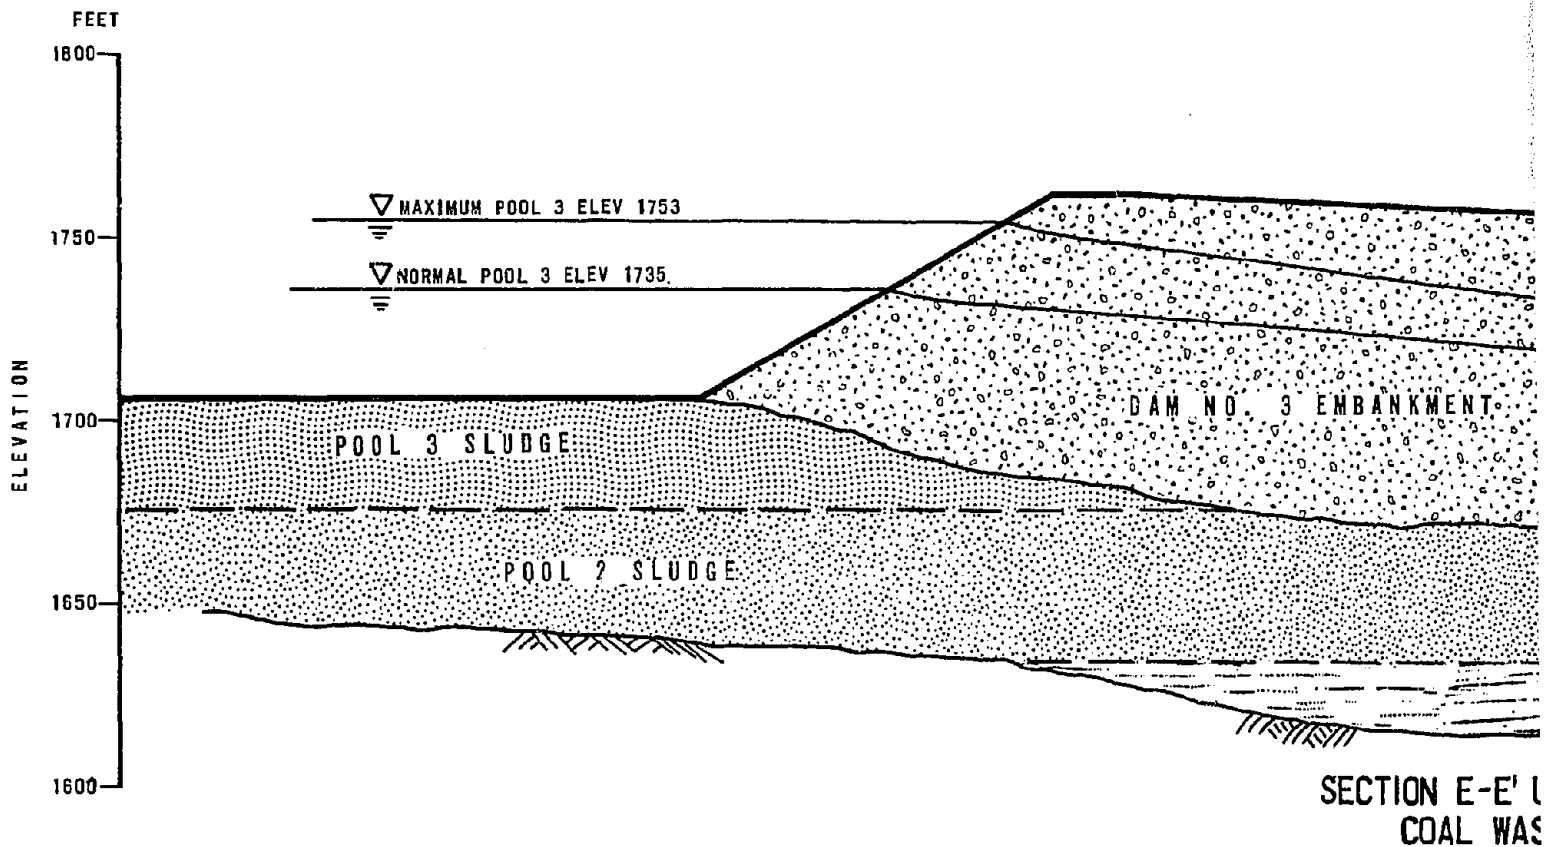
SECTION E-E' L
COAL WAS

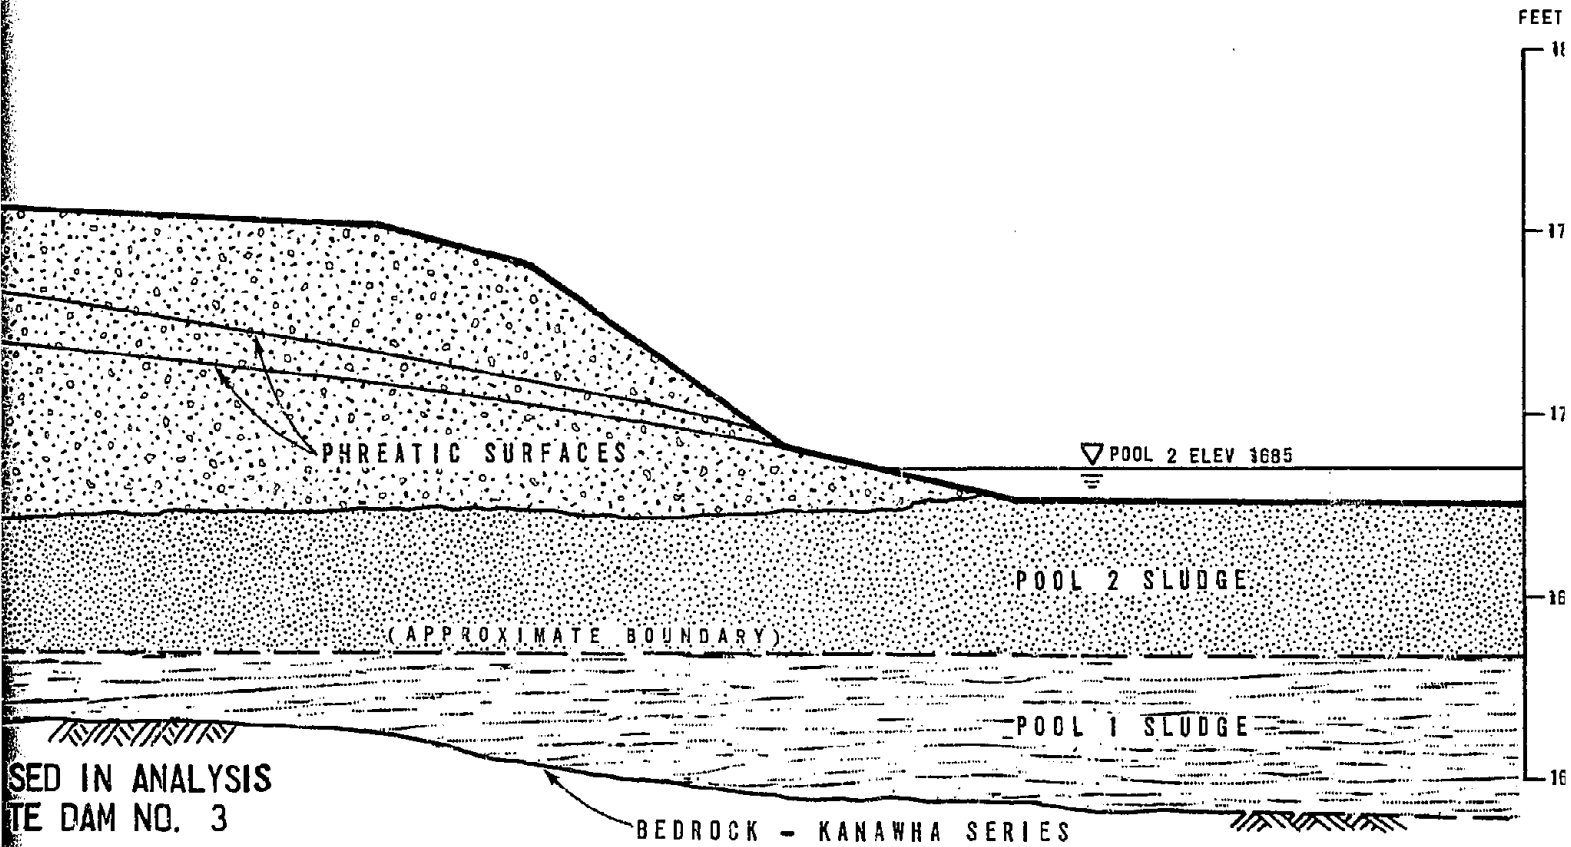
METERS	
TOTAL STRESS	
	C (ksf)
0.0	0.7
0.5	0.7
1.0	1.1
1.5	(3)

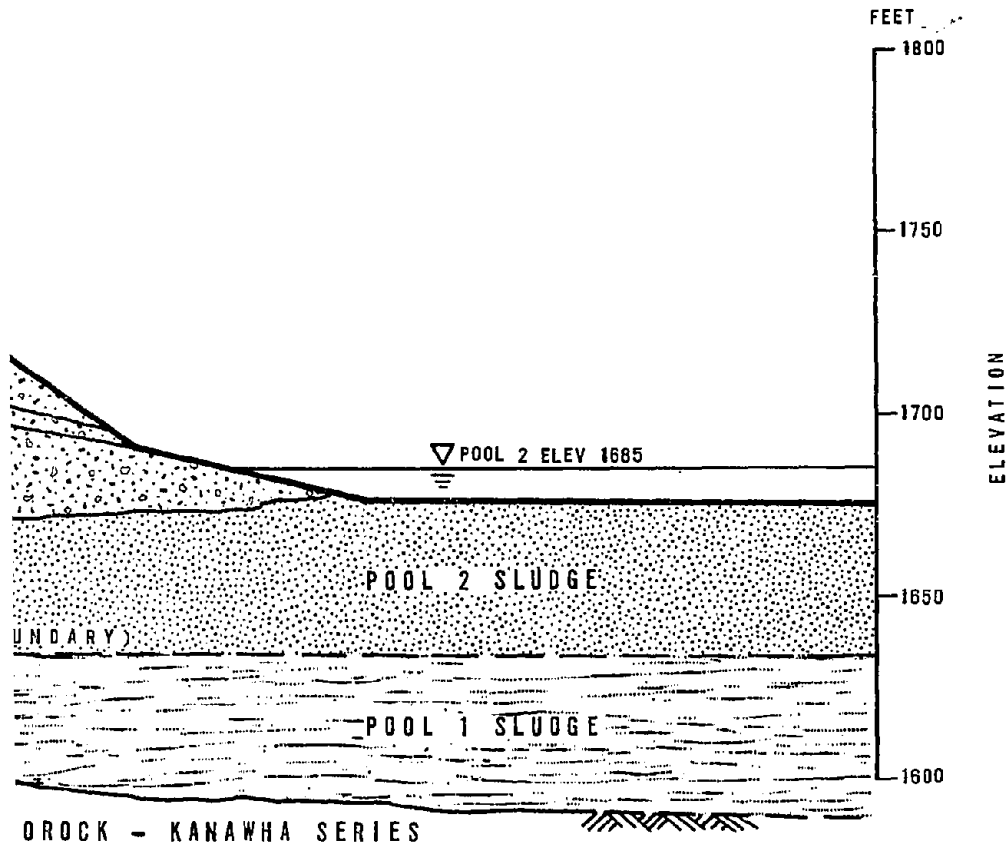
LOCATED SLIGHTLY RIGHT
 (AM) OF THE DAM MID-
 IN FIGURE VII-11.

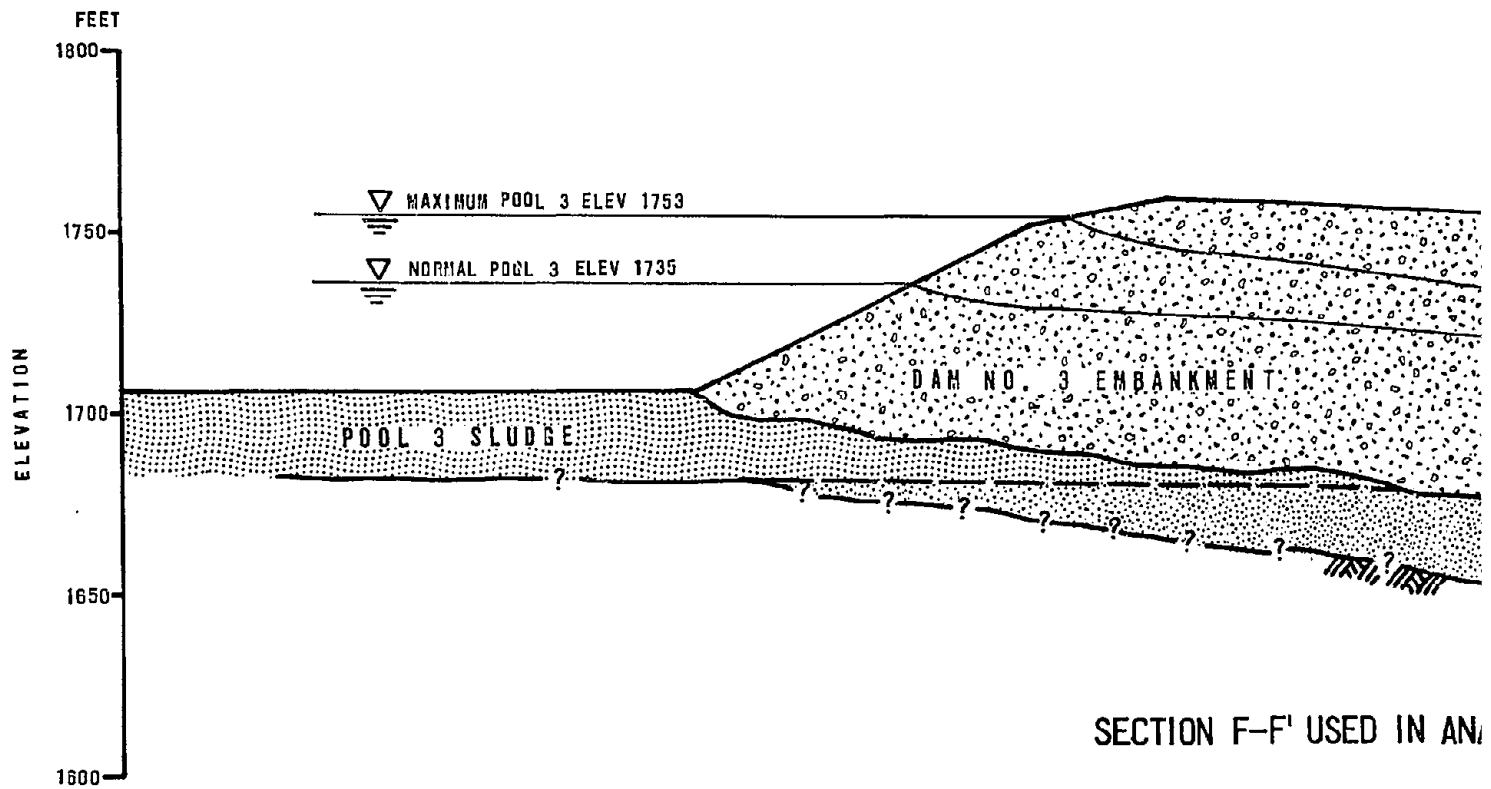
SOIL PROPERTIES USED IN STABILITY ANALYSIS.

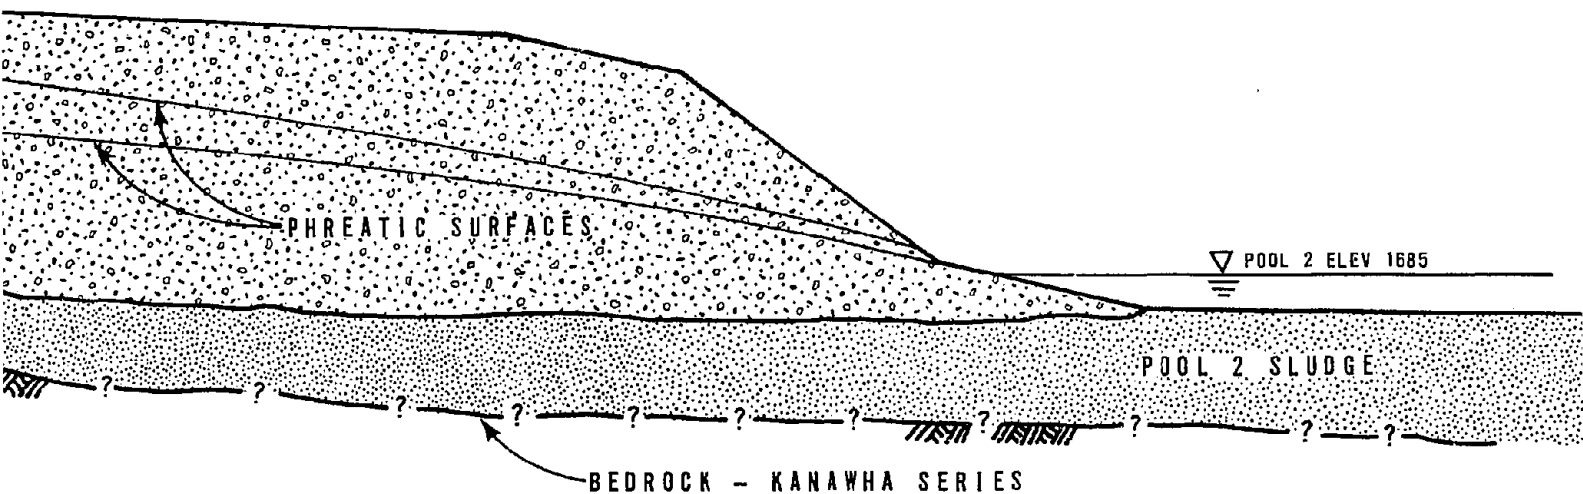
ANALYSES - COAL WASTE DAM NO. 3

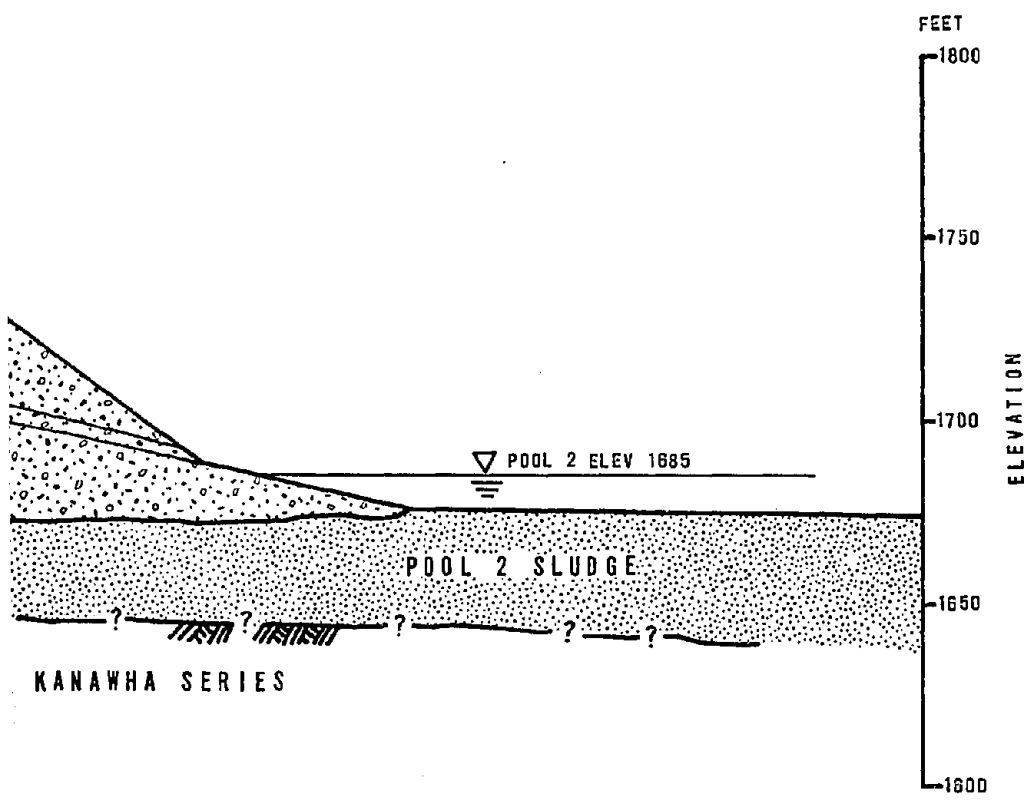
- (1) SECTION F-F' IS LOCATED RIGHT (LOOKING DOWNSTREAM) OF THE DAM MIDSECTION AS SHOWN IN FIGURE VII-11.
- (2) MOIST UNIT WEIGHTS OF THE EMBANKMENT MATERIALS WERE ASSUMED TO VARY FROM 96 pcf AT THE CREST OF THE DAM TO 106 pcf BELOW THE PHREATIC SURFACE.
- (3) INFINITELY HIGHER STRENGTHS WERE ASSUMED FOR THE BEDROCK MATERIAL AND ALL FAILURE SURFACES WERE ASSUMED TO BE CONFINED TO THE EMBANKMENT AND SLUDGE MATERIALS.
- (4) PORE PRESSURES ASSUMED FOR THE STABILITY ANALYSIS WERE DETERMINED FROM APPLICABLE FLOW NETS. (SEE FIGURES VII-18, VII-19 AND VII-20).
- (5) BEDROCK SURFACE INTERPOLATED FROM ADJACENT DRILL HOLE INFORMATION.
- (6) PATTERNS USED FOR THE SLUDGE MATERIAL OF POOLS 2 AND 3 AS WELL AS THE EMBANKMENT MATERIAL OF DAM NO. 3 ARE FOR DELINEATION ONLY AND ARE NOT MEANT TO SUGGEST TEXTURE OR COMPOSITION.

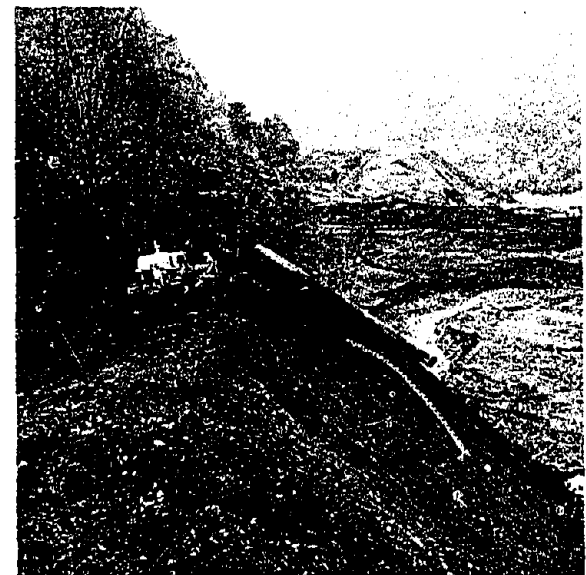
PHOTO D. UPSTREAM PIPE JUST AFTER PULLING IT TO THE EXPLORATORY BULLDOZER TRENCH ON THE LEFT ABUTMENT OF DAM NO. 3.
