**ANALYSIS OF
COAL REFUSE DAM FAILURE**

**MIDDLE FORK BUFFALO CREEK
SAUNDERS, WEST VIRGINIA**

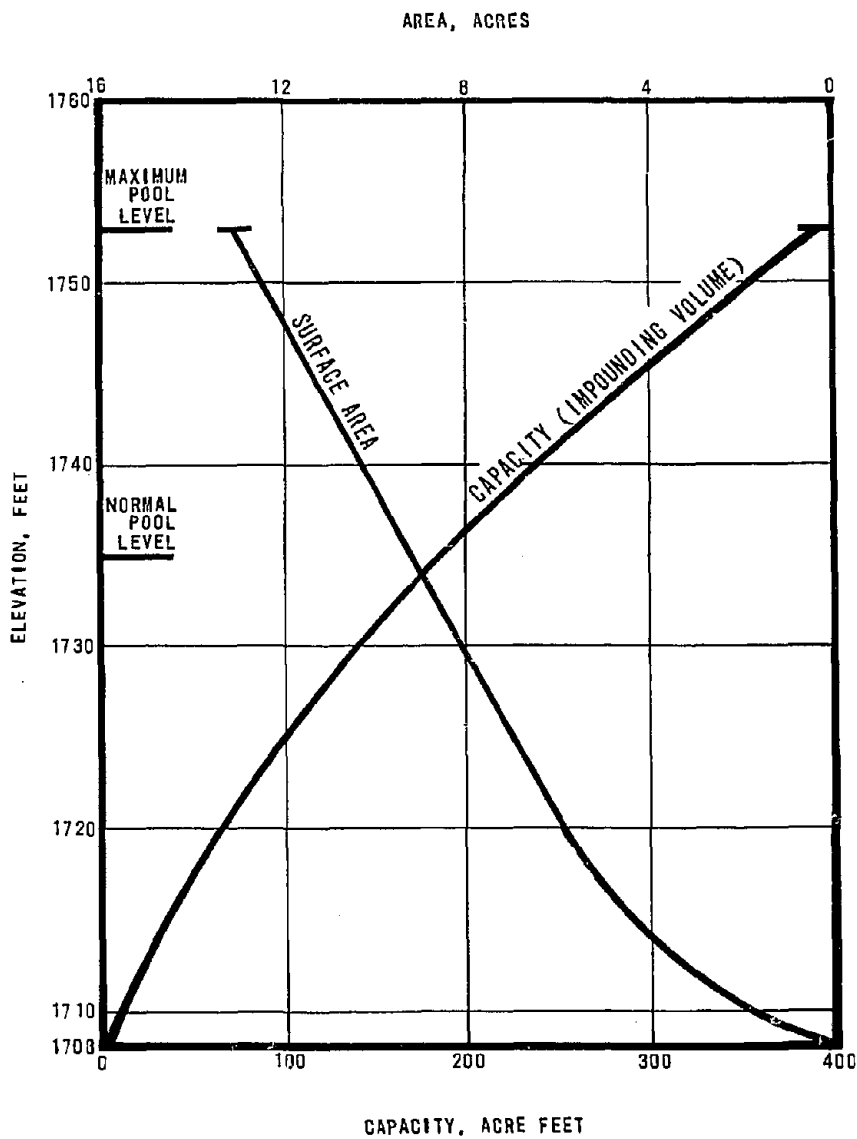
NOTE: (1) THE CAPACITY OF THE RESERVOIR IS SHOWN STARTING AT ELEVATION 1708 WHICH COINCIDES WITH THE POOL 3 SLUDGE LEVEL AT THE UPSTREAM TOE OF DAM NO. 3.

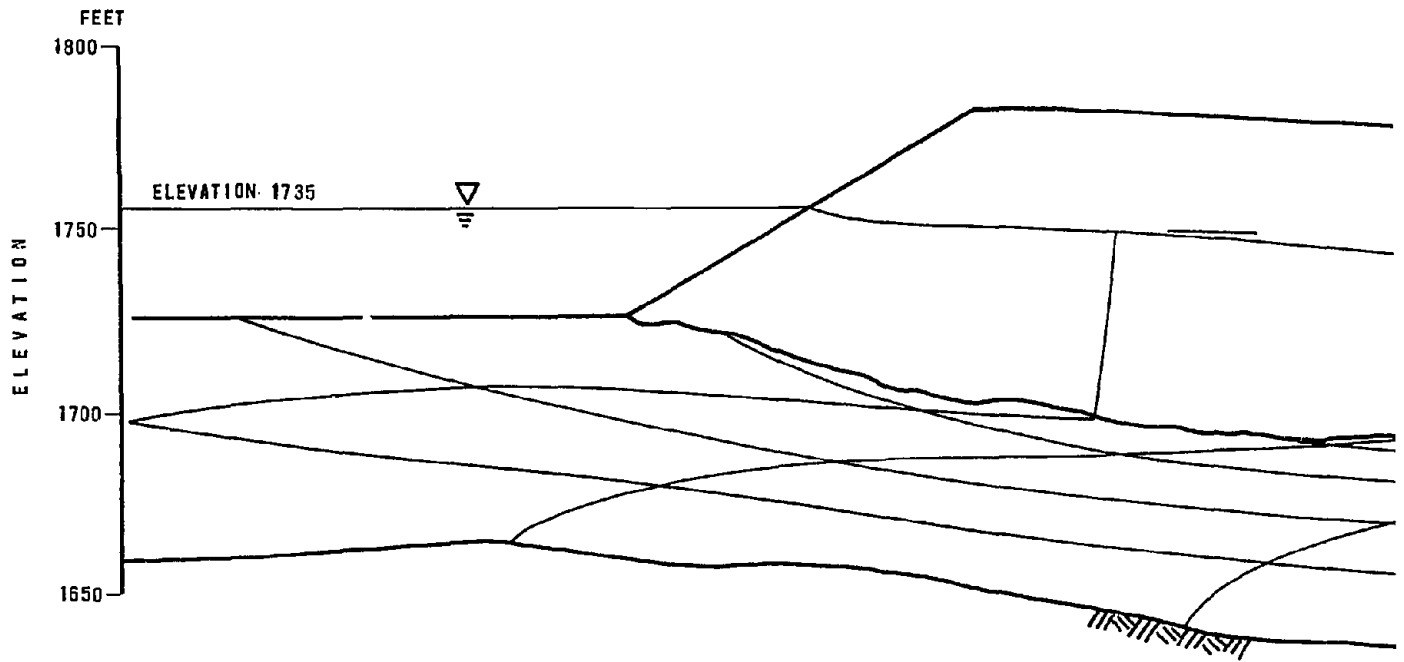
SECTION E-E' FLOW NET: FOUR

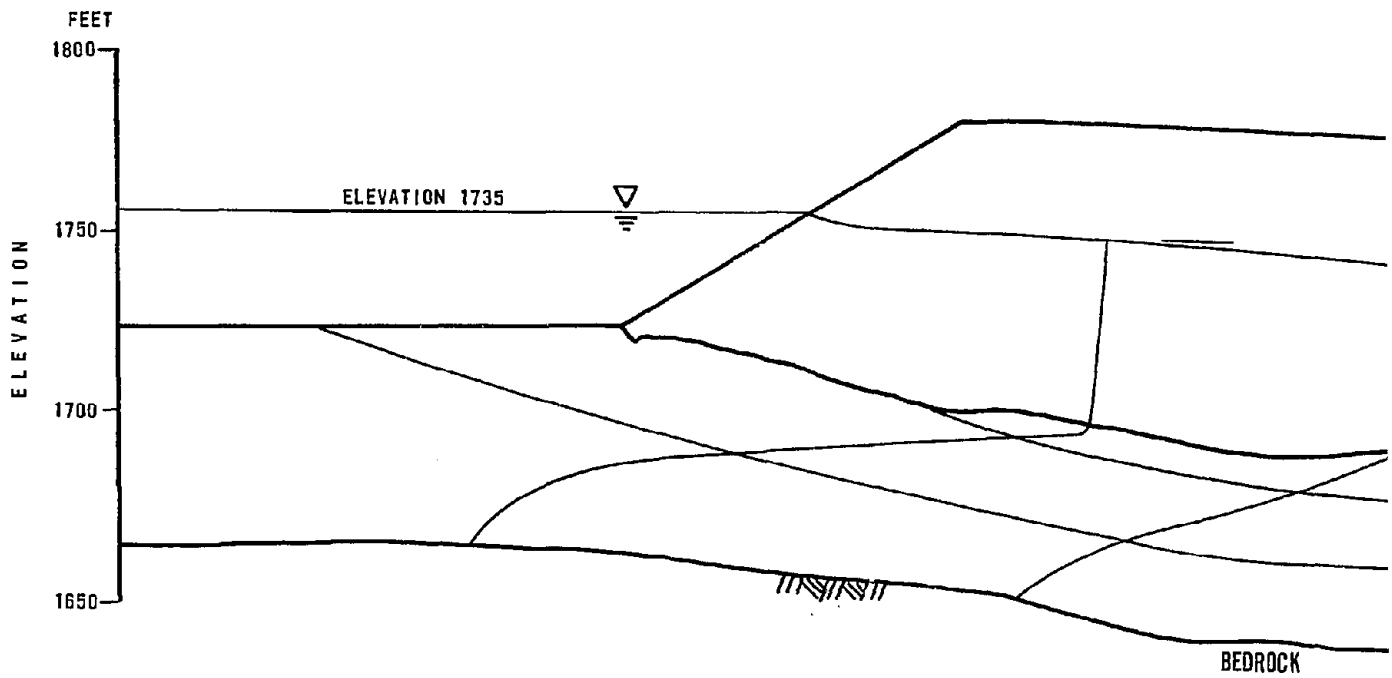
SECTION E-E' FLOW NET: FOUR

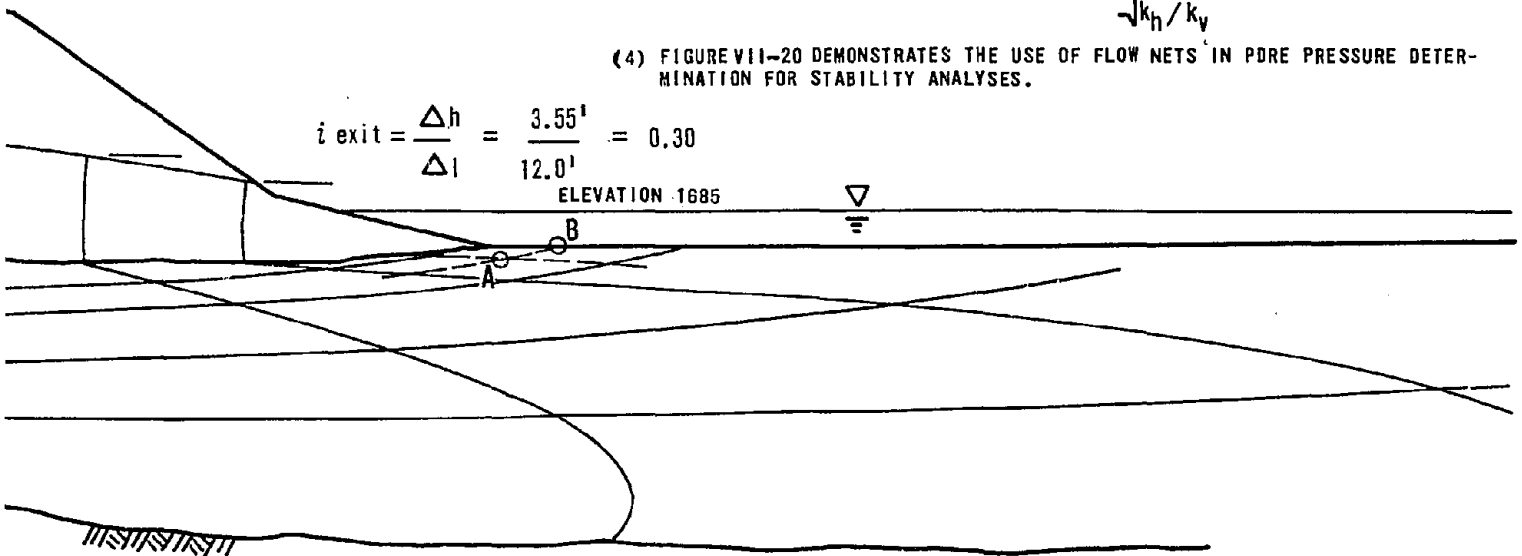
Ratio = 100; NORMAL RESERVOIR LEVEL

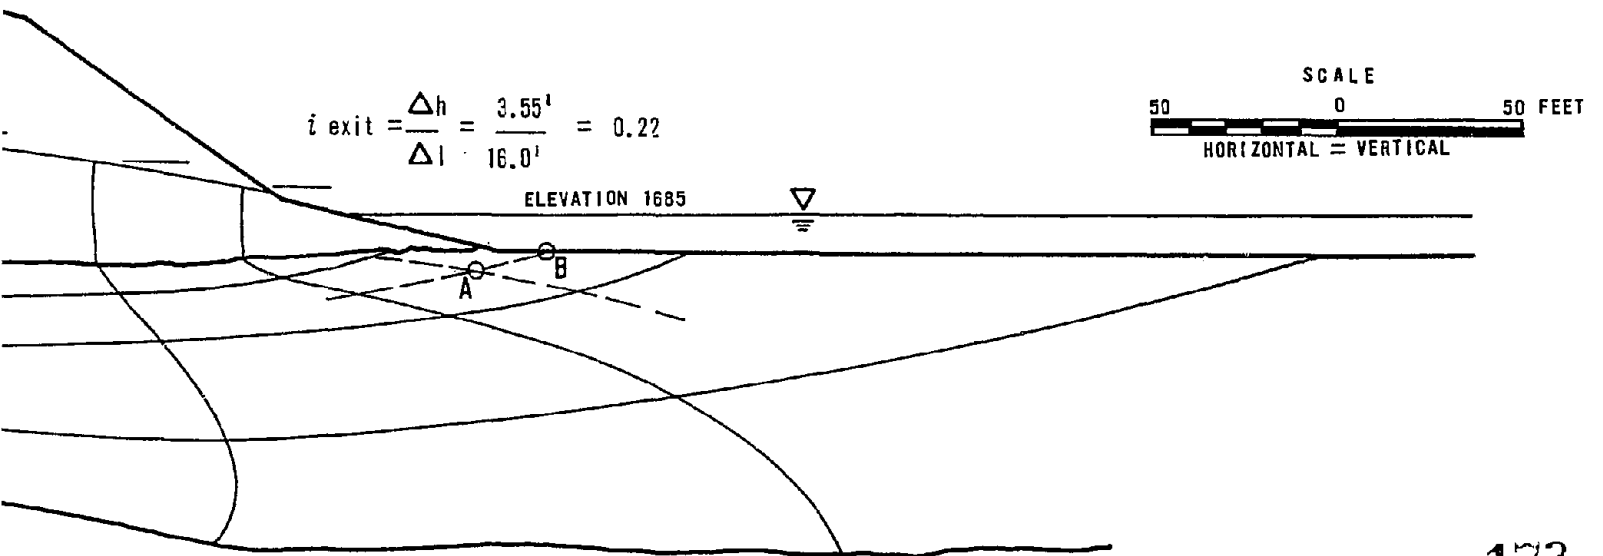
Ratio = 25; NORMAL RESERVOIR LEVEL

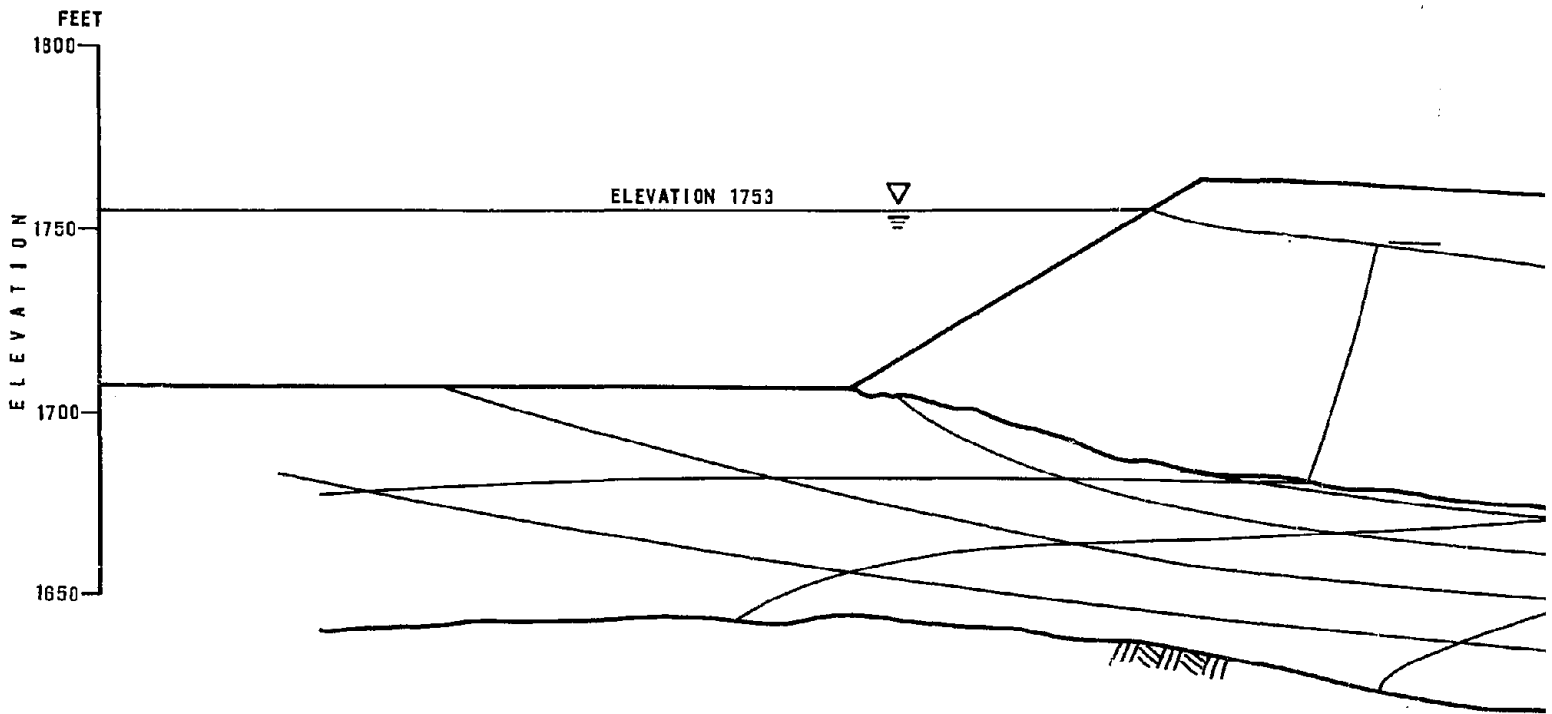
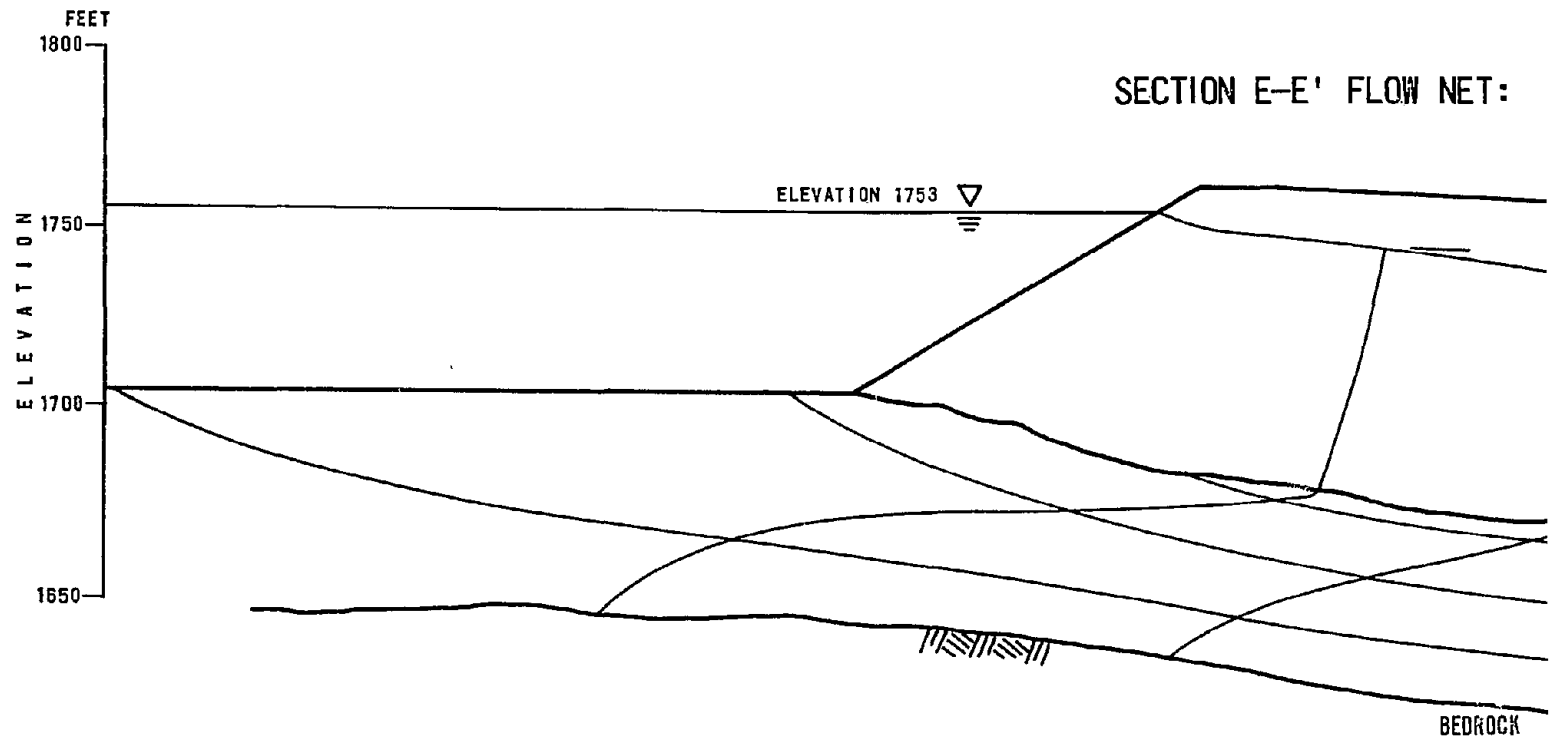
SECTION E-E' FLOW NET:

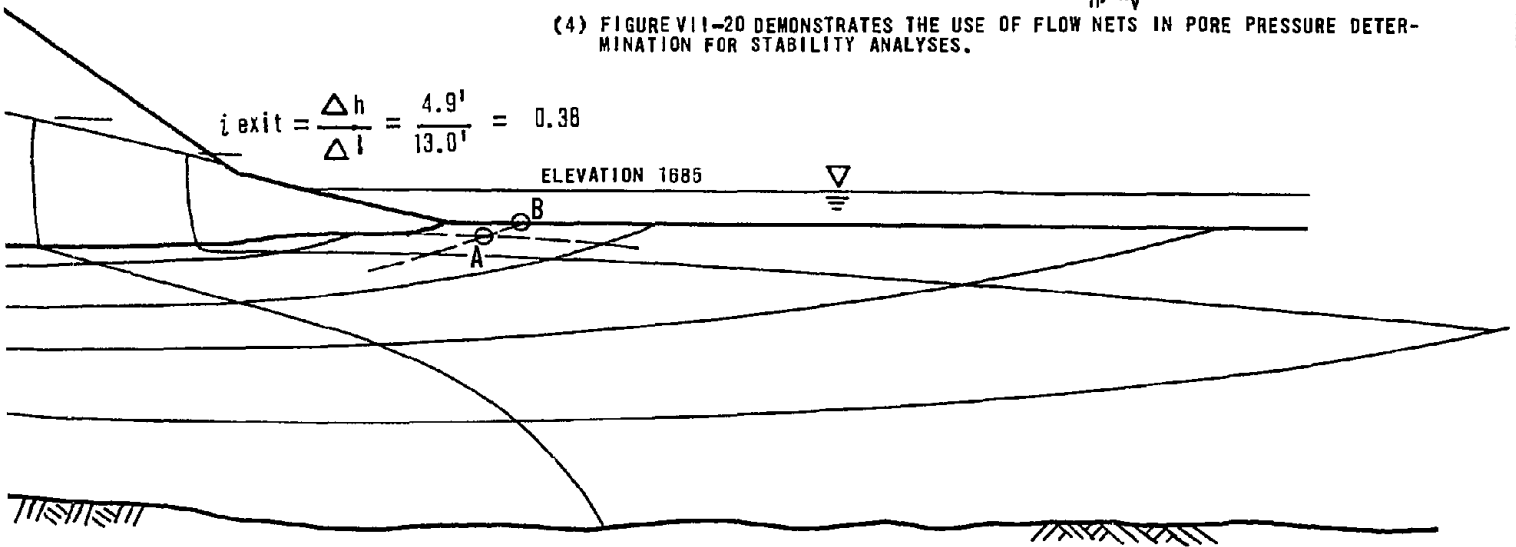
= 100; HIGH RESERVOIR LEVEL

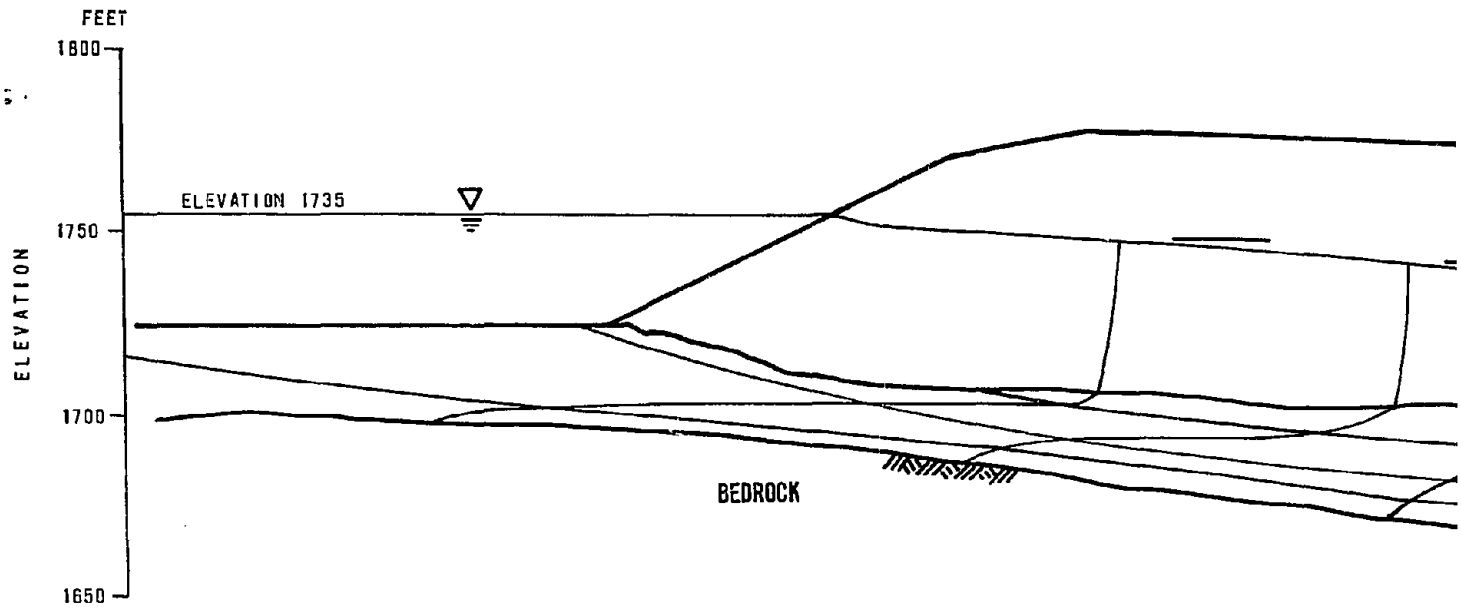
SECTION F-F' FLOW NET: FOUNDATION

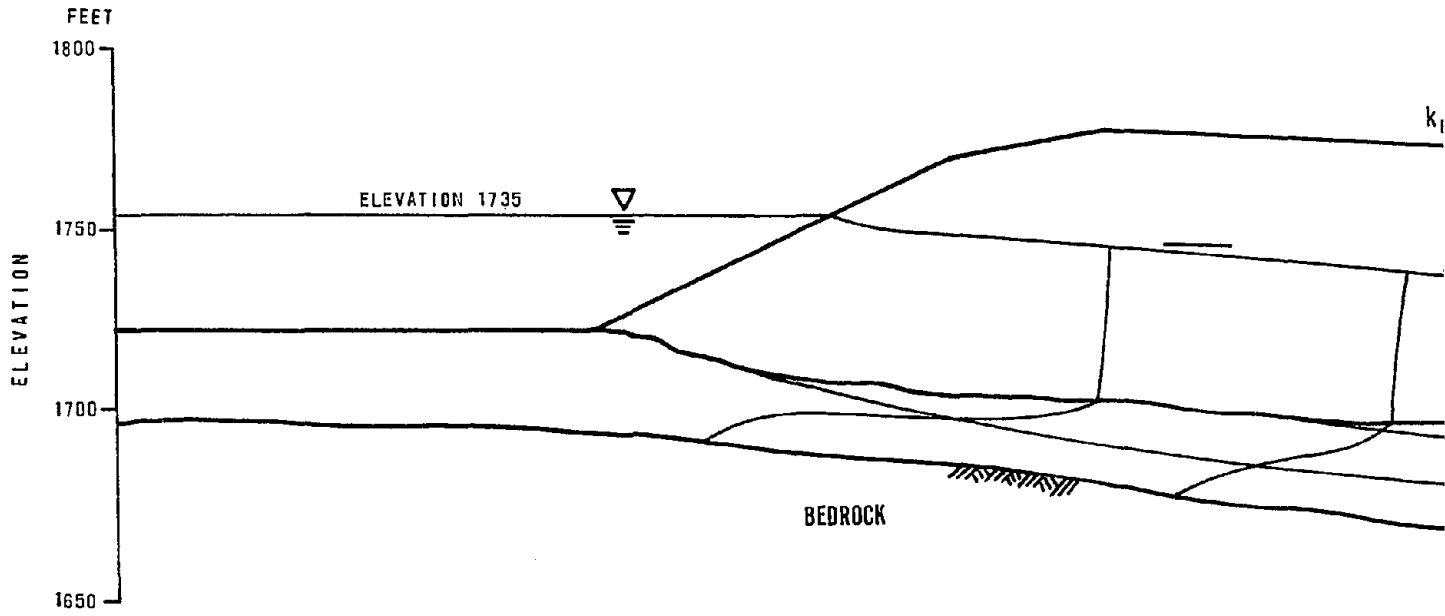
SECTION F-F' FLOW NET: FOUNDATION

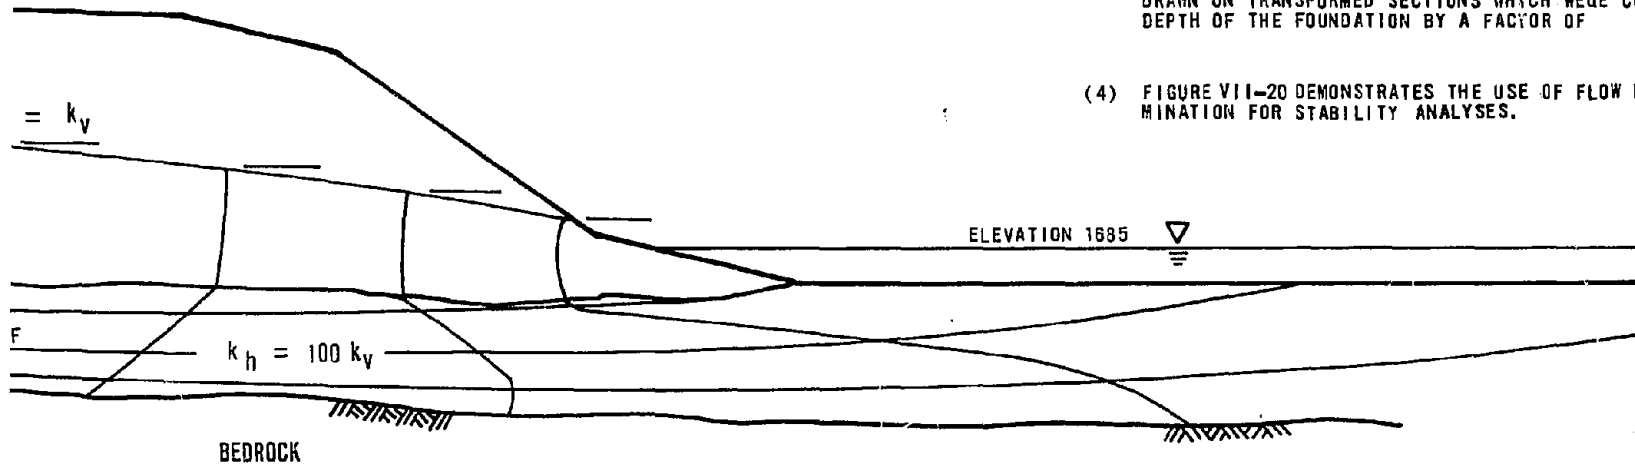
PERMEABILITY RATIO = 100; NORMAL RESERVOIR LEVEL

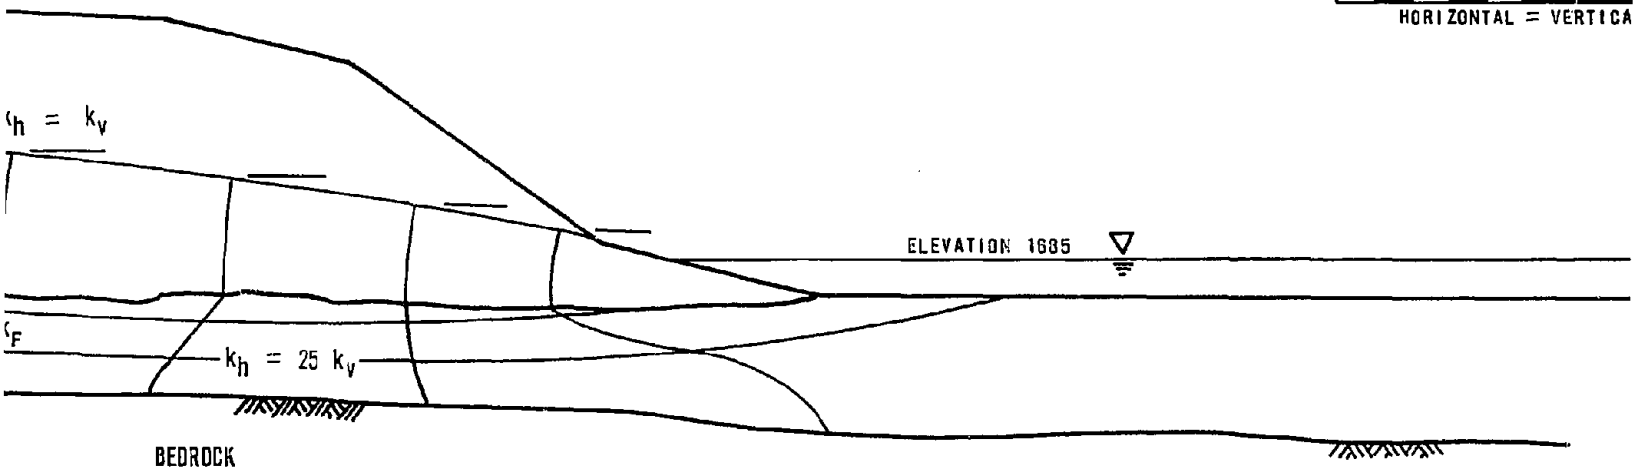
PERMEABILITY RATIO = 25; NORMAL RESERVOIR LEVEL

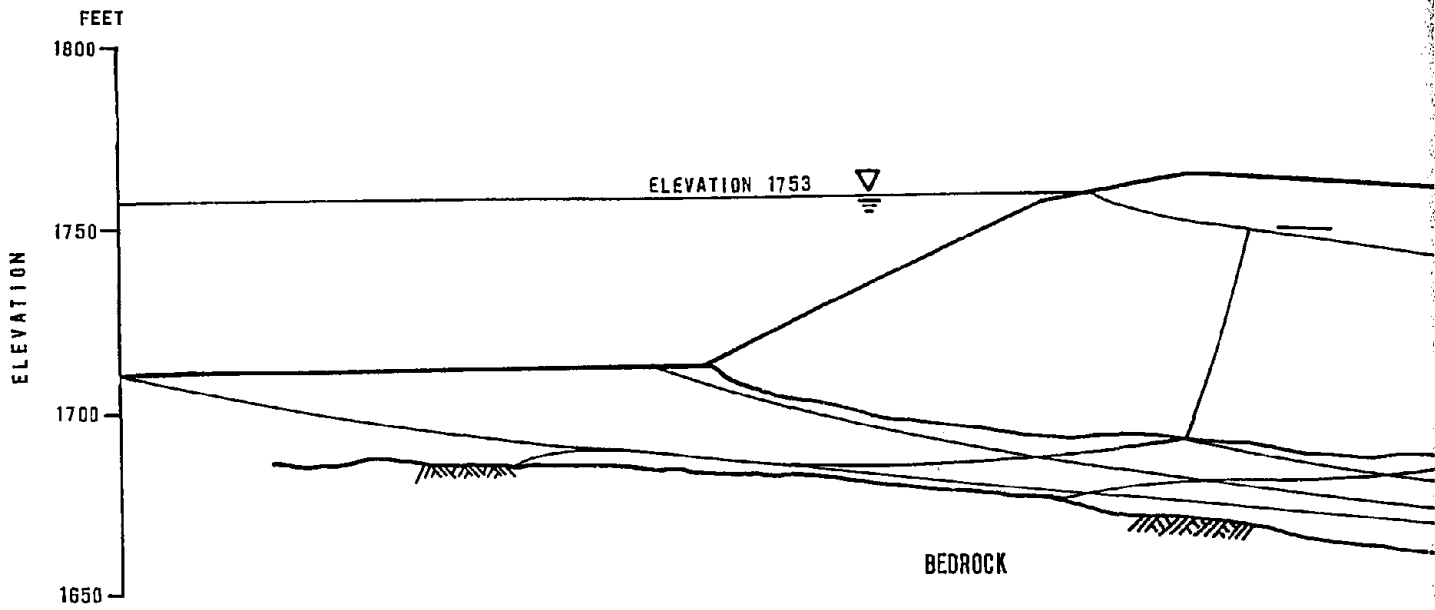
SECTION F-F' FLOW NET: F

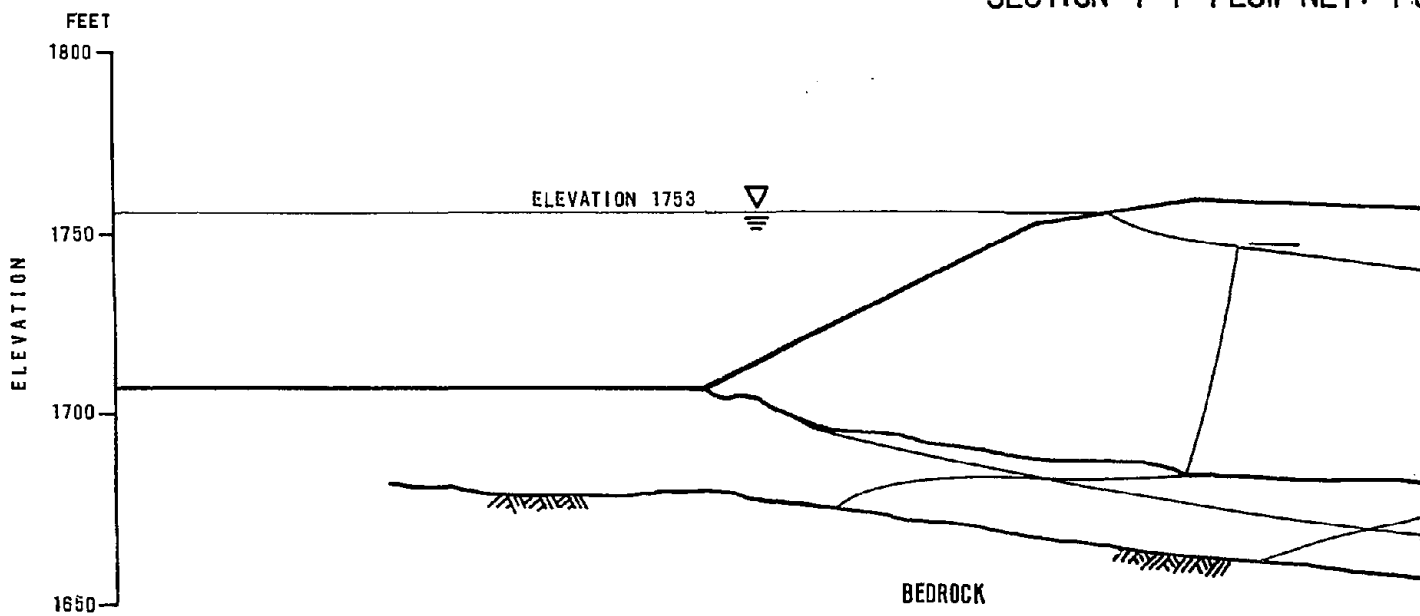
SECTION F-F' FLOW NET: F

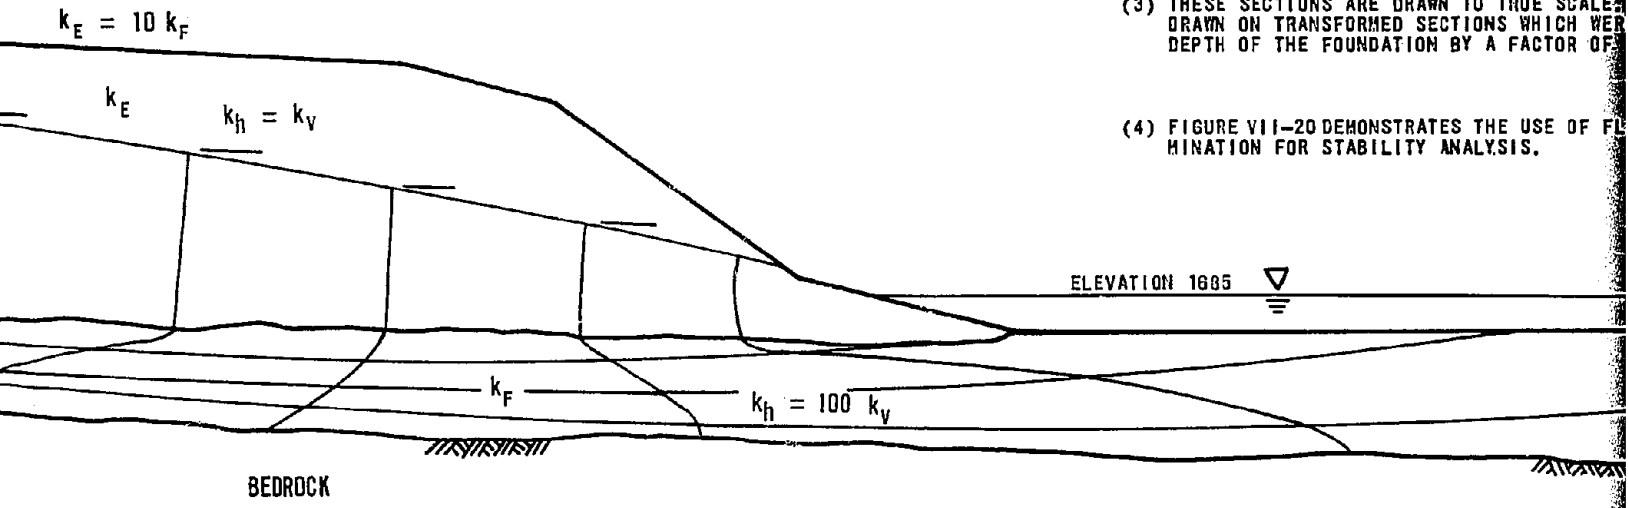
ANISOTROPIC PERMEABILITY RATIO = 100; HIGH RESERVOIR LEVEL

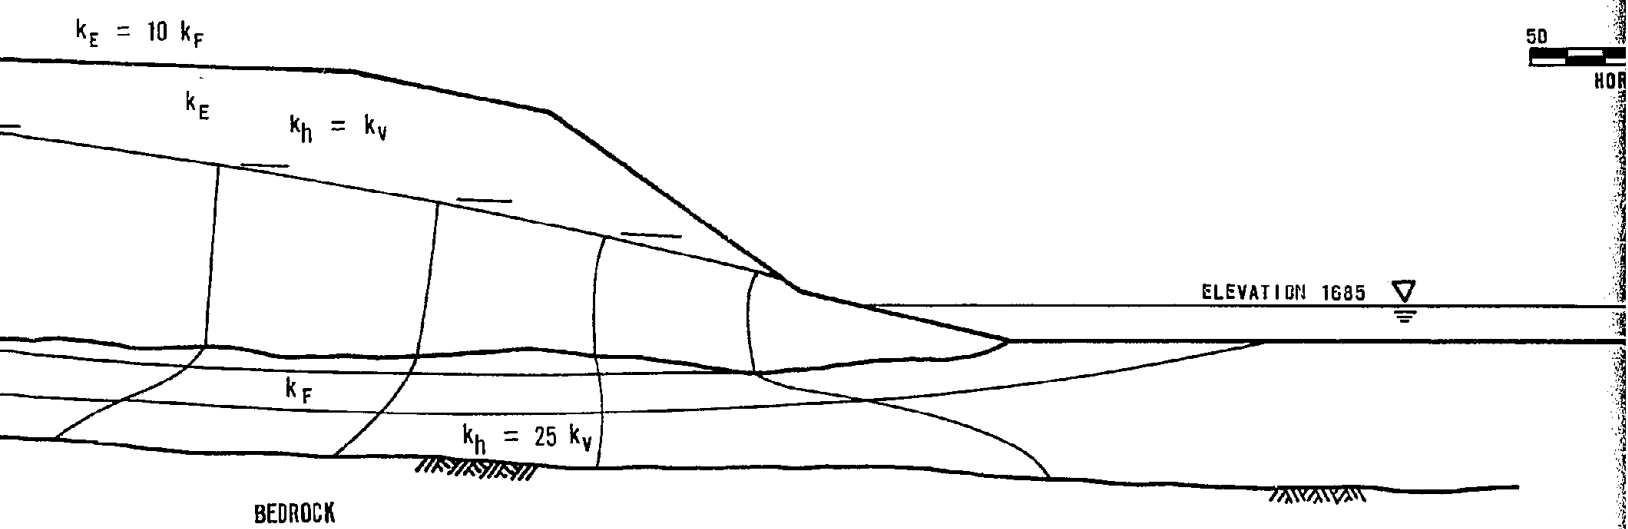
ANISOTROPIC PERMEABILITY RATIO = 25; HIGH RESERVOIR LEVEL

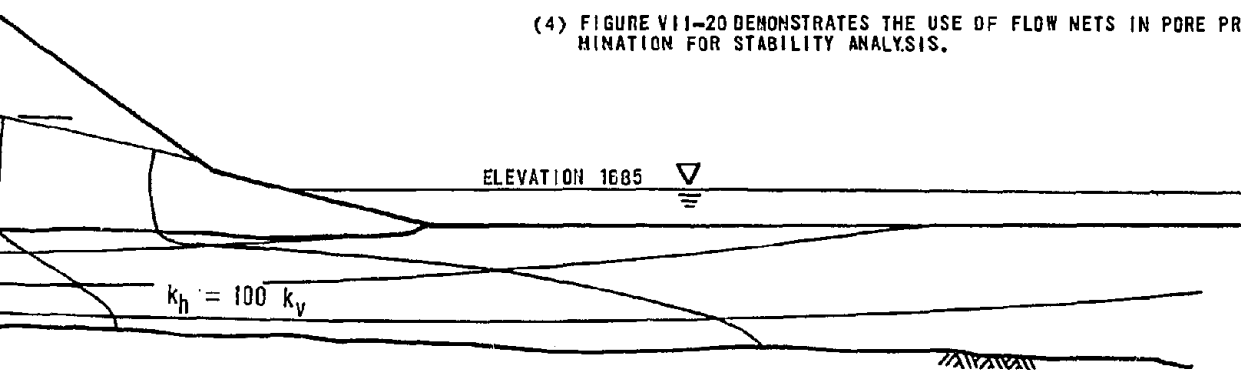
= 100: HIGH RESERVOIR LEVEL

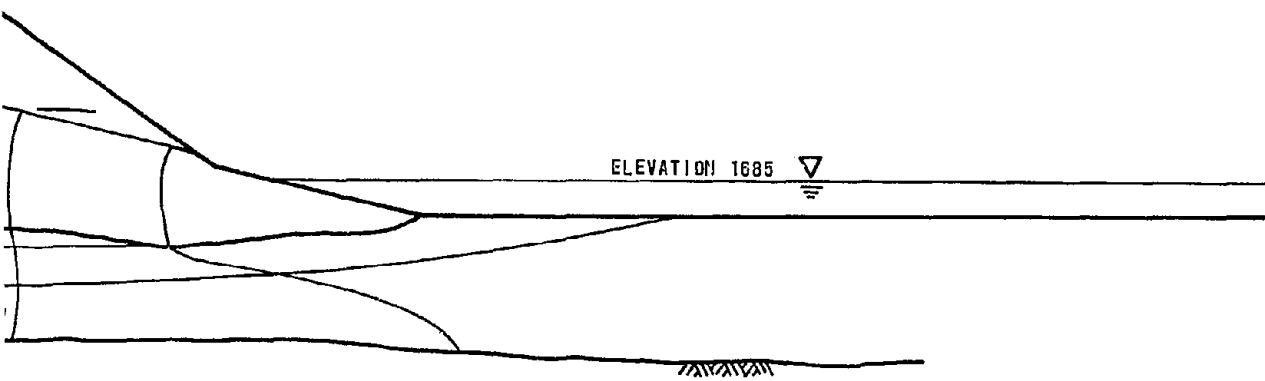
= 25: HIGH RESERVOIR LEVEL

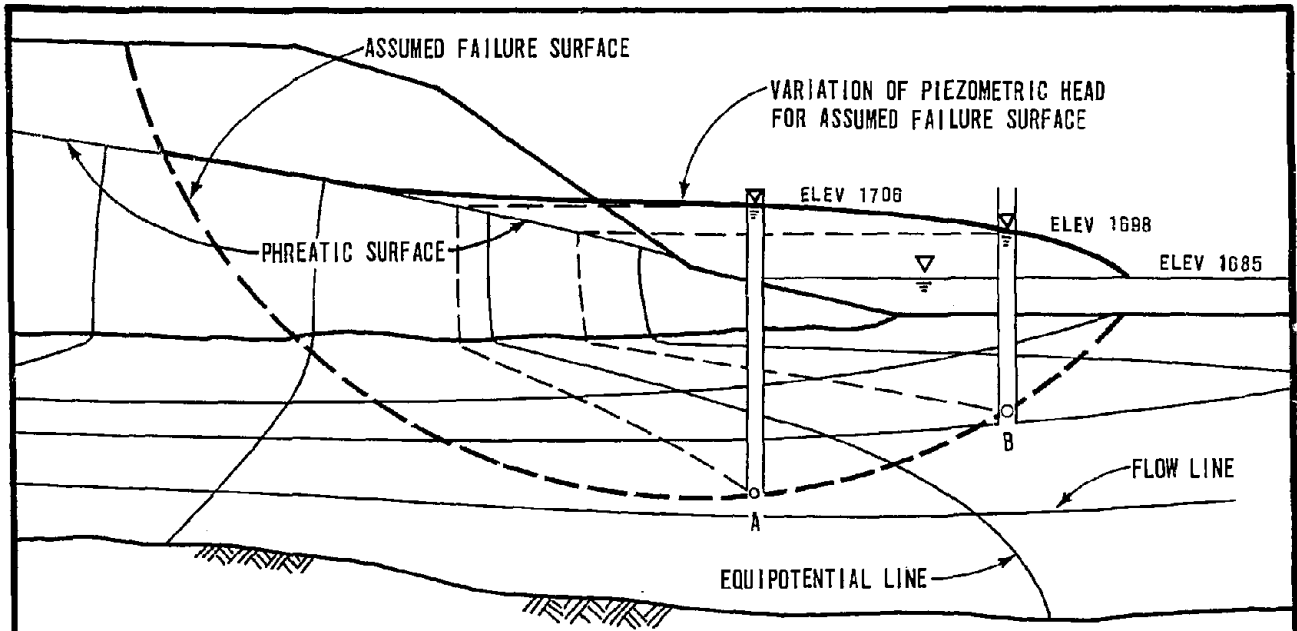
HIGH RESERVOIR LEVEL ANISOTROPIC PERMEABILITY RATIO = 100

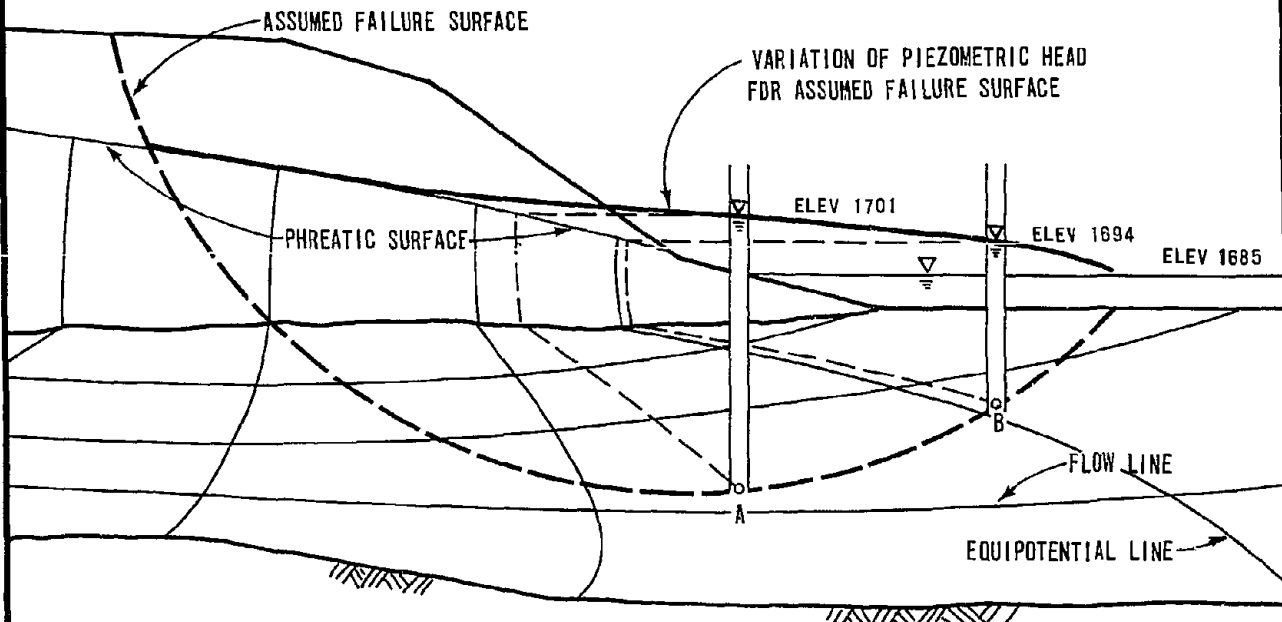
HIGH RESERVOIR LEVEL - ANISOTROPIC PERMEABILITY RATIO = 25

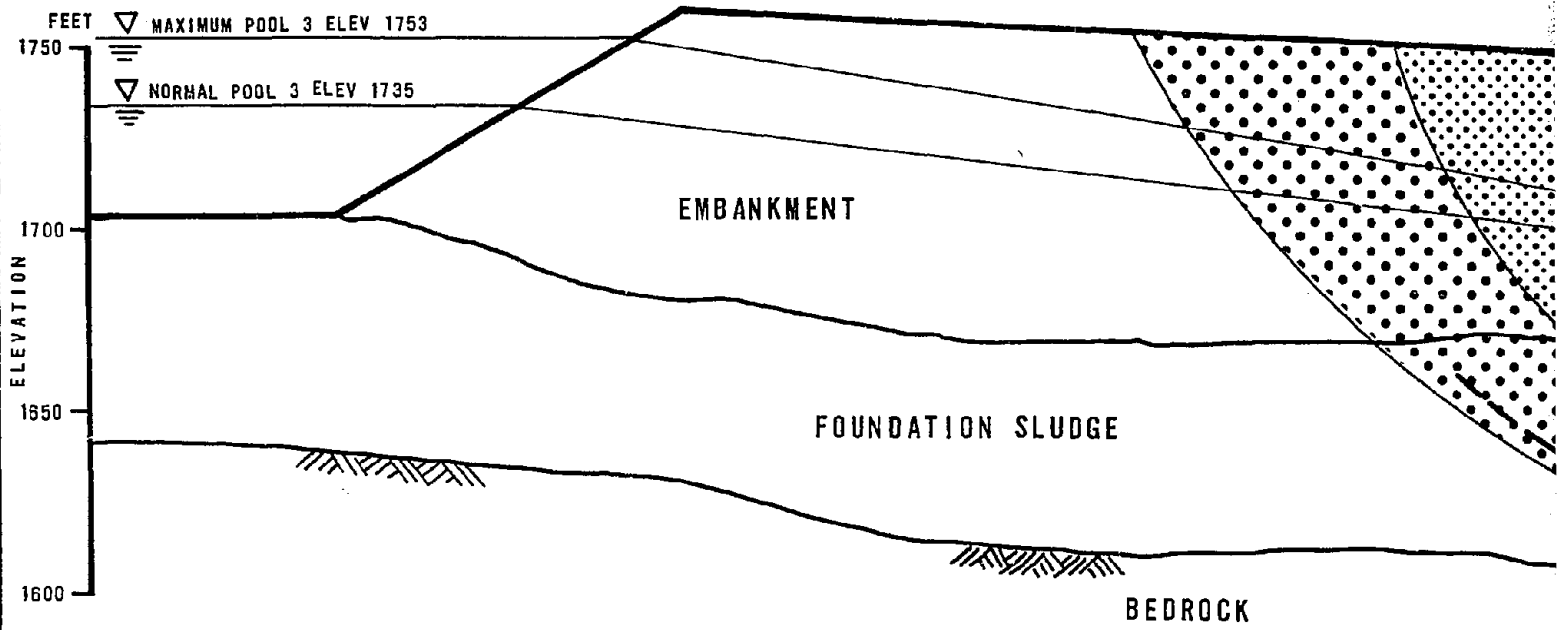
SECTION E-E' COAL WASTE DAM NO. 1

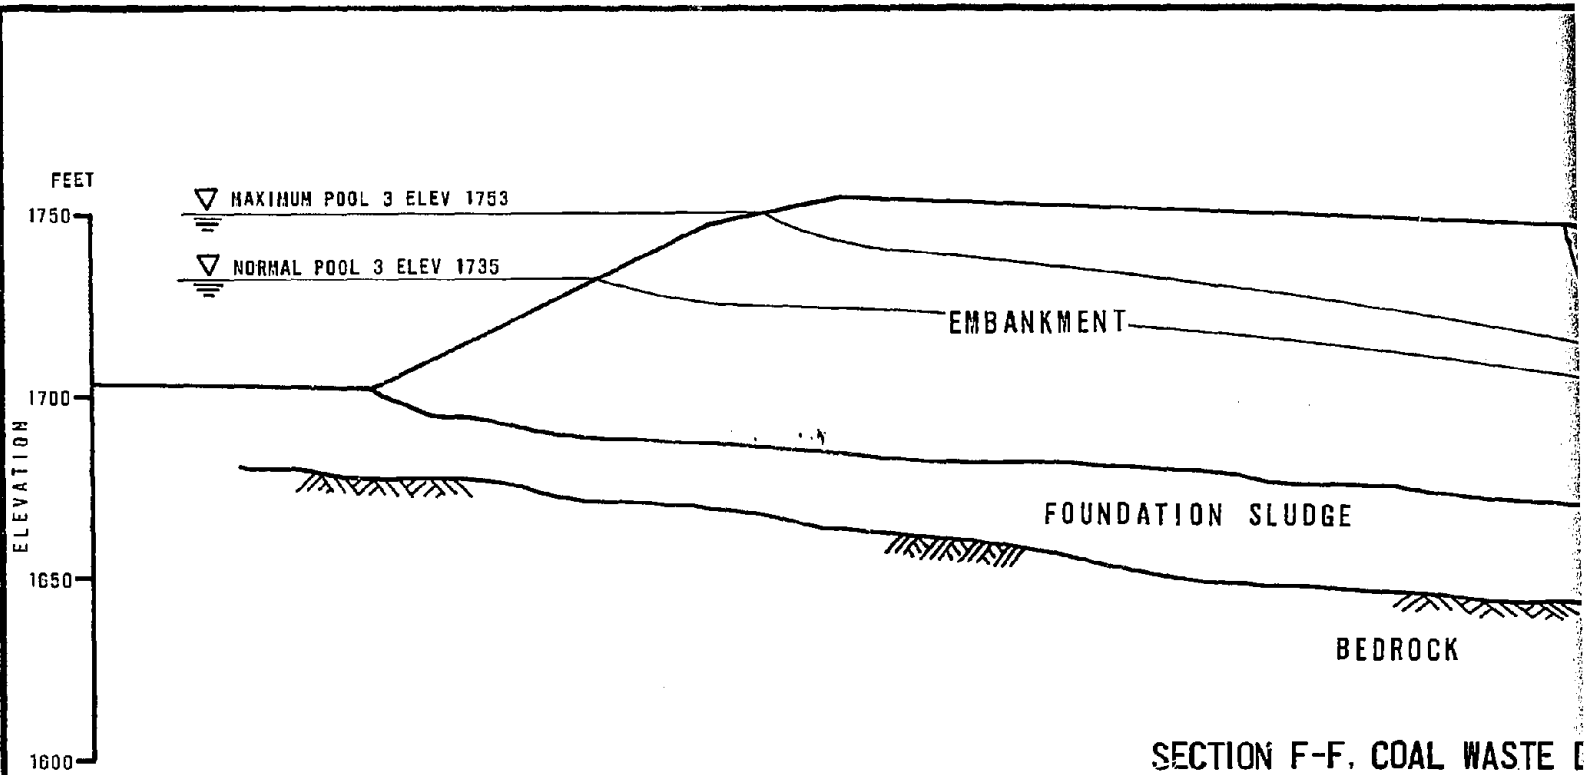
RESULTS OF STABILITY ANALYSIS

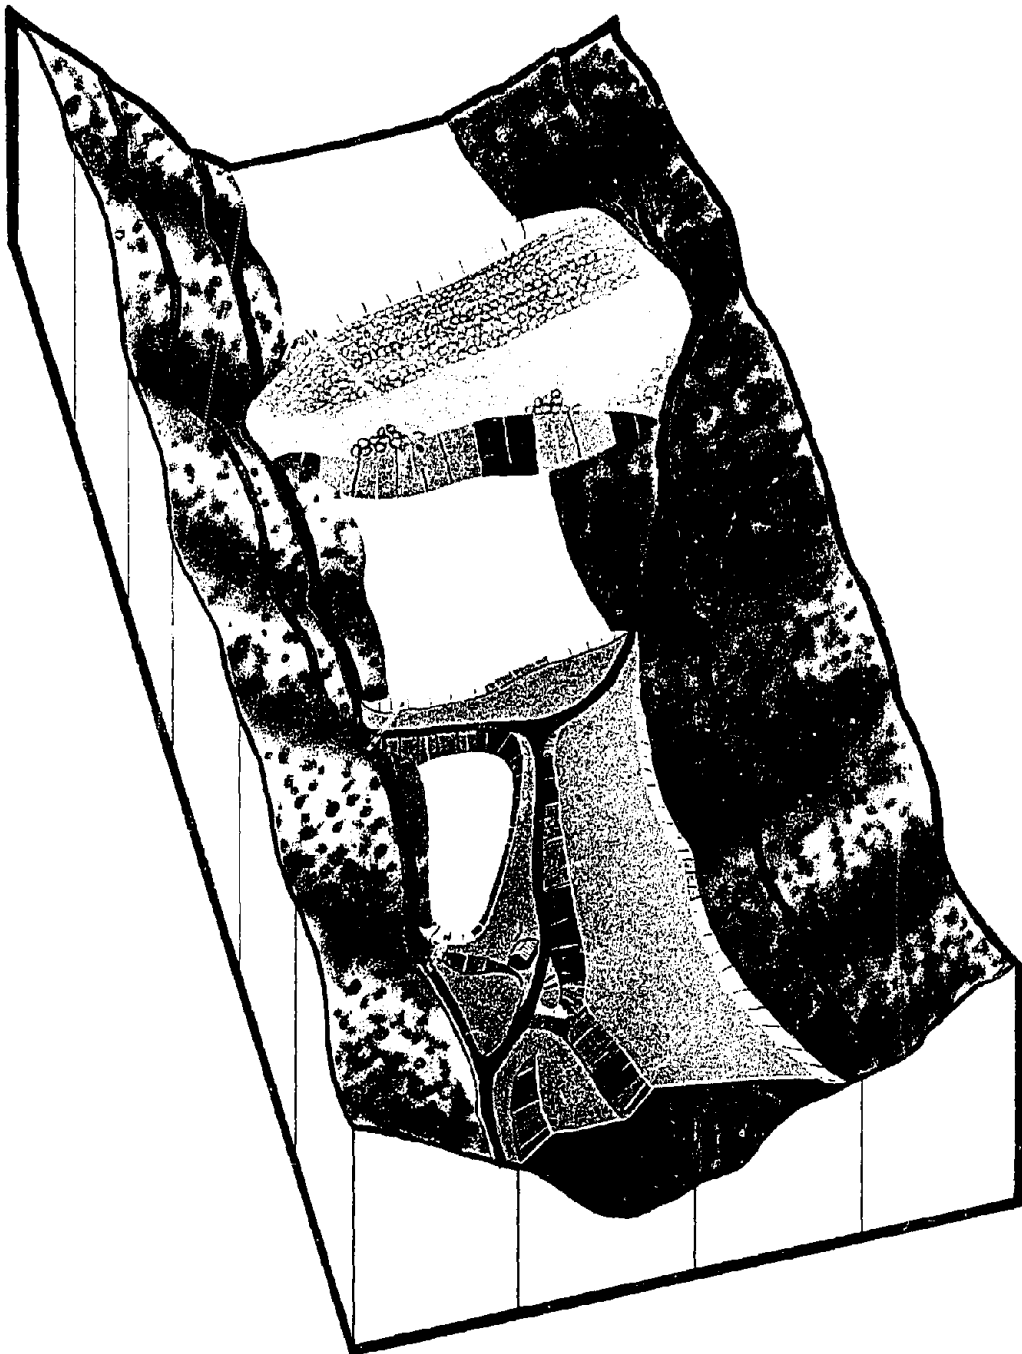
MIDDLE FORK VALLEY IN EARLY FEBRUARY 1972, LOOKING UPSTREAM. POOL 3 HAS A SURFACE ELEVATION OF ABOUT 1740-1745 FEET.

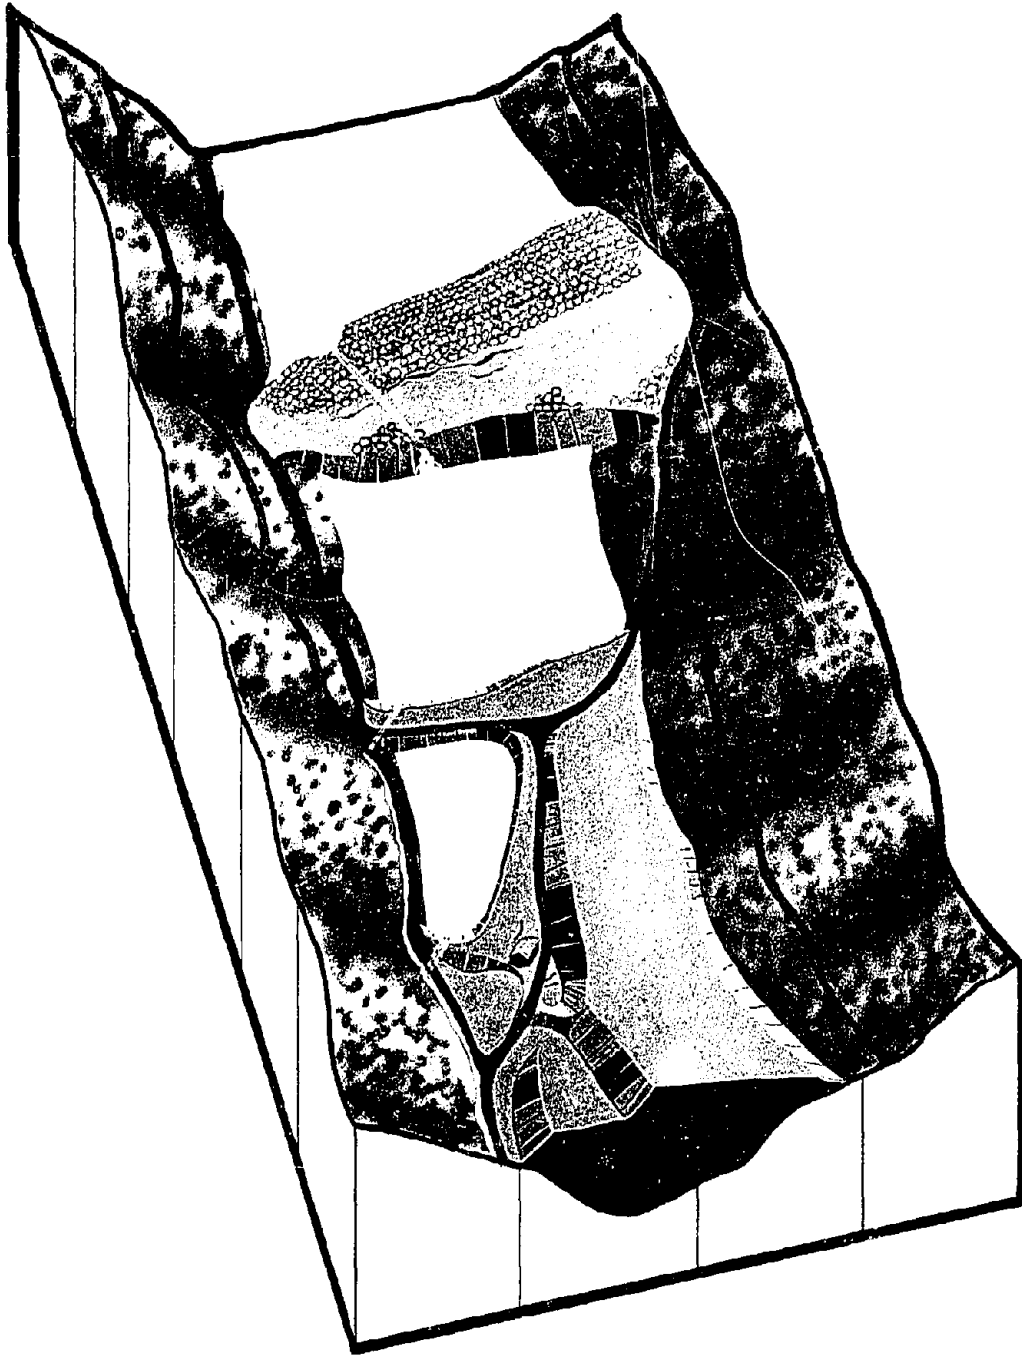
MIDDLE FORK VALLEY, FEBRUARY 26, 1972 SHOWING POOL 3 AT HIGH WATER ELEVATION OF 1753;
EARLY SIGNS OF DISTRESS OF DAM NO. 3 ARE INDICATED BY CRACKS PARALLEL TO CREST.
