**ANALYSIS OF
COAL REFUSE DAM FAILURE**

**MIDDLE FORK BUFFALO CREEK
SAUNDERS, WEST VIRGINIA**

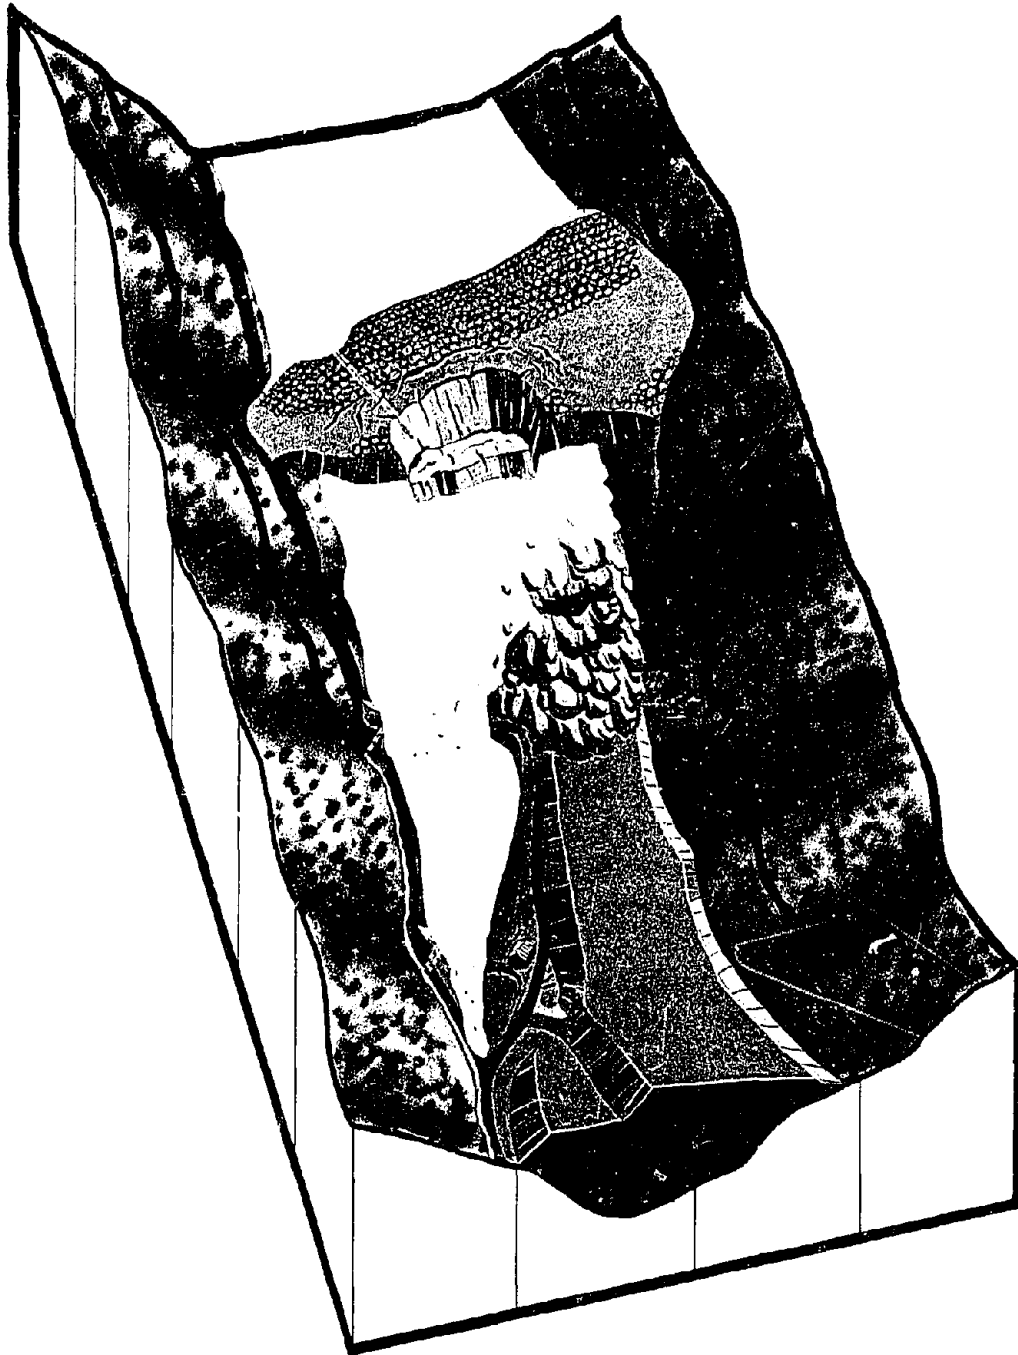
MIDDLE FORK VALLEY, FEBRUARY 26, 1972; INITIAL MASSIVE SHEAR FAILURE OF DAM NO. 3 CAUSING OVERTOPPING OF DAMS 2 AND 1. THE FOUNDATION SLUDGE FROM POOL 2 IS SHOWN TRANSLATED TO LEFT ABUTMENT AREA OF DAM NO. 2.

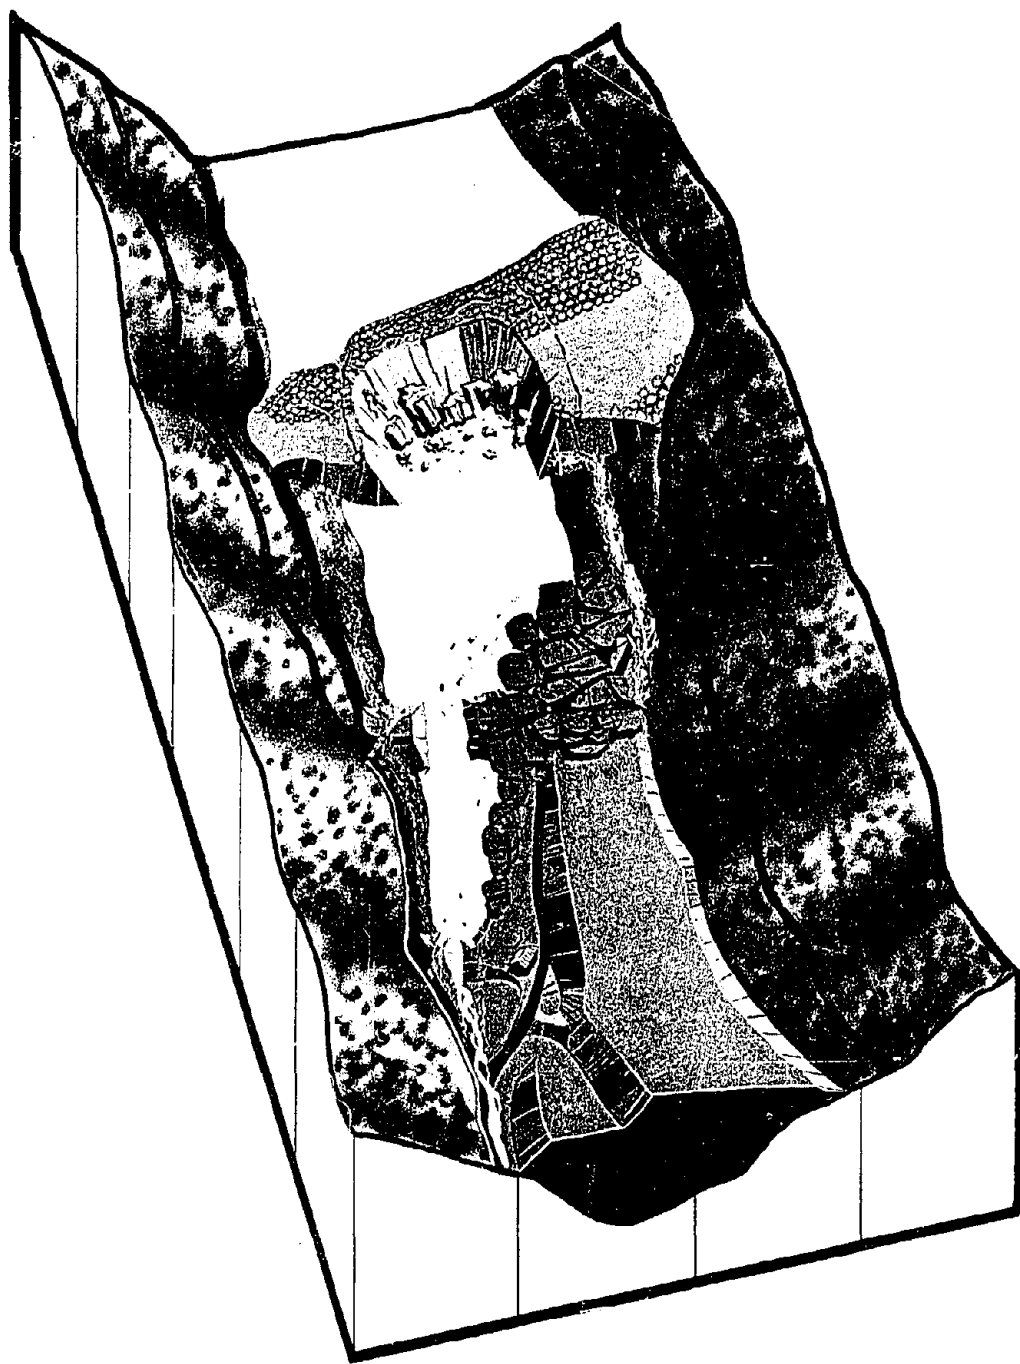
MIDDLE FORK VALLEY, FEBRUARY 26, 1972; PROGRESSIVE FAILURE CONTINUES TO DESTROY REMAINING SECTIONS OF DAM NO. 3; THE INITIAL FLOOD WATER FROM POOL 2 ASSOCIATED WITH SHEAR FAILURE BEGINS TO SUBSIDE EXPOSING THE INITIAL BREACH IN DAM NO. 2.

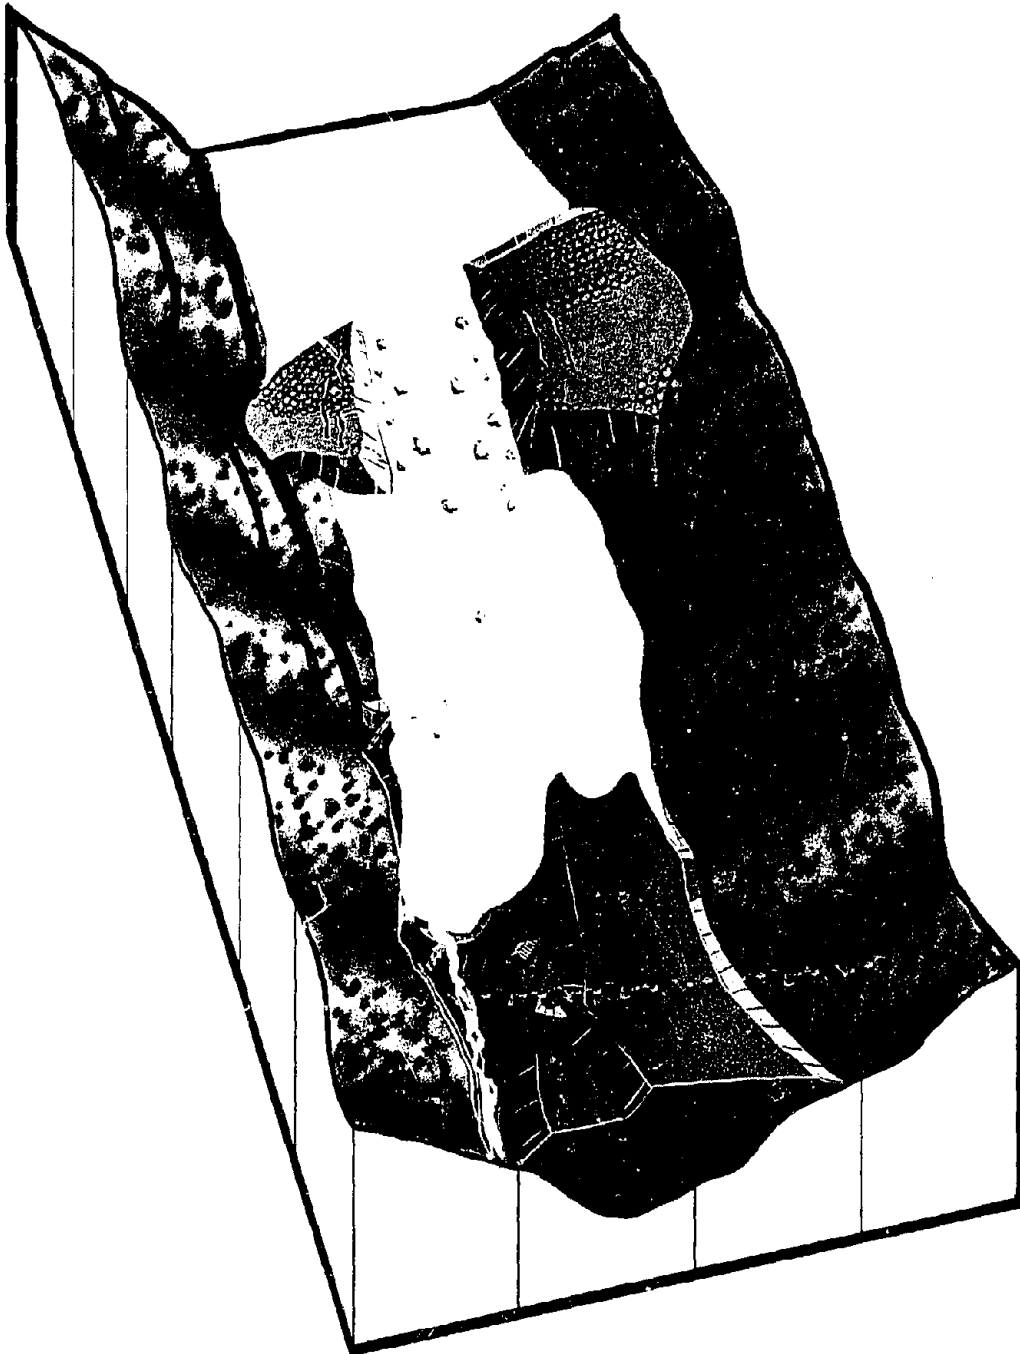
MIDDLE FORK VALLEY, FEBRUARY 26, 1972; CATASTROPHIC FAILURE OF DAM NO. 3 WHICH RELEASES
THE MAJOR FLOOD WAVE.

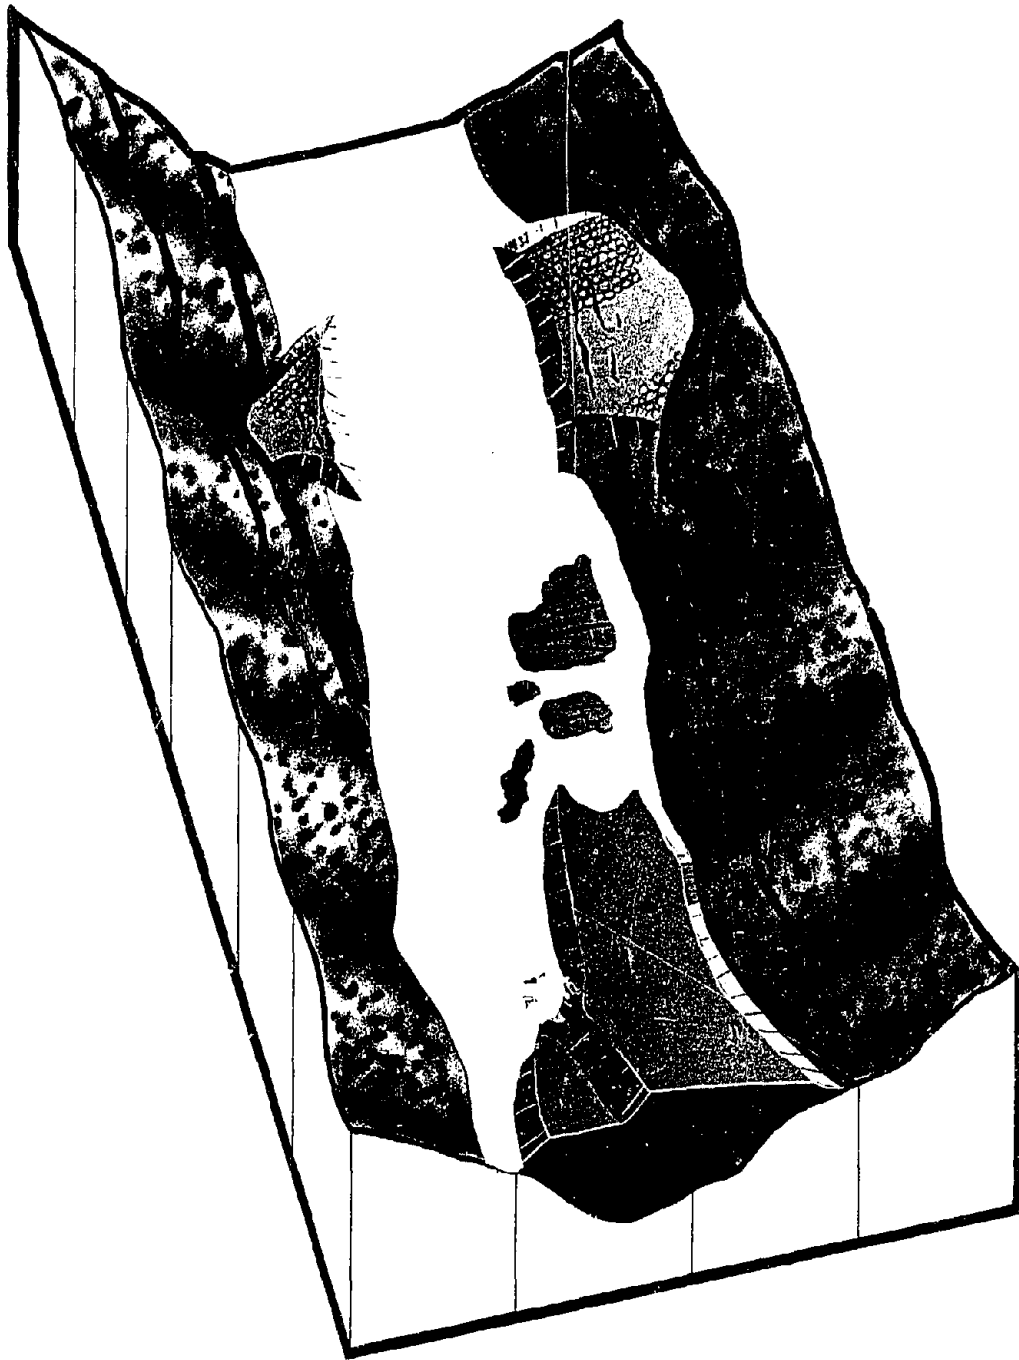
MIDDLE FORK VALLEY, FEBRUARY 26, 1972; FLOOD WAVE OVERTOPS DAM NO. 2 AND DESTROYS DAM NO. 1. BOTH REMNANTS OF DAM NO. 3 CONTINUE TO FAIL BY UNDERCUTTING ACTION OF FLOOD FLOW.

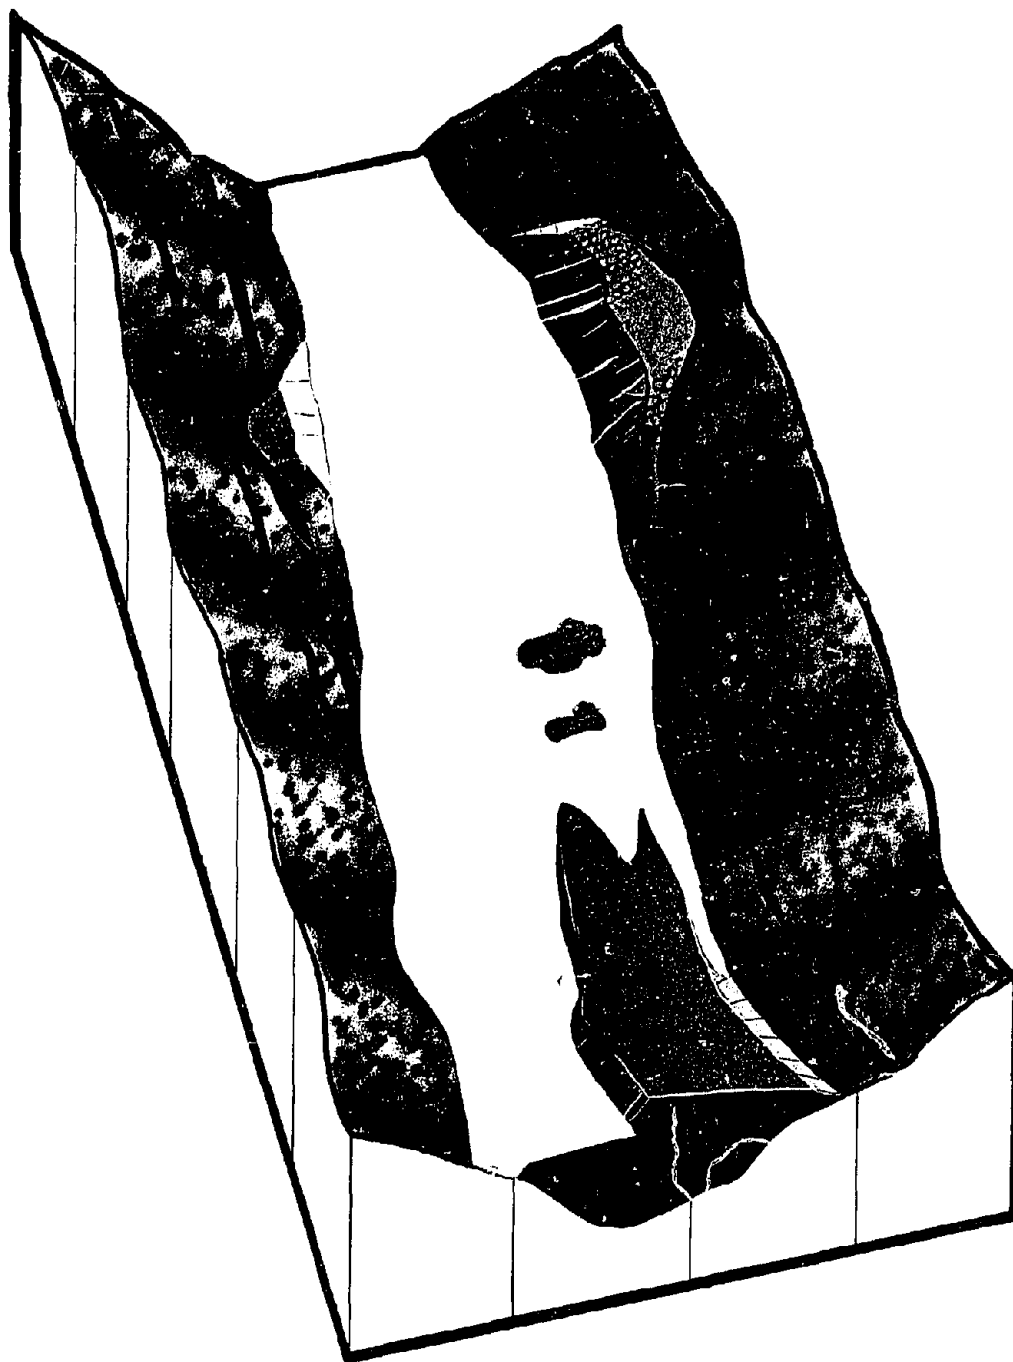
MIDDLE FORK VALLEY, FEBRUARY 26, 1972; HIGH WATER LINE ADJACENT TO REFUSE BANK IS DEVELOPED BY CONSTRICTION OF THE NARROW VALLEY DOWNSTREAM OF DAM NO. 1.

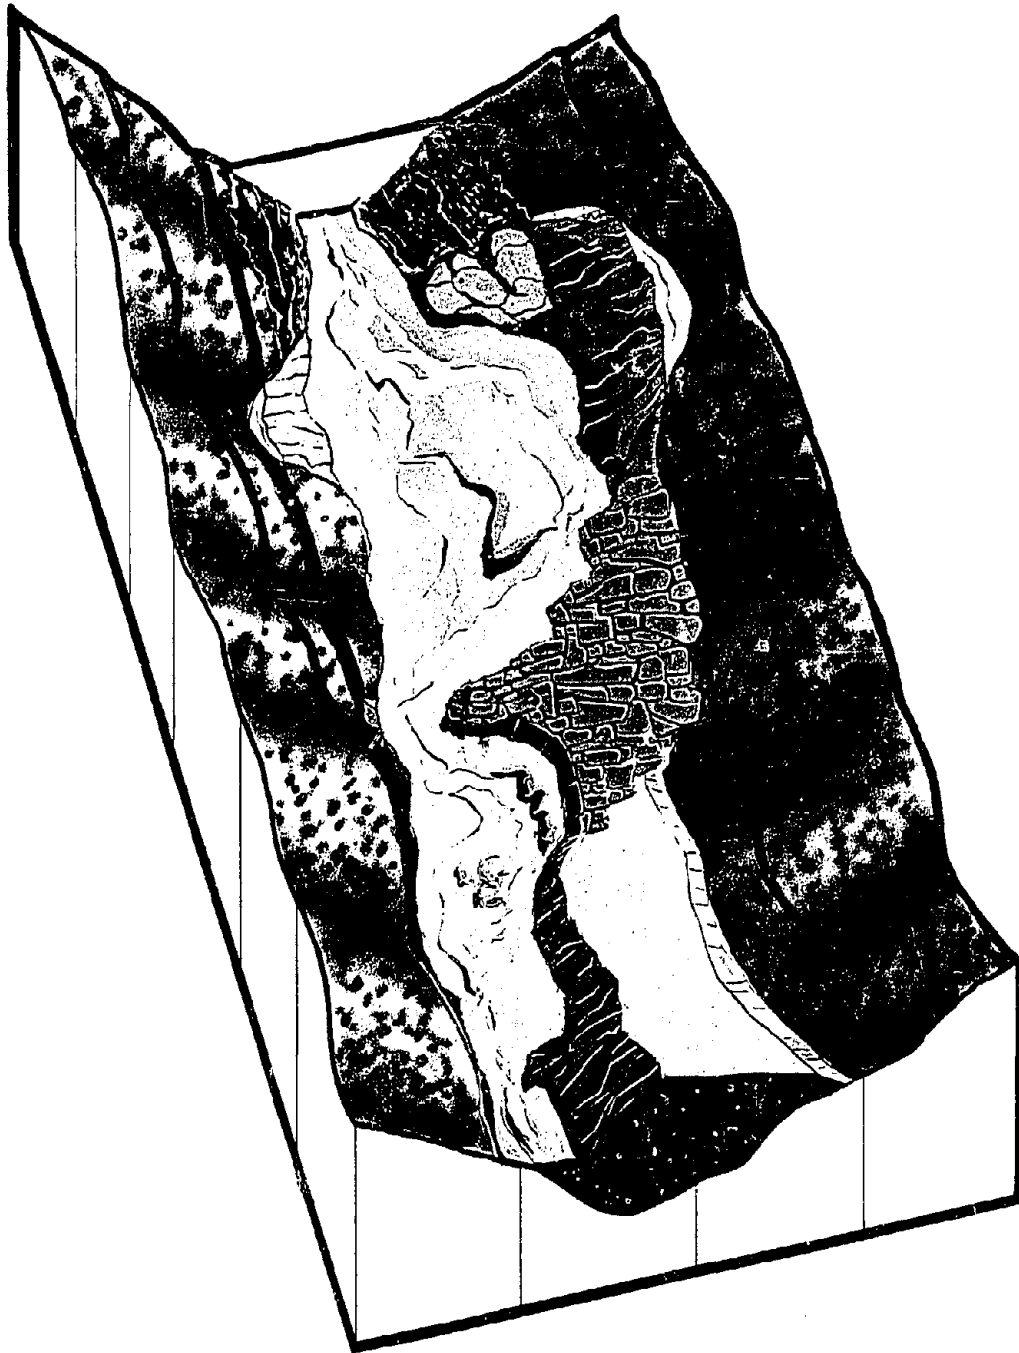
MIDDLE FORK VALLEY, FEBRUARY 26, 1972. FAILURE AFTERMATH

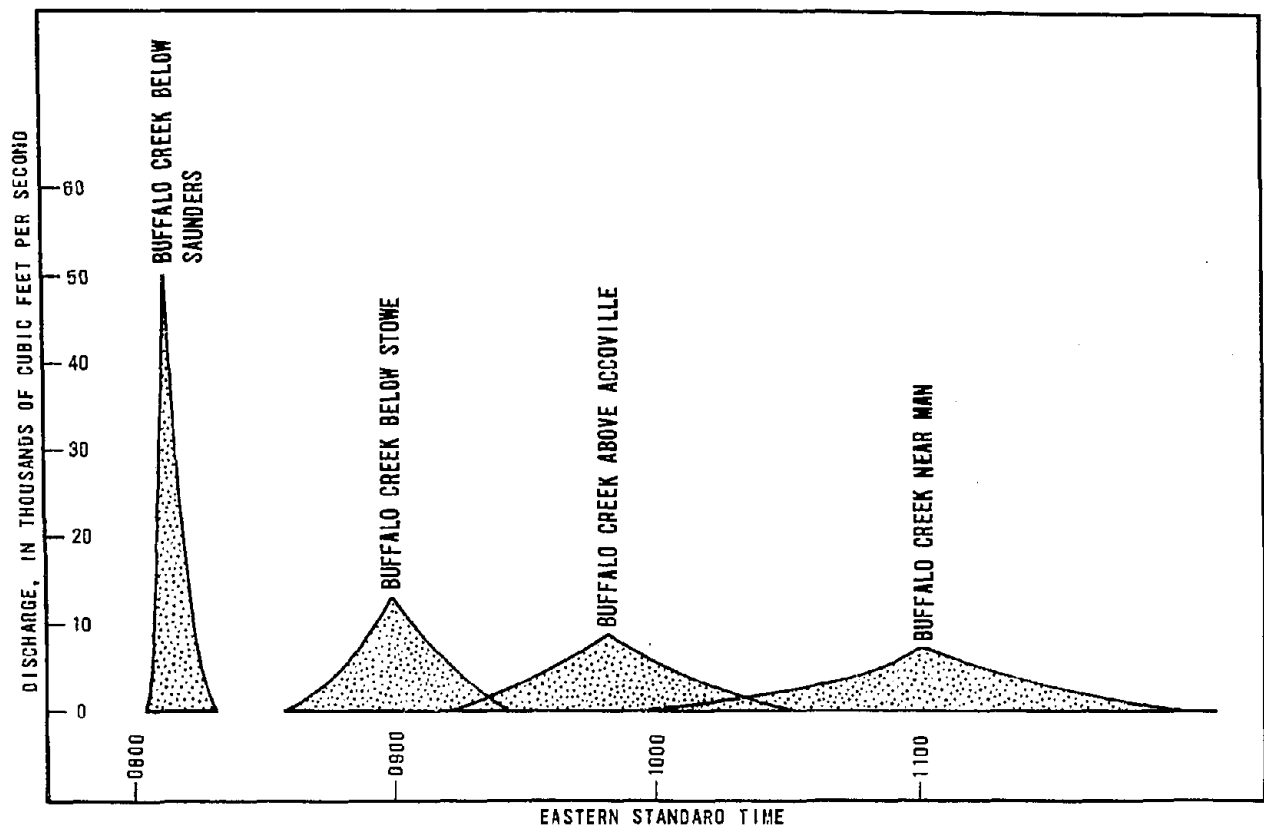
FIGURE VIII-1.—ESTIMATED FLOOD HYDROGRAPHS FOR BUFFALO CREEK BELOW SAUNDERS, BELOW STOWE, ABOVE ACCOVILLE, AND NEAR MAN ON FEBRUARY 26, 1972.

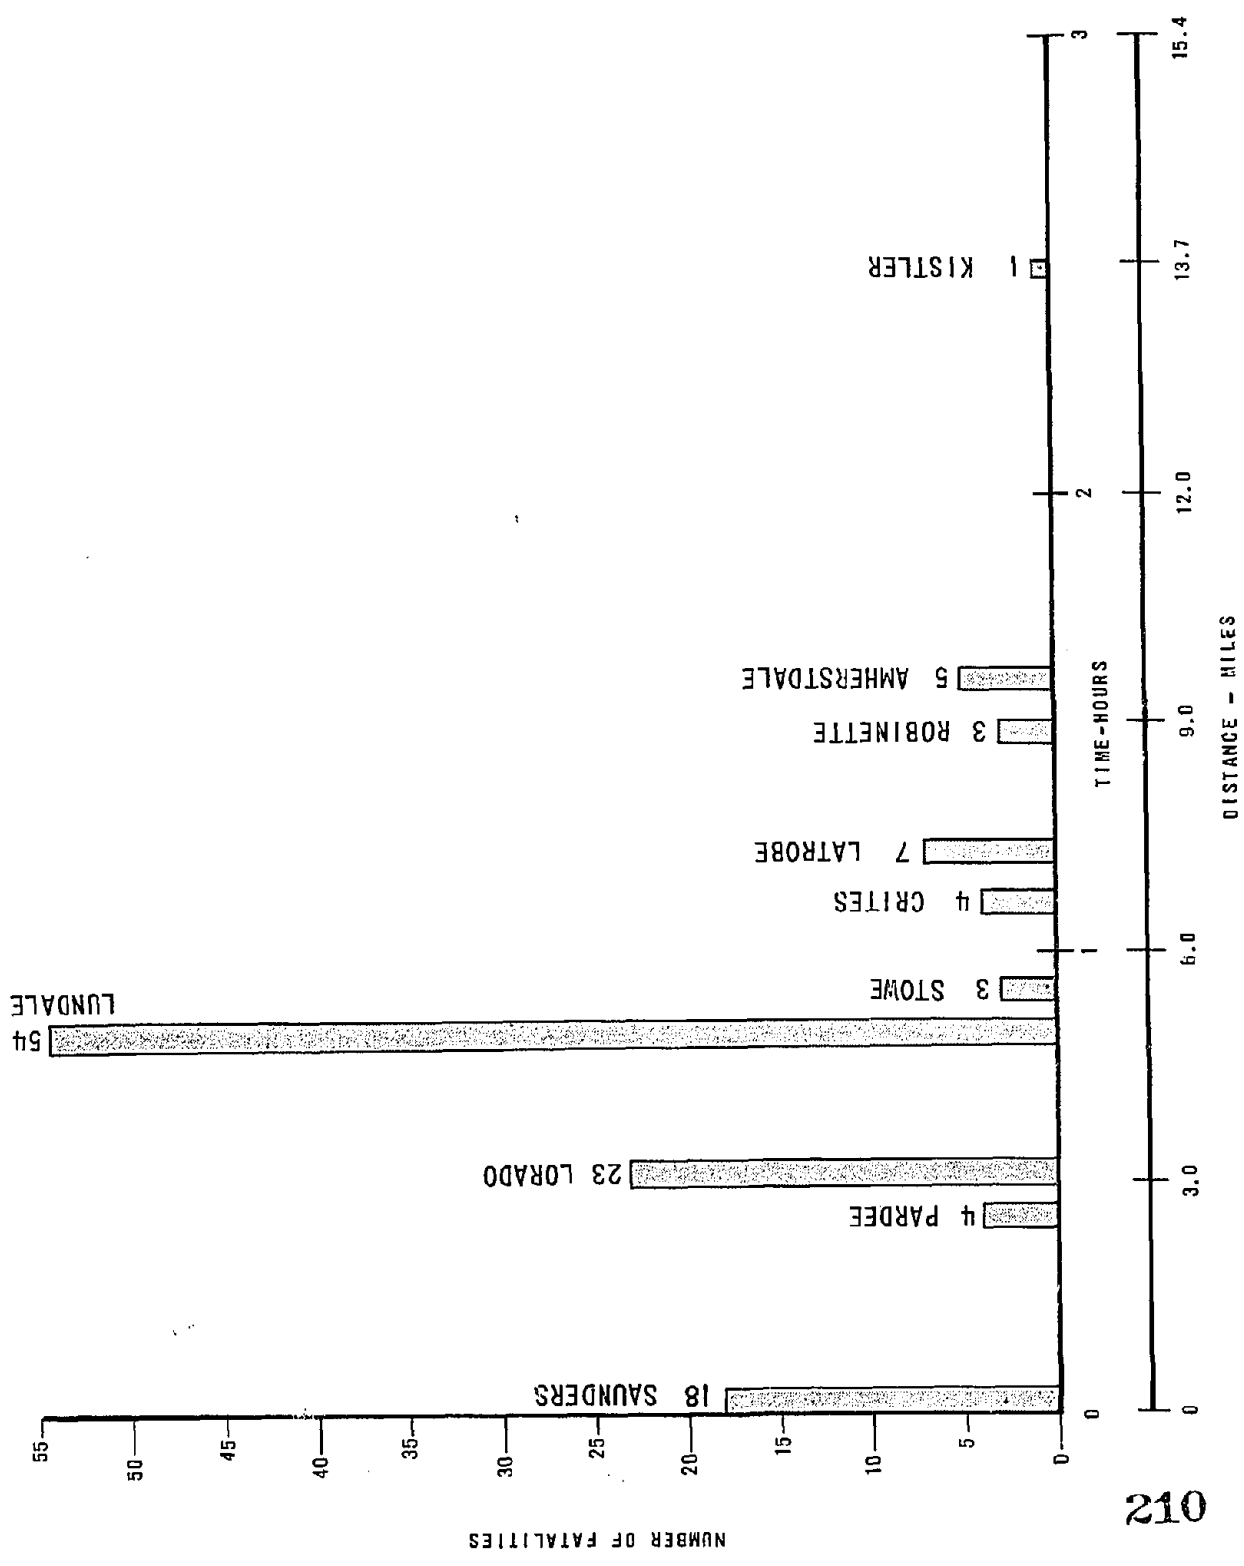
Evidence of flood deposition of the material removed from the coal waste disposal area on Middle Fork was found along the entire valley to the town of Man. However, the majority of the material was deposited in the first three miles of the flood plain between Saunders and Pardee, where Toney Fork joins Buffalo Creek from the northeast. The material deposited in this area consisted of coal waste, red dog, and ash materials from the burning portion of the dump.

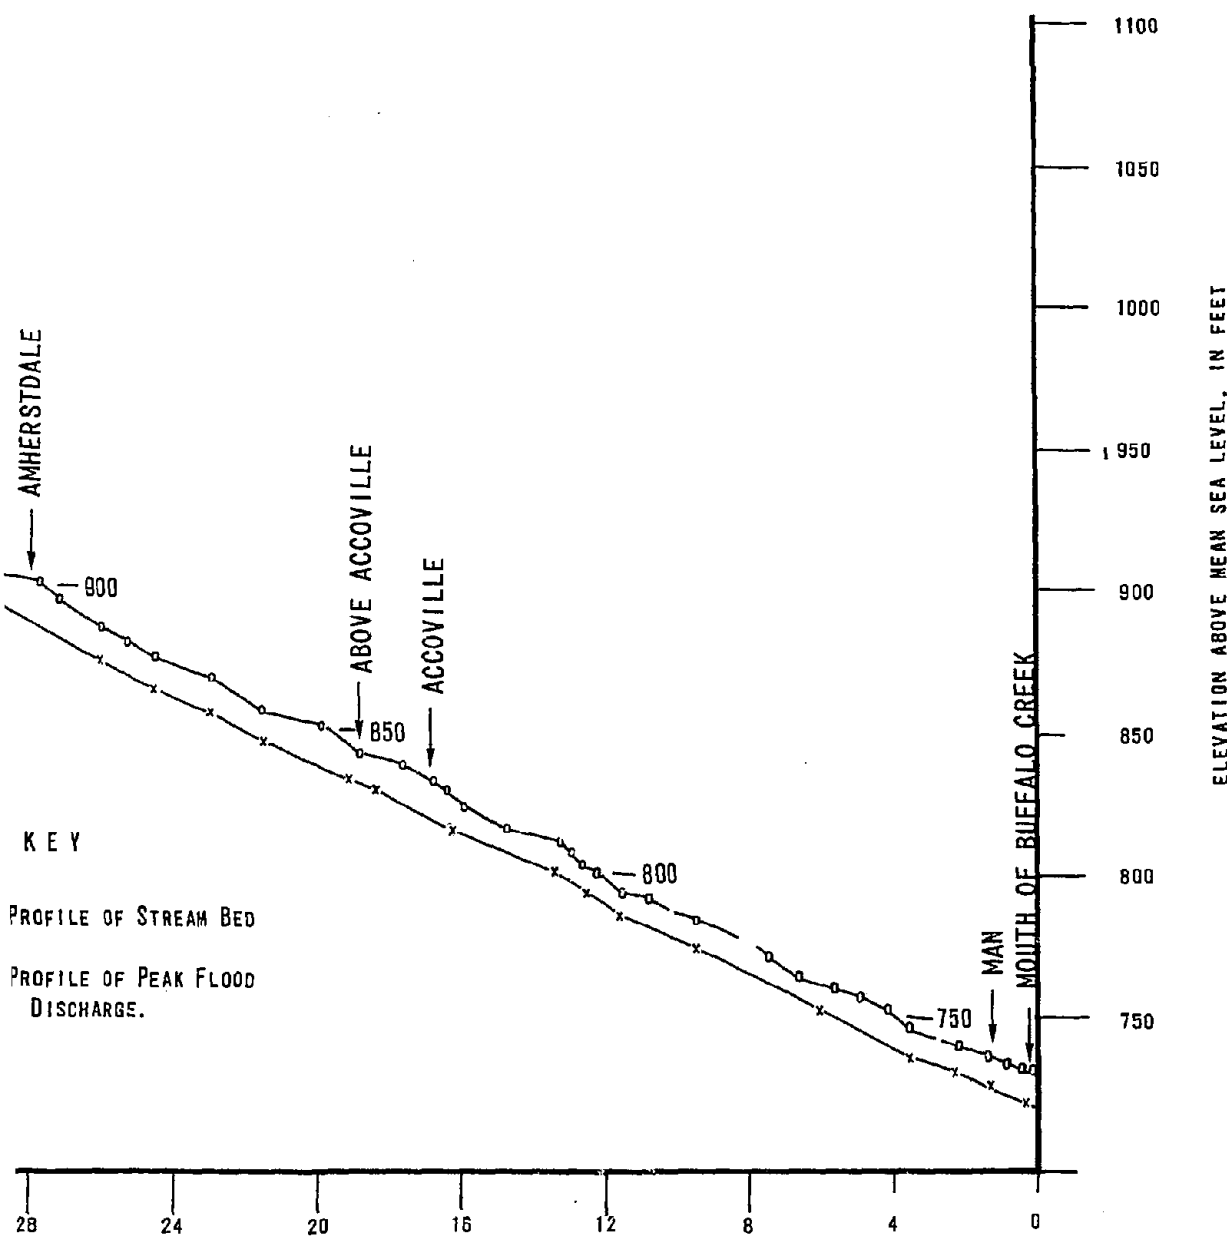
W.A. WAHLER & ASSOCIATES	COAL REFUSE DAM FAILURE SAUNDERS, WEST VIRGINIA
PALO ALTO • NEWPORT BEACH • CALIF.
