**Reducing Ergonomic Hazards during Ceiling
Module Assembly and Installation for
Walsh Construction Company**

Construction Occupational Health Project

Department of Work Environment
University of Massachusetts Lowell
College of Engineering
August 1, 1995

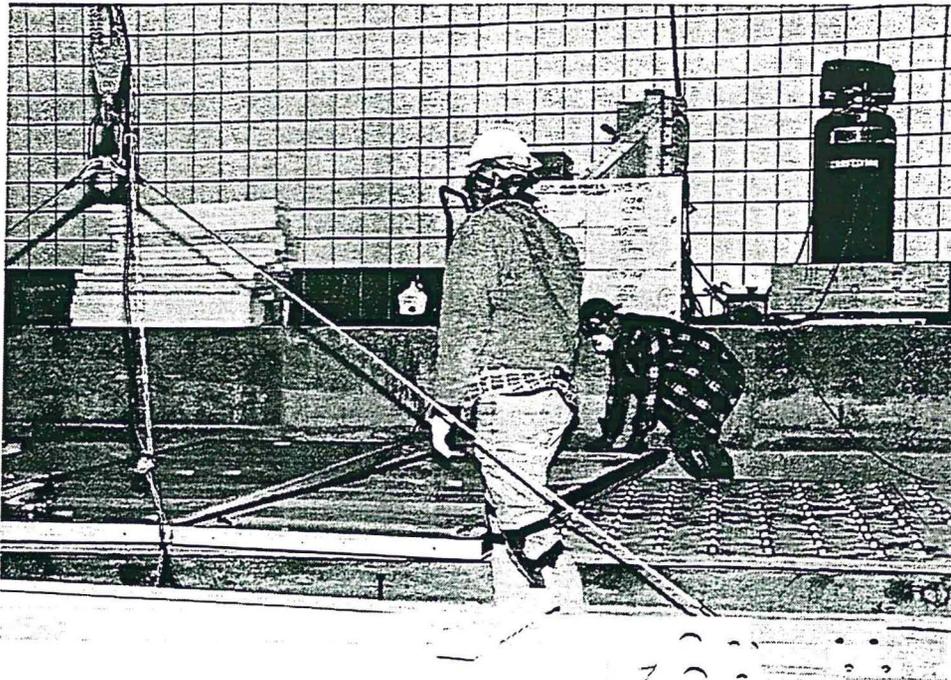
Figure 2. Aligning the panel for sub-module assembly.

1. **Raise the height of the rollers and add stairs.** Increase the height of the rollers to approximately 36 inches (slightly below average waist height). Install stairs to allow workers to get on/off of the rollers. This design is similar to what already exists at the Black Falcon ceiling module assembly operation. This design change should reduce the frequency and duration of non-neutral trunk and leg postures during the sub-module and module assembly job tasks.

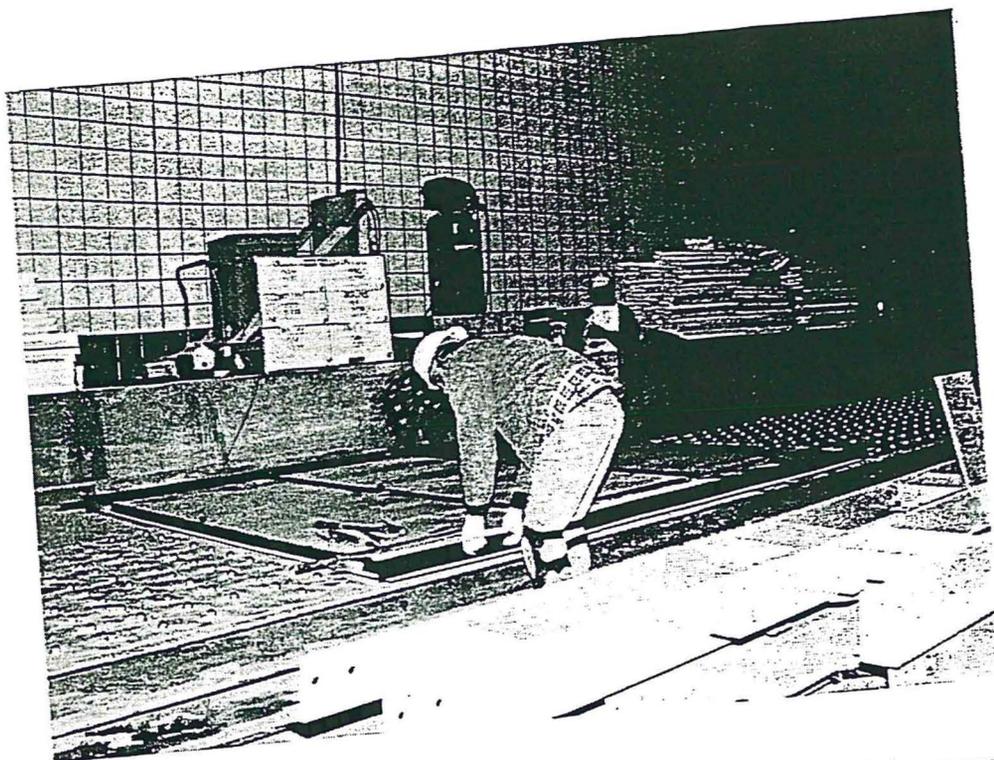
Figure 3. Gluing the gaskets onto the sub-module during sub-module assembly.

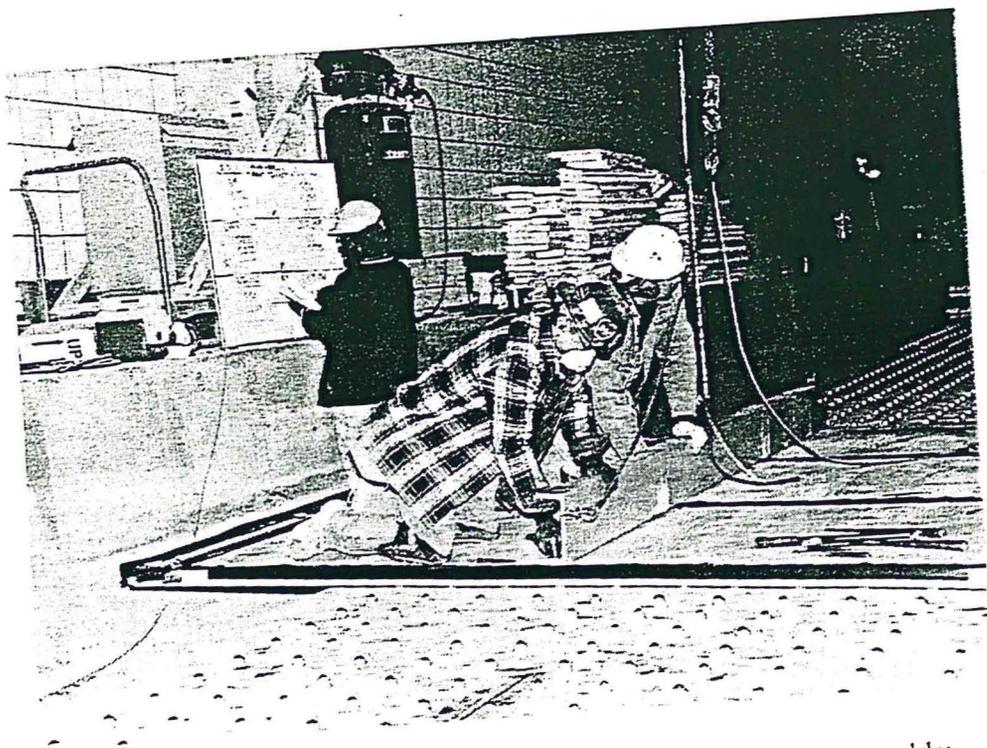
Figure 4. Aligning the I-beam with the pins during sub-module assembly.

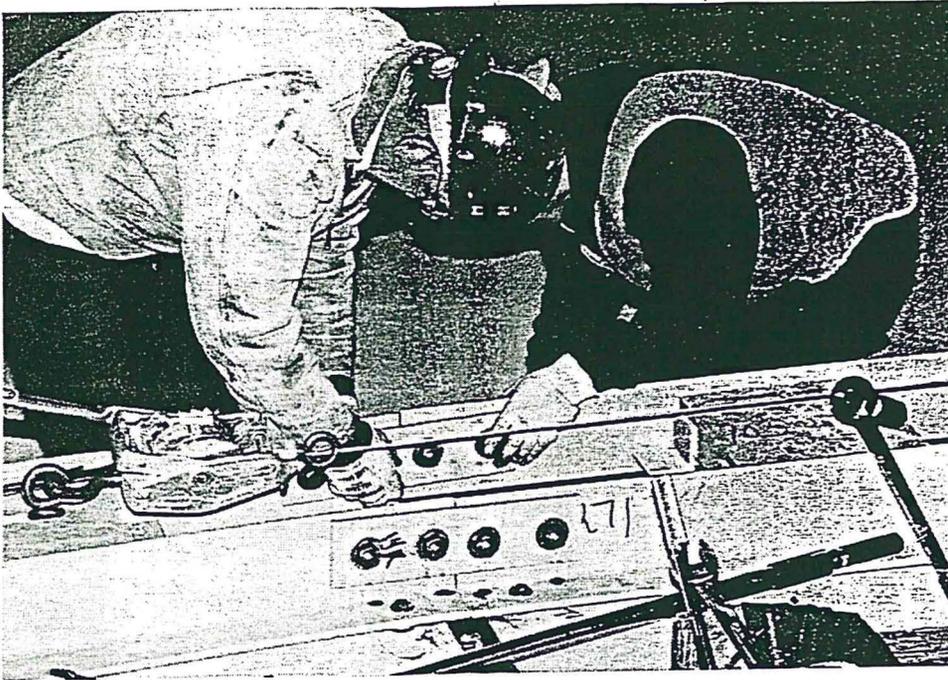
Figure 5. Tightening bolts during module assembly.

2. **Possible use of powered ratchets.** Investigate the possibility of using powered ratchets, calibrated to 45 and 350 lb. Workers currently tighten the bolts manually, and wrist deviations during bolting are highly repetitive. Powered ratchets would greatly reduce the frequency of wrist motions during the sub-module and module assembly job tasks, may help reduce some of the loading placed on the shoulders, and may reduce the duration in which workers are in non-neutral trunk postures.

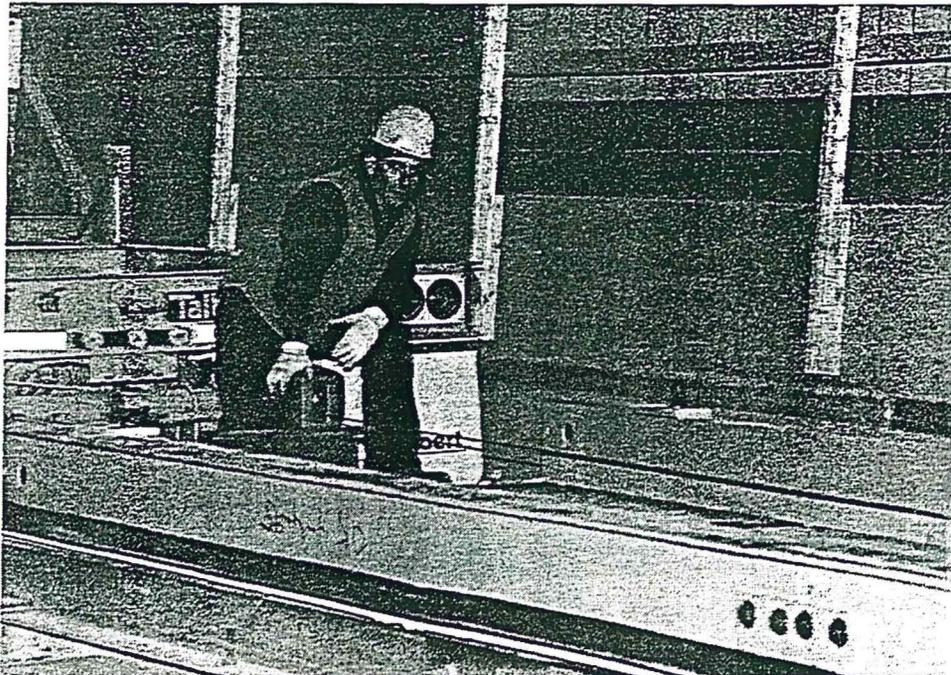
Figure 6. Operating the powered winch during module assembly.

5. **Improve the design of the powered winch.** The powered winch was not always used to move sub-modules for sub-module assembly. This may be because the winch was not functioning properly, was not easy to use or was not fast enough. The winch should be raised to about 36 inches from the floor. If feasible, the speed at which the winch pulls the sub-modules should be increased. A back-up winch should be purchased to replace the winch when it is not functioning properly.
