Bleeder Entry Evaluation Using Condition Mapping and Numerical Modeling

Pittsburgh Mining Research Division, Pittsburgh, Pennsylvania

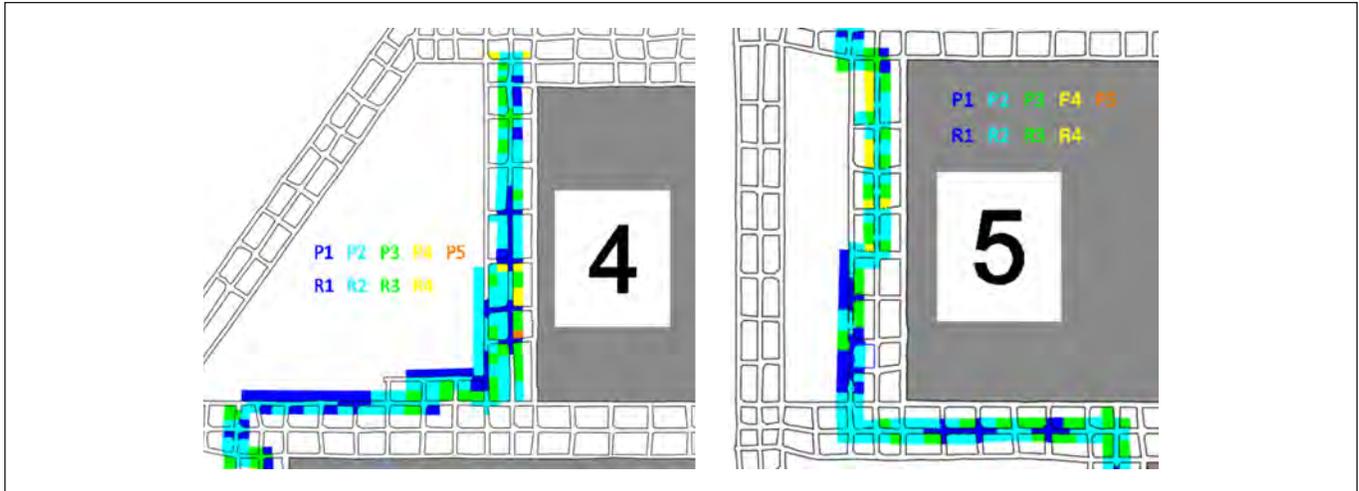
The highest observed rating for the roof was a 4, for the rib a 5, and for the floor a 3. The observed conditions averaged to a 2 across the entire study area. Panel 4 rear bleeders had one worst overall rating with one of two 5 rated ribs, while panel 5 averaged a 2 with several 1s and 4s as shown in Figure 5. Panel 6 was mostly 1s with a couple of 2s and 3s, and panel 8 averaged a 2 with a few 1s and 4s as shown in Figure 6. Panel 9A had half 1s and half 2s split at the middle between the headgate and tailgate as can be seen in Figure 7. Figure 8 shows that panel 9B averaged 1.4 with a few 2s and 3s. Near the junction of panel 9B and 9S, the worst pillar and roof ratings were observed, with several 3s, 4s, and a 5. The area is shown in Figure 8 at the far left. Panel 9S averaged 2 with one 4 rating as shown in Figure 9. Overall, the blind tailgates and headgates had lower ratings than the rear bleeders, however, not by very much. They were rated mostly as 1s or 2s with a single 5 and a few 3s and 4s. The worst rated blind gateroad was near the corner of panels 9B and 9S (Figure 8). Two of the worst conditions observed were in panels that were mined almost four years apart. Panel 4 was the first panel of the district, so it was exposed to the mine environment the longest of the study area. Panel 9B was the second to last and only exposed to the mine environment for a relatively short period of time prior to being observed.

Figure 5. Condition mapping for the bleeder entries of panels 4 and 5.

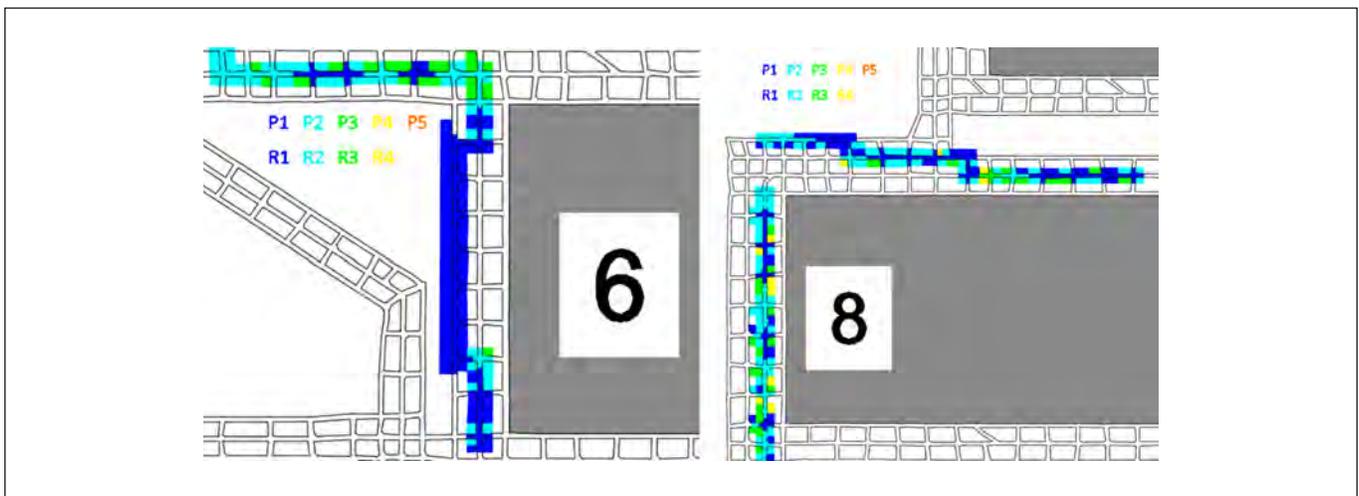
Figure 6. Condition mapping for the bleeder entries of panels 6 and 8.

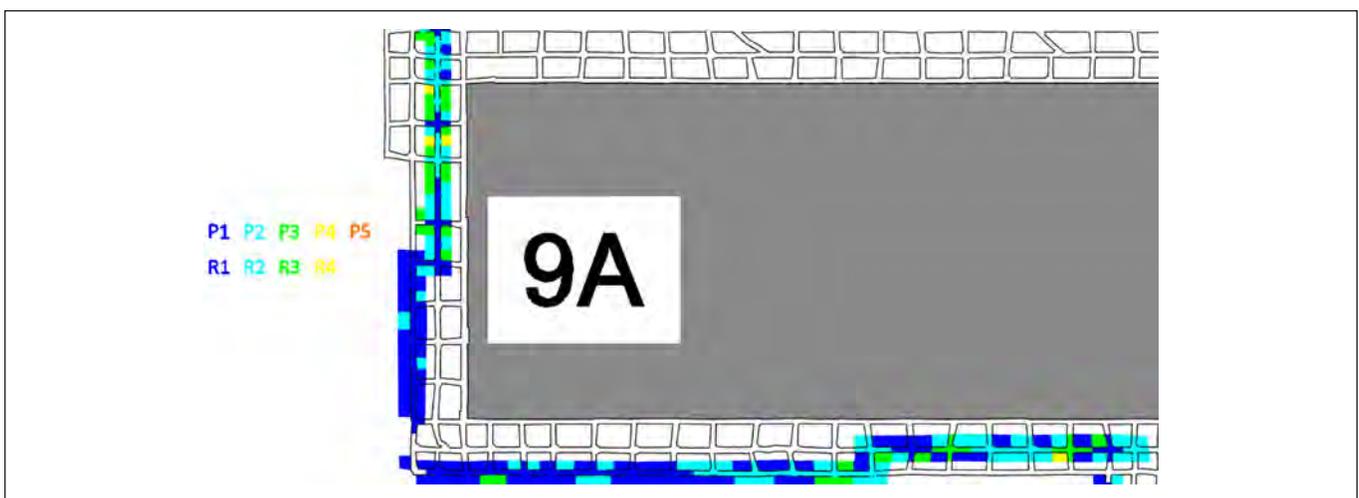
Figure 7. Condition mapping for the bleeder entries of panel 9A.

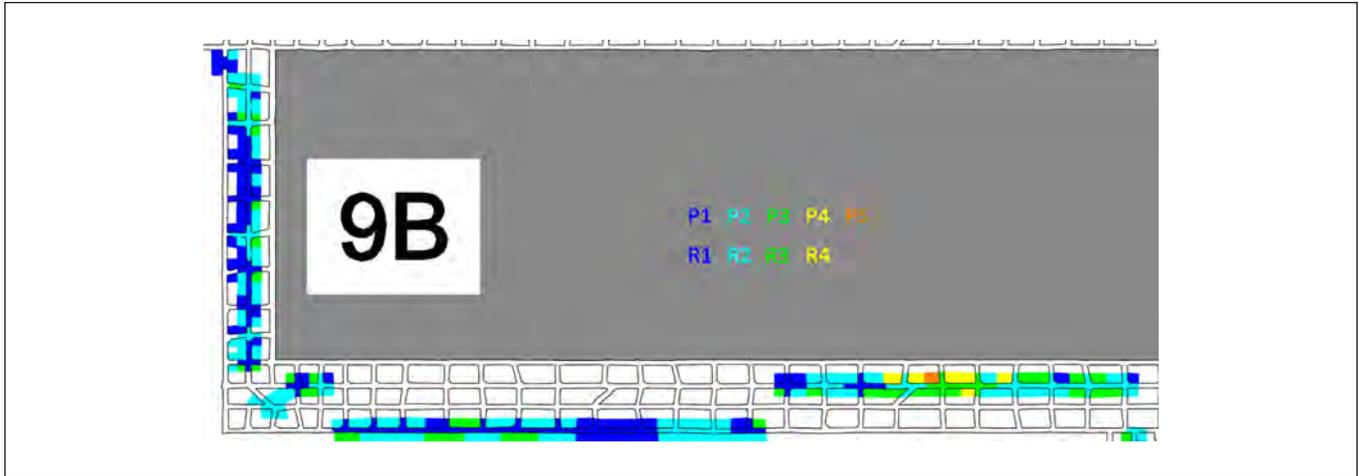
Figure 8. Condition mapping for the bleeder entries of panel 9B.

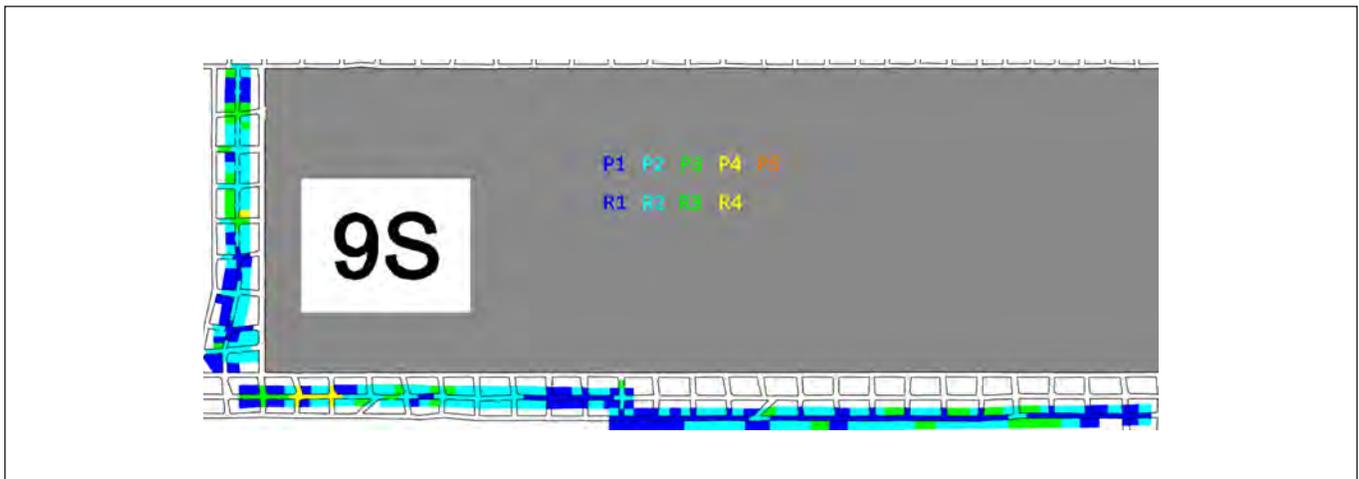
Figure 9. Condition mapping for the bleeder entries of panel 9S.

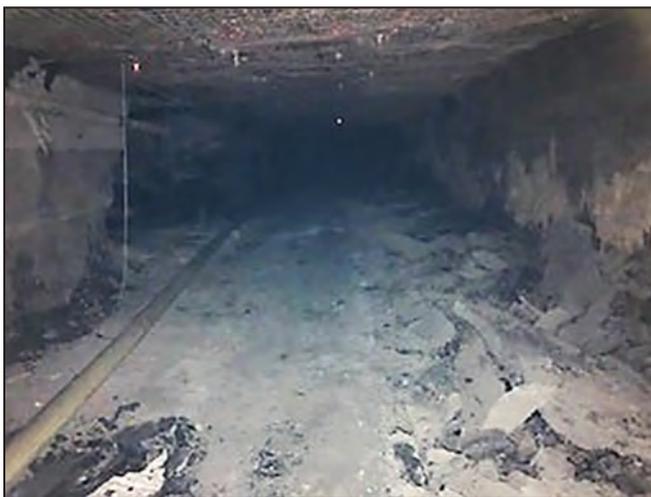
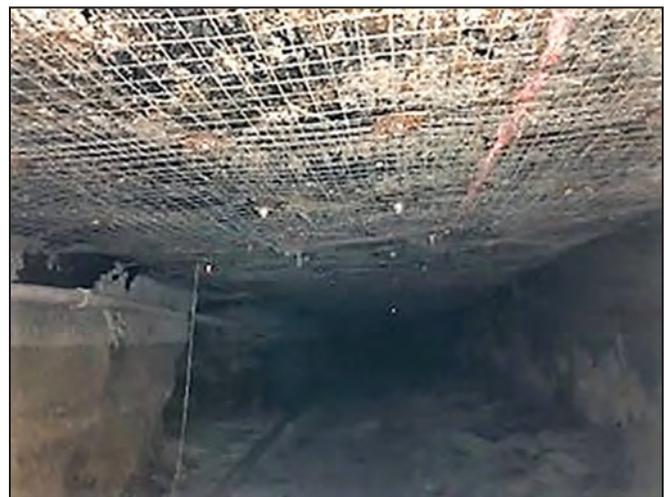
Figure 10. Images of the entry adjacent to panel 4's longwall face.

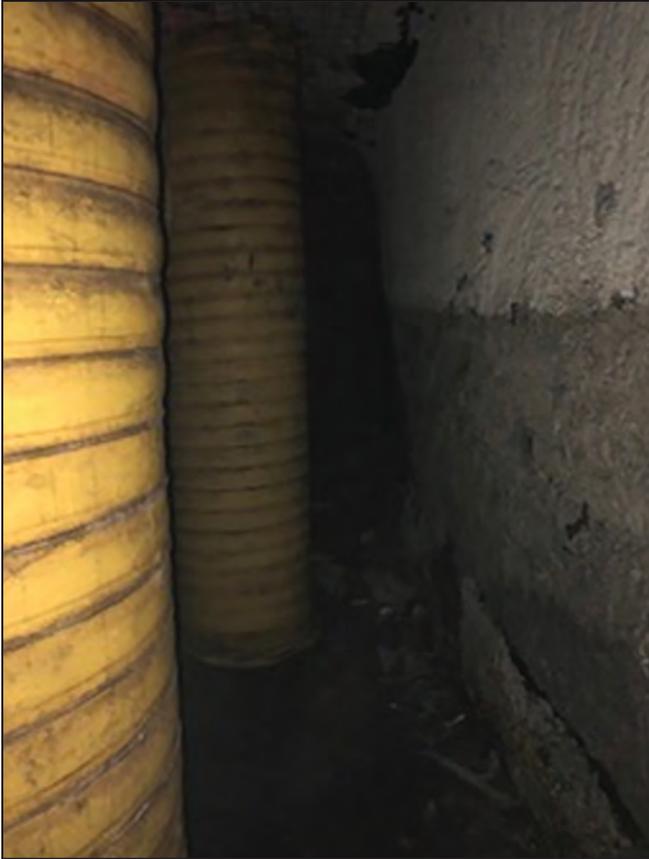
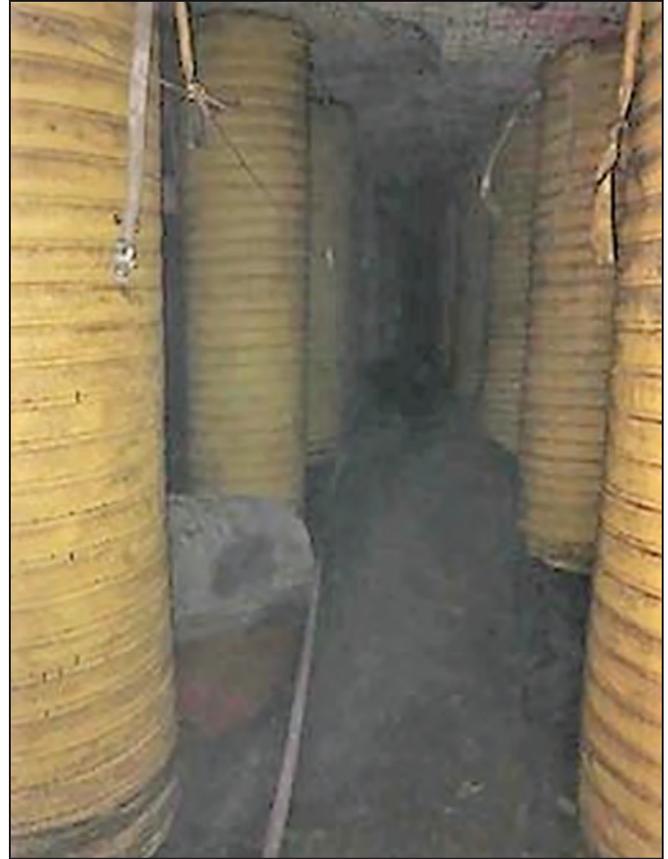
Figure 11. Images of panel 5's rear bleeder travelway.

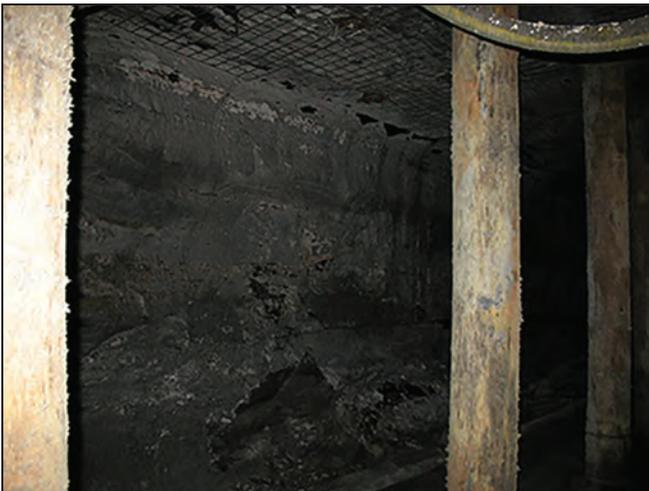
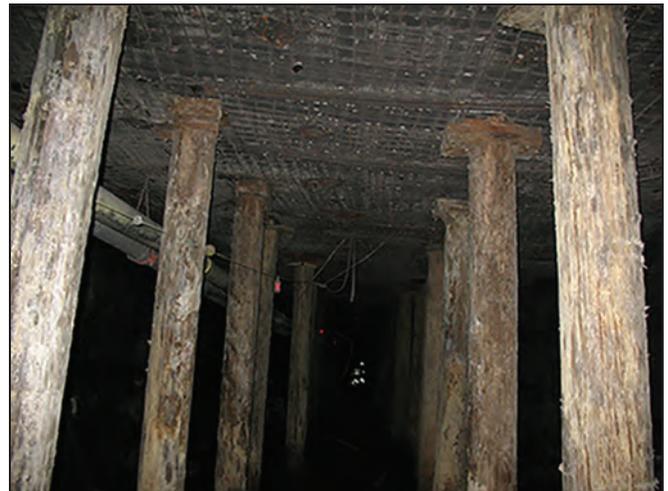
Figure 12. Images of panel 6's rear bleeder entry.

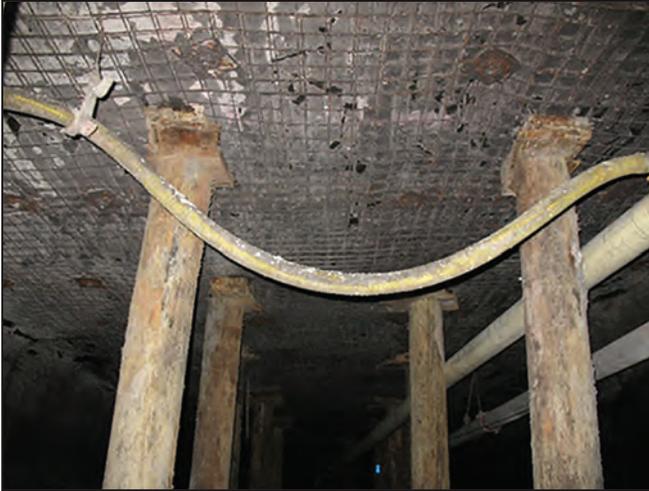
Figure 13. Images of panel 9A's rear bleeder entry.

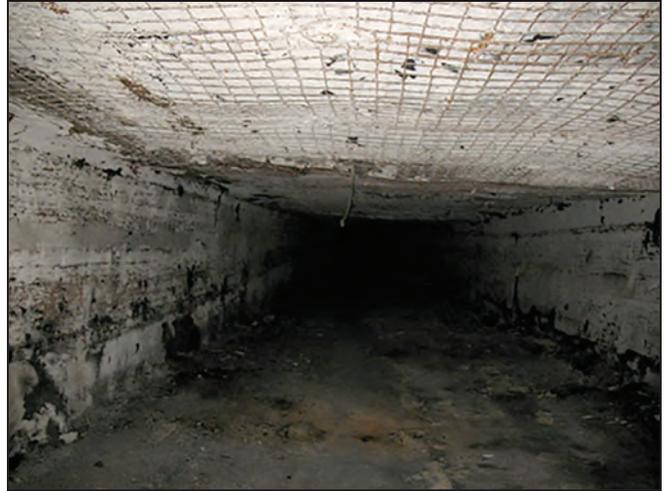
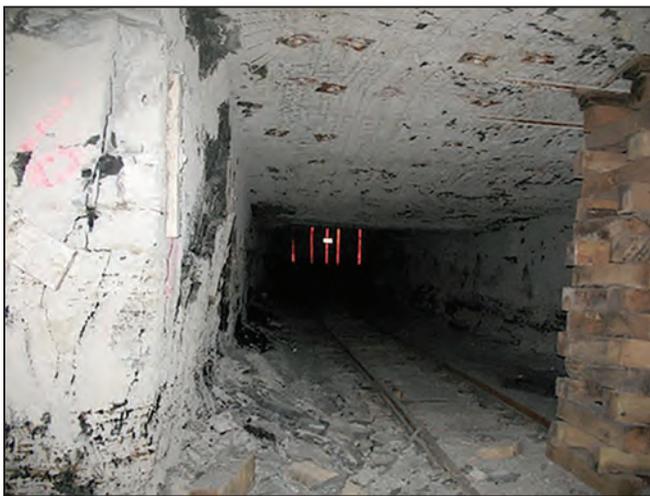
Figure 14. Images of panel 9B's rear bleeder entry.

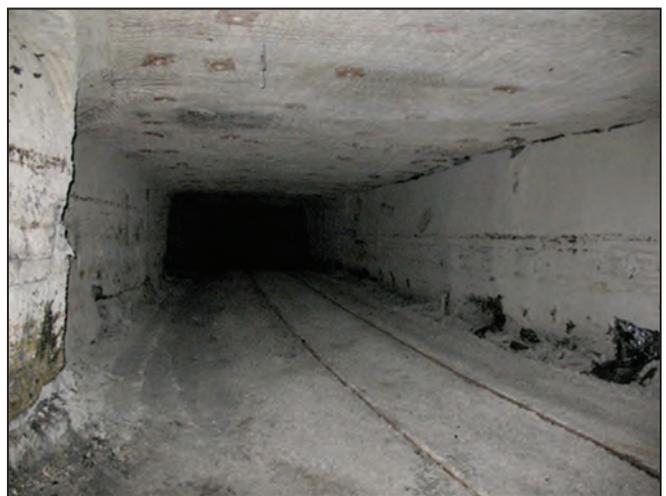
Figure 15. Image of panel 9S's rear bleeder entry.

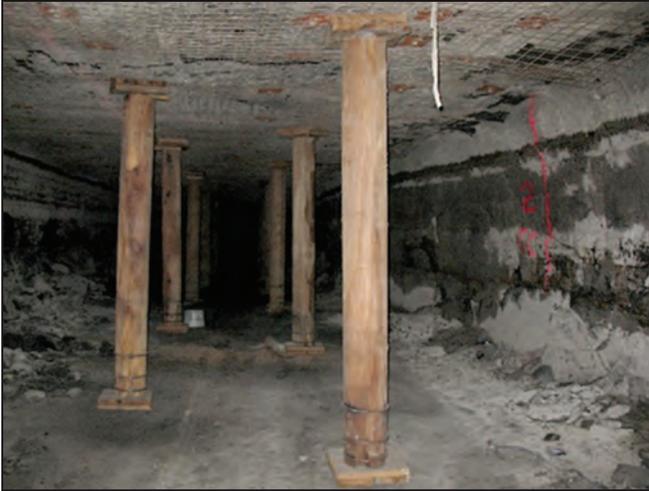
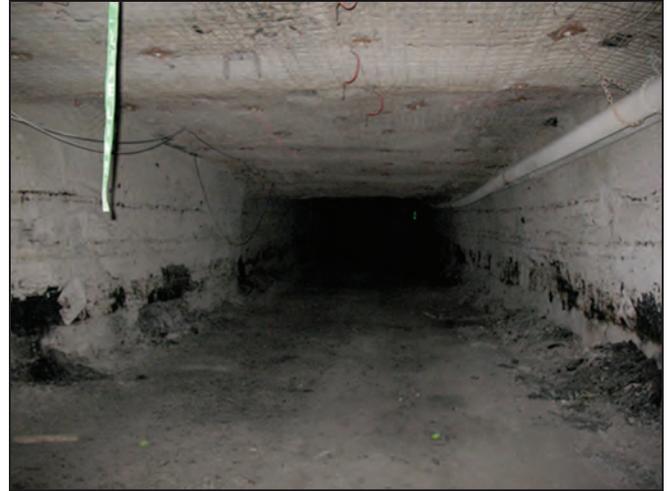
Figure 16. Images of panel 9S's blind headgate entry.

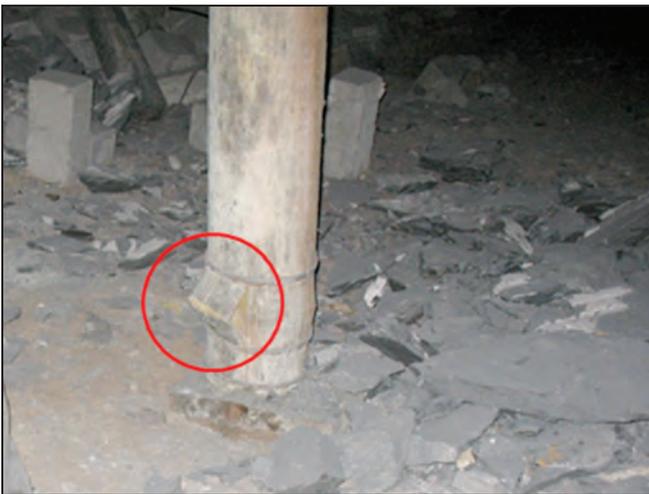
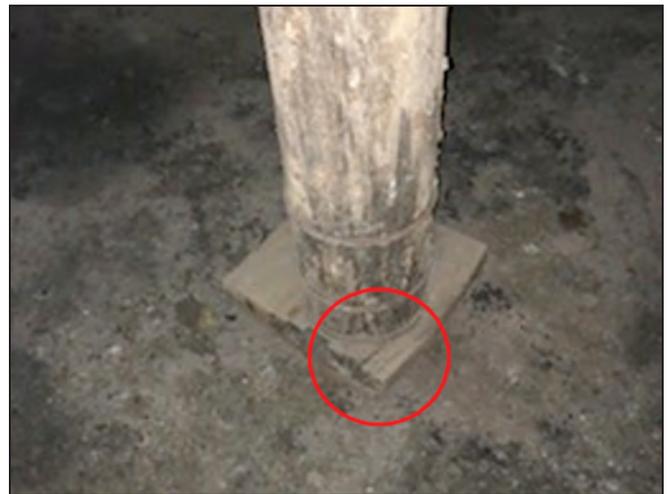
There were about five supports in the studied area where visible evidence of loading was noted. The supports were Propsetters installed in the crosscut between the travelway and the gob to act as a barrier to stop any loading or failure from migrating to the crosscut and beyond. The visual evidence on the Propsetters manifested in two different ways: (1) buckling of the cuts at the bottom of the support and (2) compaction of the bottom plates between the floor and the

Propsetter as can be seen in Figure 17. These loaded Propsetters were evidence of the effective design of the support to interrupt the progression of failure from the gob to the nearby entries.

Figure 17. Images of the two types of observed loading on the Propsetters.
