# Principal Horizontal Stress Contributing to Massive Roof Collapse at the Subtropolis Mine

**2024 SME Annual Conference & EXPO**

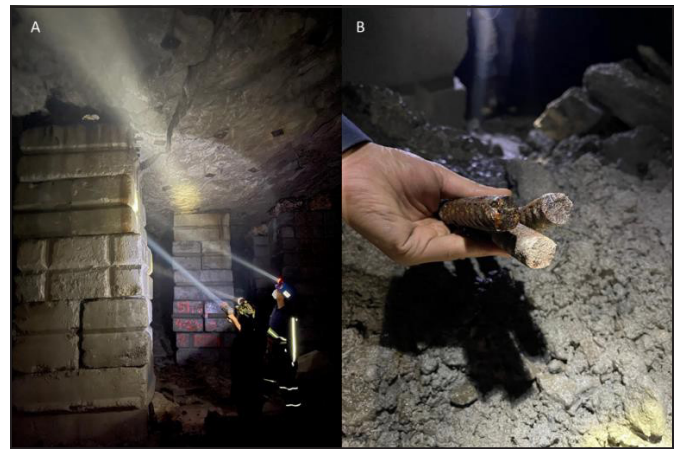
Figure 5 shows 3D LiDAR scans capturing the shape of this type of fall and its growth over time (shown in red). In this roof fall, the failure extends approximately 30 ft into the roof and up into the overlying coal seam. The shear failure orientations are parallel to the long axis of the elliptical-shaped cavities in this case study. All of these damages have been captured using detailed geologic mapping and, in some cases, 3D LiDAR scanning. For example, Figure 6 contains two photos from the Subtropolis Mine. Photo A is an example of a dilating beam and Photo B shows shear failure in three separate fully-grouted bolts from the same area.

**Figure 6. A) Photo of shear failure in roof and B) Photo of sheared bolts**

The operator noticed that these types of failures in the N-S entries appear to concentrate at the northwest and southeast corners of the pillars. In order to minimize the number of these types of roof failures, the mine utilized the stress control layout. The stress control layout utilizes the headings in the principal horizontal stress direction. This minimizes damage to the headings but concentrates damage into the crosscuts. To minimize damage to the crosscuts, the mine has implemented the use of rectangular pillars. The mine also has implemented a secondary bolting strategy and included windows in every other crosscut. According to Evanek et al. (2020), “Windows are used to resist horizontal movements or deformation that occur parallel to the maximum horizontal stress direction or perpendicular to the direction of stress failures. A window is developed by leaving an increased thickness of roof rock in the crosscuts, thus reducing the crosscut dimensions

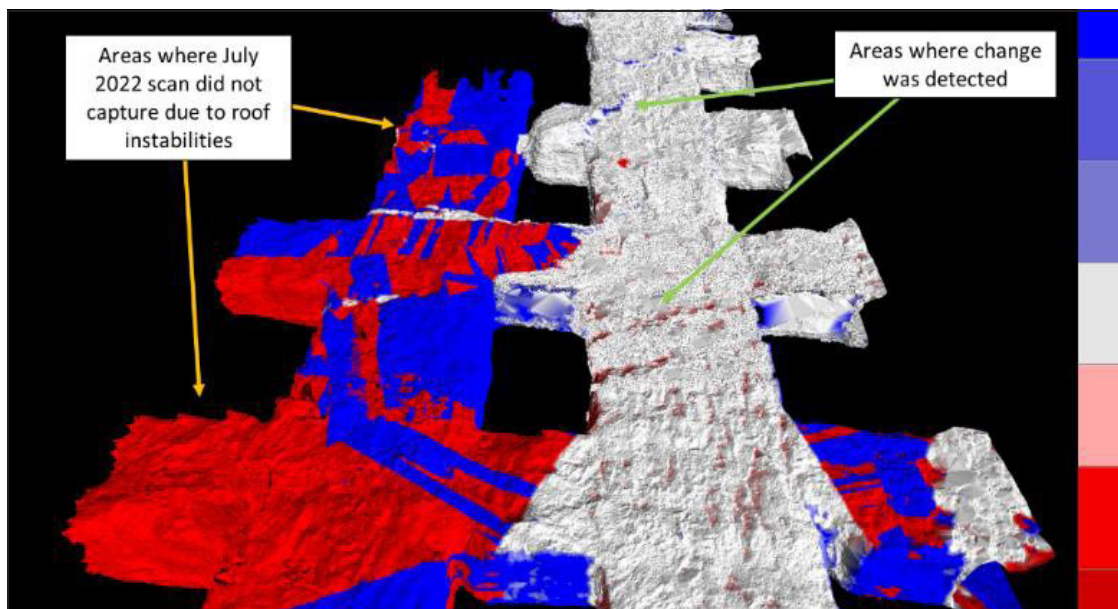
Therefore, July 2022 scans could be compared to June 2019 scans in entry N3N2. Changes were detected in the roof of N3N2 at an angle perpendicular to the principal horizontal stress direction as shown in Figure 12.

Figure 12. Ariel view of N3N2 changes over time from June 2019 to July 2022 (Red represents material removed and blue represents material added)

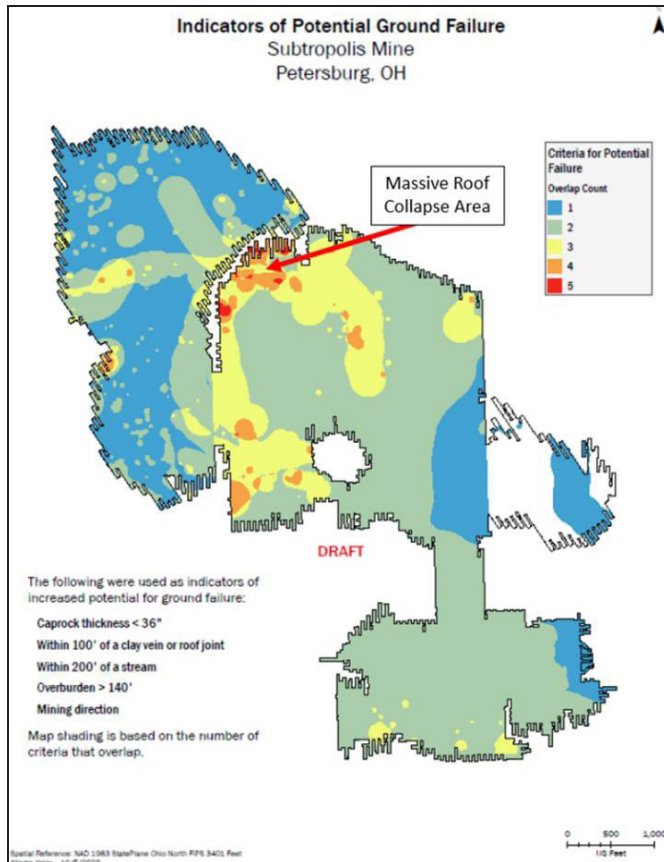
The AutoCAD version of the mine map that included the mine outline and the indicators listed above was imported into ArcGIS where a hazard map was produced (Figure 13). This map was produced without previous knowledge of the location of roof failure or the massive roof collapse. However, the map was able to indicate a potential for ground failure right over the massive roof collapse region. This may indicate that heading orientation,

**Figure 13. Indicators of Potential Ground Failure Map of the Subtopolis Mine**

overburden, stream beds, joints, clay veins, and caprock thickness might be leading factors in the cause of this massive roof collapse. The hazard map was also able to correctly map a hazardous area in the southwestern part of the mine, where a large roof fall occurred. This area had crisscrossing clay veins in the overlaying shale with several fractures in the roof and a constant flow of water prior to the fall. Cutter roof failures and rock flour were present during the failure as well indicating the shear failures as discussed in Figure 4. According to the operator, the Lower Kittanning Coal Seam may have also rolled down towards the top of the Vanport in this area.
