DEPARTMENT OF HEALTH & HUMAN SERVICES

Centers for Disease Control  
and Prevention (CDC)  
National Institute for Occupational  
Safety and Health (NIOSH)  
1095 Willowdale Road  
Morgantown, WV 26505-2888  
PHONE: (304) 285-5894  
FAX: (304) 285-6046  
July 2008

## Career Fire Fighter Dies and Chief is Injured When Struck by 130-Foot Awning that Collapses during a Commercial Building Fire – Texas

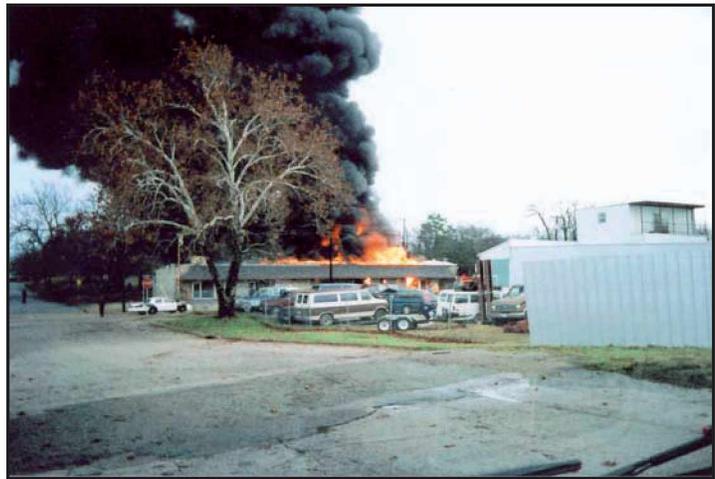
*Incident scene. Photo courtesy of fire department*

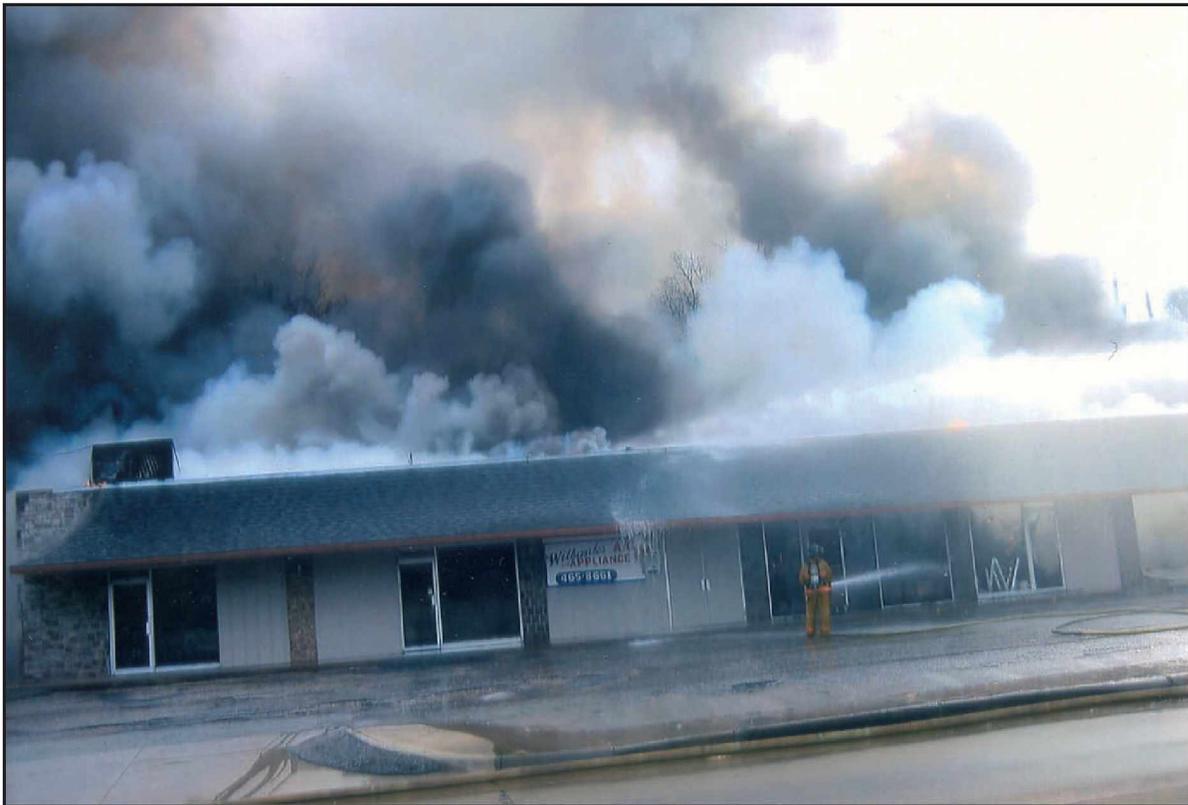
*Photo 1. Front of incident structure prior to awning collapse. Photo courtesy of fire department.*

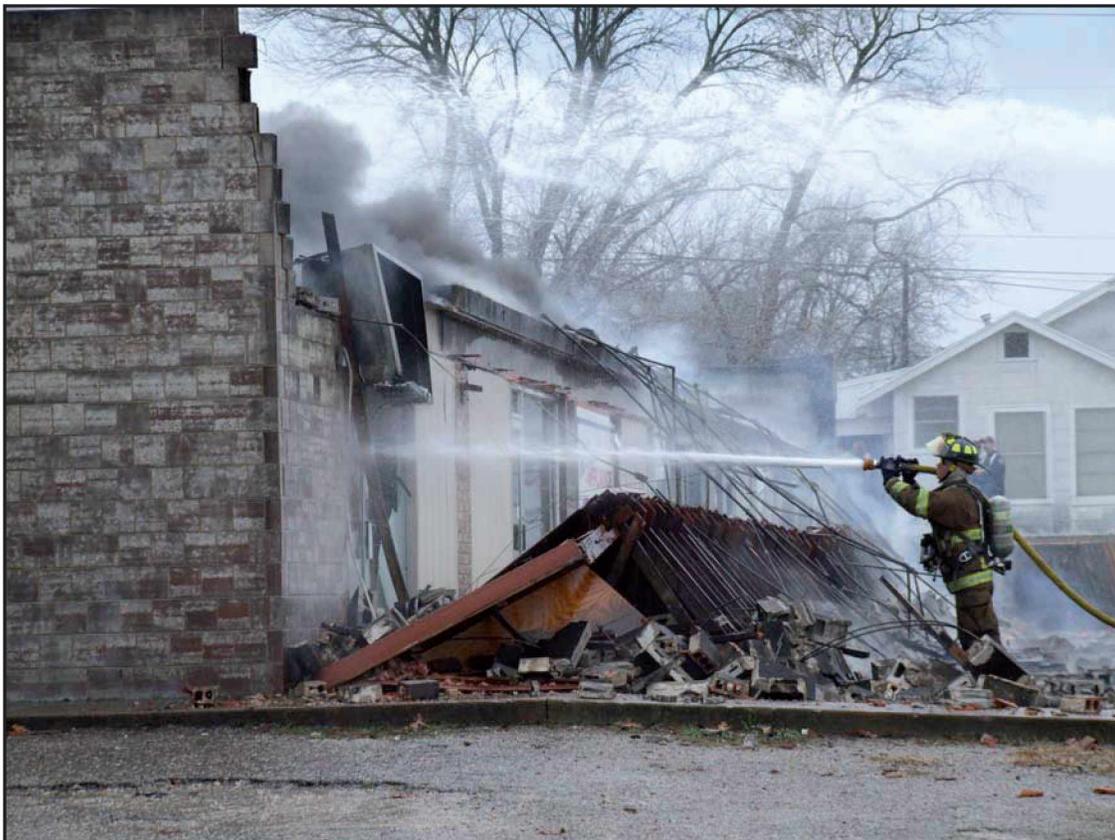
*Photo 2. View from North end of building – post collapse. Photo courtesy of fire department.*

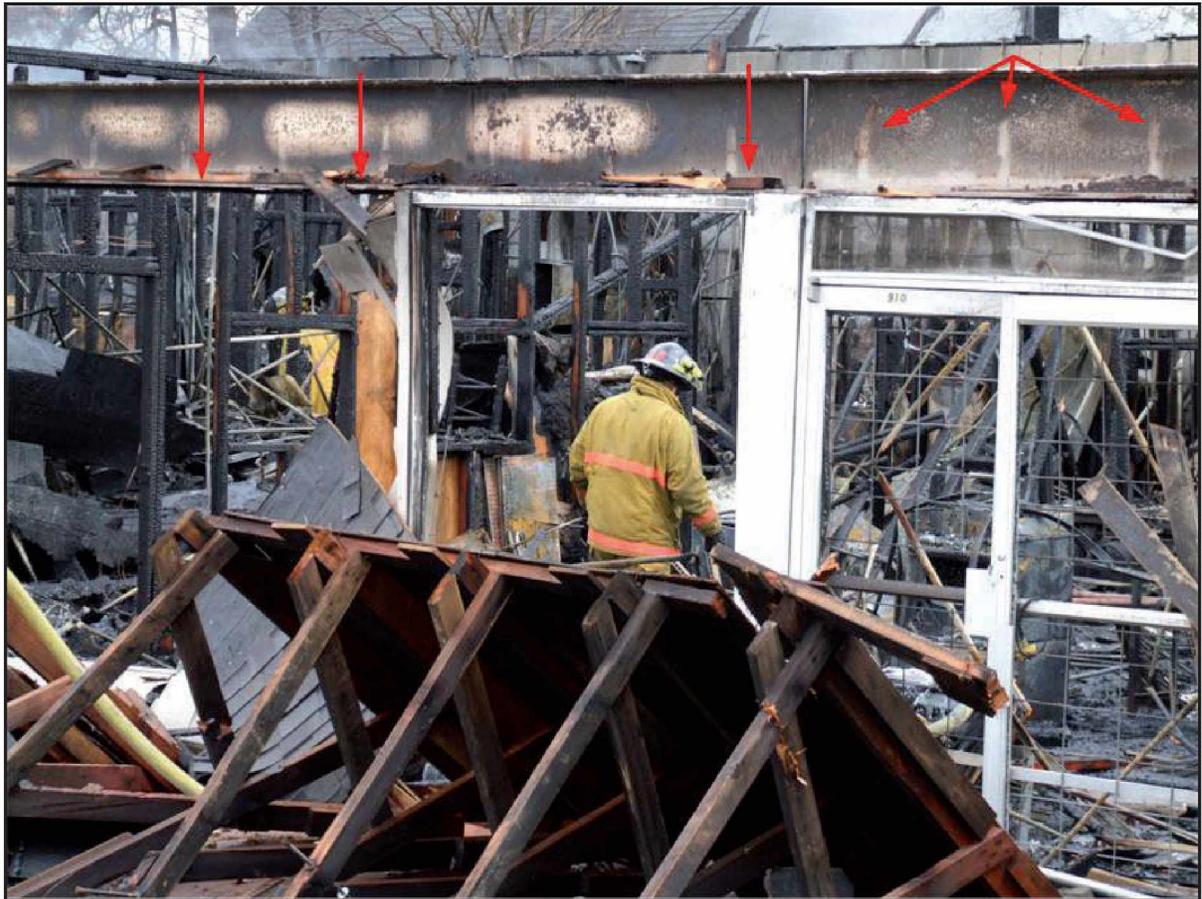
*Photo 3. Note steel I-beams running across front wall above windows and doors. Note wood fragments where awning frame was connected to the I-beam. Burn patterns also indicate location of awning frame. Photo courtesy of fire department.*

In this incident, the attack crew followed proper procedures in backing out of the building as the conditions deteriorated. Once outside, the lieutenant discussed the conditions with the Incident Commander and told fire fighters to stay out from under the awning. However, a collapse zone was not established and defensive operations were not officially declared. The roof collapsed approximately 3 minutes before the awning fell. Once the trusses failed, lateral support to the front wall was lost. The front wall could no longer support the weight of the awning.

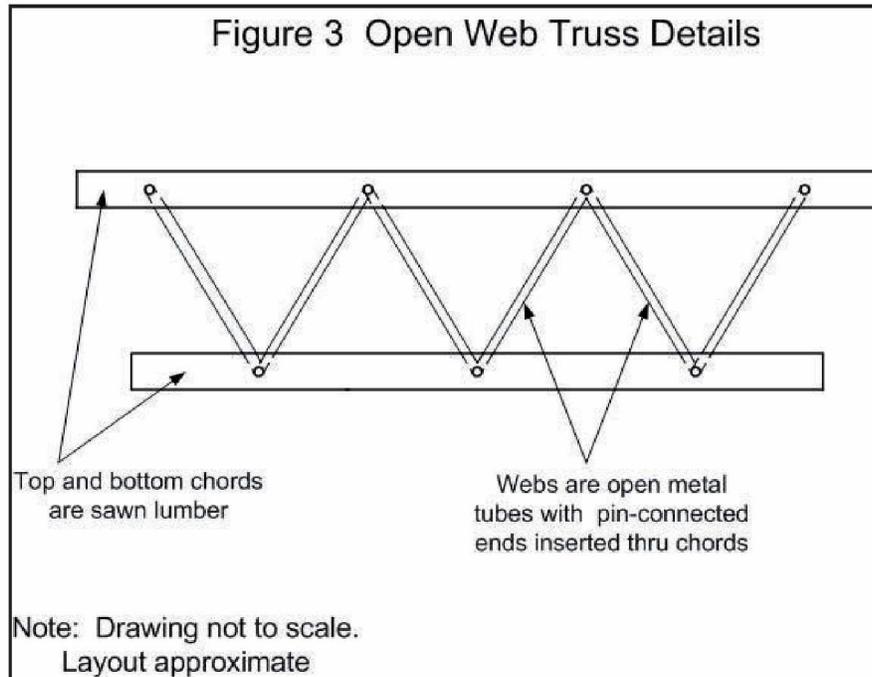
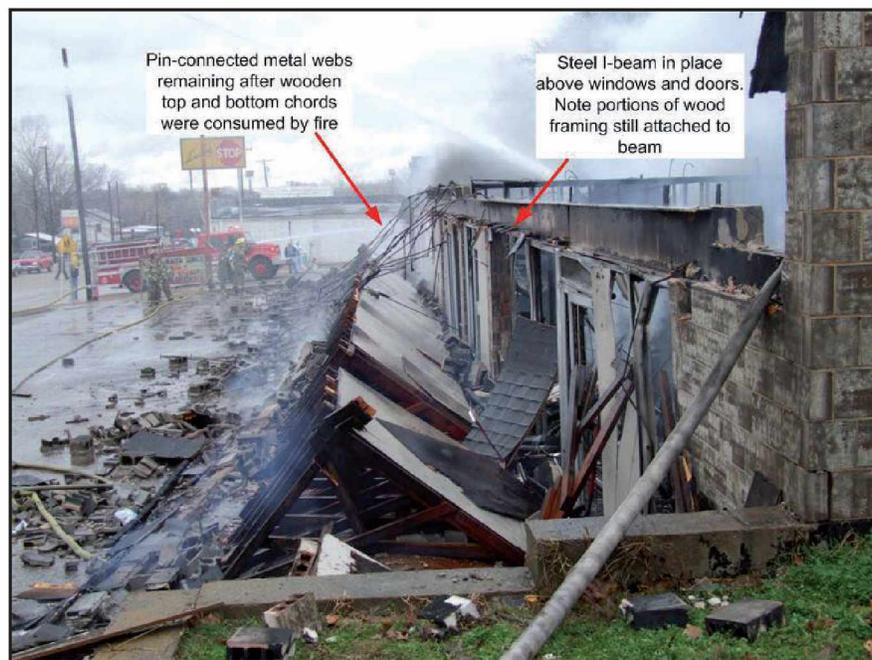
*Photo 4. View from south-end of structure after awning collapse. Note the pin-connected metal webs still connected to the awning. The top and bottom chords of the trusses have been consumed by the fire. Also note the steel I-beam in place above the windows and doors. Refer to Figure 3 and Photos 5 and 6 for more details of the truss construction. Photo courtesy of fire department.*

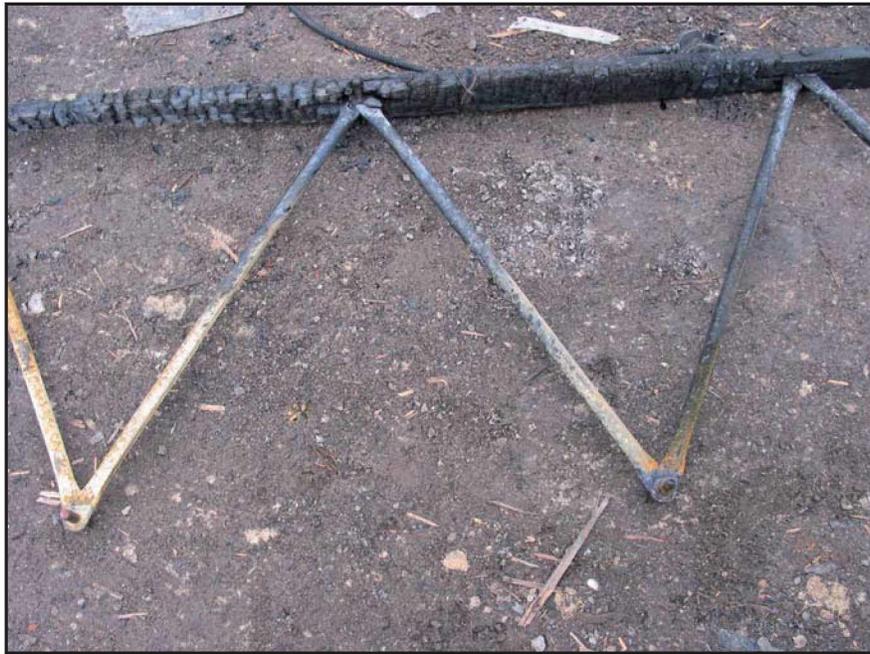
*Photo 5. Open-web pin-connected trusses after fire. Photo courtesy of fire department.*

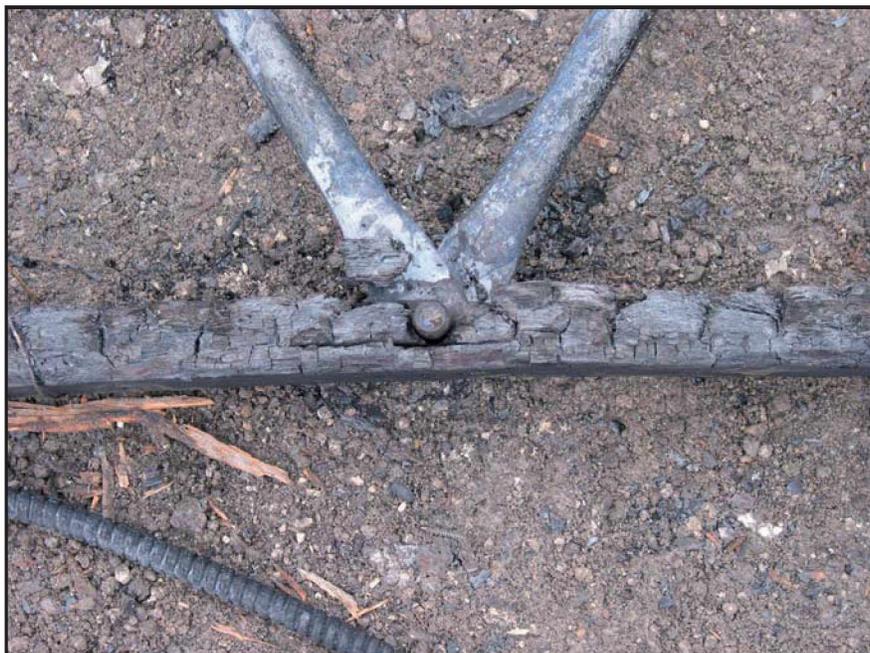
*Photo 6. Close-up of pin connection in open-web pin-connected trusses  
Photo courtesy of fire department.*

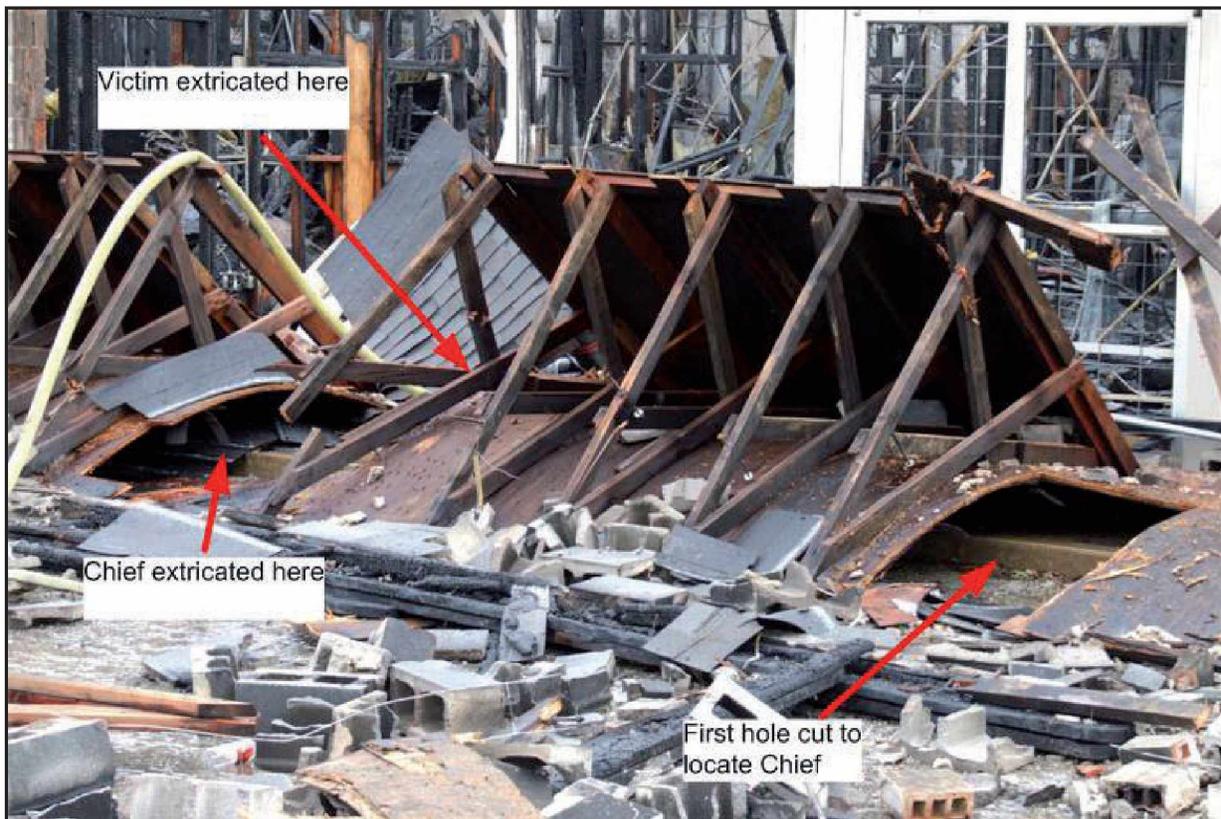
Moments later, at approximately 0913 hours, the awning broke loose at the south end of the structure, rolled over and fell, pulling the entire awning down. It struck the victim and the Chief, pinning them under the debris. The victim was standing approximately 28 feet from the south wall and

*Photo 7. Awning after collapse. Note holes cut through awning during extrication to free the trapped fire fighters. Also note how curvature of awning creates a void underneath Photo courtesy of fire department.*

***Recommendation # 1: Fire departments should establish and monitor a collapse zone for structures that have become unstable due to fire damage.***

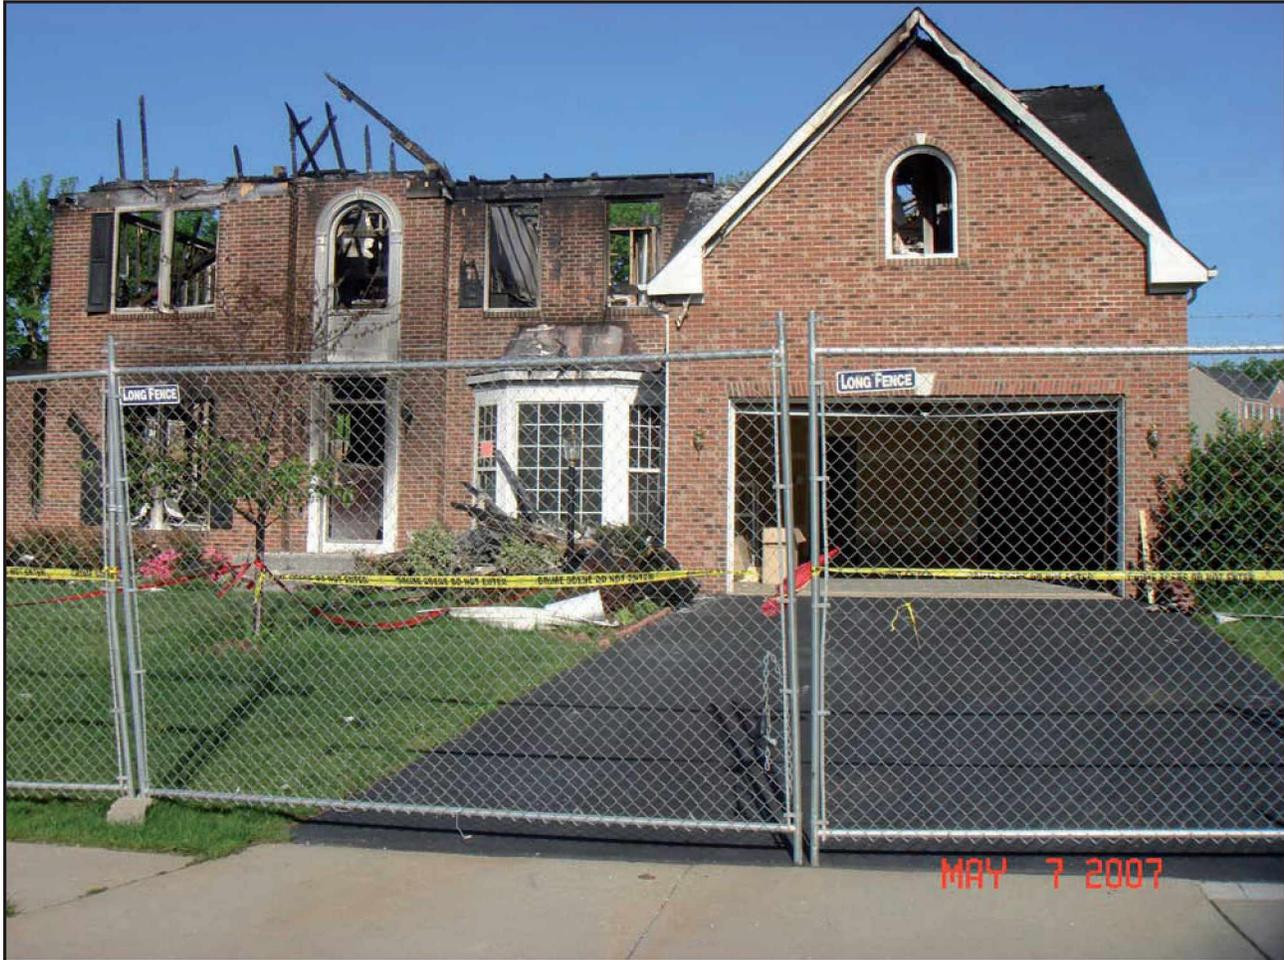
Photo 1: A-side of the structure where the victim entered. The victim was found in the second floor master bedroom above the bay window.

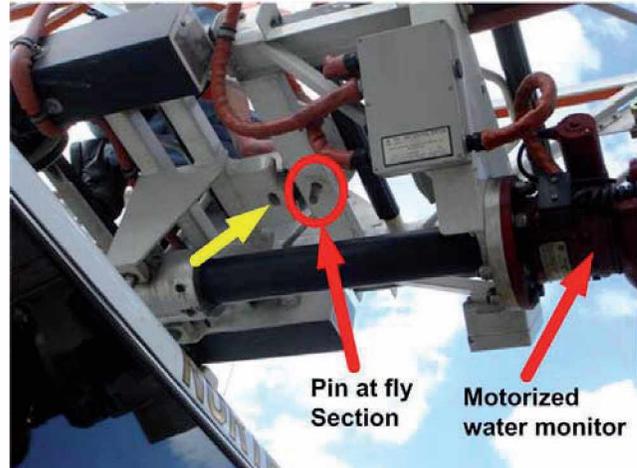
Photo 1 - A properly seated pin at the fly section for defensive water stream operations is highlighted in the red circle. The hole behind it (yellow arrow) shows the location where the pin would be inserted (from the top) to keep the monitor assembly back at the second ladder section for rescue mode. NOTE: Various methods are used throughout the fire apparatus industry to secure the waterway; this picture represents a pin-anchored waterway design.

- Ensure that Standard Operating Procedures (SOPs) and/or Guidelines (SOGs) on setting up multi-position waterways include steps to properly position the waterway and to inspect and verify that the locking mechanism (anchoring pin(s), lever, clamps, etc.) are properly installed and functioning as designed before pressurizing the waterway.
- Properly train and practice the correct method of securing waterways and verifying they are secured (per manufacturer's recommendations).

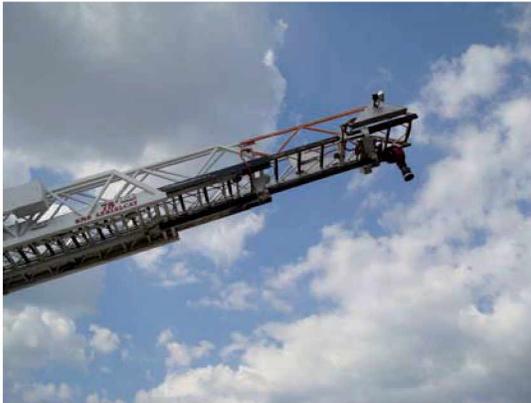
Photo 2 – Aerial ladder with monitor at tip

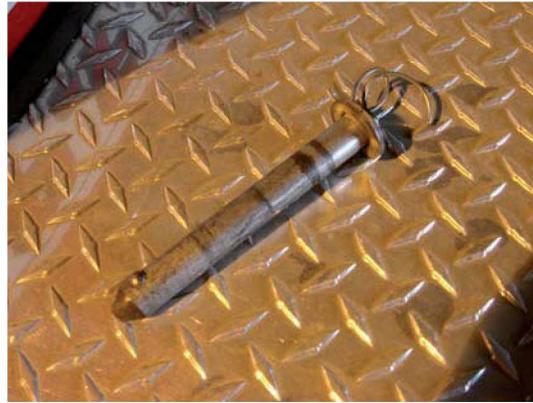
Photo 3 – anchoring pin

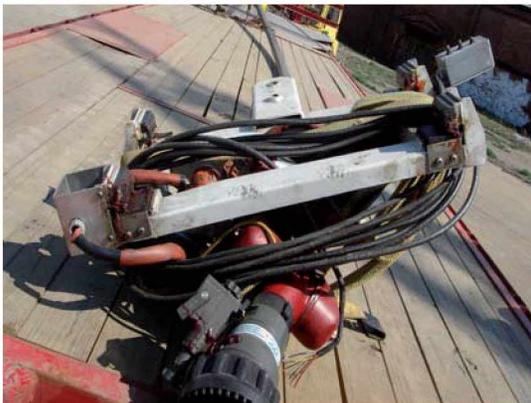
On April 8, 2008, a volunteer Deputy Fire Chief (the Incident Commander), was killed when struck by a motorized water monitor and 30 feet of aluminum pipe that was “launched” off an elevated aerial ladder at a fire at an industrial manufacturing plant in Pennsylvania. The truck was normally transported in the “rescue mode” with the monitor pinned to the second section of ladder so that the waterway would not be in the way if the ladder was set up for rescue operations. At the incident scene, when the waterway was pressurized, the monitor and its support bracket, along with the last 30-foot section of pipe were “launched” off the aerial ladder by the force of the water pressure in the pipe. The monitor flew approximately 75 feet and fell, striking the Incident Commander on the head, killing him instantly. After the incident, the anchor pin was found on the ground, in front of the truck’s cab. The waterway did not include any secondary mechanical stops to prevent the separation of the water monitor in the event the anchoring pin was not properly seated. The NIOSH Fire Fighter Fatality Investigation and Prevention Program is currently investigating this incident and a full report will be available at a later date.

Photo 4 – Monitor and pipe that “launched”

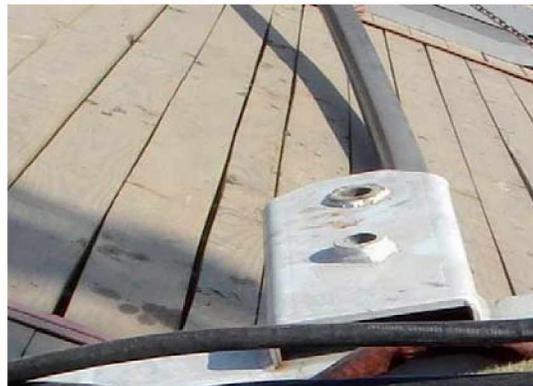
Photo 5 - The receiver assembly where the pin is inserted
