AN INVESTIGATION OF THE CAUSES OF CUTTER ROOF FAILURE IN A CENTRAL PENNSYLVANIA COAL MINE: A CASE STUDY

by John L. Hill, III and Eric R. Bauer

Proceedings Twenty-Fifth Symposium on Rock Mechanics

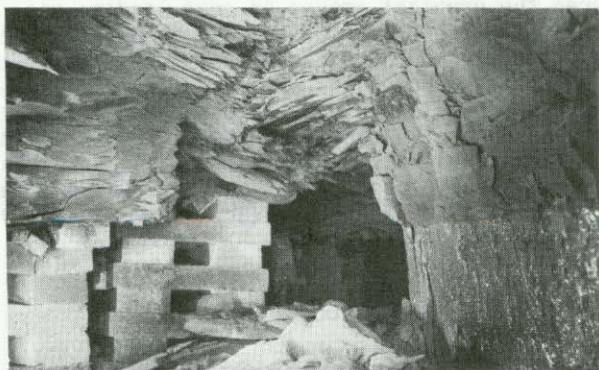
Fig. 2. Close view of cutter roof failure along rib. Crib blocks are approx. 0.1 m (4 in) thick.

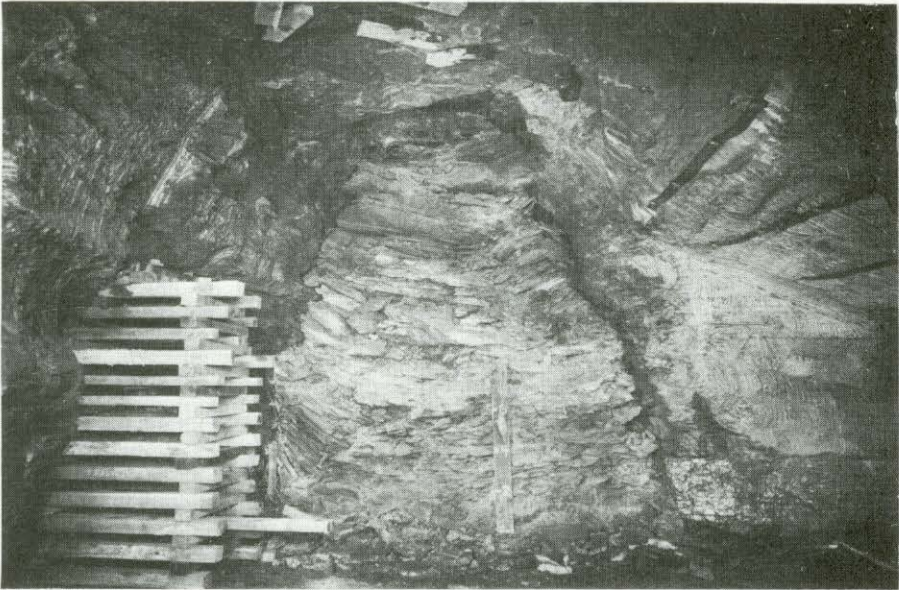
Fig. 3. Roof fall as result of cutter roof failure in study mine. Numbers on board represent feet above floor rock.

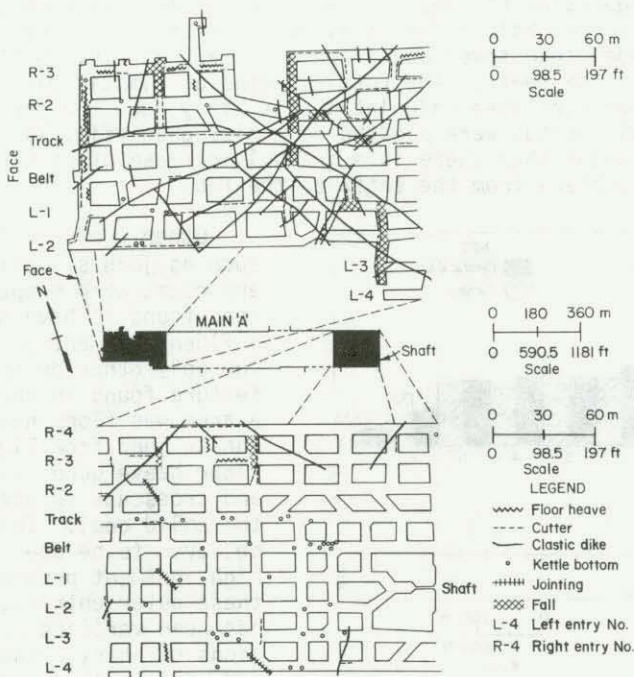
Fig. 6. Geologic structure and deformation map of Face and Shaft areas showing difference in clastic dike and cutter frequencies.

illustrates the relation of geologic features to mining-induced deformation. Clastic dikes (commonly known in mining terms as clay veins) ranged in thickness from 30 cm (1 ft) of claystone matrix with fragments of shale and coal to as thin as a filmlike trace of calcite or clay. The dikes were observed (in roof falls) to extend as high as 8 m (26 ft) into the roof rock and would penetrate the coalbed at various angles. Few dikes reached the floor rock. Fractures and slickensides in the roof were associated with the presence of clastic dikes and slickensided faces were often marked with horizontal striations. Cutters normally formed adjacent to clastic dikes, with their deepest penetration (often greater than 60 cm (2 ft)) into the roof directly next to a dike and lesser penetration as distance from the dike increased. When cutter roof failure deteriorated enough to form roof falls, clastic dikes often formed their boundaries (fig. 6). It can also be seen from Figure 6 that frequencies of clastic dikes and cutters are much greater near the face of Main A than they are near the shaft area.² Main A was divided into seven equal areas of 2500 m² (26,880 ft²) from the face to the shaft. The total lengths of clastic dikes and cutters in each area were then calculated separately, and the percents of their total lengths were plotted on a histogram (fig. 7). This histogram shows that there is a gradual increase of both clastic dikes and cutters from the shaft to the face.

Other geologic features such as joints, kettlebottoms, and cleat were mapped but were found to have no major influence on entry stability. The only other deformational feature found in the Main A area was floor heave. As can be seen from Figure 6, floor heave occurred in entries and crosscuts adjacent to the solid coal. This is believed to be due to rather high abutment pressures in these outer entries, which has been verified by observations of entry advancement and will be investigated further through in situ stress measurements.

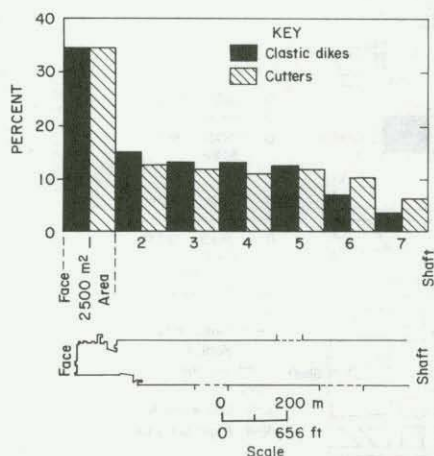
Fig. 7. Percents of total lengths of clastic dikes and cutters in equal areas of 2,500 m².

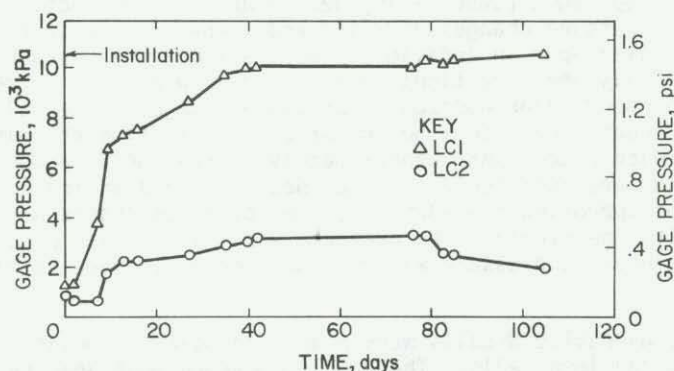
Fig. 9. Behavior of load cells 1 and 2.

The first area monitored was in the L-1 entry of Main A; two load cells were installed (fig. 8, A). The entry had been advanced to a position approximately 3 m (10 ft) west of load cell 1 when the cells were installed. At the time of installation no cutter had formed in the entry, and the clastic dike to the west of the cells had not been exposed by mining. Approximately three days after installation, the face had passed the next inby crosscut, and loading occurred on load cell 1 which measured pressure changes perpendicular to the heading of the entry (fig. 9). Six days after installation, both cells were showing signs of increased loading as a cutter began to develop adjacent to the clastic dike just inby the cells. As the cutter progressed to the next outby clastic dike, the loading on load cell 1 continued to increase. By day 10 posts were installed for additional support; however, loading continued to increase on both cells and roof conditions continued to deteriorate. On day 30 the entire entry had to be cribbed to control the roof. Loading eventually leveled off as the cribs took the load, and the entry finally stabilized. Both load cells responded as would be expected if the roof was acting as a cantilever beam with support on the southern pillar and the cutter along the northern pillar allowing the beam of the roof to bend (fig. 8, A and fig. 9).

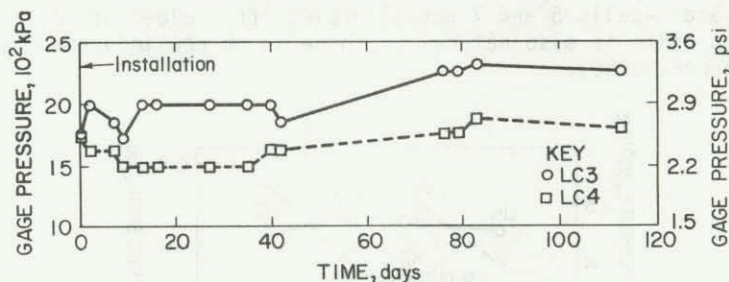
Loading of U-cell 1 and load cell 3 occurred as soon as the next 6 m (20 ft) cut into the face was taken from the crosscut which exposed the two clastic dikes (fig. 10 and 11). Load cell 3 measures pressure changes perpendicular to the entry and showed a total increase of approximately 240 KPag (35 psig) in the first day while load cell 4 bled off. Some natural bleed off is expected as the hole deforms if there is no movement in the roof to apply a load to the cell or if extension occurs in the beam of the roof. By the second day the U-cell closest to the inby rib (U-cell 1) showed an increase in load of nearly 2000 KPag (290 psig) as cutter roof failure was beginning to develop along the inby rib between the clastic dikes intersecting the rib (fig. 8, B). From past experience with cutters developing this quickly, it was suggested that supplemental support be installed immediately. Trusses were installed between the rows of bolts, resulting in an immediate decrease in the rate of loading. The addition of trusses effectively reunited the natural beam of the roof and prevented the roof from deteriorating further. Finally loading leveled off (fig. 10 and 11) and the cutter did not become

Fig. 10. Behavior of load cells 3 and 4.

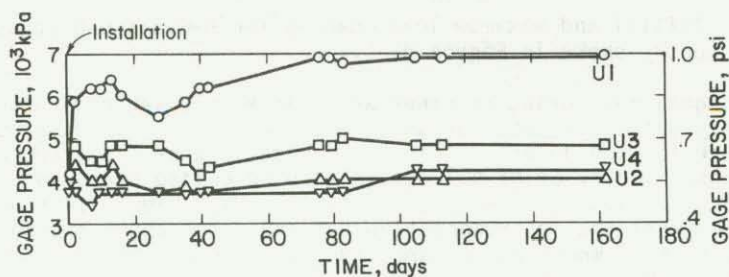
Fig. 11. Behavior of U-cells 1-4.

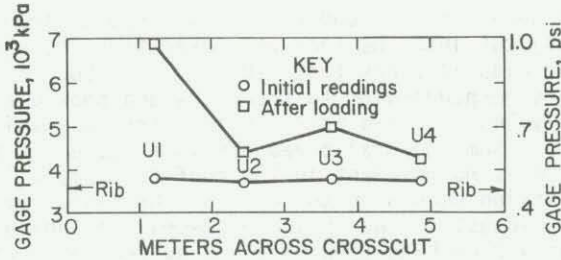
any more severe. Figure 12 shows the maximum load seen by each U-cell in the crosscut of Figure 8, B. Once again the loading roughly parallels that which would be expected from a cantilever beam (figs. 10, 11, and 12).

Fig. 12. Initial and maximum loads for U-cells 1-4 across crosscut shown in Figure 8, B.

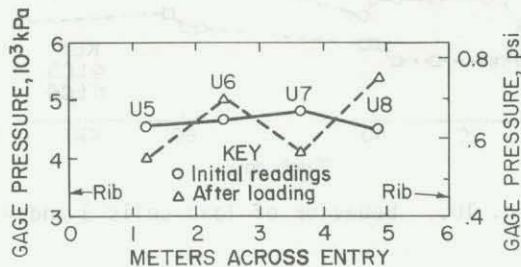
In the next area (fig. 8, C) trusses were being used on a regular basis and had been successful in deterring the formation of cutters. Shortly after this cut was mined, some rock did fall from the clastic dike in the roof, but this activity ceased once trusses were installed. Figure 13 shows the total loading seen by each U-cell across the entry. Very little total loading occurred on U-cells 6 and 8, and U-cells 5 and 7 actually bled off. Bleed off of loading on bolts is also natural if there is no new inducement of load (Roberts, 1980).

Fig. 13. Initial and maximum load changes for U-cells 5-8 across entry shown in Figure 8, C.

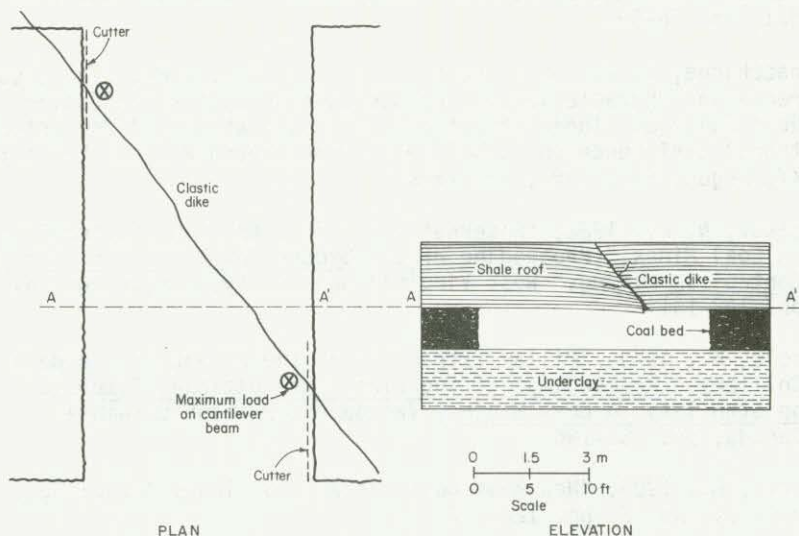
Additional monitoring of other areas in Main A is continuing. Preliminary data from these areas tend to support our findings that cutters are forming in association with clastic-dike-disturbed roof. Initial instrumentation of pillars is also revealing pressure changes around clastic dikes as mining advances. Figure 14 roughly illustrates what the instrumentation has indicated about the formation of cutters. When trusses are added as supplemental support, the clastic dike is effectively supported, allowing the roof to act as a solid beam.

Fig. 14. Roof deflection at clastic dike due to weight of cantilever beam as would be expected from figure 12.
