The diagnosis and reduction of mine roof failure

Geology-related failures: what they are, and what can be done about them

by Noel N. Moebs
and Raymond M. Stateham

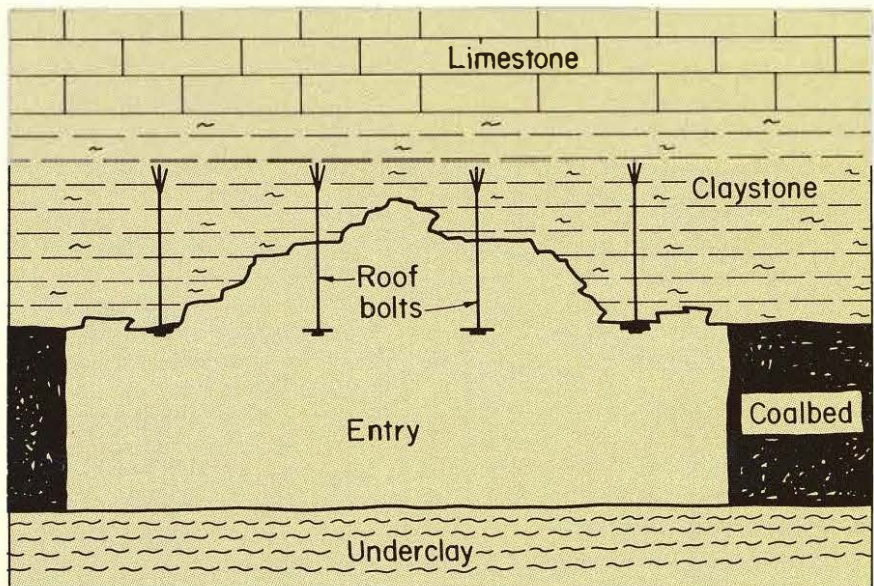
Low-strength rocks include most claystone, especially the "drawslate" that overlies the coalbed, and underclay or seatearth. These rocks generally are not self-supporting for normal entry widths (see Fig. 1), tend to fall from the roof soon after coal extraction, and therefore must be supported as quickly as possible after exposure.

Fig. 1—Subtype G_1 roof failure attributed to low rock strength.

Bolted headers or straps are usually needed, and trusses are useful in severe cases, where the deadweight of collapsing roof is not excessive; otherwise posts and crossbars become necessary. Although full-column resin bolts have adequately sup-

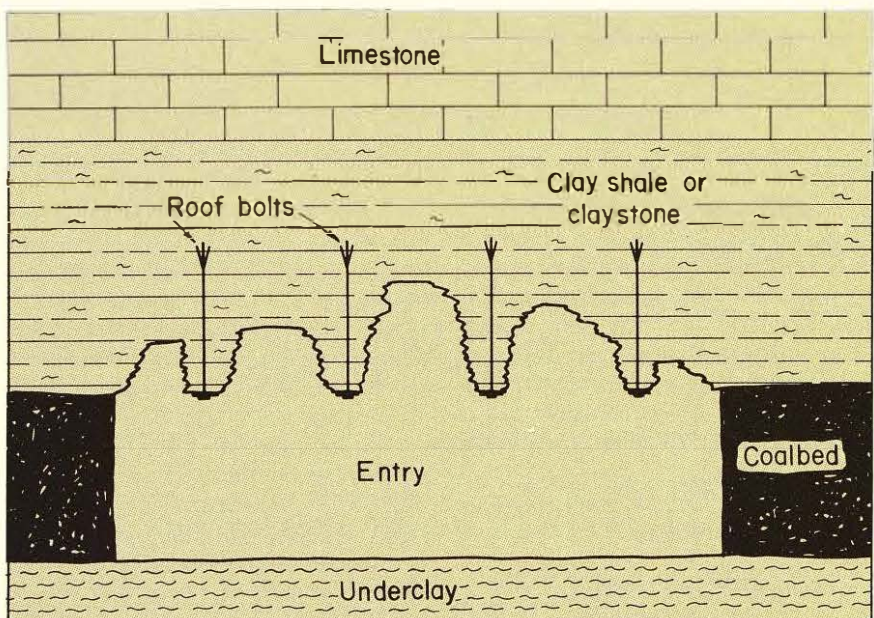
Fig. 2—Subtype G_2 roof failure attributed to moisture sensitive roof rock.

This G₂ category (see Fig. 2) includes those failures due to a significant reduction in the strength of roof rock from exposure to high humidity or water commonly found in the mine environment. The effects of moisture sensitivity consist of a progressive softening or slaking whereby rock gradually disintegrates and eventually reverts back to a mudlike unconsolidated condition.

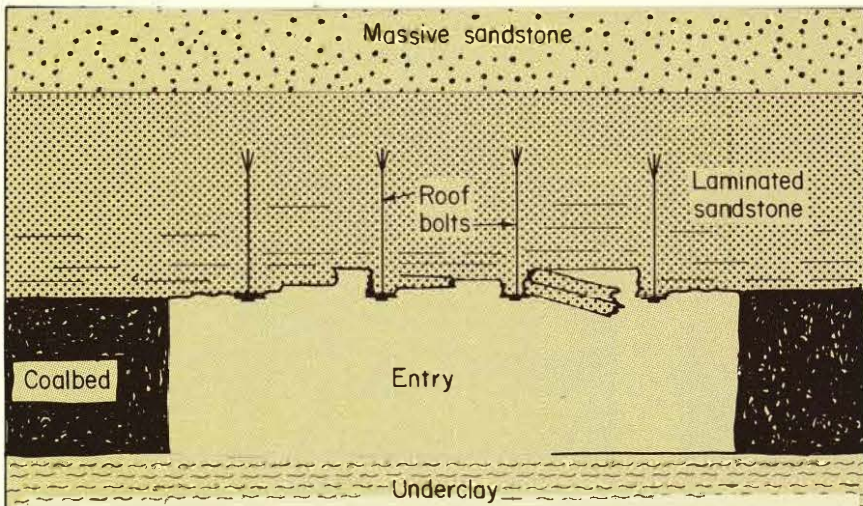
Fig. 3—Subtype G₃ roof failure attributed to thinly laminated strata.

Subtype G₃ failures are those attributed to thinly laminated strata. A bedding plane in laminated roof strata constitutes a potential plane of separation. The weaker the bonding along the bedding plane, the more likely a roof separation will occur as the coal underneath is removed (see Fig. 3).

Severe sag of thinly laminated strata that does not respond to resin or longer bolts calls for the use of roof trusses, posts and crossbars, or entry narrowing where feasible.

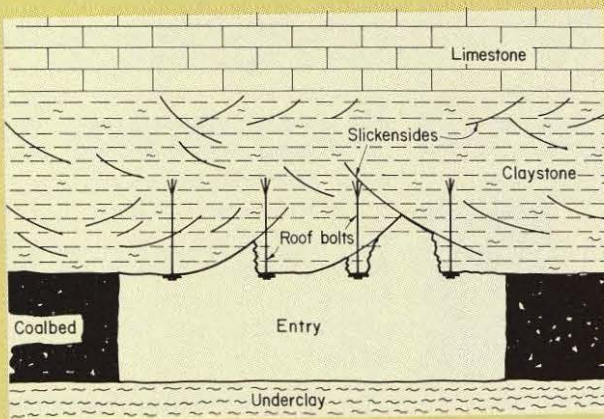
Fig. 4—Subtype G₄ roof failure attributed to slickensides.

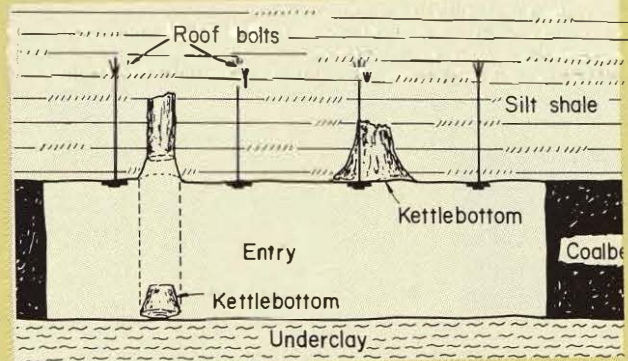
Fig. 5—Subtype G₄ roof failure attributed to kettlebottoms.

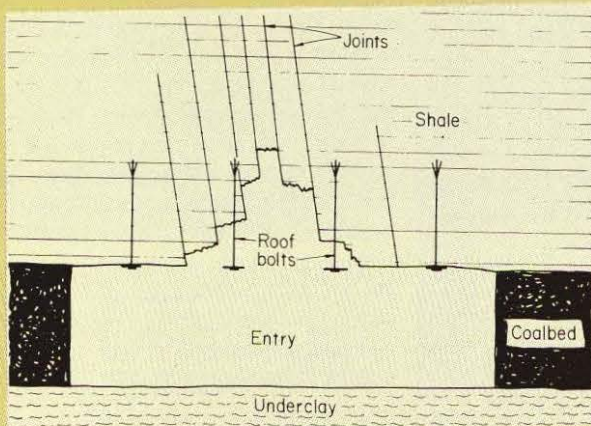
Fig. 8—Subtype G₄ roof failure attributed to joints.

Intraformational joints are found in virtually every mine where thick, massive strata occur. They commonly will form a boundary of a roof fall but are not a major causative factor as are some of the other structures. Joints are reported to play a much greater role in roof failure in the Western United States than in the eastern regions.

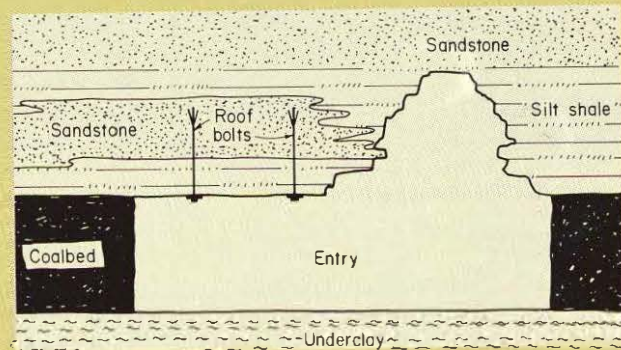
Fig. 9—Subtype G₄ roof failure attributed to pinchouts.

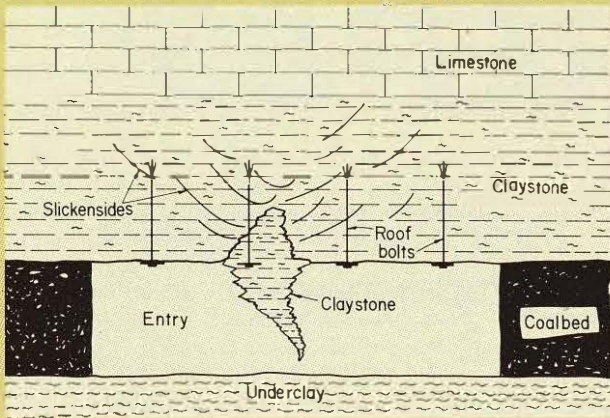
Fig. 6—Subtype G₃ roof failure attributed to a clay vein (clay dike).

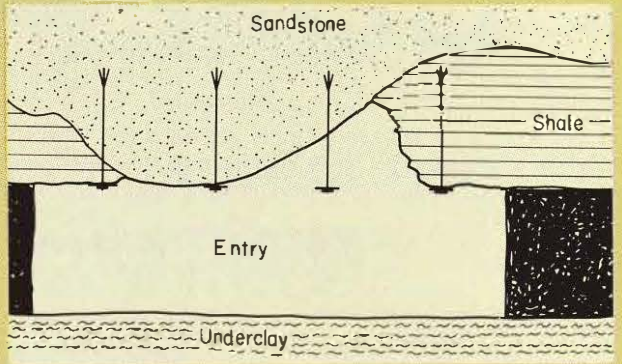
Fig. 7—Subtype G₄ roof failure attributed to a paleochannel (roof roll).

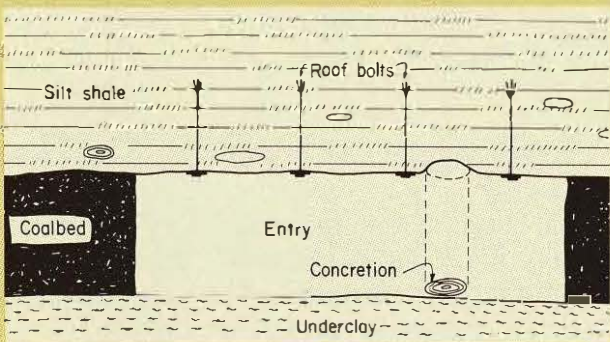
Fig. 10—Subtype G₃ roof failure attributed to concretions.

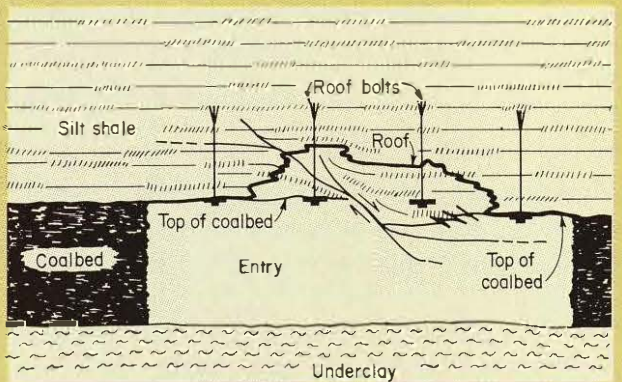
Fig. 11—Subtype G₄ roof failure attributed to faults.
