GATE DESIGN KEY TO BUMP CONTROL

Bump-related fatalities in the Appalachian coalfields spur investigation by U.S. Bureau of Mines

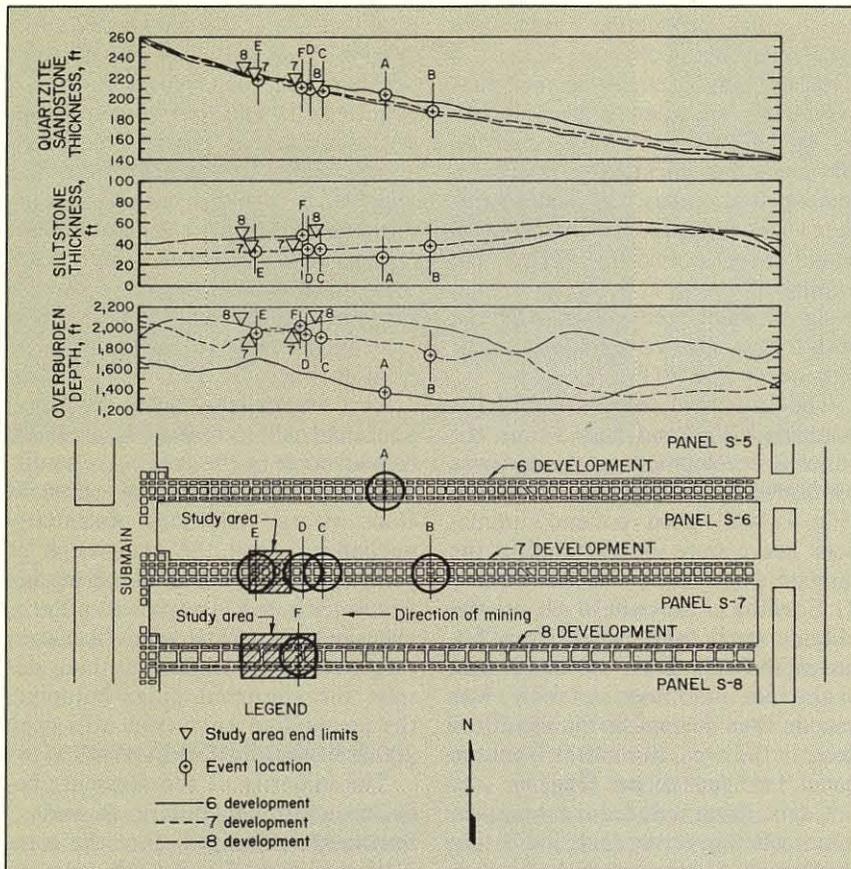
In the first study area, abutment pillar bumps began to occur adjacent to the tail drive within the panel 6 development gate road after 3,650 ft of the 6,000-ft-long panel had been extracted. Fig. 2 illustrates the location of the bump area, labeled *A*, as well as the overburden depth, the thickness of the immediate siltstone

Fig. 2—Superjacent strata conditions over the 6, 7 and 8 development gate roads showing the location of bump.

Tailgate abutment pillar bumps, similar in magnitude to bump *A*, occurred during the extraction of panel 7 (Fig. 2). They began, however, approximately 450 ft earlier in the panel extraction with the occurrence of bump *B*. As the mining of panel 7 progressed, the tailgate abutment pillars began bumping 500 ft in advance of the longwall face. These failures transferred load onto panel

Following the experiences suffered on the previous panels, the mine modified the yield-abutment-ward configuration for the panel 8 development gate road in an attempt to improve ventilation between active and inactive gobs, to enhance entry stability and to control tailgate bumps. This new 238-ft-wide design consisted of yield pillars on 40-ft centers and abutment pillars on 140-ft centers. Between the yield pillars, the crosscuts were driven at 60° on 100-ft centers, whereas between the abutment pillars, the crosscuts were driven at 90° on 2,000-ft centers. This layout resulted in 20-ft by 80-ft yield pillars on either side of a 120-ft by 180-ft abutment pillar (Fig. 2).

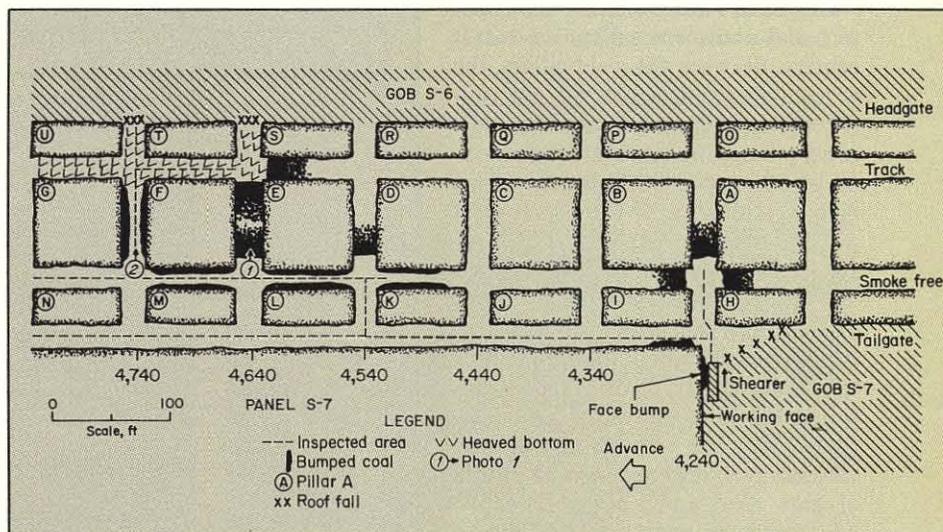
Two of the face bumps, *C* and *D*, were significant events that affected normal operations. These events occurred after panel 7 was extracted to 4,240 ft and 4,430 ft, respectively. (A plan view of bump site *C* is presented

in Fig. 3.) In bump *D*, the panline was lifted and thrust toward the gob, while in the *C* and *D* bumps approximately 40 ft of the coal rib of panel 7 was thrown into the tailgate.

A visual inspection of pillar conditions in the tailgate indicated that the load bearing capacity of abutment pillars *A* to *F* had been destroyed by bump *B* prior to the occurrence of face bump *C* (Fig. 3). The smoke-free entry between pillars *B* and *I* was completely closed by abutment pillar *B*'s bumping, thus making travel along this entry virtually impossible.

Fig. 3—Plan view of bump *C* within the panel 7 development gate road showing the extent and location of bumped coal.

After the *D* bump, the tail of the face was kept 10 ft in advance of the head in an attempt to decrease the stress concentration on the tail by redistributing stresses toward the head. Also after this bump, the shearer was operated remotely when mining near the tailgate corner of the panel. In this way the panel was completed without any further face bump delays. The absence of further incidents in the panel could not be conclusively attributed to changes in procedures or on tailgate design.

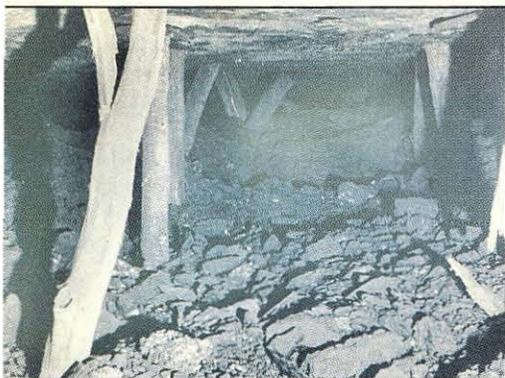
The area containing abutment pillars *G*, *F* and *E* was found to have experienced floor heave (Photo 1) between abutment pillars *E* and *F*. Since the posts were not broken, as would have been the case if roof-to-floor convergence had occurred, it can be deduced that the main overburden load was supported by panel 7, and consequently, that the abutment pillars had not been deformed or forced into the floor.

Photo 1—Condition of crosscut between pillars E and F showing bump fall out.

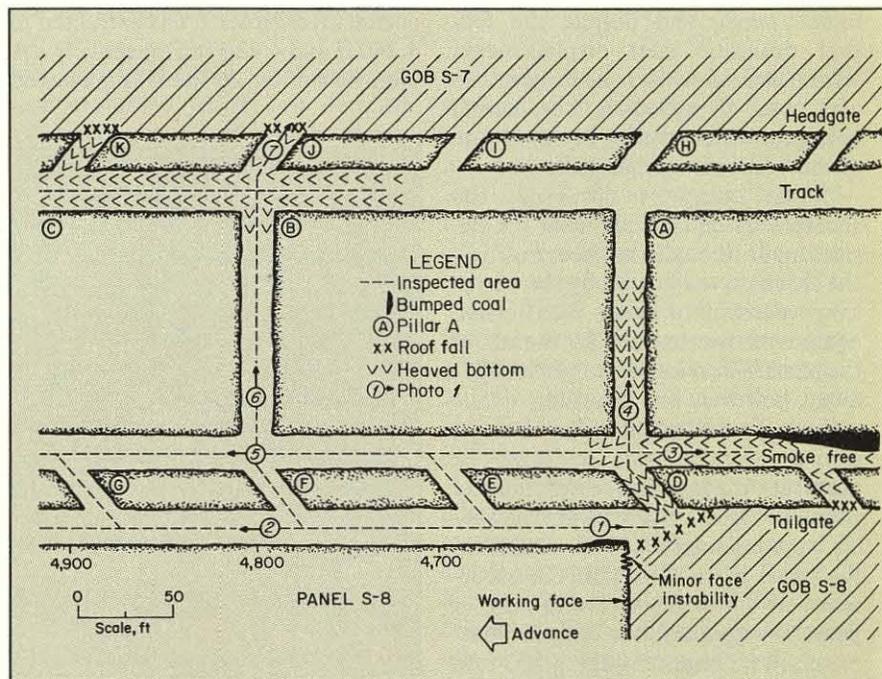
The structural competence of the immediate roof and floor within the panel 8 development gate road was confirmed by the conditions at site F (Fig. 4), while good roof and minimal floor heave were encountered in the tailgate adjacent to the face (Photo 2). Spalling of the panel 8 rib into the tailgate entry was evident over approximately the first 40 ft in advance of the face and minor instability was encountered during the mining of the face, in the area 20 to 40 ft from the panel 8 tailgate corner (Fig. 4).

hind the face in the smoke-free entry (Photo 3), as well as in the crosscut between abutment pillars A and B (Photo 4). In addition to this, bumping of abutment pillar A occurred approximately 100 ft behind the face (Fig. 4). It therefore seems probable that the 120-ft by 180-ft abutment pillars, when subjected to high abutment zone stresses, form a solid column that punch into the mine floor, causing the floor to fail in a brittle fashion (Photo 3).

Fig. 4—Plan view of conditions at site F, within the panel 8 development gate road showing the extent and location of disturbance.

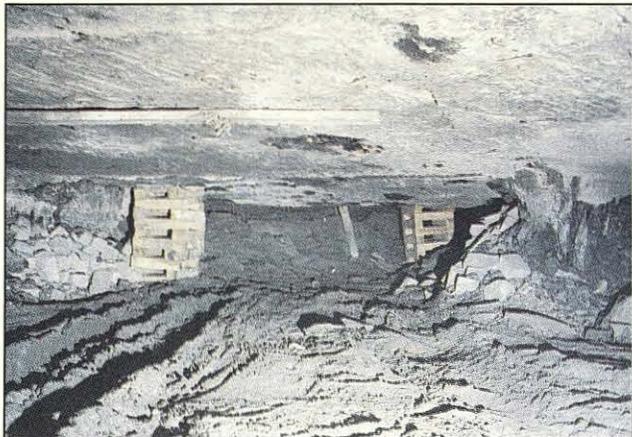
Photo 2—Good roof and floor conditions at tail shield following alteration of the gate design.

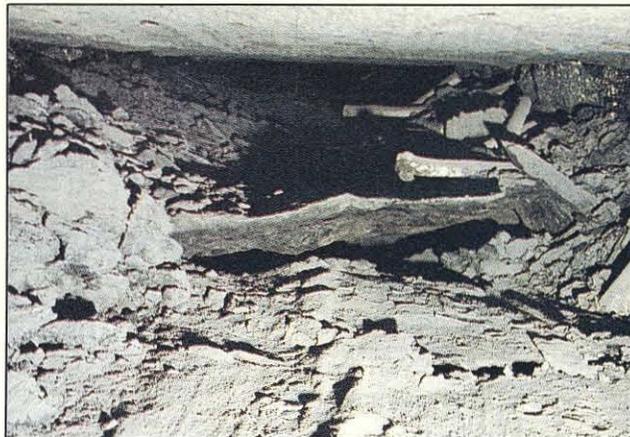
Photo 3—Brittle failure of bottom in smoke-free entry adjacent to mining of panel 8.

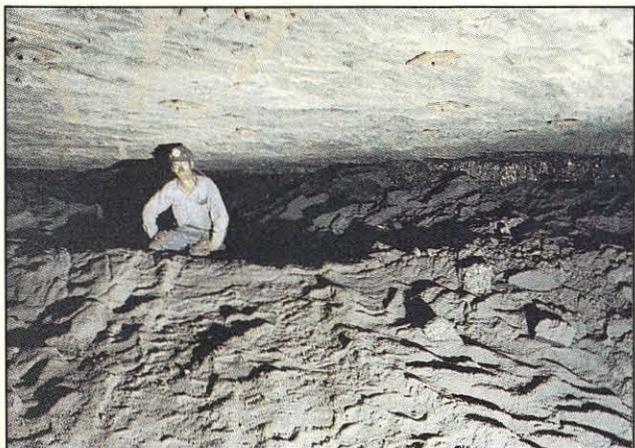
Photo 4—Conditions in abutment pillar crosscut adjacent to mining of panel 8.

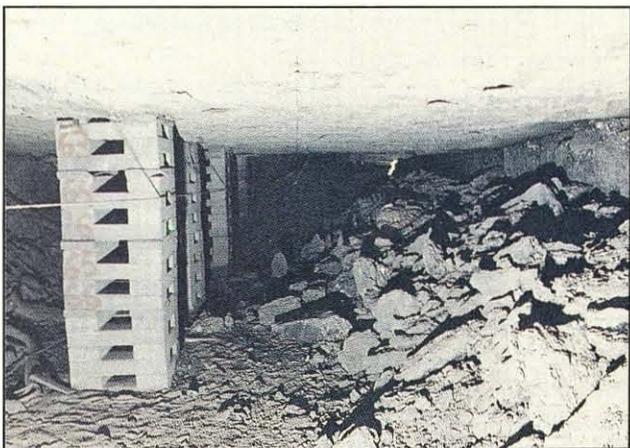
Photo 5—Good strata conditions at the edge of panel 7 and gob 200 ft in advance of the mining of panel 8.
