Blasting-Related Carbon Monoxide Incident in Bristow, Virginia
By Marcia L. Harris, James H. Rowland III, and Richard J. Mainiero

**PROCEEDINGS
OF THE
THIRTIETH ANNUAL CONFERENCE ON
EXPLOSIVES AND BLASTING TECHNIQUE**

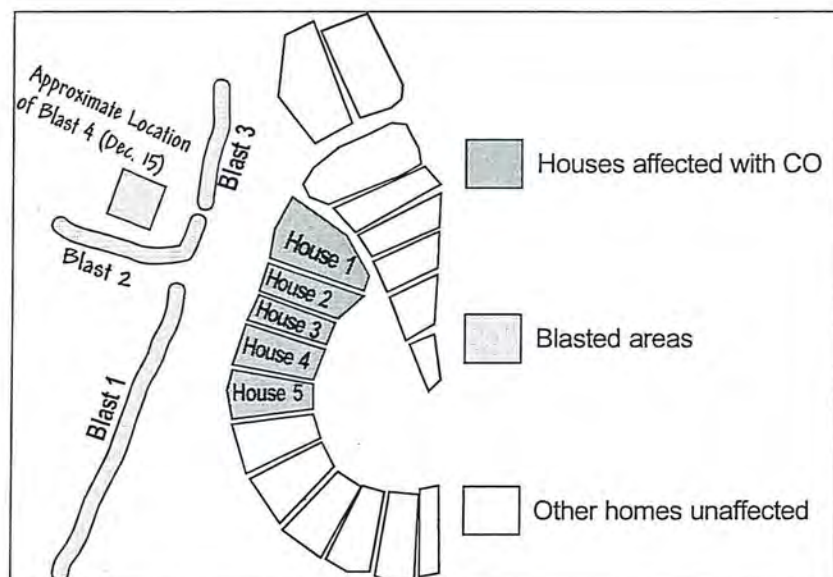
During the evening of November 8, a CO monitor in a home located approximately 90 ft (27.4 m) from the blast (see Figure 1) alarmed. The residents called the gas company and the local fire department of Prince William County. The gas company measured in excess of 800 parts per million (ppm) of CO near the water sump in the basement of the house. The fire department also took CO readings on the first floor of the house and in the basement. The CO readings were 100 ppm on the first floor and more than 200 ppm in the basement. Exposures for long periods of time at these levels can be hazardous to a person's health. The NIOSH recommended exposure limit (REL) is 35 ppm time weighted average (TWA) for an 8-hour period.⁴ In the range of 200 ppm, slight headaches, tiredness, dizziness, and nausea (after 2-3 hours) may be experienced. A person could experience frontal headaches within 1-2 hours when the CO is in the 400 ppm range. In the 800 ppm range, dizziness, nausea and convulsions may occur within 45 minutes of exposure. If exposed to 800 ppm for 2-3 hours, death will occur.⁵

The second trench blast (see Figure 1) occurred on November 14, 2002. The blast consisted of 82.5 lbs (37.4 kg) of boosters and 770 lbs (349.3 kg) of packaged cap sensitive emulsion. To reduce the possibility of CO entering the four affected homes, the fire department covered the water sumps in the homes with plastic and sealed the plastic with duct tape. CO monitors were also purchased and placed in each of the homes. After the shot, the CO monitors did not alarm in any of the houses.

The third trench blast (Figure 1) was shot on December 3, 2002, at 11:30 a.m. The trench was 120 ft (36.6 m) long with boreholes 20 to 27 ft (6.1 to 8.2 m) deep. The shot consisted of 3,504 lbs (1,605.7 kg) of bulk emulsion blasting agent primed with 167.75 lbs (76.1 kg) of booster. Immediately after the shot, four venting pits approximately 6 ft x 6 ft x 5 ft (1.8 m x 1.8 m x 1.5 m) deep were excavated along the length of the shot to release the trapped gases into the atmosphere. Following the shot, the home CO monitor alarmed in house # 2. The fire department was called to take measurements. In the basement near the water sump, the CO reading was 370 ppm, while in the living area the CO reading was 55 ppm. The levels measured in the living areas of the other three homes ranged from 55 ppm to 182 ppm. The next day, CO readings taken in the living area of each home ranged from 27 ppm to 226 ppm. Every home except one was evacuated. Two days later on December 5, 2002, no CO could be detected at house #3. None of the other home owners were available for access to their homes. At this point, the fire department voided the blasting permit and would not reissue the permit until the department was confident that measures had been put in place to protect the homeowners from CO poisoning.

After submitting a revised blasting plan, a blasting permit was reissued. On December 13, 2002, a shot was fired to break up rock for excavation of a house foundation pad (Figure 1). The blast pattern consisted of about 120 holes, each 7 to 8 ft (2.1 to 2.4 m) deep, loaded with 4.6 lb (2.1 kg) of explosive primed with ¾-lb (0.34 kg) boosters. The total 630 lbs (285.7 kg) of bulk emulsion blasting agent was primed with 101.5 lbs (46 kg) of boosters. To prevent migration of CO to the homes that were affected previously, the shot was excavated immediately following the blast as required in the new blasting permit. Additionally, the 15 to 25 ft (4.6 to 7.6 m) deep storm sewer trenches between the shot and the homes were left open to ventilate any CO to the atmosphere before it could migrate away from the blast.

On Saturday, December 14, 2002, at 5:00 a.m. CO was detected in homes 1 and 2. This result was totally unexpected considering that there was an open 15 to 25 ft (4.6 to 7.6 m) deep trench between the pad and the homes and the shot was excavated immediately after the blast. After this incident, the county would not reissue a blasting permit until a guarantee could be made that CO would not enter the homes. No guarantee could be given with the current knowledge and information. The blasting company would no longer conduct blasting at this site. This decision was encouraged by the blaster's insurance company.

Figure 1 - Locations of houses and blasts.

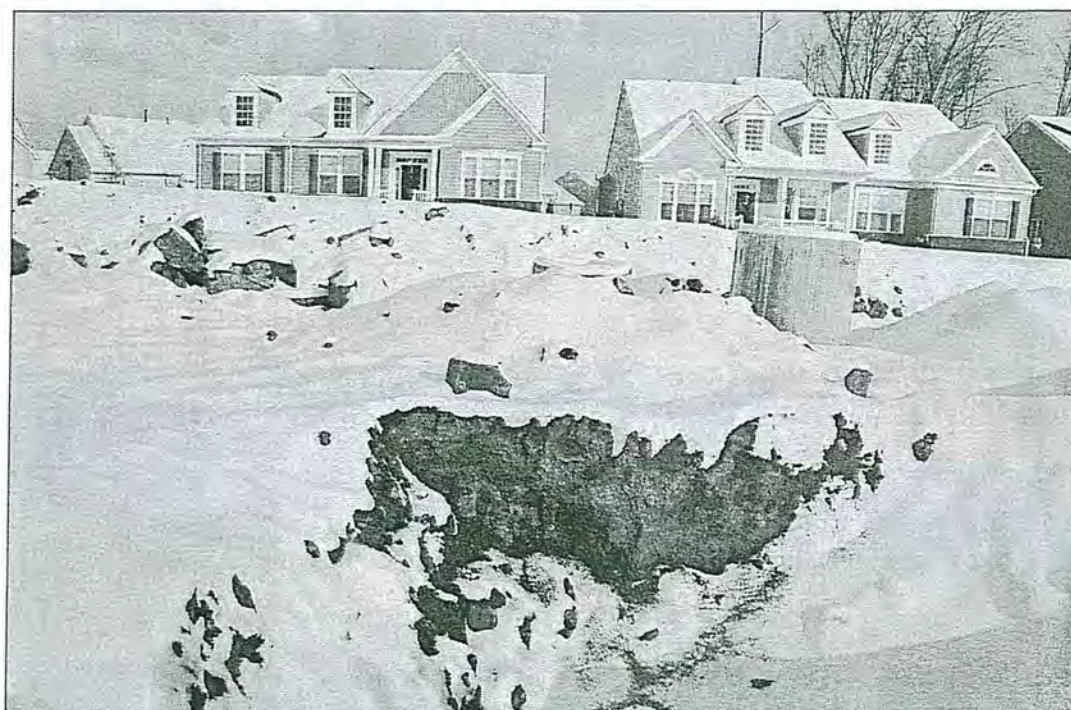
In this study, the first shot was not immediately mucked out, which may have contributed to CO migrating through the ground into the homes. Four excavated pits measuring 6 ft x 6 ft x 5 ft (1.8 m x 1.8 m x 1.5 m) were installed on the second and third shots to vent any generated fumes. No CO accumulated in the nearby homes after the second shot. However, the venting pits still were not sufficient to ventilate the detonation fumes of the third shot. CO appeared in the homes the same day as the shot.

Figure 2 - The first of four pits dug at the location of the trench blast in an effort to vent CO. Homes 1 and 2 can be seen in the background.

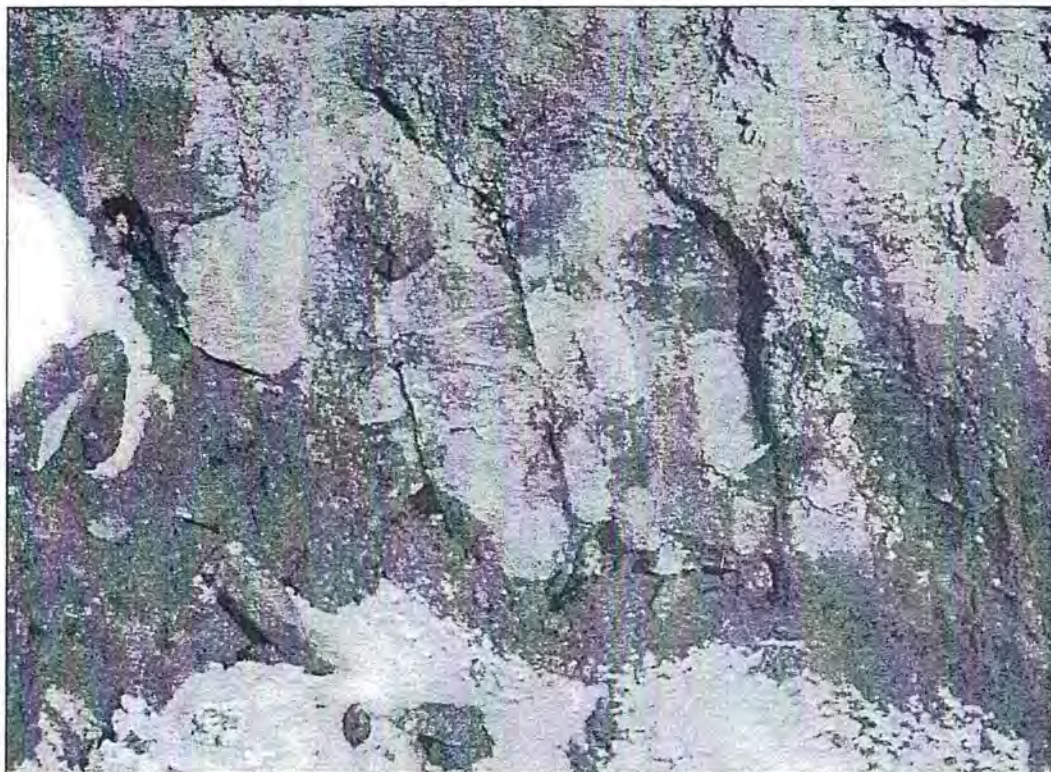
Before the meeting on December 6, the blaster took NIOSH personnel to the construction site where the incidents occurred to assess the geology and their blasting operation. In the venting pits, fractures with an orientation of approximately 20 degrees east of north were observed in the bedrock; this orientation lines up perfectly to intercept the homes affected by the CO migration after the blast shots 1 and 3 (Figures 2 and 3). Another observation was that the fractures appeared to be naturally occurring and not caused by blasting. It was not determined how deep the fracture system may extend. It may be entirely possible the fracture system may extend below the blast site and trenches. Also, the elevation of the bedrock in the pits excavated after blast shot #3 visually appeared to be at the same elevation as the basements of the houses affected by the CO migration. It appears that a fracture system is in place that is positioned just right to result in a strong conduit from the blasted material to the homes.

Figure 3 - A close-up of the bedrock seen in Fig. 3. Note the fractures are oriented towards nearby homes.
