Fatal accidents due to flyrock and lack of blast area security and working practices in mining

MINES METALS & FUELS

MINING INDUSTRY ANNUAL REVIEW FOR 2003

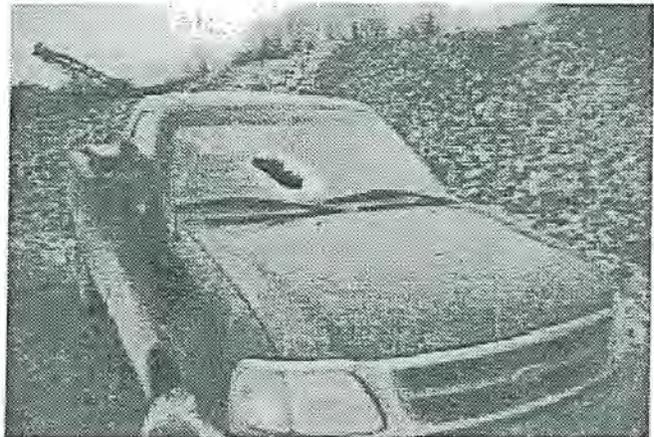
Fig.1 Fatal injury due to flyrock at a limestone mine in Pennsylvania (case study no. 6)

On December 21, 1999, a 32-year-old equipment operator was in a pickup truck while guarding an access road leading to the blast site [MSHA, 1999b]. The pickup truck was about 800 ft from the blast site. Flyrock entered the cab through the windshield and fatally struck the victim (Fig.1). The victim had seven years mining experience as an equipment operator at this mine.

The mine normally operated two 8-10 hour shifts a day, five days a week, and had 22 employees. The mining company used a drilling contractor to drill the holes, and a blasting contractor for loading and blasting. The highwall face was about 50 ft high and the depth of holes ranged between 49 and 54 ft. The blast round consisted of 22 holes drilled on a 16- by 16-ft pattern. Approximately 9,595 lb of explosives were used in this round and the length of stemming varied from 9 to 36 ft. The weight of explosive used in each blasthole was not recorded. Some of the holes were slanted up to 25° toward the highwall to compensate for irregularities in the highwall face. The investigation report indicated that at least one of the blastholes blew-out causing a massive amount of flyrock. This incident emphasizes several factors, such as excessive powder loading, voids, discontinuities, break in the rock strata, and blasthole inaccuracy.

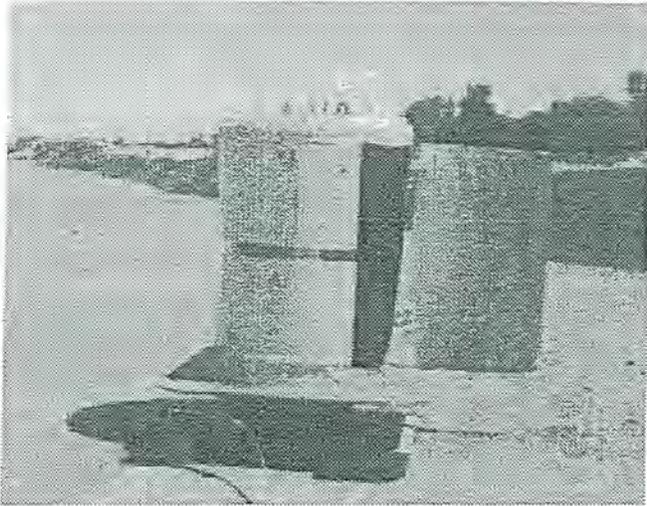
At a surface mine a blasting shelter (Fig.2) was readily available for use. No one was allowed in the blast area after blastholes were loaded and lead-in line connected. The

Fig.2 Blasting shelter

blasting shelter was available for the blaster to stay inside the blast area during any scheduled blasting. In general, access to the blast area was controlled by signs, barricades, and ground supervision. The blaster removed all unused explosives, communicated with the guards, and visually inspected the bench top prior to firing the shot. Radio communication was used by personnel involved in these activities.
