# OCCURRENCE AND REMEDIATION OF COAL MINE BUMPS: A HISTORICAL REVIEW

By Anthony T. Iannacchione<sup>1</sup> and Joseph C. Zelanko<sup>2</sup>

Pittsburgh Research Center, U.S. Bureau of Mines, Pittsburgh, PA.

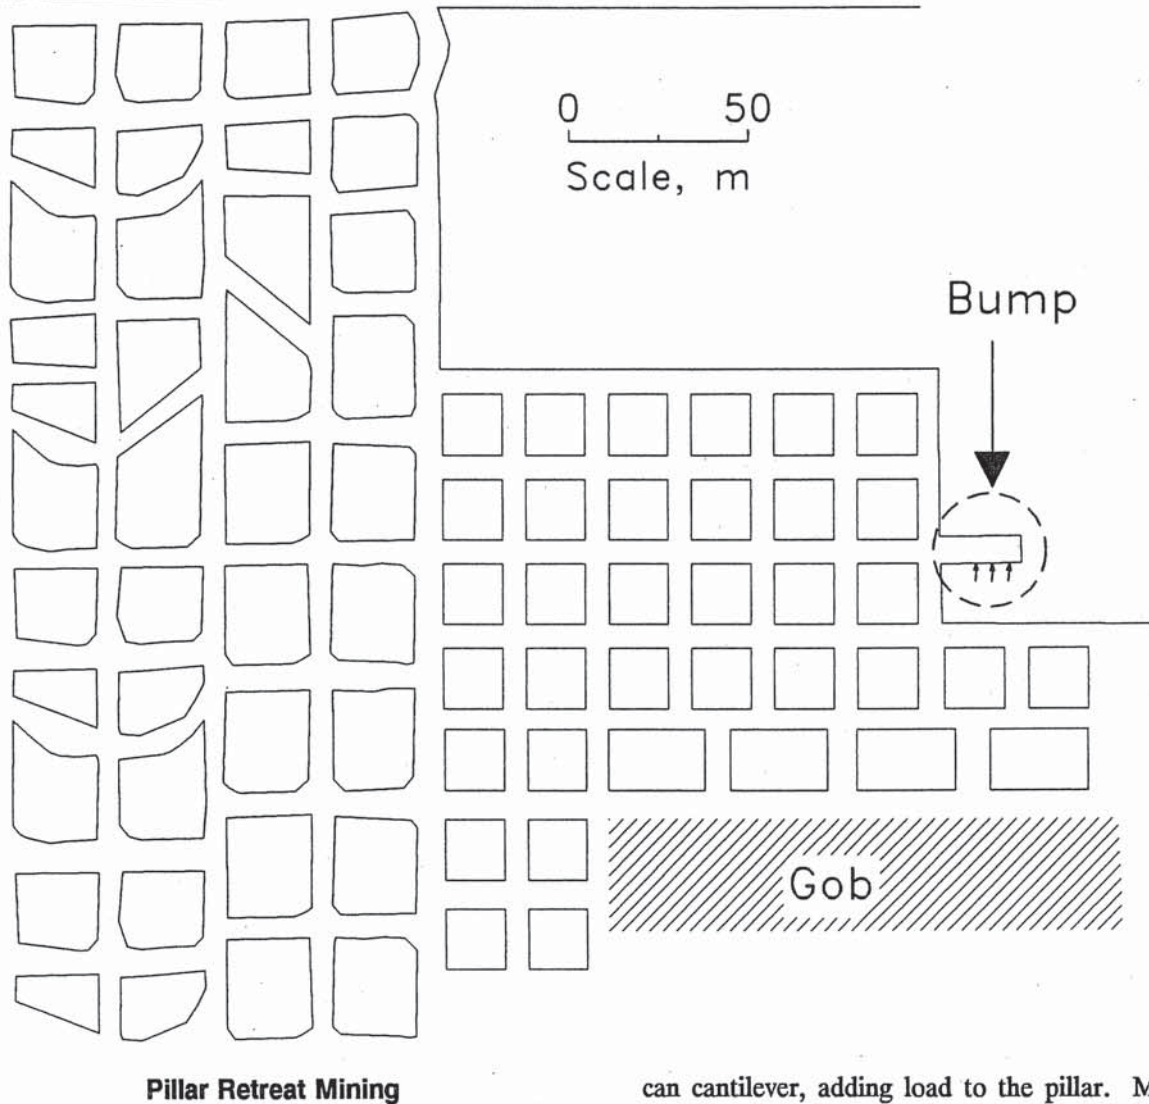
**Figure 6**  
**Violent Bump During Development of Pillar Section Within Beatrice Mine That Injured Three Miners.**

At the Beatrice Mine, development work was underway in the No. 9 unit section off the Skip South Mains, approximately 70 m from an adjacent gob area (figure 6), when there was a violent bump in the face area on July 24, 1976, that injured three miners. Abutment loading from the adjacent gob area may have contributed to the bump. Therefore, this event could be explained as resulting from the barrier-splitting operations. However, because the gob

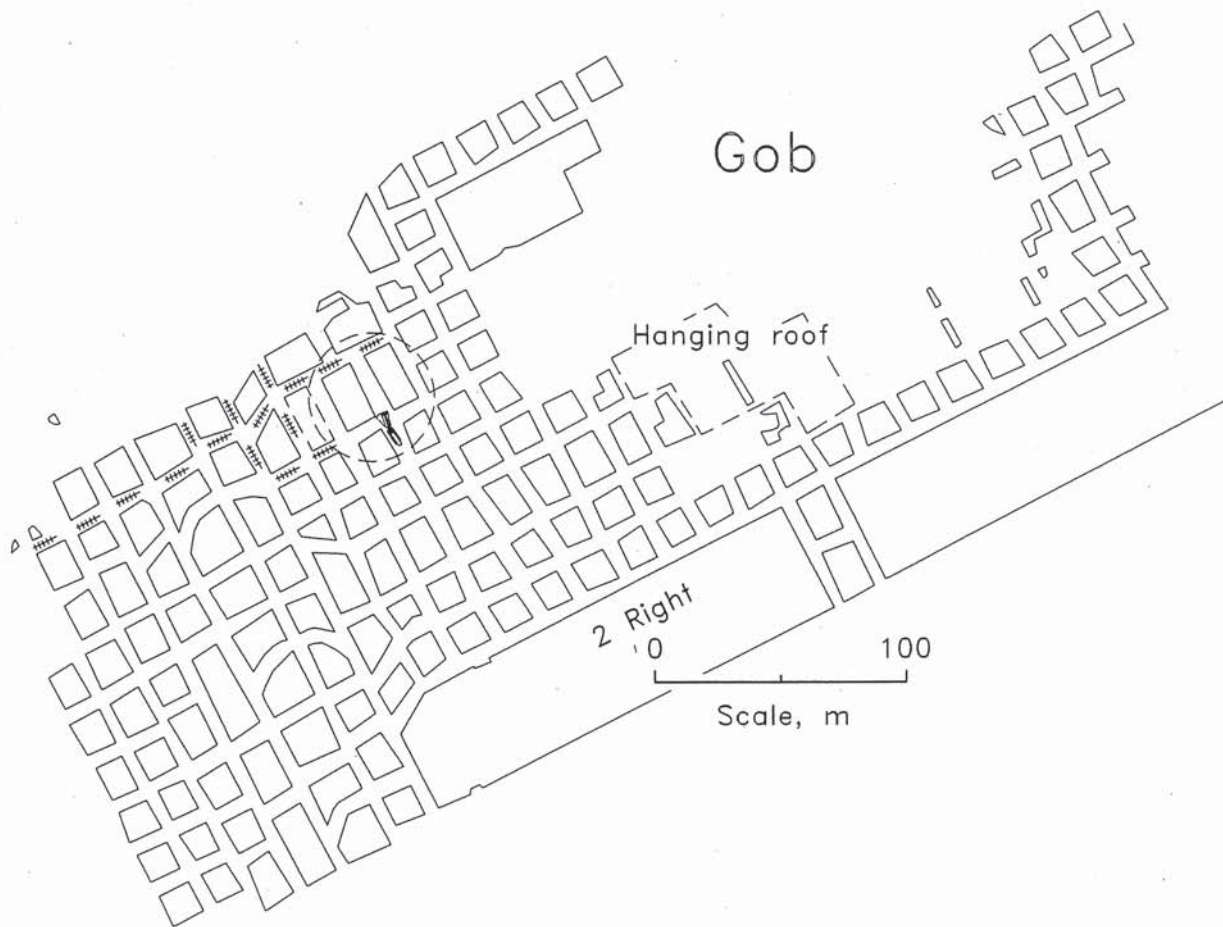
**Figure 10**

**Effects of Pillar Remnants and Hanging Roof Strata on Pillar Retreat Bump at Moss No. 2 Mine, August 4, 1960.**

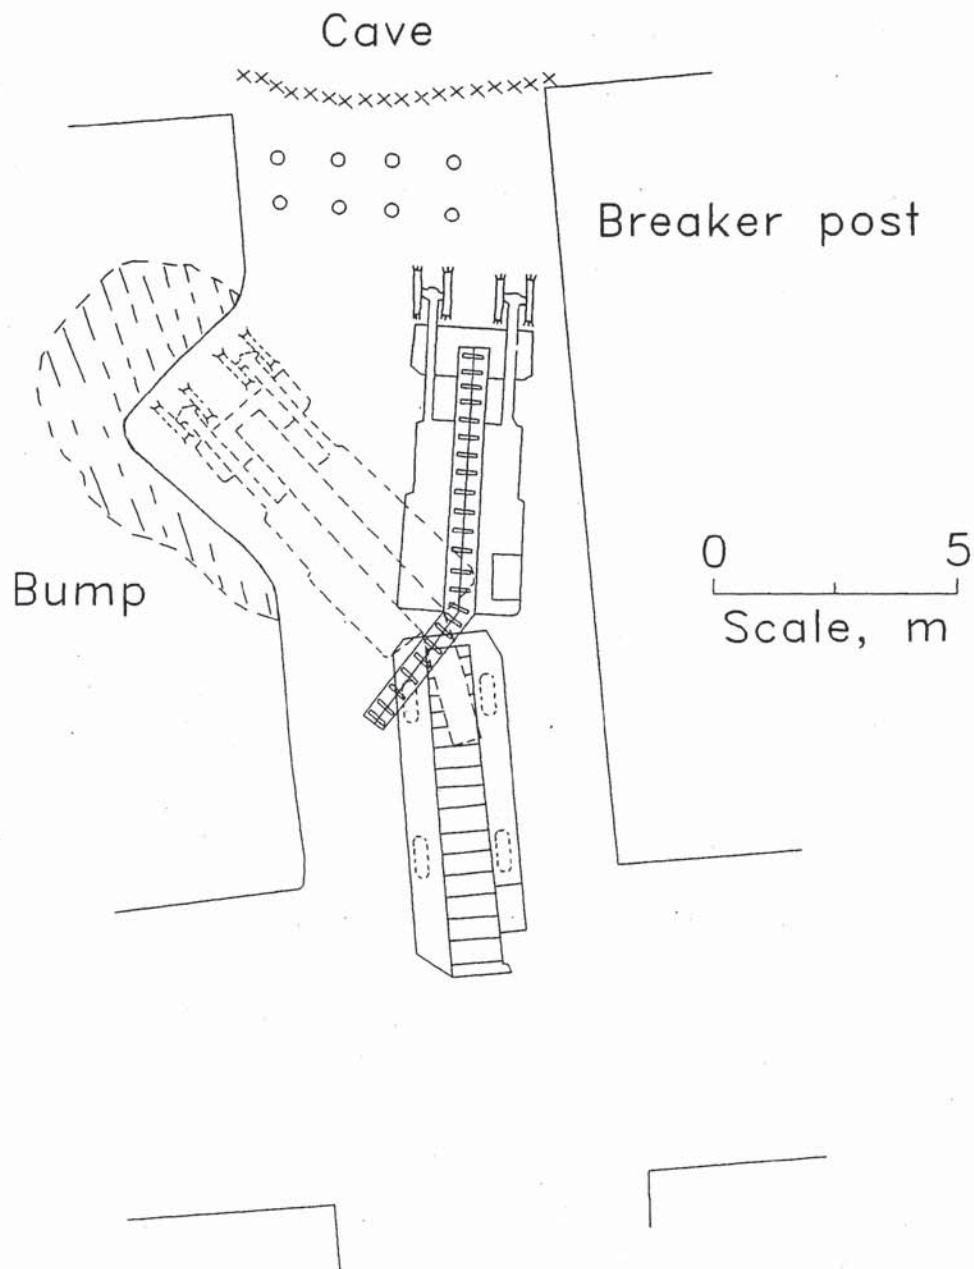
**Figure 13**  
**Detailed View of Bump at Moss No. 2 Mine, July 30, 1970.**

Note position of caved roof line and postbump continuous mining machine (solid lines).

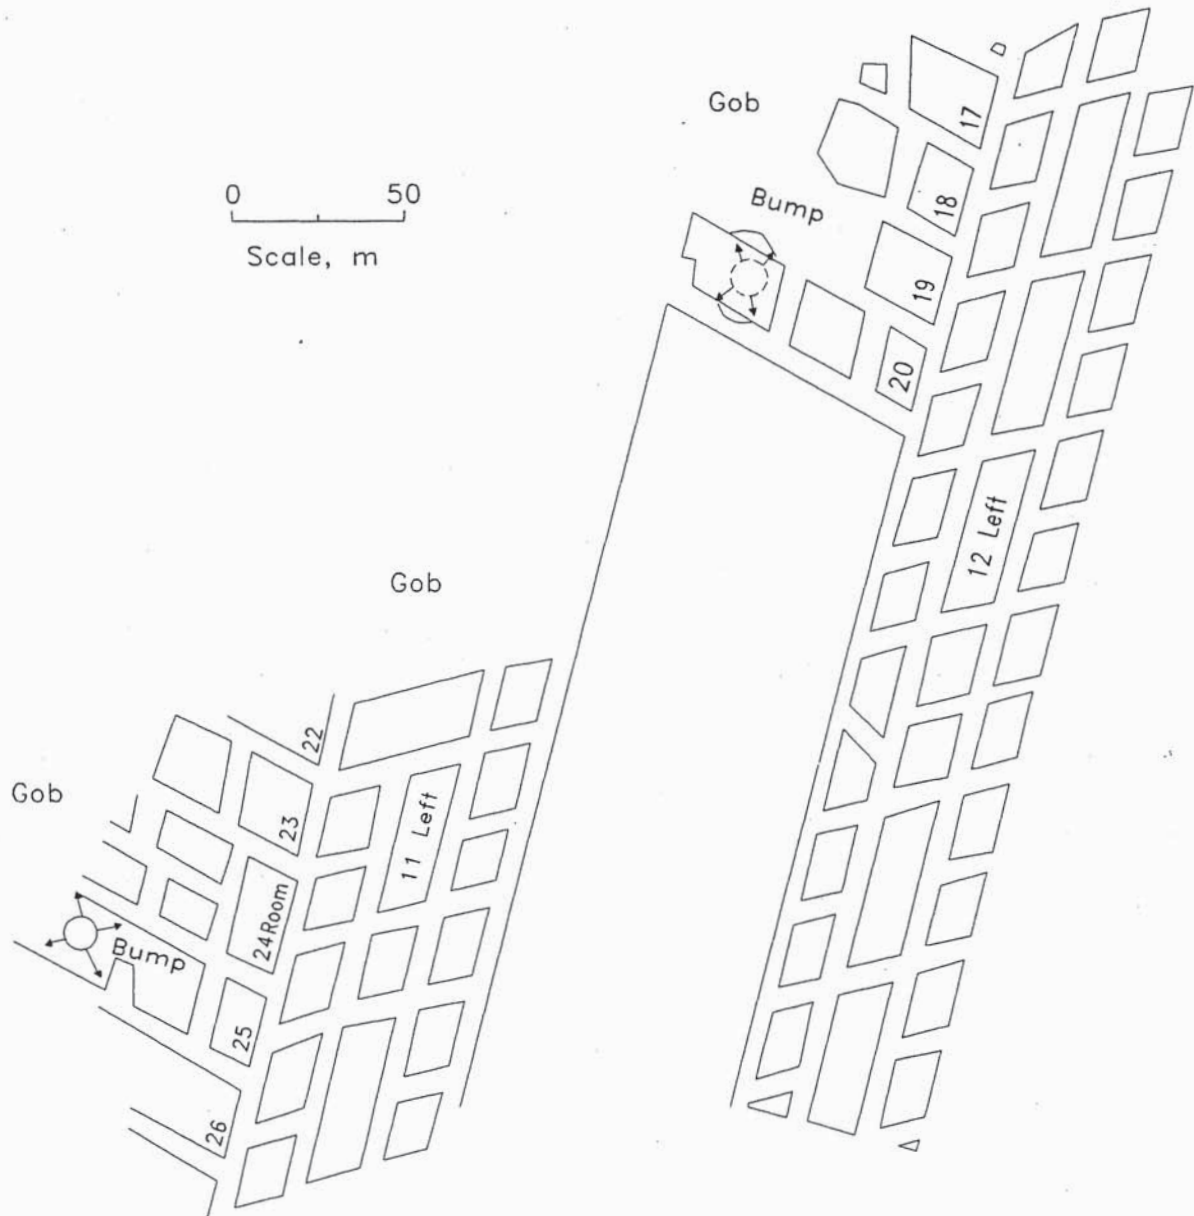
**Figure 15**  
**Barrier-Splitting Bumps in Adjacent Sections With Similar Layout Positions, Gary No. 2**  
**Mine, January 1951.**

Figure 15 illustrates the Gary No. 2 Mine plan in the vicinity of a bump in the 12-Left section in January 1951. In this mining plan, four-entry development sections were driven at intervals off a set of main entries. Sections were separated from one another by a barrier block that was developed just ahead of the retreat line during second mining. However, as indicated in figure 15, bumps were

encountered in some locations. USBM researchers, including Holland, found several factors they believed influenced bumps in this system and elsewhere in the Gary No. 2 and No. 6 Mines. For example, pillars of irregular sizes were located adjacent to the retreat line, secondary development was done within the abutment zone, and rooms were not driven in proper sequence. As a result of these and several other related issues, U.S. Steel, the owner, developed another mine plan for the Gary No. 2 Mine.

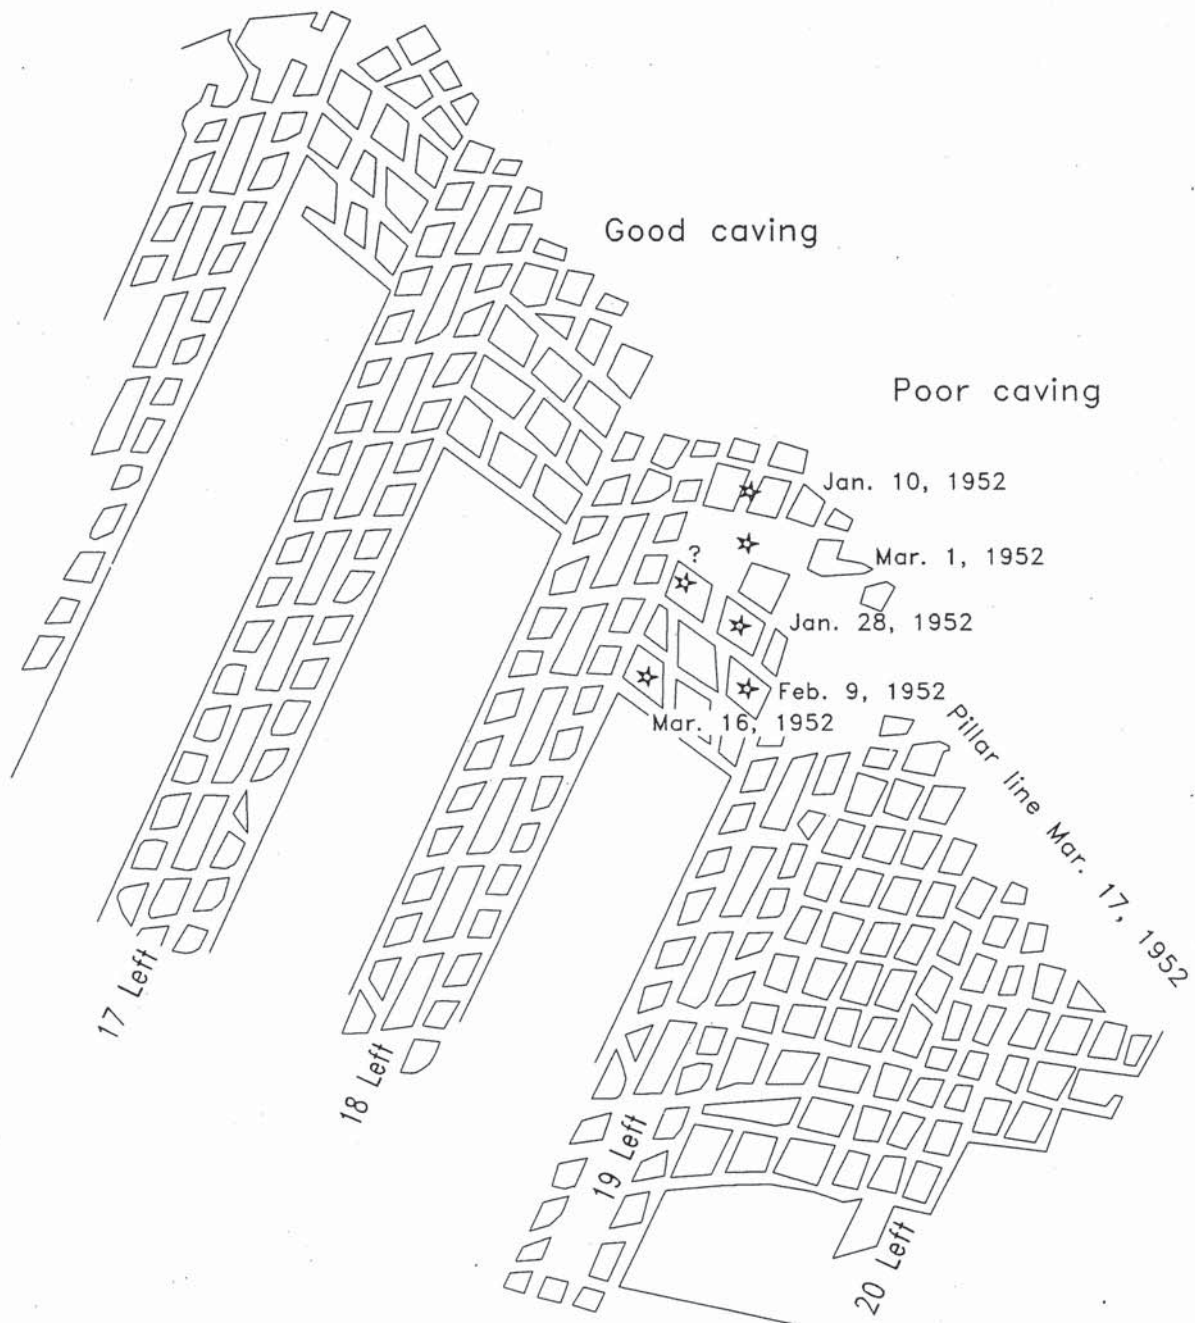
**Figure 16**  
**Multiple Bump Events During Splitting of 18 Left Barrier at Gary No. 2 Mine, 1952.**

The next-generation mine plan differed from earlier ones in several respects. Figure 16 indicates, for example, that secondary development took place farther outby the retreat line and adjacent sections were retreated simultaneously; when all sections were activated, the length of the pillar line was approximately 670 m. Nevertheless, bumps were encountered in early 1952. Company personnel indicated that poor caving in the gob inby 18 Left contributed to squeeze and bump conditions. Secondary development well in advance of the retreat line appeared to allow the pillars to crush and the massive sandstone main roof to settle into the gob rather than breaking

Star denotes location of mountain bump.

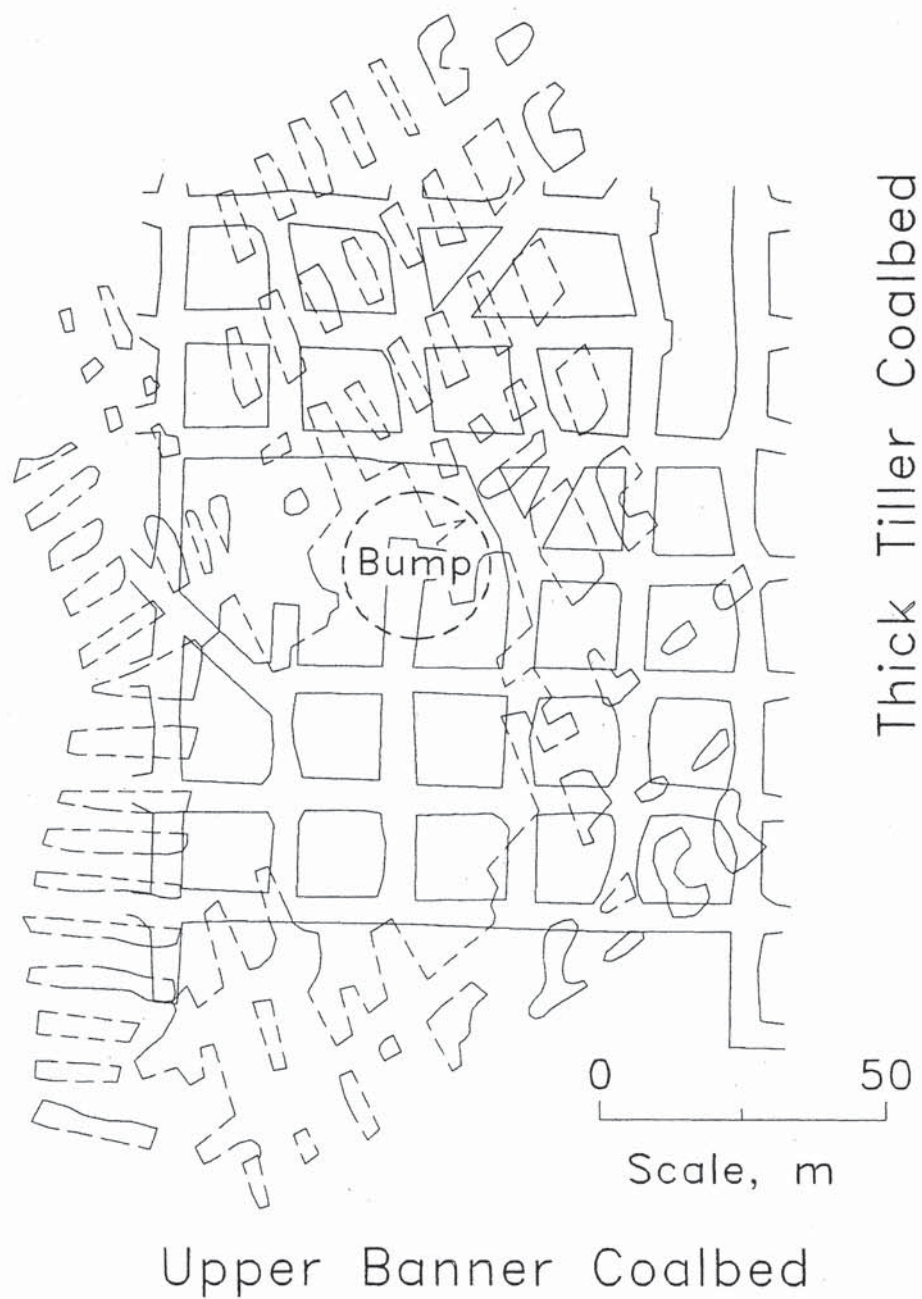
**Figure 19**

Effects of Multiple-Seam Mining on Barrier-Splitting Bumps at Moss No. 3 Mine, November 4, 1977.

pillar measured about 116 m long by 43 m wide. Adjacent pillars were generally square and appeared to be spaced on 24-m centers. Reports of the Moss No. 3 coal bump did not indicate overburden or interburden thickness between the Thick Tiller and superjacent Upper Banner Coalbeds at the bump site. However, it was concluded that the combined effects of abutment loads generated as a result of barrier-splitting and retreating, along with concentrated stresses caused by overmining, created an excessive stress condition. Isolated pillars that were left in the Upper Banner Coalbed during second mining apparently intensified the stress interaction (figure 19).

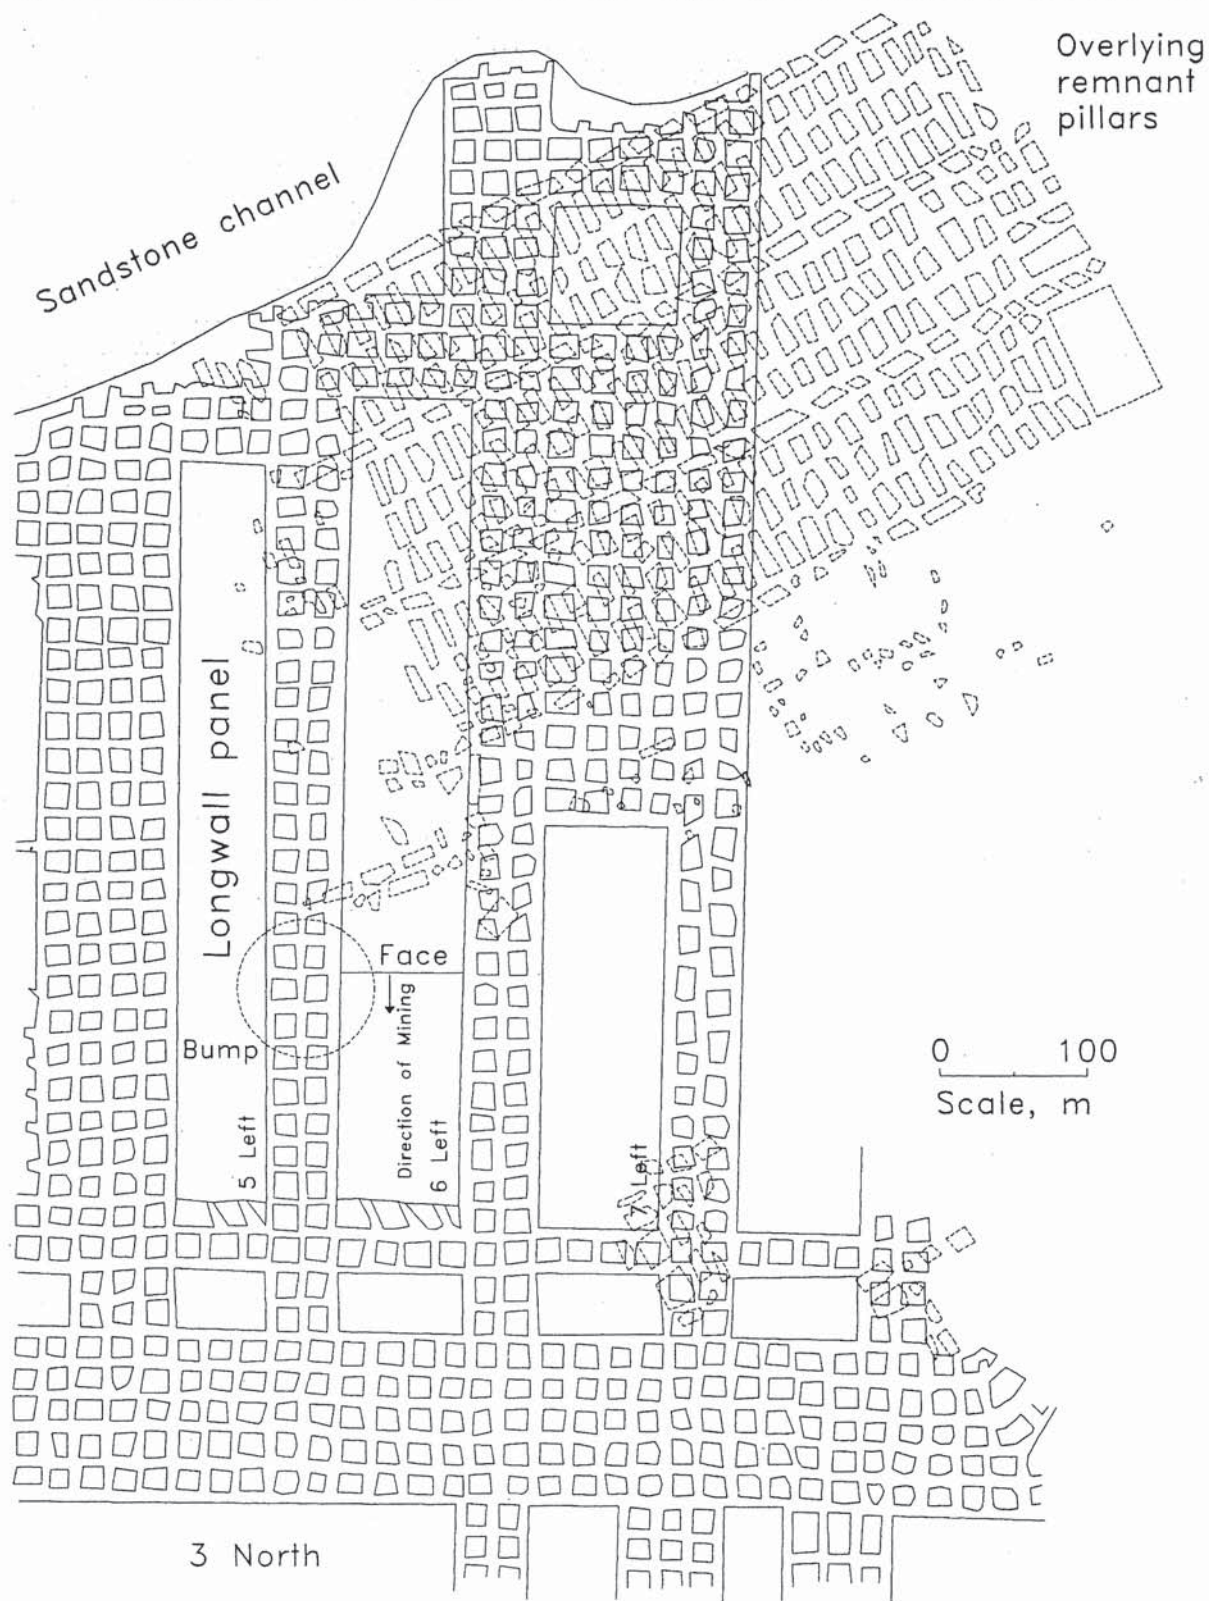
**Figure 20**

Several contributing conditions were readily apparent. Multiple-seam mining occurred in the overlying Lower and Upper Banner Coalbeds. At the time of the bump, the longwall itself was progressing from under a group of unmined pillars (figure 20). Additionally, a large sandstone channel was located about 450 m in by the face and evidently contributed to the poor caving characteristics in the main roof member. Finally, the chain pillars left to protect the longwall panel were of inadequate size and too weak to withstand abutment loading from the adjacent gob areas.

Effects of Overlying Remnant Pillars and Underdesigned Entry Pillars on Longwall Pillar Bump at Moss No. 2 Mine, January 8, 1970.

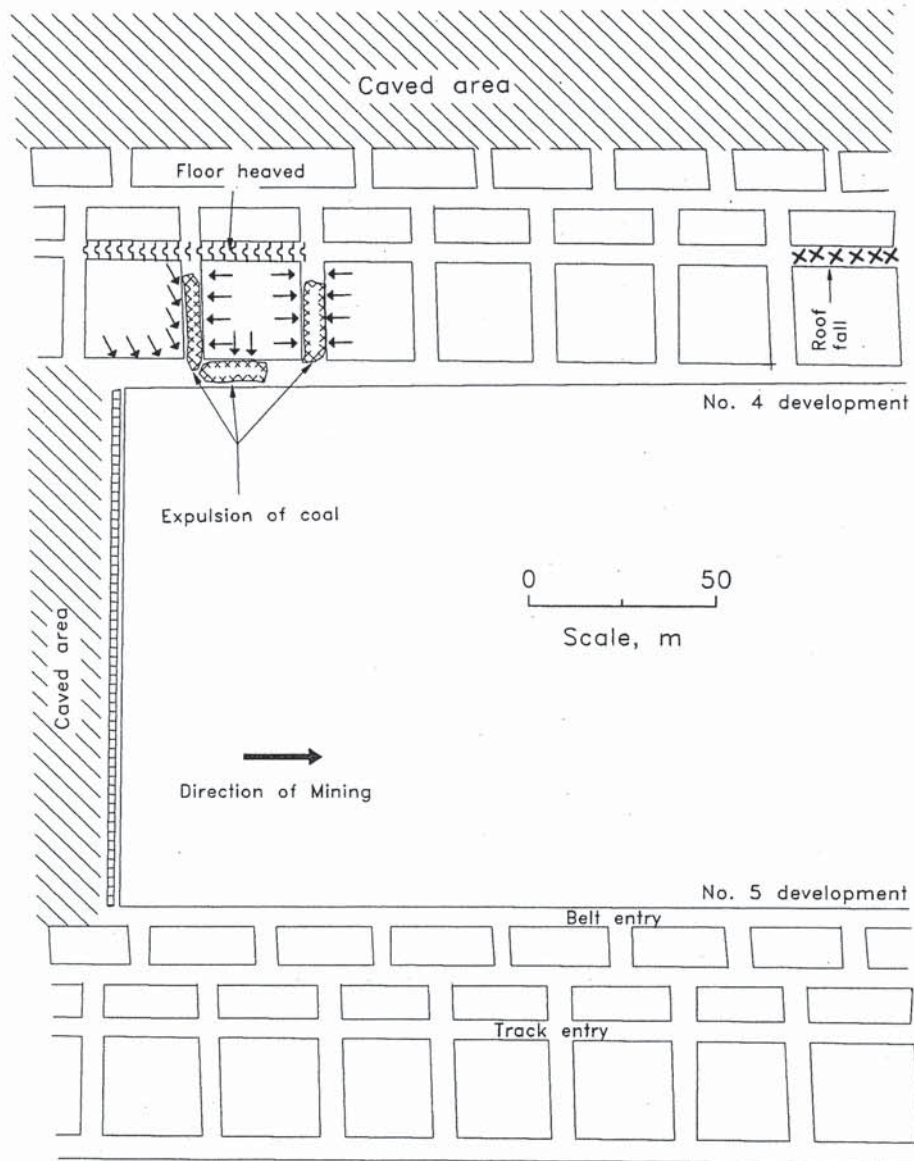
**Figure 21****Longwall Tailgate Entry Pillar Bump at Beatrice Mine, January 26, 1973.**

The first coal bumps associated with longwall mining at the Beatrice Mine took place in March 1972 on the tailgate of No. 3 development. At approximately the same panel location on the next panel, another bump occurred on January 26, 1973 (figure 21). Twenty minutes before, the section had been quiet. The bump exploded three chain pillars and completely filled the adjacent entries with loose coal. Several more bumps occurred during the mining of this and the adjacent panel. These events did not appear to be particularly difficult to address and did not result in any injuries.

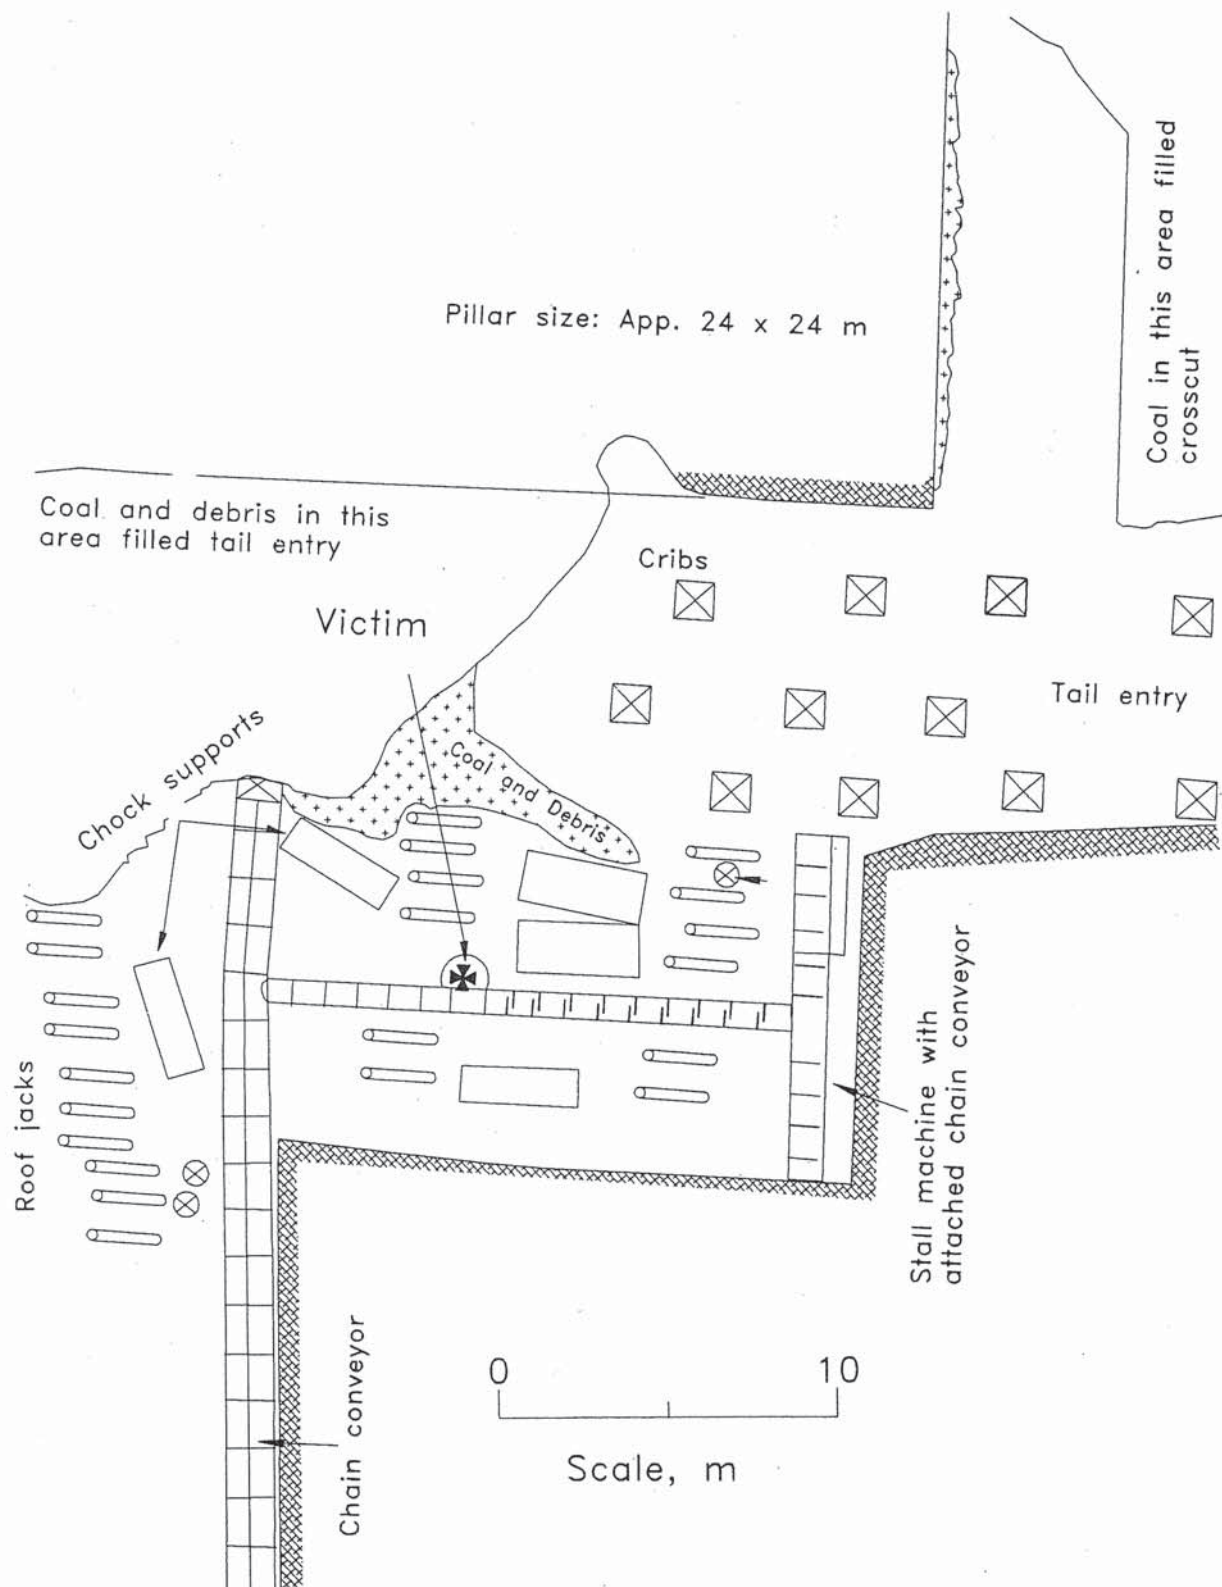
**Figure 23**  
**Detailed View of Bump at Beatrice Mine, May 15, 1974.**

This section of longwall panel was referred to as the "stall area." ✕ indicates miners.

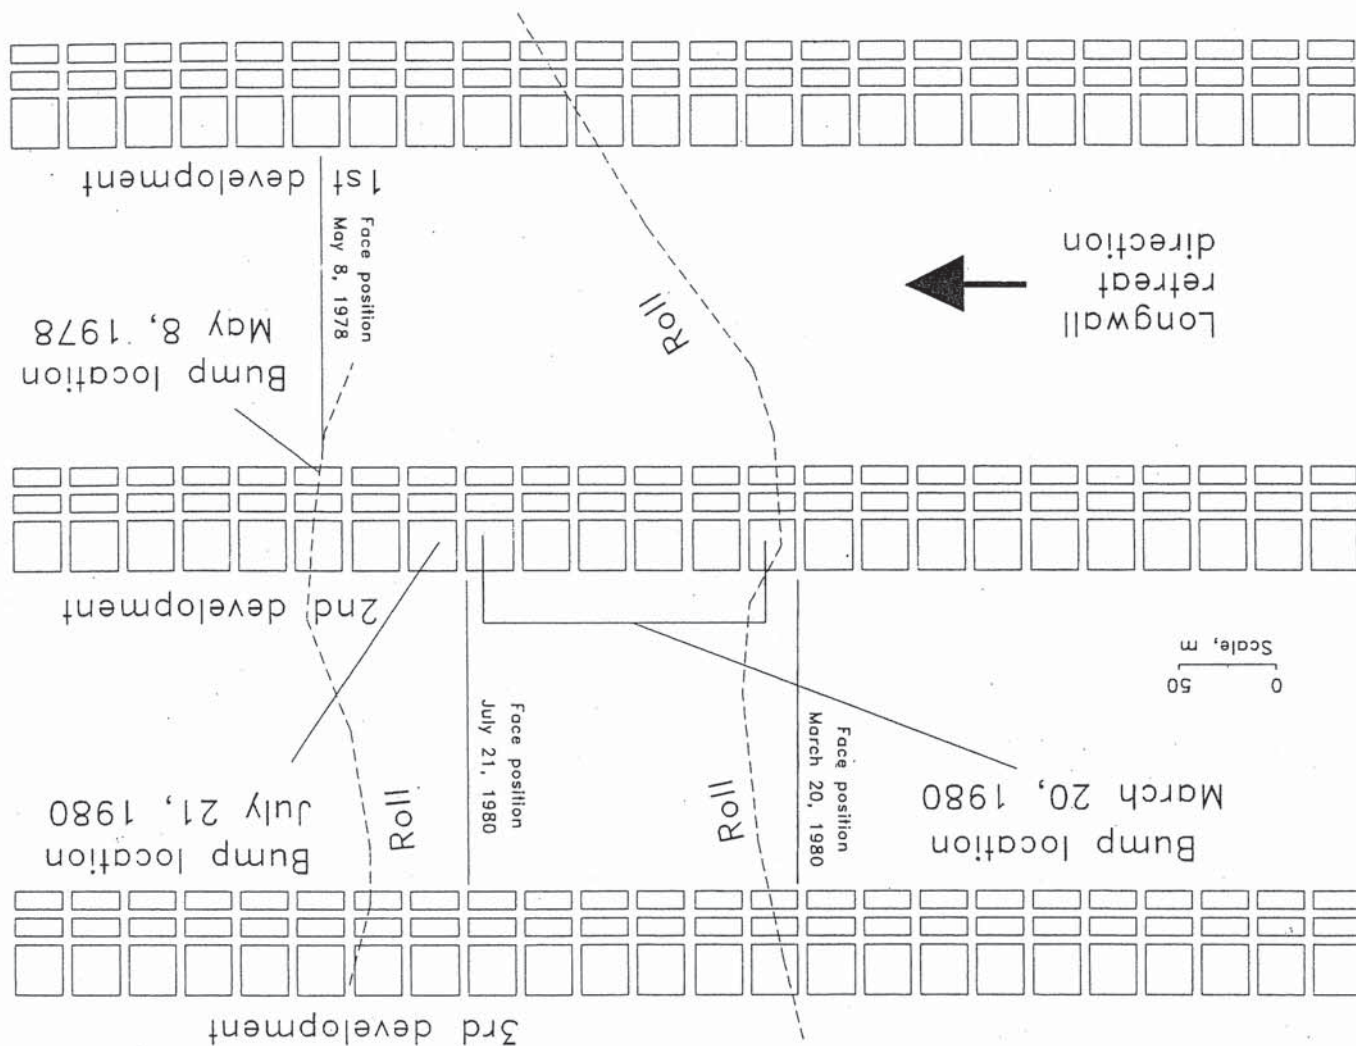
Figure 24

Effects of Large-Scale Structural Roll on Three Headgate and Tailgate Entry Bumps at Beatrice Mine.

longwall panel approached this same roll (figure 24). Then, on March 20, 1980, six narrow pillars bumped, two of them violently (11). No miners were injured in this tail-gate bump. Because the floor in the roll area resisted heaving for a distance of 200 m, the operator decided to volley fire or shot fire ribs of three abutment pillars outby

the longwall face. The final bump in this area was on July 21, 1980, approximately 50 m from the location of the bump occurring on May 8, 1978. The July 21 bump took place over a weekend, so no miners were on the section; the exact time of occurrence could not be estimated.
