# INTEGRATED SHIELD AND PILLAR MONITORING TECHNIQUES FOR DETECTING CATASTROPHIC FAILURES

By Robert M. Cox,<sup>1</sup> David P. Conover,<sup>1</sup> and John P. McDonnell<sup>1</sup>

**Special Publication 01-95**

# **Proceedings: Mechanics and Mitigation of Violent Failure in Coal and Hard-Rock Mines**

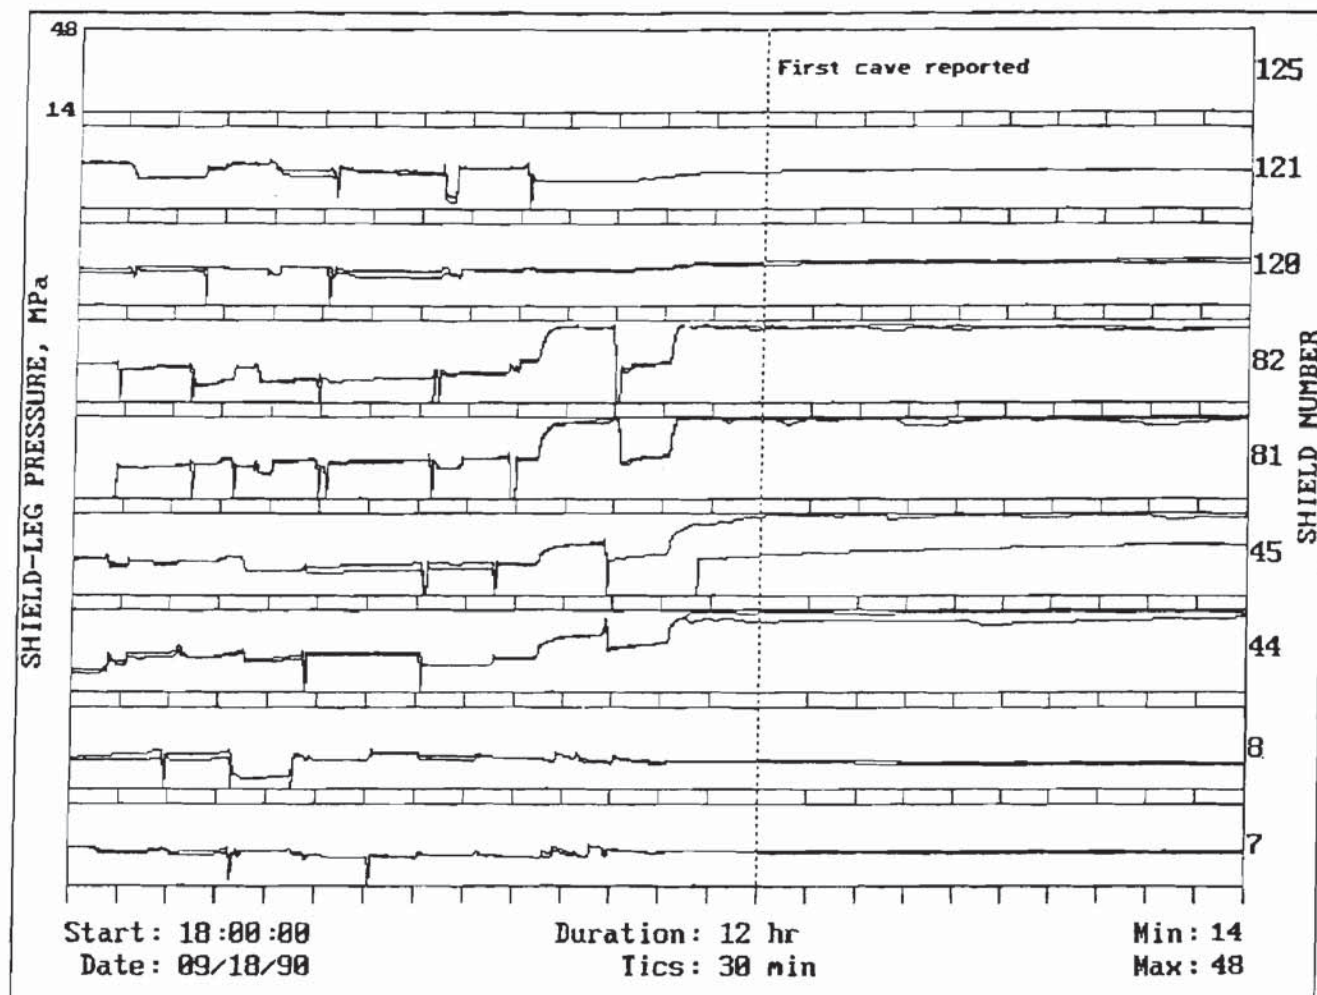
Figure 14

Anomalous shield-loading patterns have been observed in association with catastrophic ground failure events at the test mine, such as major roof caves and/or abrupt tailgate roadway closures. Anomalous shield loading was first detected while analyzing the shield data collected during the initial roof caving of panel 2. As shown in figure 14, pressure on the four midpanel shields increased rapidly to yield pressure during two consecutive cycles several hours before the initial roof cave. Also, note that shield pressures did not relieve after the cave but remained at the yield pressure until the shields were advanced at the start of the next shift (10).

Computer Display of Shield-Loading Behavior Associated With Panel 2 First Cave.

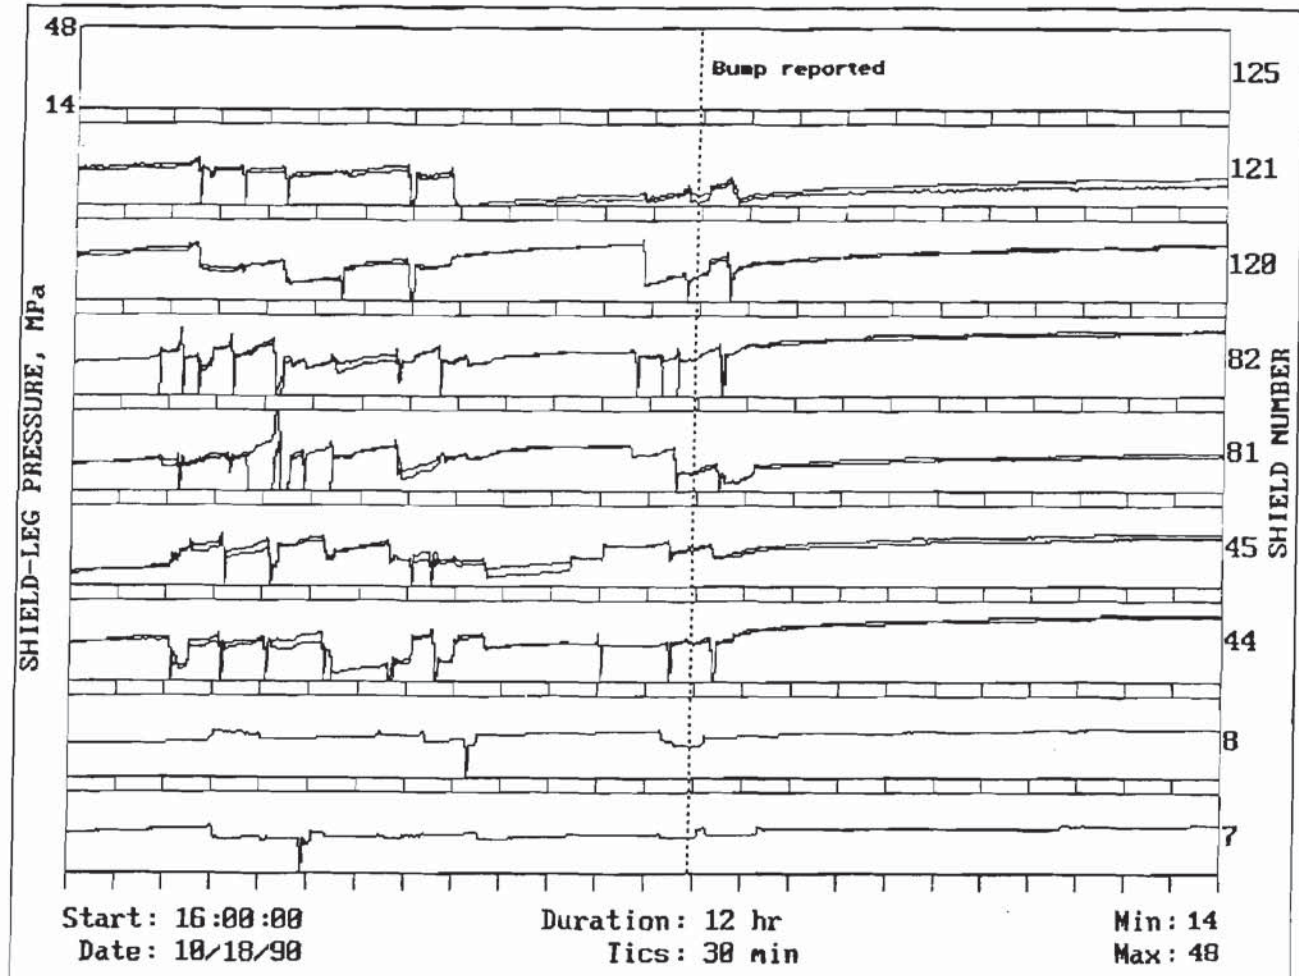
Figure 15

During the mining of panel 2, a significant tailgate floor bump occurred near gate road instrument site 6L-74 (figure 6) at about 10:30 p.m. on October 18, 1990. A computer display of shield loading behavior during this event is shown in figure 15 and corresponds to the characteristic bump signature previously described. Figure 16 is a computer display of ground pressure changes monitored in the adjacent instrumented gate road pillar site. An analysis of these data indicates a series of increasingly severe ground failures over a period of about 6 h, which culminated in a severe floor bump around 10:30 p.m. The tailgate roadway was closed for the remainder of the shift, and mining did not resume until the tailgate roadway supports were replaced two shifts later.

Computer Display of Shield-Loading Behavior Associated With Catastrophic Floor Bump Near Panel 2 Tailgate Roadway Instrument Site 6L-74.

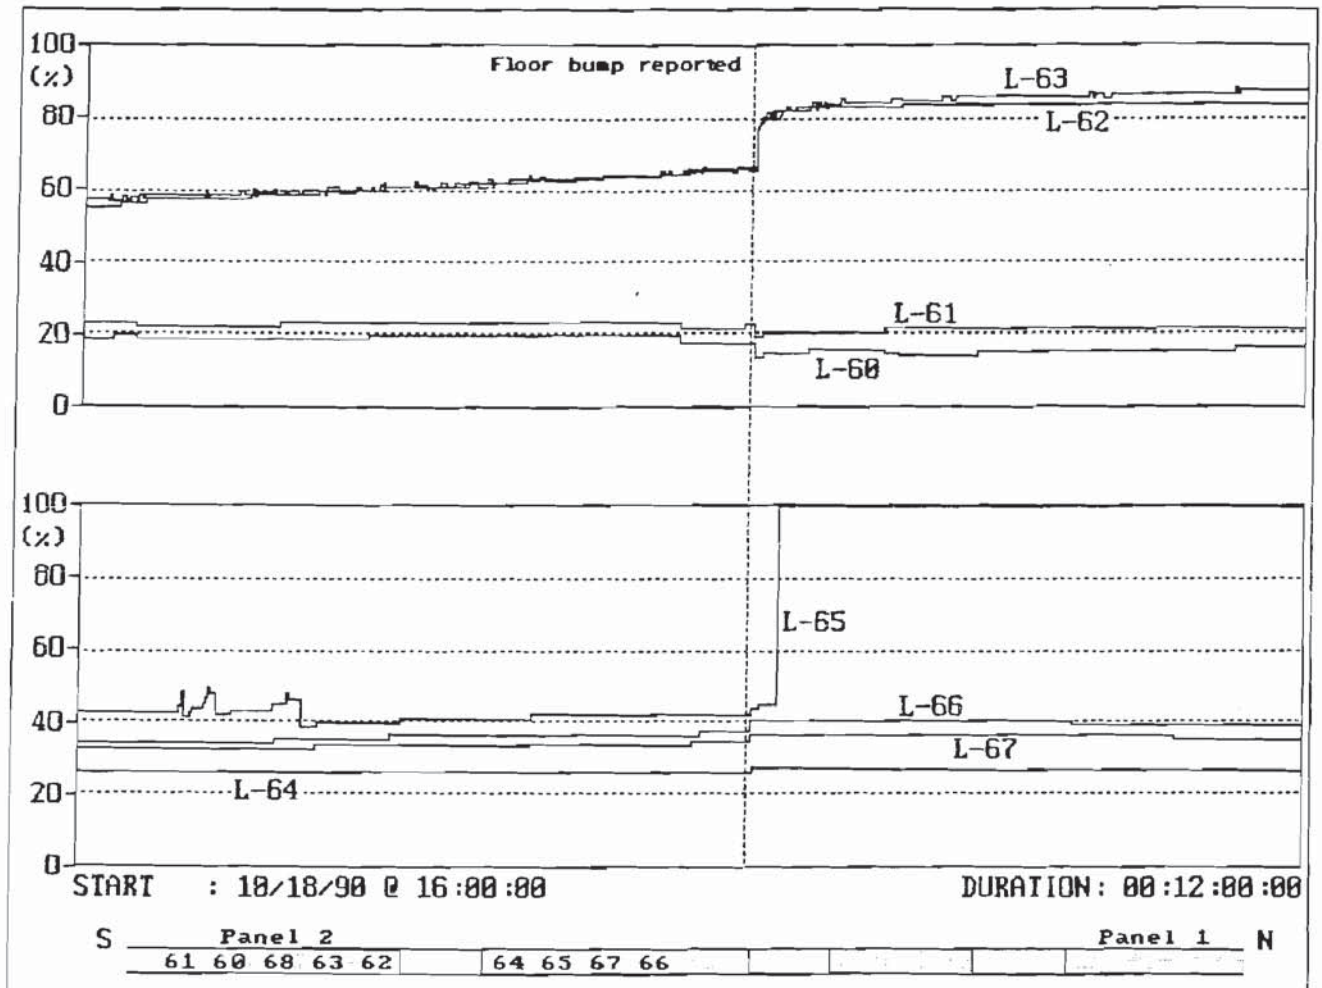
Figure 16

Computer Display of Ground Pressure Changes Associated With Floor Bump Monitored at Instrument Site 6L-74.

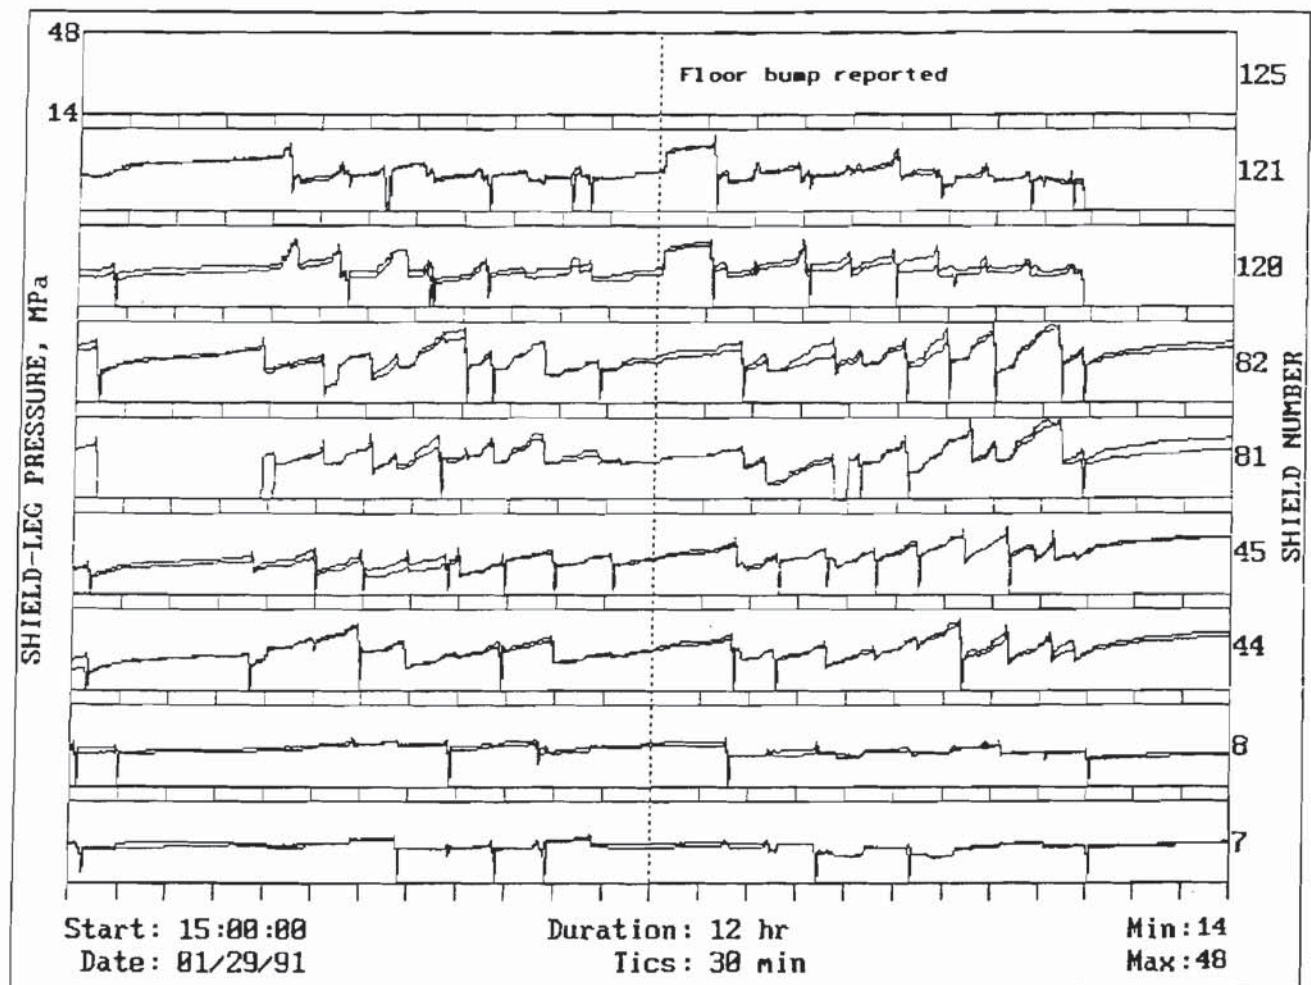
display of shield-loading behavior monitored during the first of these floor bumps reported by the miners to have occurred about 1 p.m. on January 29, 1991, at crosscut 6L-41. The characteristic bump signature is very evident in the plot of the shield pressure data shown in figure 17. Figure 18 is a computer display of the gate road ground pressure changes monitored during the same floor bump. These data show significant ground pressure increases in the pillar site located approximately 45 m (150 ft) outby the longwall face at the time of the floor bump. Figure 19 is a computer display of gate road ground pressure changes associated with the second floor bump that occurred on January 31, 1991, at crosscut 6L-40 adjacent to the instrument site. These data indicate abrupt failure of both the pillar and panel coal ribs adjacent to the tailgate roadway to a depth of at least 6 m (20 ft) inside the original entry rib line. Shield pressure data were not being collected at this time because of problems with the trunk line serving the longwall face instruments. The third significant floor bump occurred as the face passed through crosscut 39 on February 6, 1991, at about 4:45 p.m. just prior to the start of the evening production shift. The characteristic bump signature is very evident in the computer display of the shield pressure data shown in figure 20.

Figure 17  
Computer Display of Characteristic Signature Plot of Shield-Loading Behavior During Floor Bump  
Monitored at Crosscut 6L-41.

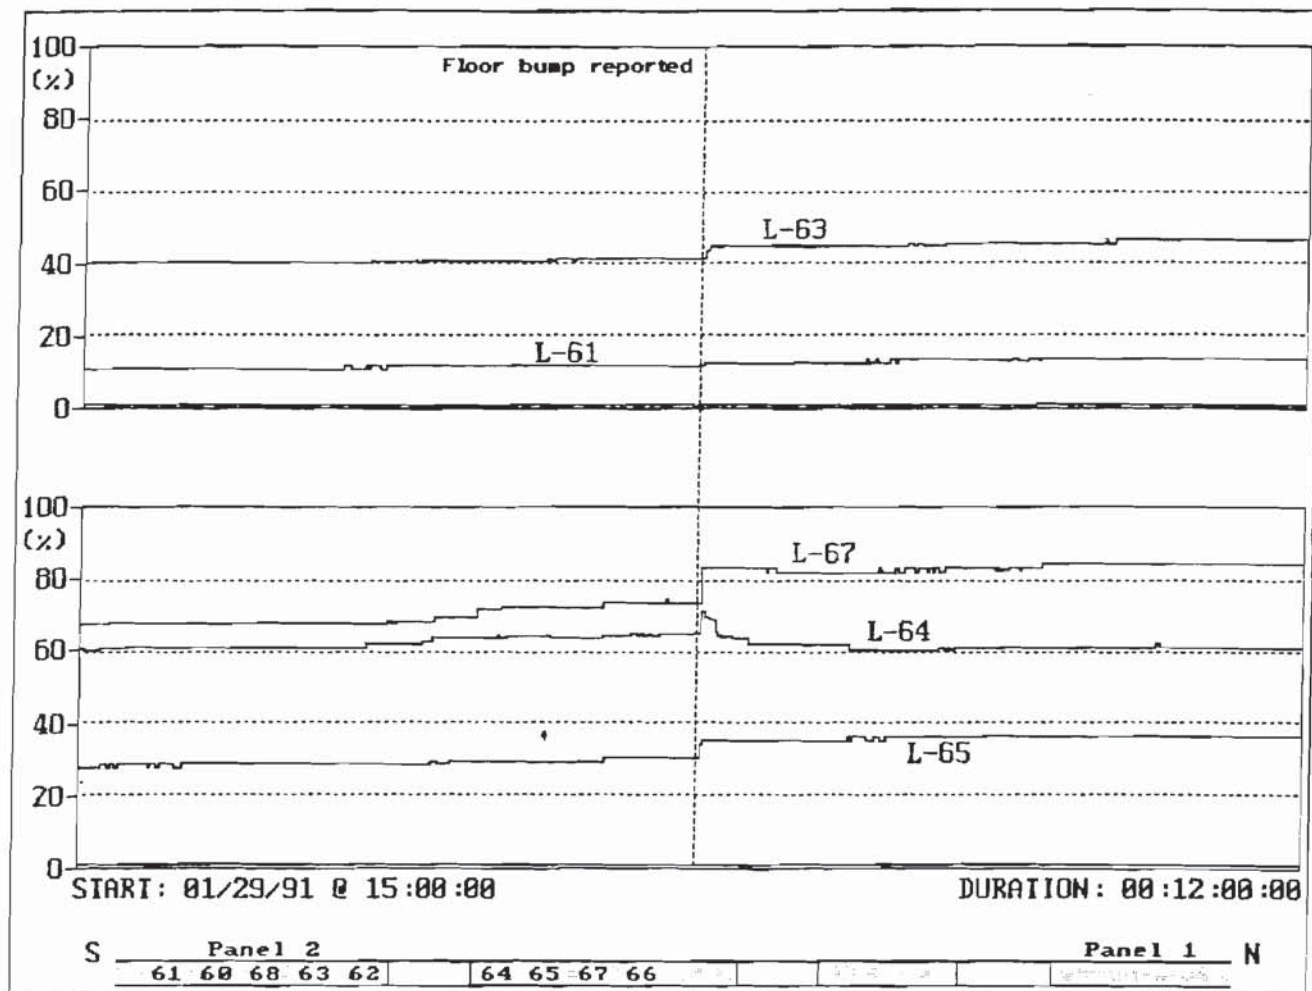
Figure 18

Computer Display of Gate Road Ground Pressure Changes Monitored During Floor Bump at Crosscut 6L-41.

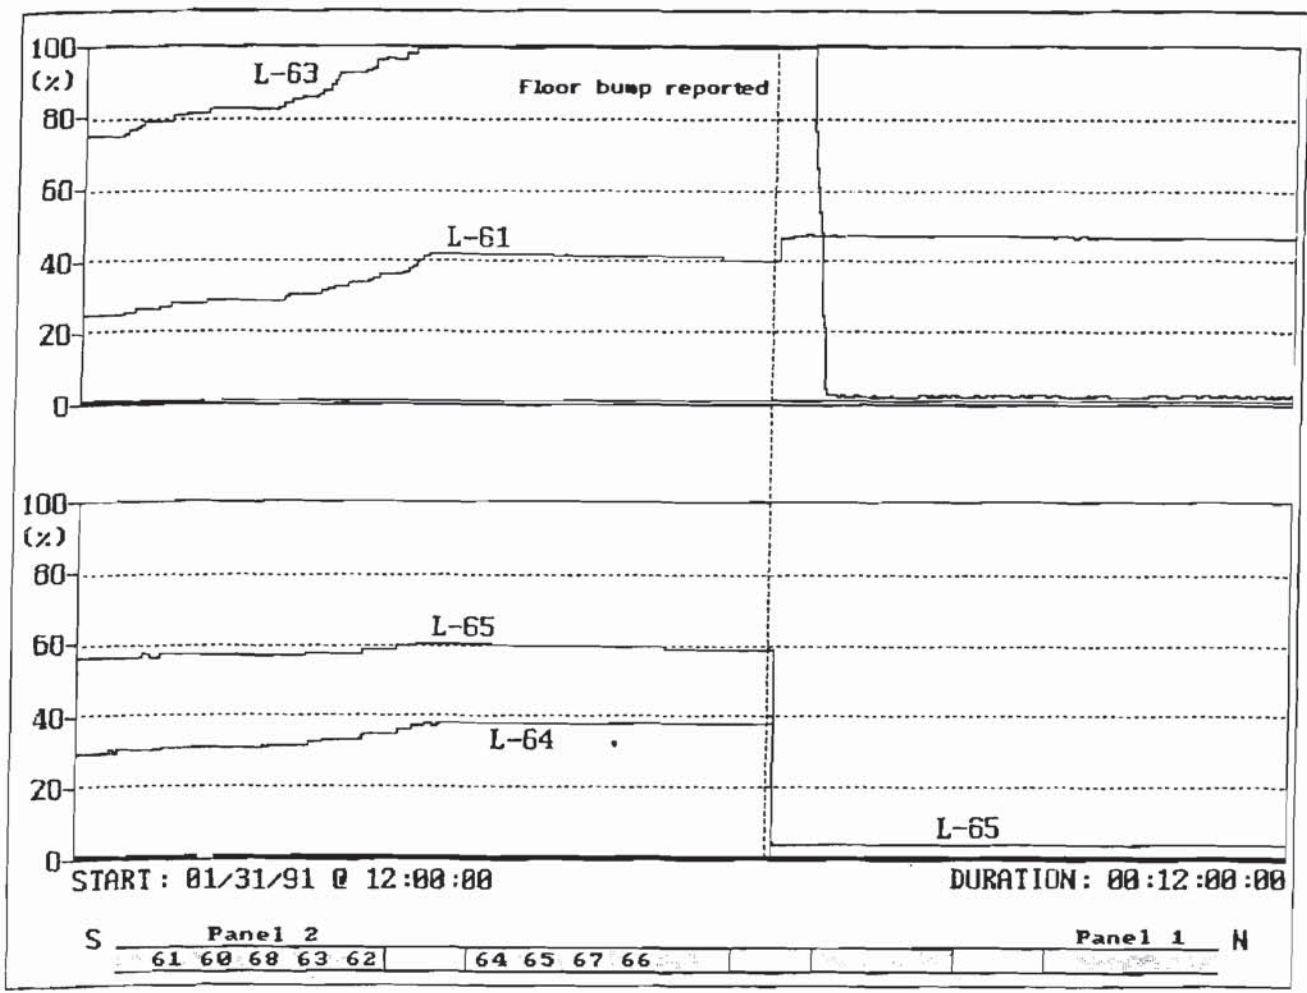
Figure 19  
Computer Display of Ground Pressure Changes Associated With Floor Bump Monitored Adjacent  
to Instrument Site 6L-40.

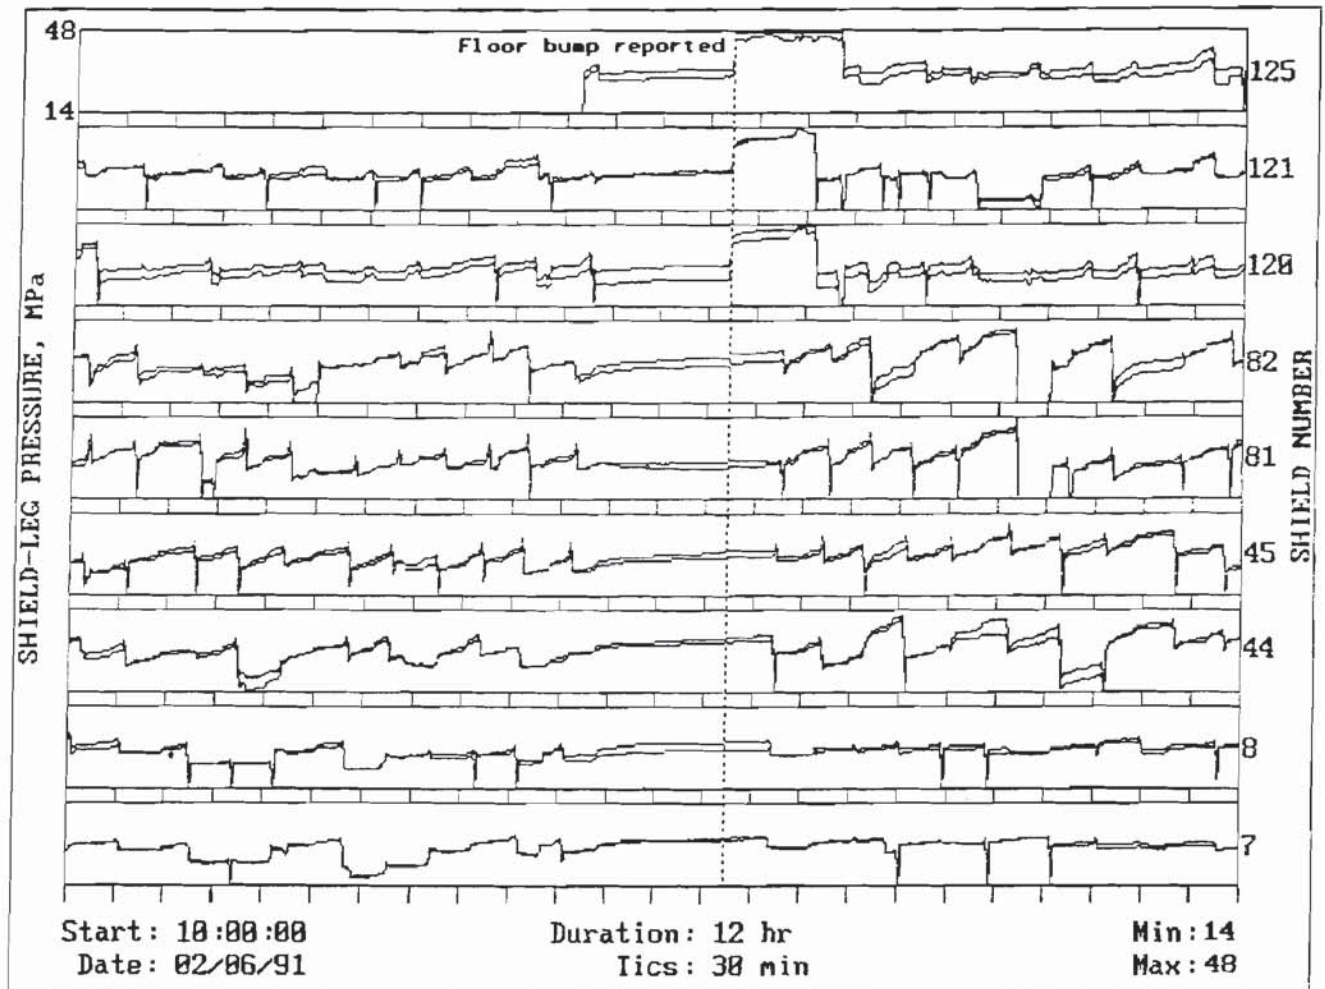
*Figure 20*

Computer Display of Characteristic Signature Plot of Shield-Loading Behavior During Floor Bump Monitored at Crosscut 6L-39.

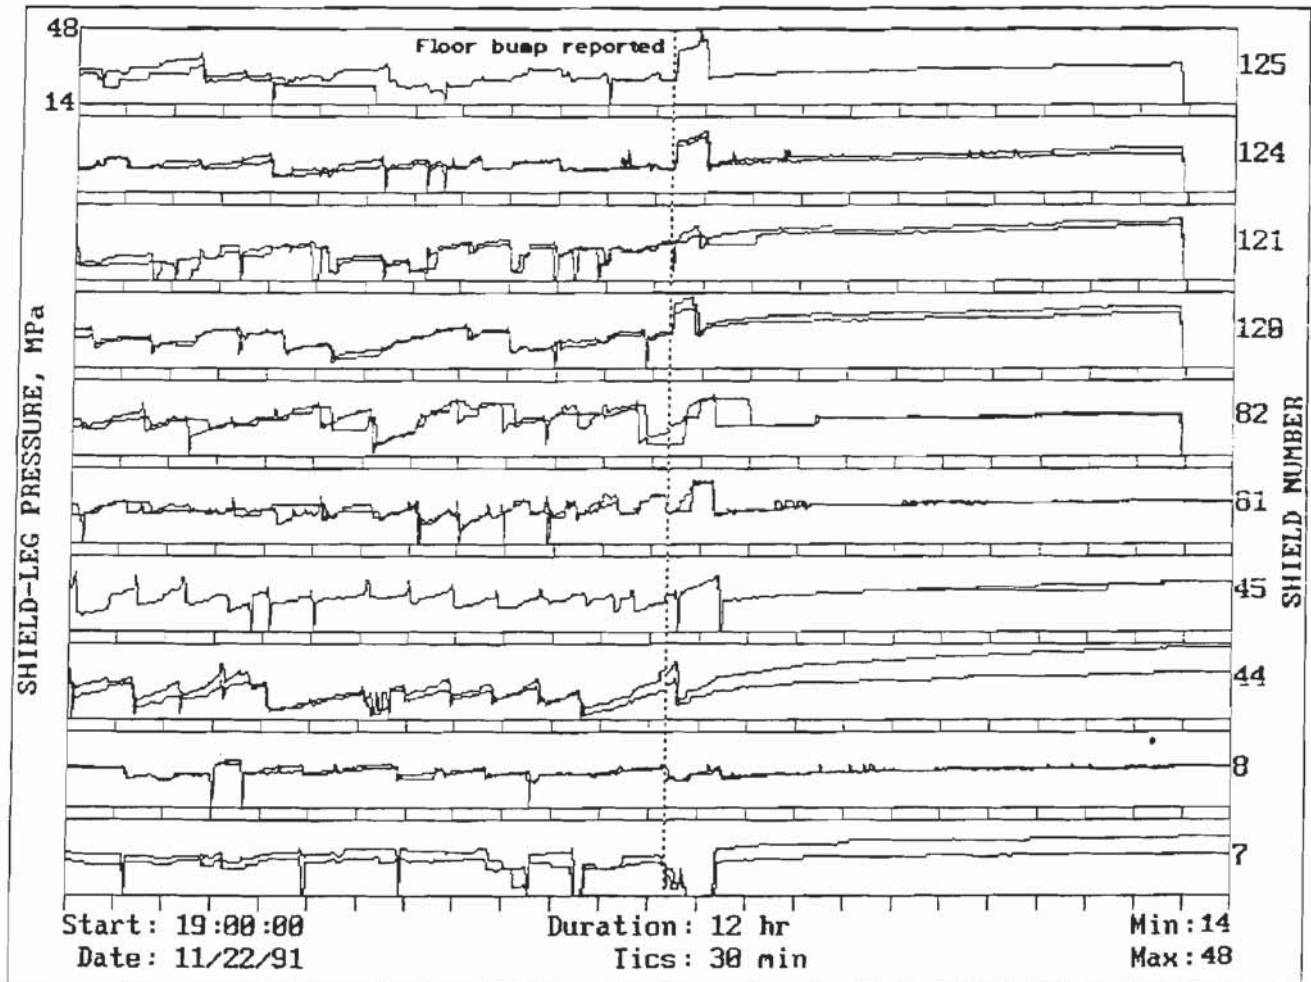
Figure 21

During the mining of panel 3, at least five consecutive tailgate floor bumps occurred as the longwall face passed through crosscuts 44, 43, 42, 41, and 40 during November of 1991 (figure 6). The characteristic bump signature was evident in shield pressure data for each of these events, as shown in figure 21, which is presented here as a representative computer display of panel 3 data. Three of these floor bumps caused severe damage to the tailgate roadway support structures (cribs and posts) outby the face, resulting in cessation of mining operations until re-support of the roadway could be effected.

Representative Computer Display of Panel 3 Shield-Loading Behavior During Tailgate Roadway Floor Bumps.

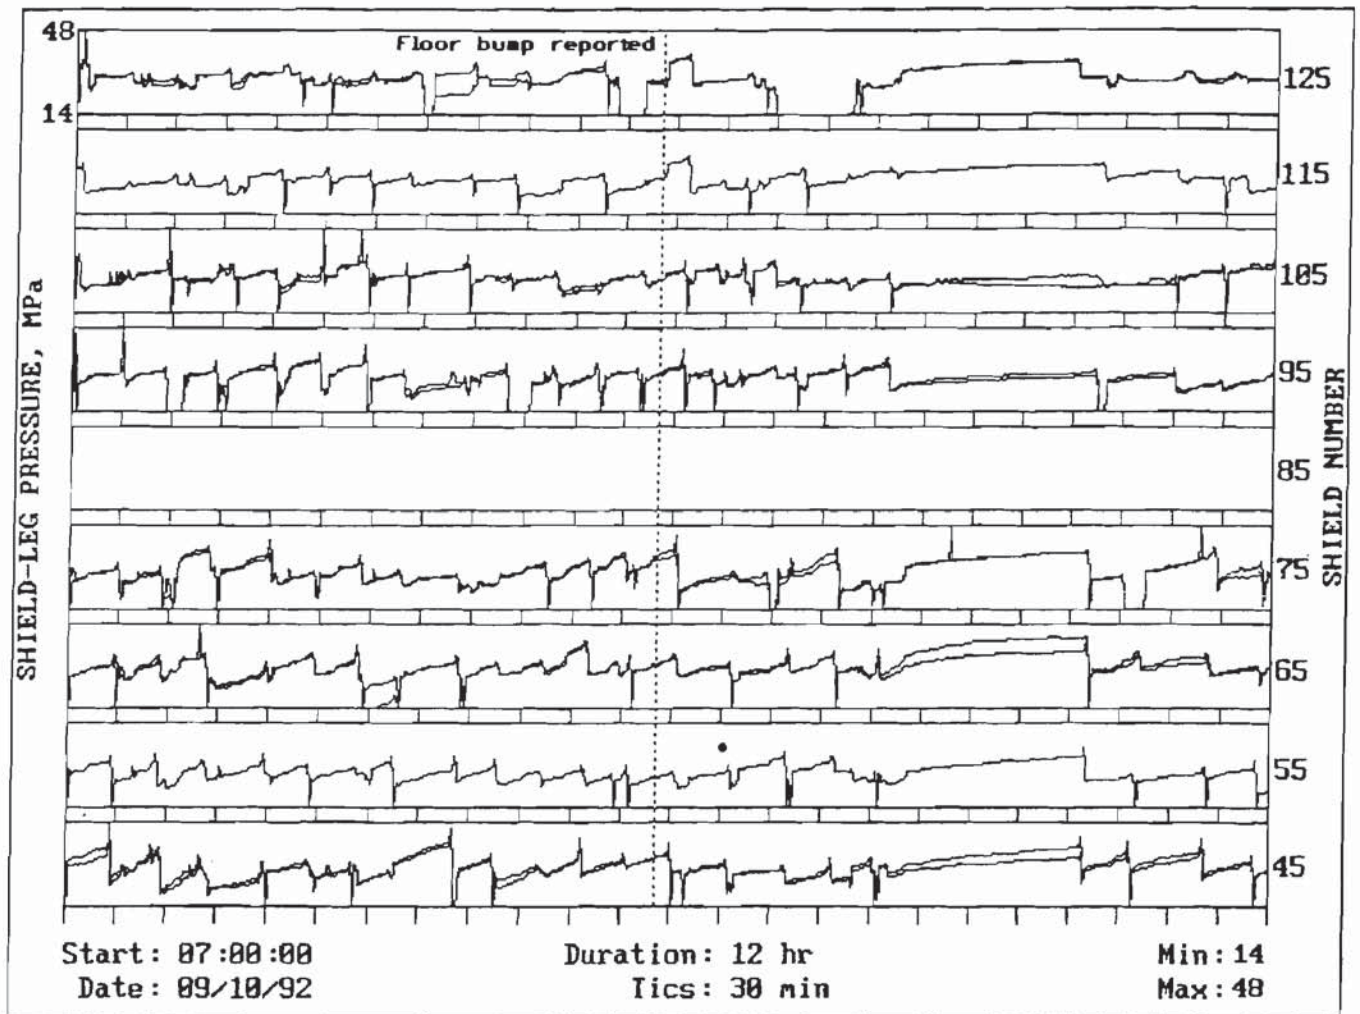
*Figure 22*

A similar set of data was collected for floor bump events that occurred during the mining of panel 4 (figure 6). Each of the tailgate floor bumps monitored during the mining of panel 4 produced the same characteristic floor bump signature, as shown by the example computer display presented as figure 22.

Representative Computer Display of Panel 4 Shield-Loading Behavior During Tailgate Roadway Floor Bumps.

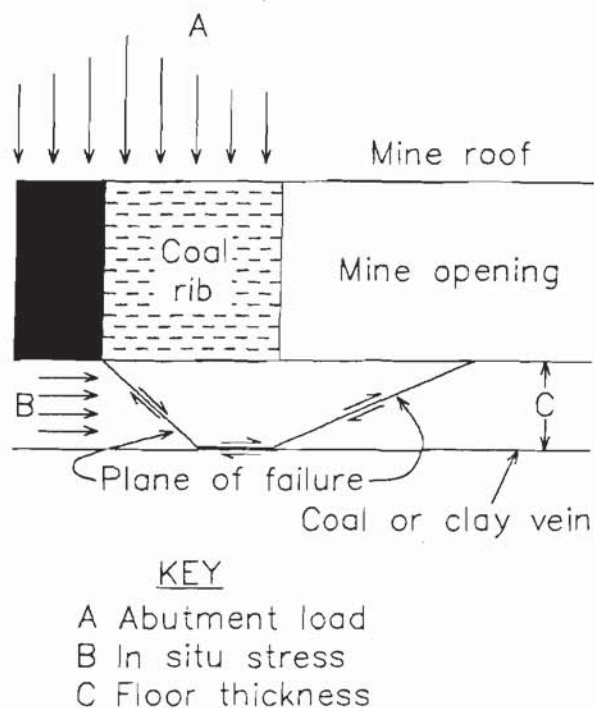
The catastrophic tailgate roadway closures typically involved instantaneous floor heave associated with rib spalling and pillar sloughing for a distance of approximately 25 m (80 ft) outby the active face (14). In general, the floor bump problem is believed to be related to stiff floor rock conditions. It has been observed that when the tailgate ground conditions are "soft" and roadway convergence is in the range of 15 cm (0.5 ft) or more, catastrophic failure of the tailgate floor and adjacent pillar does not occur. However, when the tailgate ground conditions are "stiff" and entry closure is less than 10 cm (0.4 ft) at the tailgate, catastrophic gate road ground failures usually occur as the face passes through the roadway crosscut. The catastrophic ground failures are usually severe enough to dislodge support structures (i.e., cribs and props) and shut down face operations until the roadway ground structures can be repaired or replaced. In the bump-prone regions of the mine, the immediate floor consists of a relatively strong bed of thin sandstone underlain by a much weaker layer of interbedded coal and clay stringers. This weak layer forms the initial failure plane for the abrupt failure and extrusion of the immediate floor from beneath the adjacent coal ribs when the

instantaneous floor heave and associated rib sloughing occur, as shown schematically in figure 23 (15). Thus the relative thickness and strength of the immediate floor strata are thought to be the critical factors in determining the relative stability of the tailgate roadway as it is subjected to the increasing ground pressures of the abutment zone created by the retreating longwall panel. Several methods of preventing and/or controlling the floor bumps were devised to facilitate the safe and efficient operation of the longwall panels. Destress blasting of the immediate floor of the tailgate roadway was adopted as being one of the most effective methods of preventing abrupt tailgate floor heave (15) and was used successfully to prevent serious floor bump problems during mining of the fifth longwall panel at the test mine.

**Figure 23**  
**Schematic of Floor Bump Failure Mechanism.**
