Analysis of Bench Crest Performance at the Yellowstone Mine: A Case Study

A case study is presented that relates statistical descriptions of joint sets to the distribution of local wedge failures along the crest of a catch bench at the Yellowstone Talc Mine. The fracture sets and bench width were mapped by teams of geological engineering students from Montana Tech under the direction of Dr. Mary MacLaughlin. The students analyzed the fracture data, conducted physical property tests, and used a beta version of a NIOSH program "Bwedge" to predict the distribution of surviving bench widths. In the course of this analysis the students developed evidence of software performance issues that, unfortunately, frustrated their analysis. These have now been addressed and a full analysis completed. The analysis confirms the validity of the student mapping program and provides insight into the effects of blasting and excavation practices on the bench. It also provides a tool for exploring the pattern of bench crest failure that would result from variations in both bench geometry and blasting practices.

II. North Bench, Yellowstone Mine

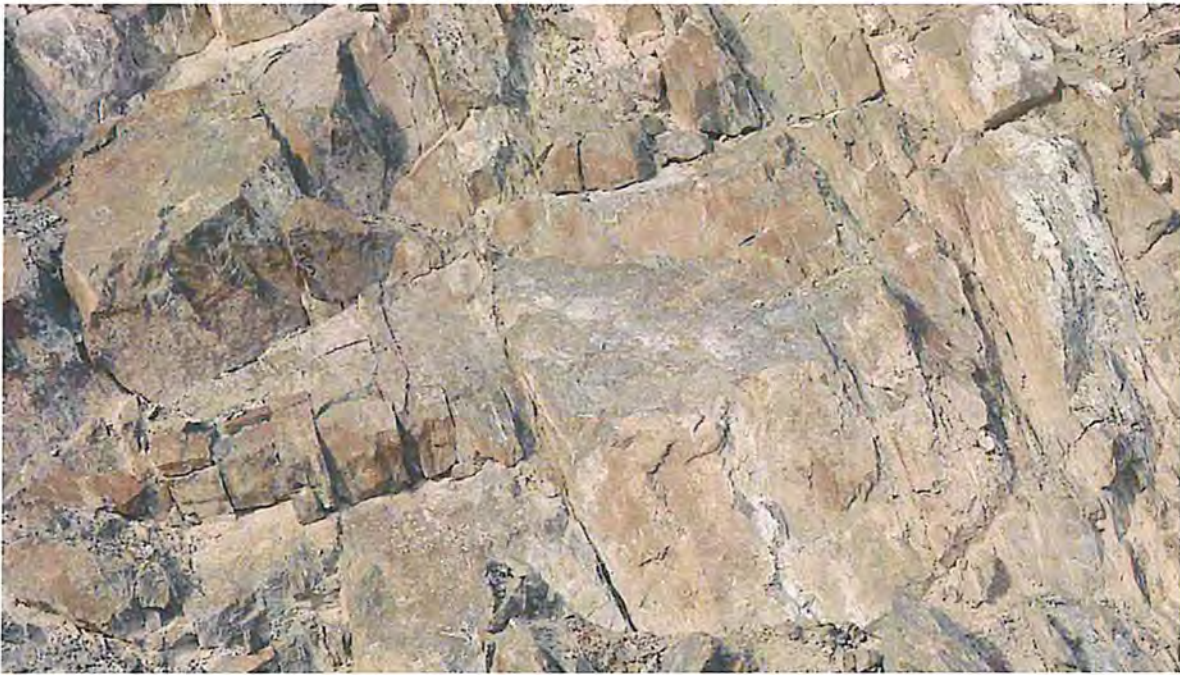
The study focused on a 90 m (300 ft) section of a single bench within the north wall of the south pit in hydrothermally-altered dolomite of Precambrian age. This rock is overlain by Tertiary age Huckleberry ridge tuff. Severe fracturing of the dolomite appears to form at least four major sets (figure 1). Fractures are likely related, at least in part, to movement along a major fault that runs through the pit, striking N-NW with near vertical dip. This fault lies adjacent to the west end of the study scan line. The rock mass was classified as "Fair" for the RMR and "Very Poor" for the "Q" system (Appendix A).

Figure 1: Fractured rock on a bench face.

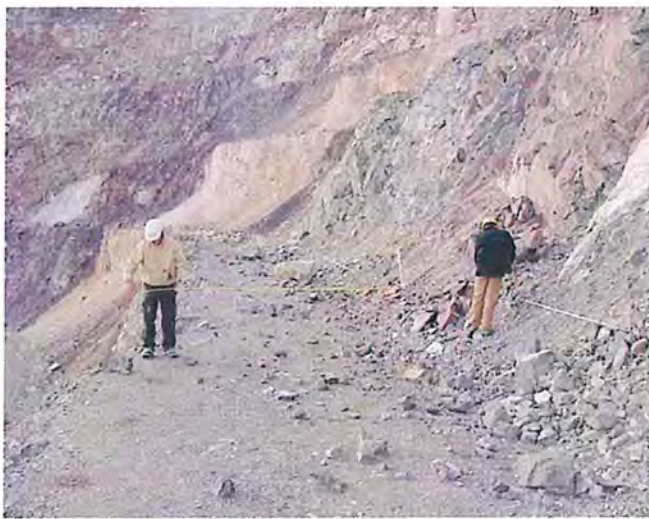
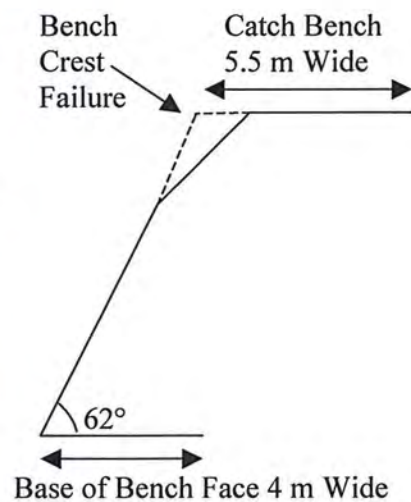
The overall slope angle of the north wall was measured by Brunton compass at roughly 40° . Benches are 7.6 m (25 ft) high with an estimated intact bench width of 5.5 m (18 ft) and bench face dip of 62° . However, the students found that the bench crest was intact at only a handful of locations along the study bench section (figure 2). Widths measured along the study bench are plotted in figure 3. Narrower sections of bench were caused primarily by wedge failures of various sizes along the bench crest (figure 4). Wedges were formed by, and have slid upon, pre-existing fracture planes.

Figure 2: Students measuring the bench width and idealized cross section.

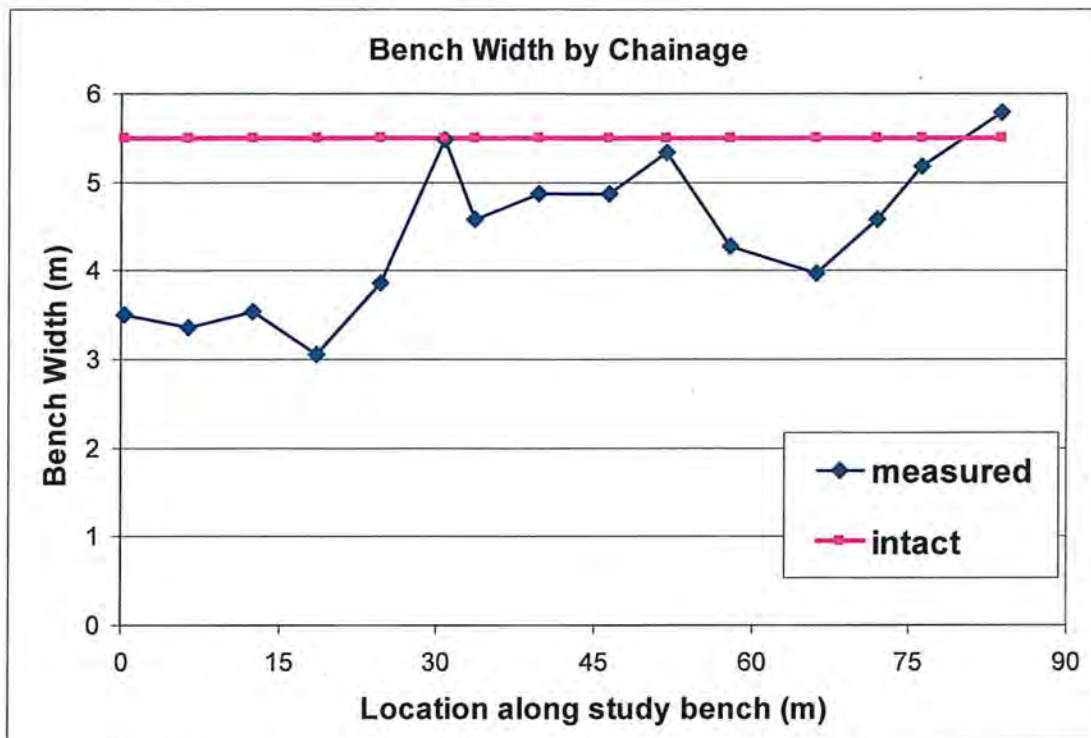
Figure 3: A plot of measured bench widths by distance along the mapped section of the study bench.

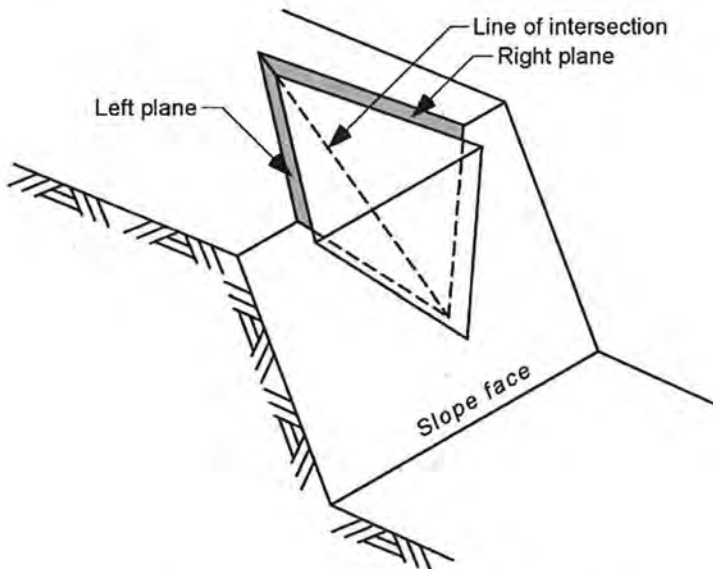
Figure 4: Idealized wedge geometry showing left and right fracture planes.

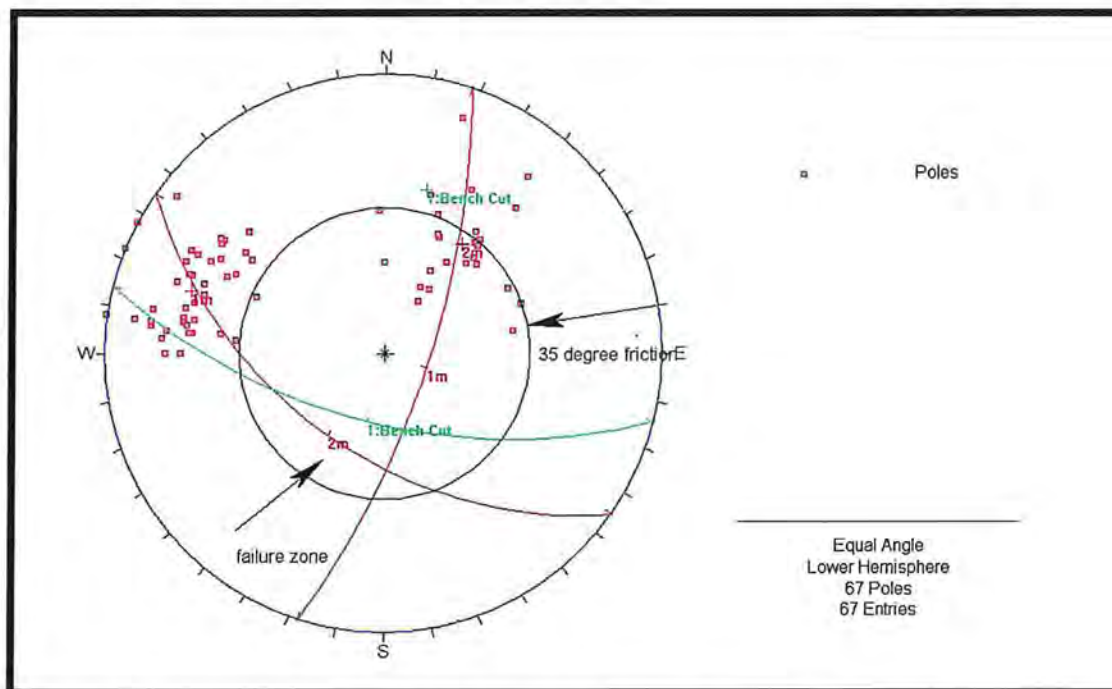
Figure 5: Stereonet plot of joint poles, joint set average orientations and pit slope.

A first cut analysis of wedge stability was developed as shown in figure 5. Bench slope, average fracture-set orientations and the wedge formed by “average” fractures were plotted to show that the wedge formed by set “average” fractures daylight in the bench face. The plunge of the fracture set intersection beneath this wedge was found to be steeper than a 35° friction angle circle, a typical joint friction angle. Thus, failure of such a wedge is likely. Plane failure on the joint set is also possible but its apparent dip in the bench cross section is flatter than the plunge of the wedge fracture plane intersection. Thus, wedge failure will be preferred where both are possible. This tendency is evident in the predominance of wedge failures observed in the field.

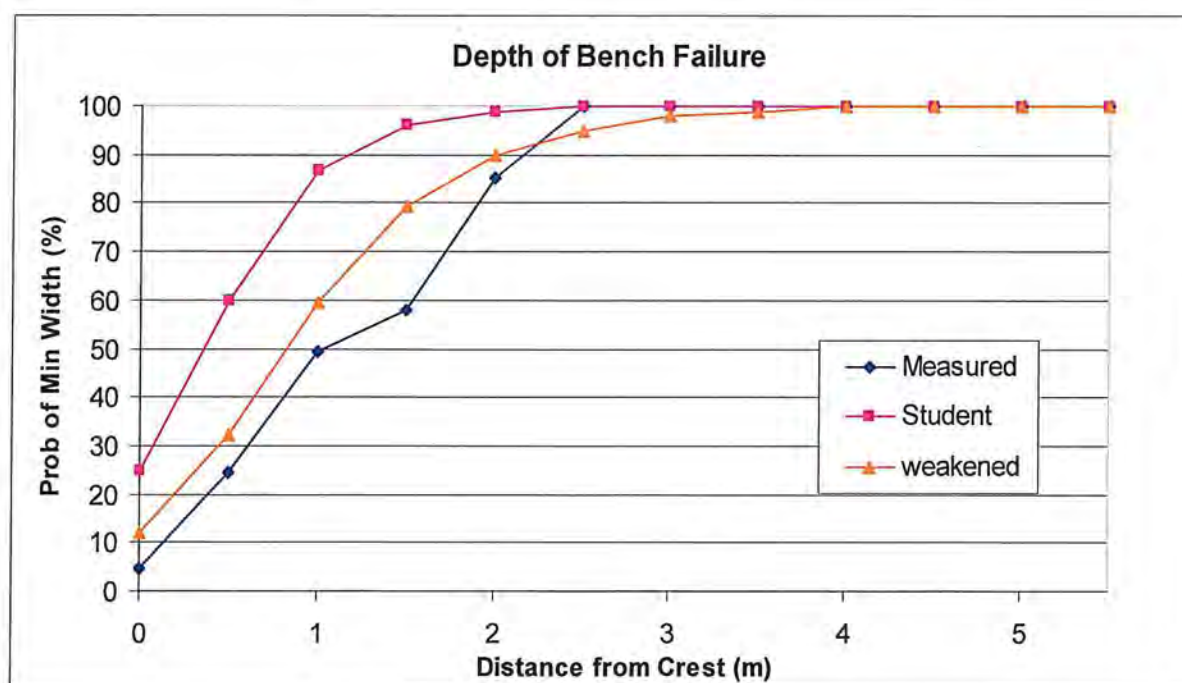
Figure 6. Estimates of the probability of losing various widths of bench to crest failure based on (1) measurements, (2) a model using the student set of fracture parameters and (3) a set of weakened parameters.

An attempt was made to explore the effects of blasting on the bench model by weakening fracture strength. The friction angle was decreased from in situ to saw-cut values and the stabilizing influence of fracture waviness removed. Bwedge runs using these weaker values more closely fit observations for the outer bench, but also underestimate retention deeper into the bench – which is also more sheltered from blasting. This result suggests that the student set of parameters may well describe the fracturing in situ, prior to the influence of blasting. To the extent that this proves to be the case, the overall slope angle could be steepened, while preserving both bench face angle and effective bench width, through more careful blasting. If all blasting effects were removed, and a 90% probability of maintaining a minimum bench width was desired, benches could be narrowed by a full meter. The overall slope angle could be steepened by about 5°, to roughly 45°.

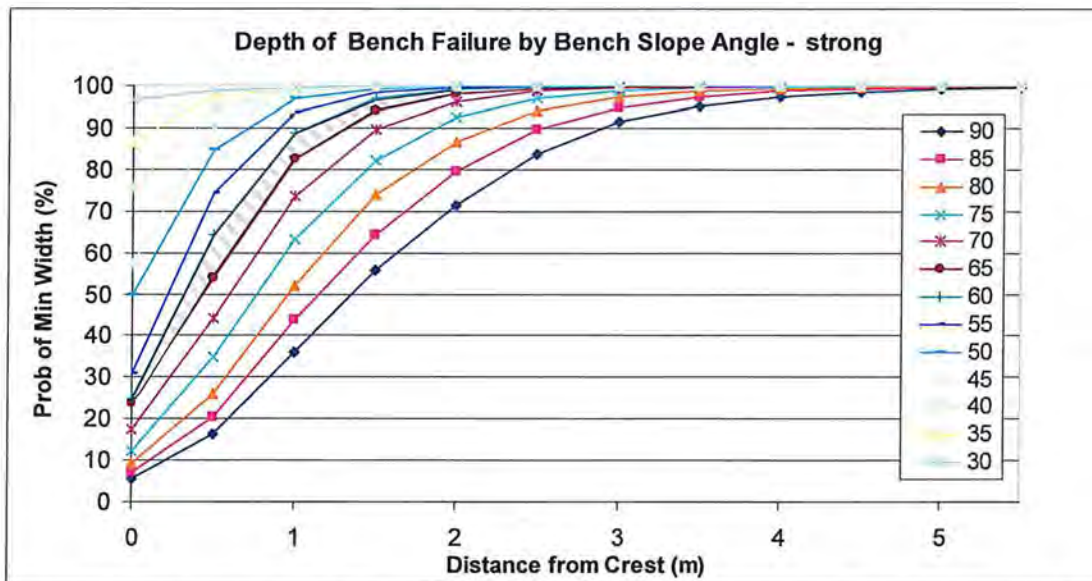
Figure 7. Plot shows probability of bench failure to various depths for various bench face angles. Curves for steepened slopes are, in sequence, below and to the right of the shaded interval which indicates the actual bench face angle. Curves were computed with Bwedge using the “strong” set of fracture properties.

For example, we can examine the current design for strong properties (figure 7) and a threshold probability of 90%. Recall that this chart is most relevant when failure extends into rock that is not weakened by blasting. For instance, when careful blasting practices are used or steepening of the bench face pushes failure deeper into the bench. With the current design, the sacrificial width is a little more than a meter. If the bench face were steepened to a vertical dip, the unreliable portion of bench width would increase to more than 3 m. The bench width would have to be increased by a similar amount to maintain the necessary catch bench width.

Given a desired surviving bench width, figures 7 and 8 can be used to estimate the additional bench width that should be developed to allow for local crest failures. That is, the design should consist of a “sacrificial” width that will likely fail, at least locally, and a deeper “protected” width that should have a high probability of survival as a functioning catch bench. Obviously, steepening the bench face increases the sacrificial width while cutting this angle back reduces it. However, it is clear from these figures that it is not possible to completely eliminate crest failure, only manage how much must be dealt with.

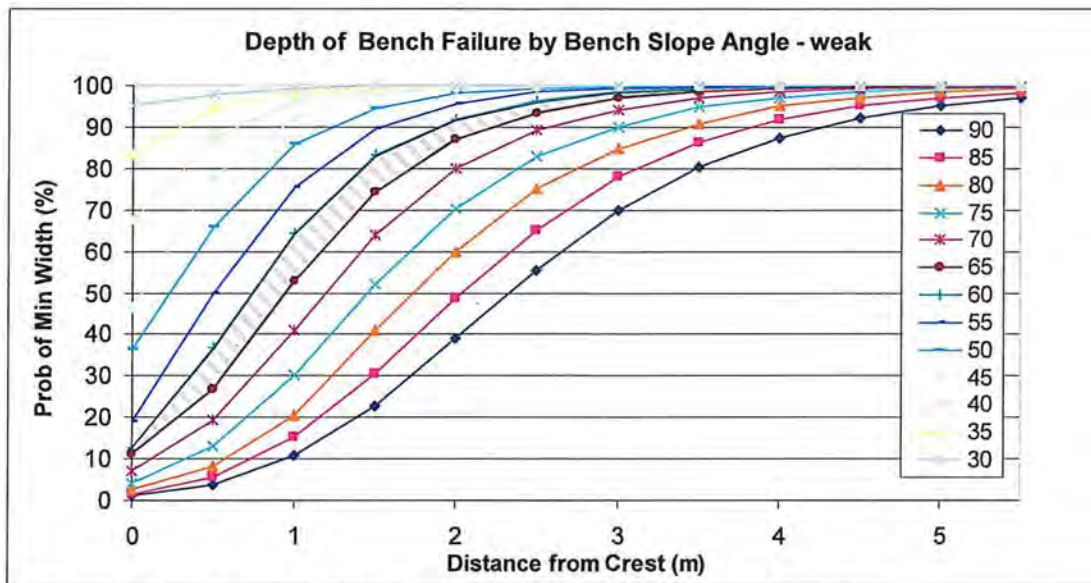
Figure 8. Plot of figure 7 recalculated for “weak” set of fracture properties.

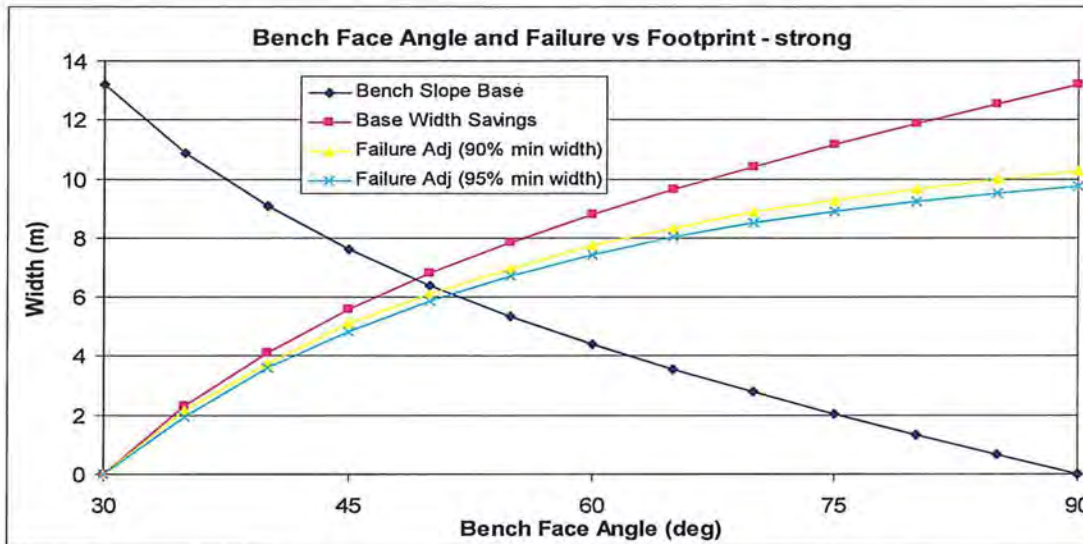
Bench footprints can be calculated for a variety of face angles (and other parameters) and the results used to obtain an optimal overall slope angle. This tradeoff is illustrated for this case in figures 9 and 10. The absence of an inflection point in these curves shows that a vertical bench face is optimal, at least for the wedge bench crest failure mechanism.

Figure 9: Bench slope footprint plotted as a function of bench face angle. The savings in footprint width are plotted for steepening of the bench face from an initial angle of 30°. These savings are then adjusted for a sacrificial segment of bench width containing crest failures with 90% and 95% probabilities. Sacrificial segment width was calculated with Bwedge using the “strong” set of fracture properties.

Other operational concerns might limit this angle, however. These considerations might include handling the increased volume of relatively intact material that is likely to fall out in crest failure wedges. It's also possible that other modes and scales of slope failure might be activated as the face is steepened.

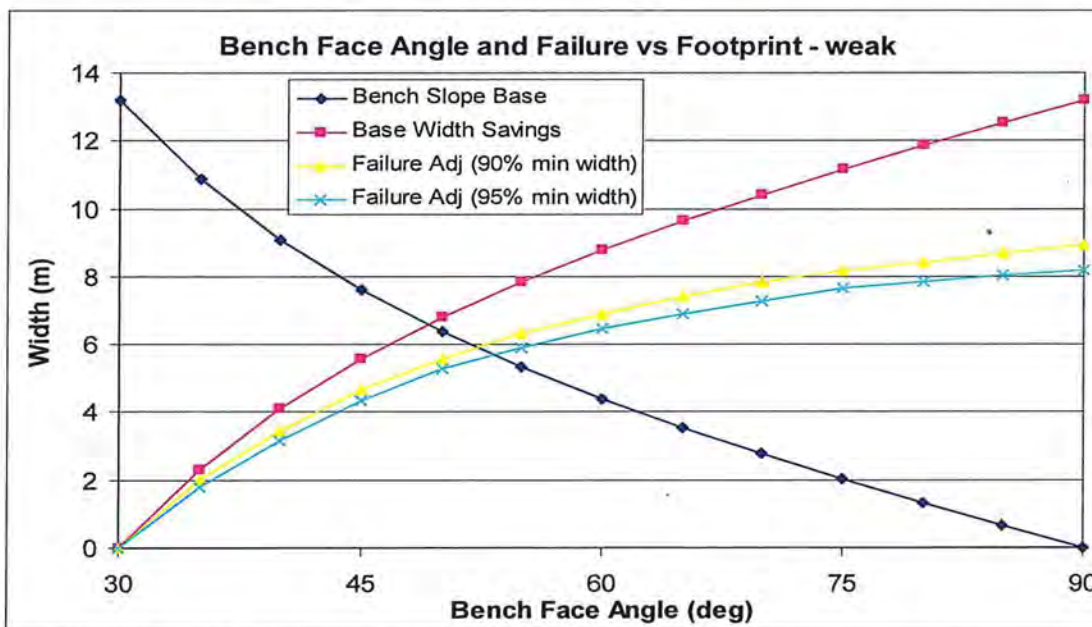
Figure 10: Plot of figure 9 recalculated for the “weak” set of fracture properties.

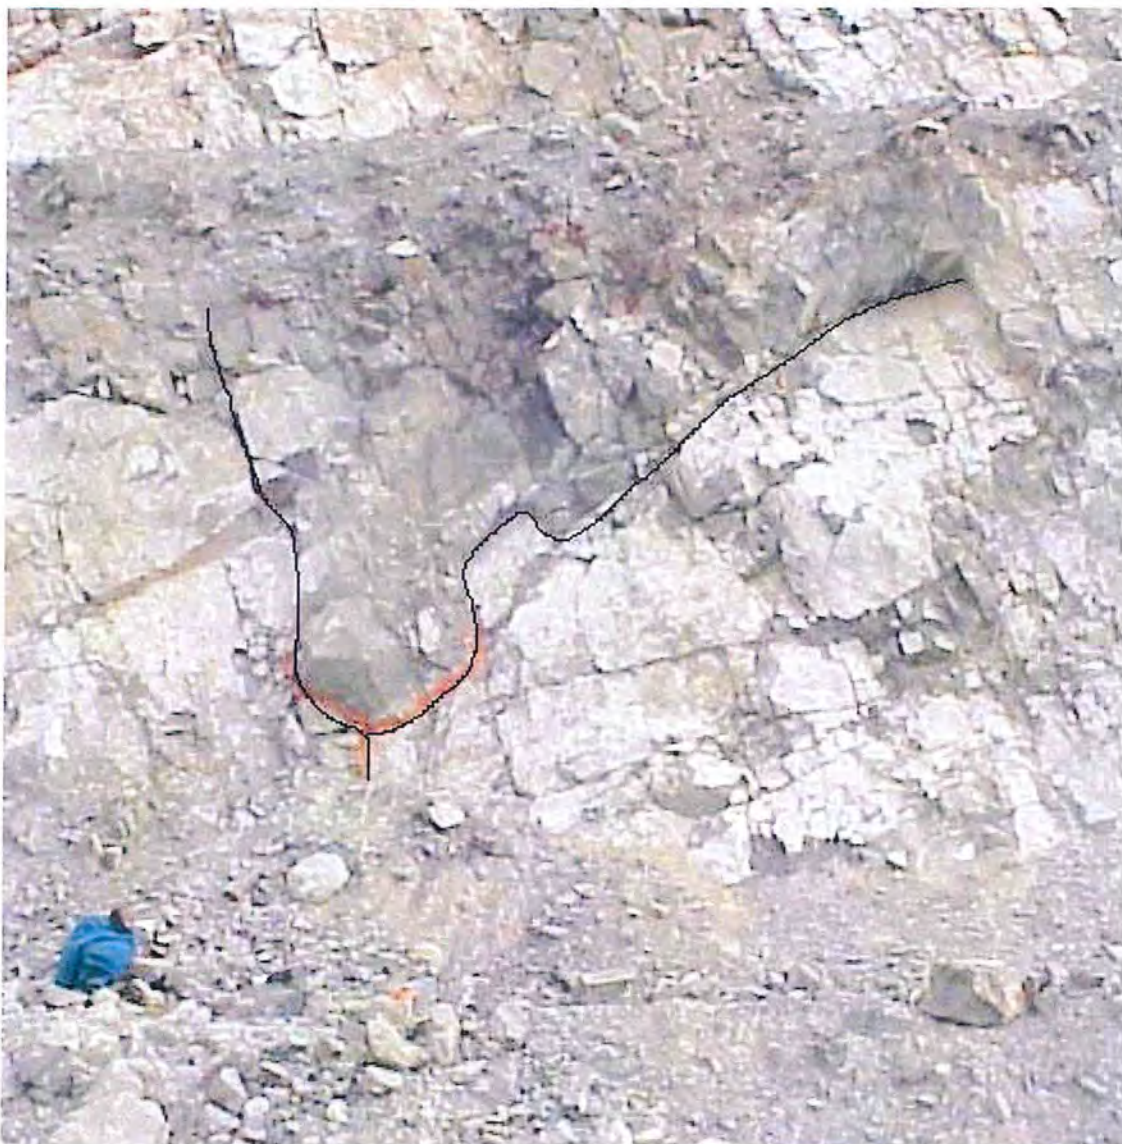
Wedge 1:

- Joint striking 132°, dips 53°, 6.1m (20 ft) long, cemented caliche infill up to 13 mm (½ inch) thick - broken in places and intact in others, waviness 26 cm (14 inches) amplitude over a 3 m (10 ft) wavelength.
- Foliation fracture striking 15°, dips 72°, 3.7 m (12 ft) long, infill broken, planar.
- Apex of partially failed wedge daylights 4.3 m (14 ft) from crest (photo below). (Note: 4.3 m (14 ft) depth of apex is longer than the foliation fracture, because of rubble on top of the wedge. The actual fracture length was likely longer than 3.7 m (12 ft) before blasting.)

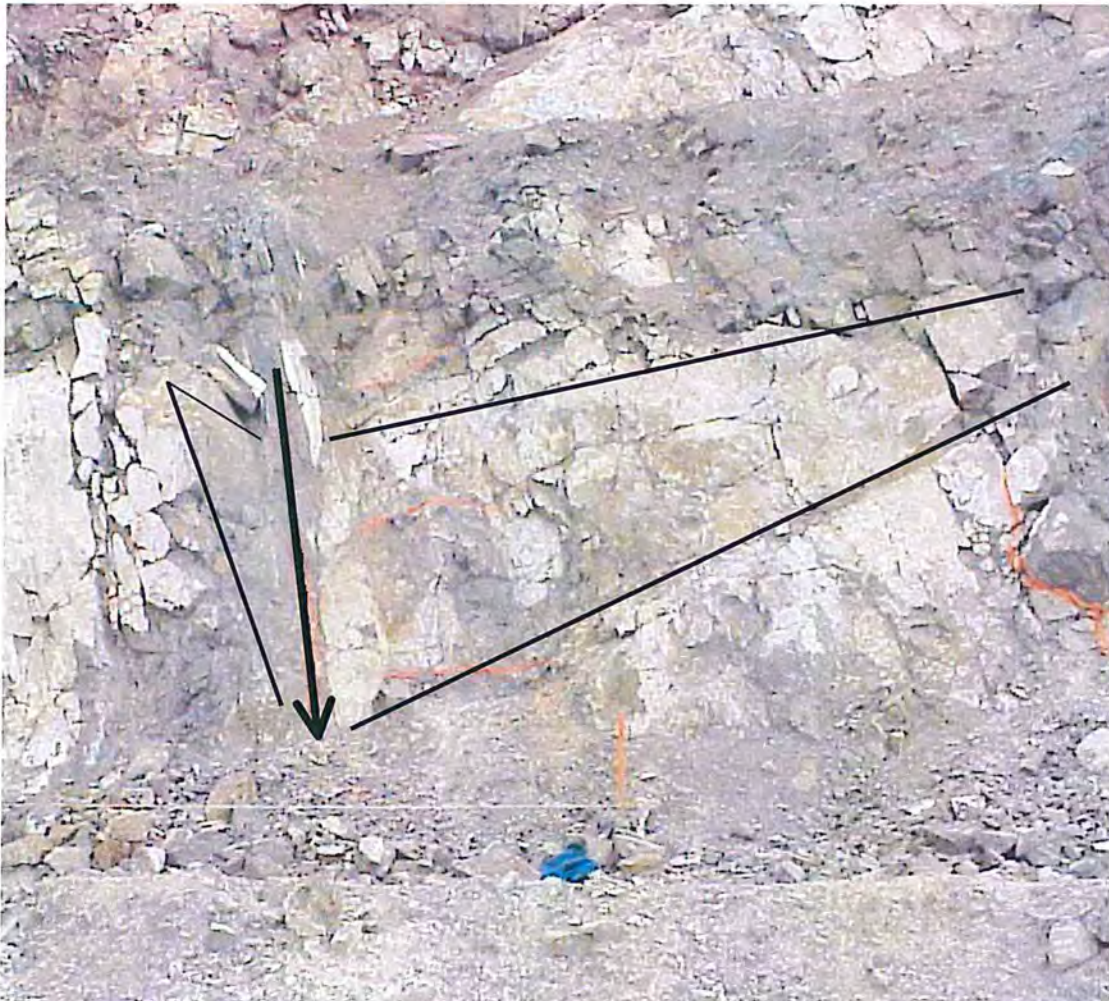
Wedge 2:

- Joint striking 113°, dips 51°, 6.1 m (20 ft) long, cemented caliche infill with steps, waviness 2 cm ($\frac{3}{4}$ inch) amplitude over a 15 cm (6 inch) wavelength.
- Foliation fracture striking 20°, dips 70°, 6.1 m (20 ft) long, open fracture with caliche infill.
- Failed wedge apex daylights 6.1 m (20 ft) from crest (photo below). Arrow traces apex of steeply dipping wedge and lines illustrate sliding planes. Bench crest is near the top of the picture.
